**UNDERGROUND  
STORAGE TANK  
REMOVAL AND  
CLOSURE REPORT**

**CONTINENTAL BAKING  
COMPANY FACILITY  
6841 VILLAGE PARKWAY  
DUBLIN, CALIFORNIA**

October 11, 1993

**Woodward-Clyde**

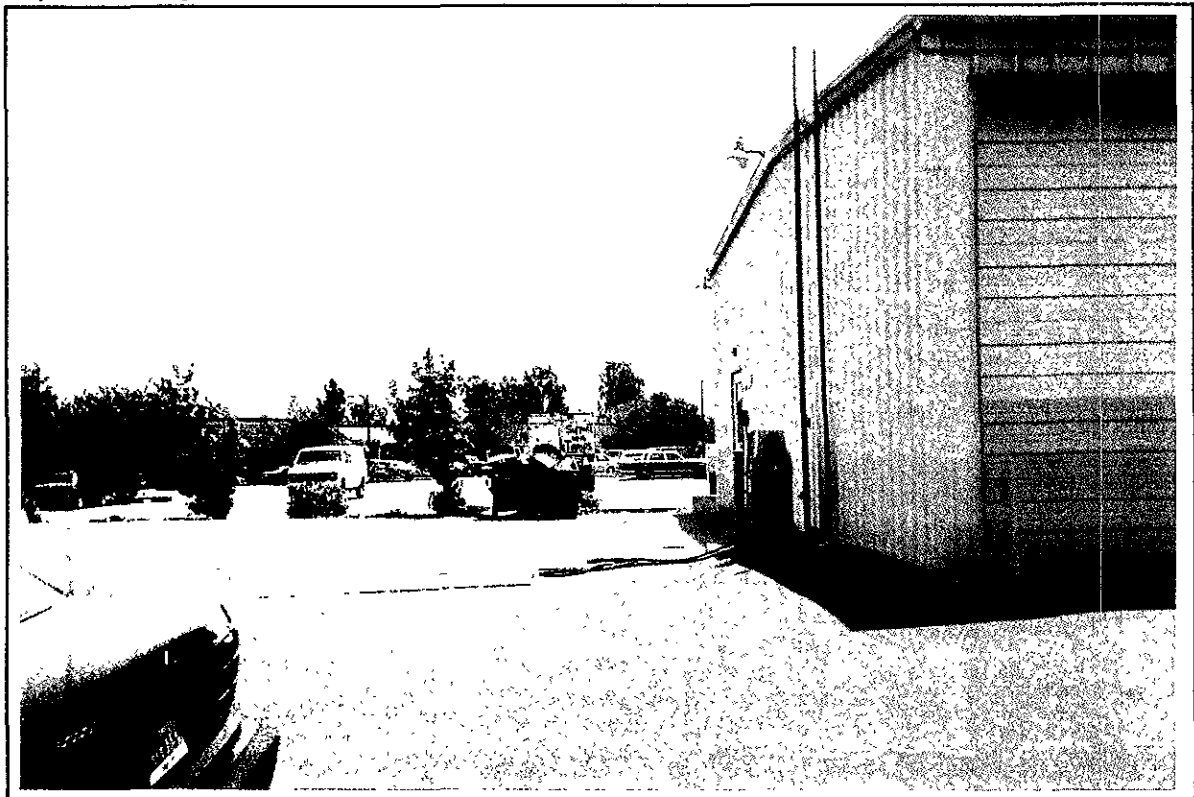
May 7, 1992: Dispenser and UST vent lines before removal (facing southeast)

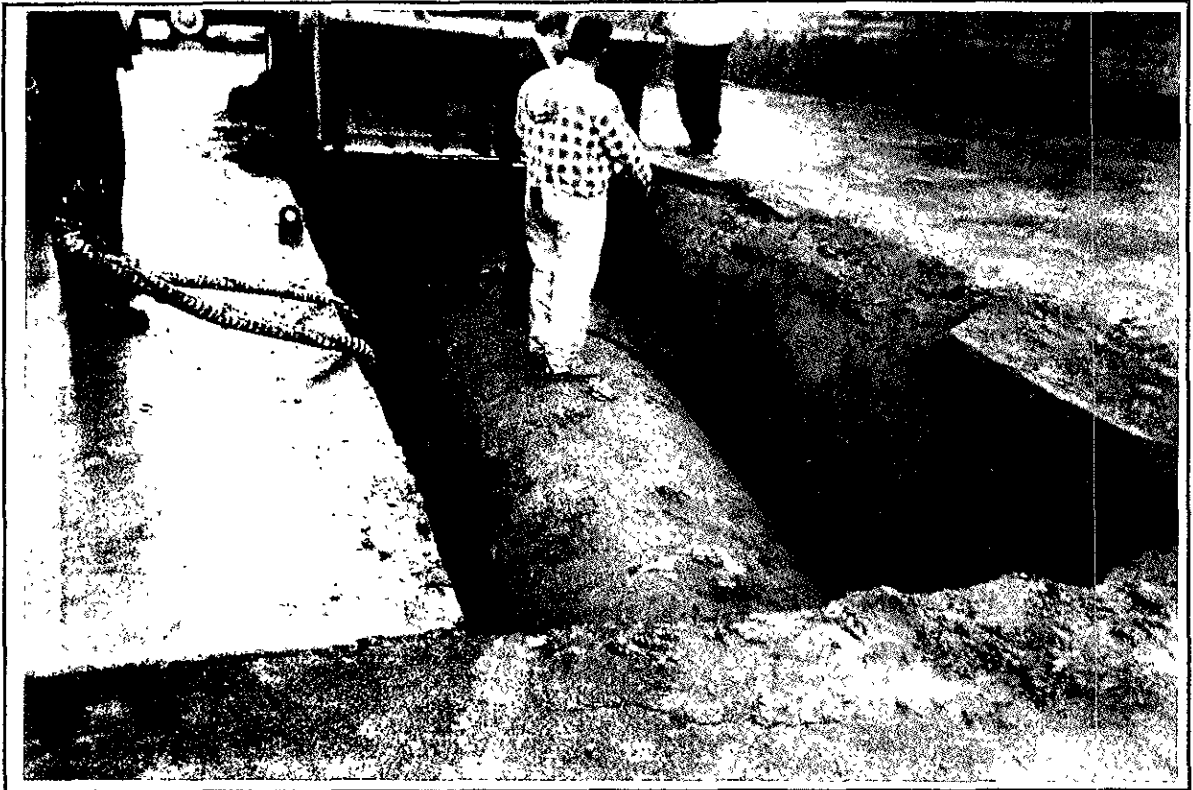
December 17, 1992: Top of UST during removal activities (facing north)

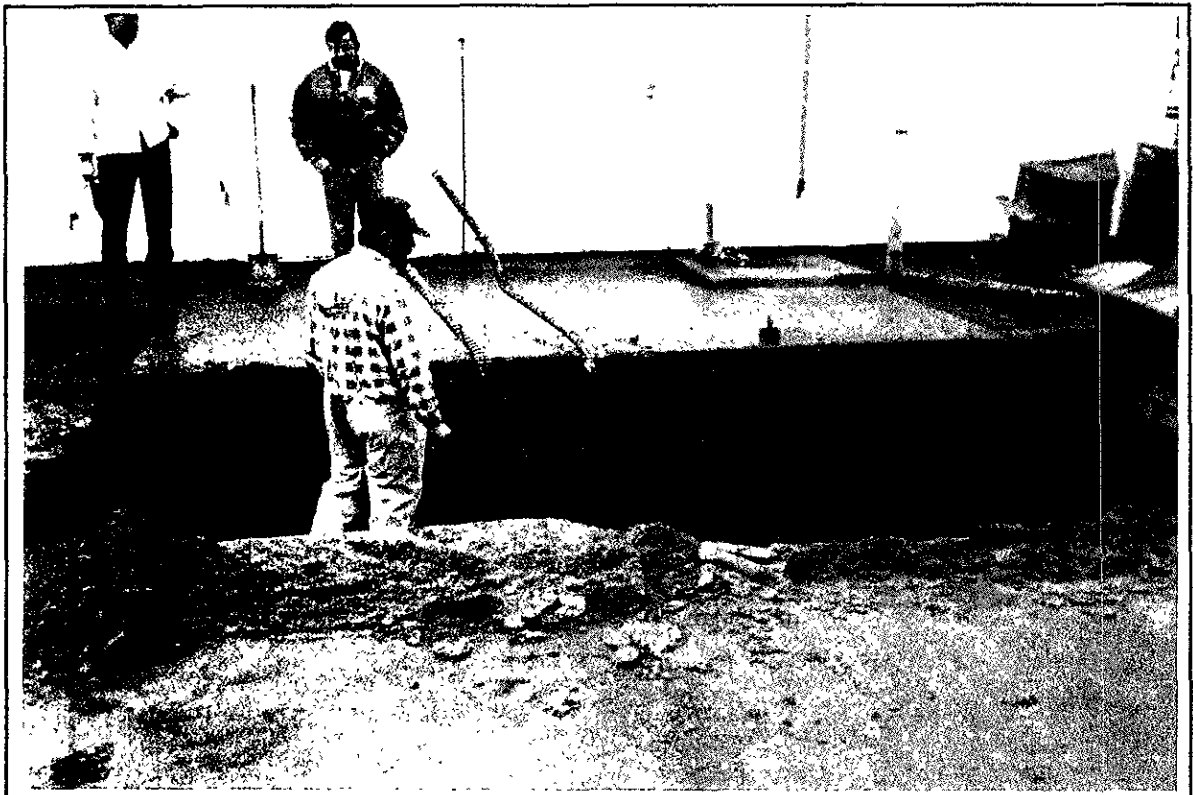
After the UST had been removed from the excavation, it was subjected to an above-ground inspection by the County Health Inspector. The UST apparently had been heavily wrapped and thickly coated to protect it from corrosion. No significant signs of rust nor holes were found in the tank during the above-ground inspection. The steel underground piping was also protectively wrapped. No perforations were observed in the short lengths of piping, which had been bent during the excavation process.

December 17, 1992: Product and vent lines during removal activities (facing west)

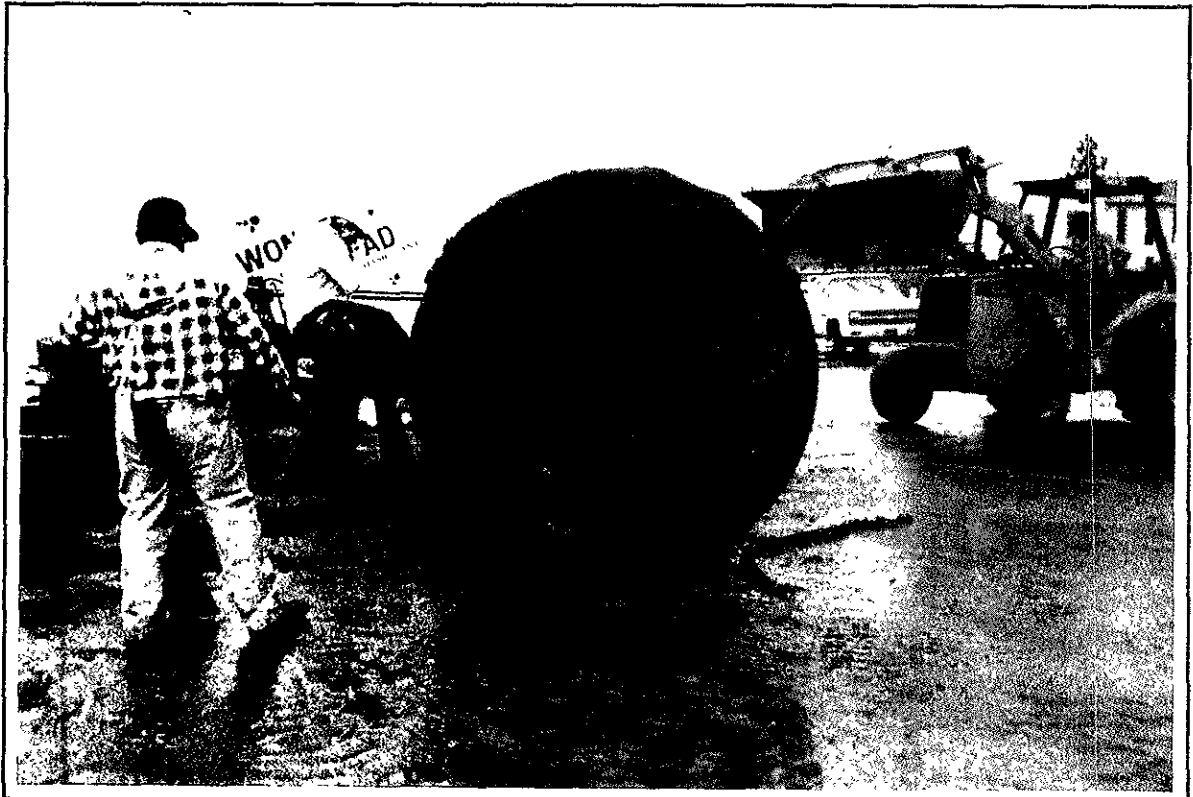
December 17, 1992: South end of UST immediately following removal

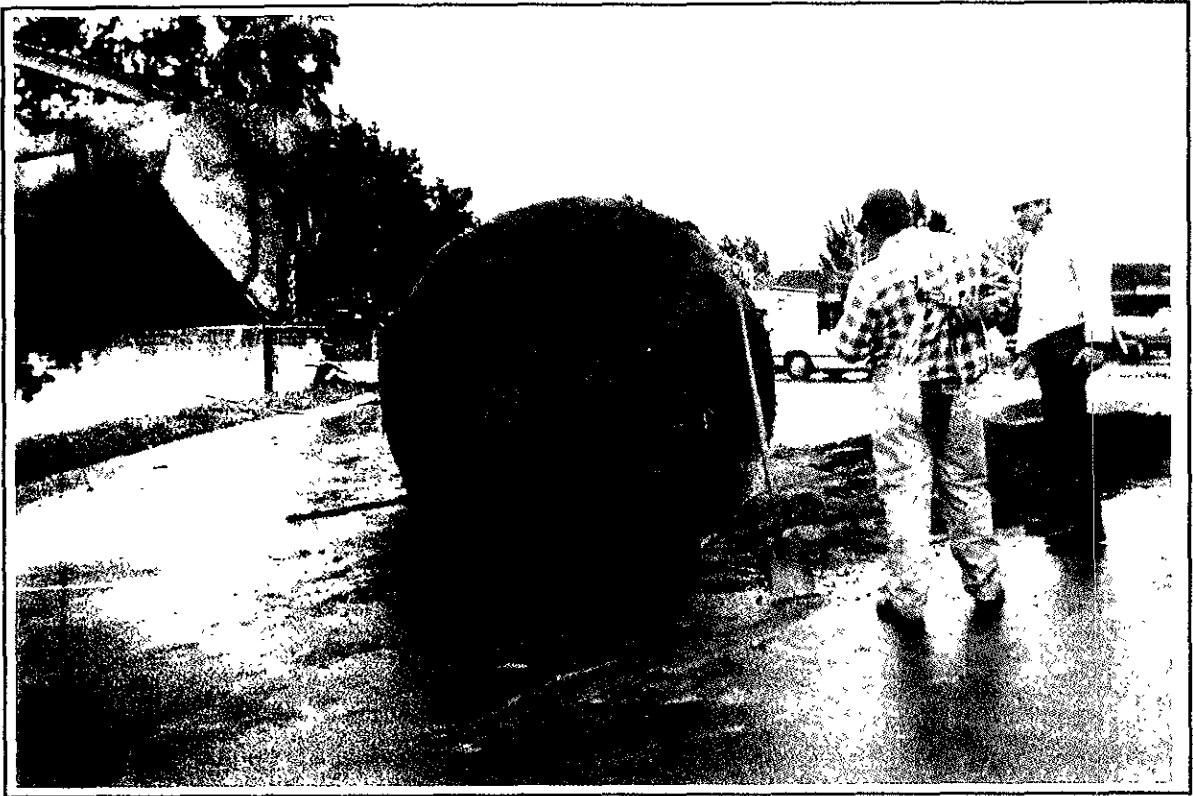
December 17, 1992: North end of UST immediately following removal

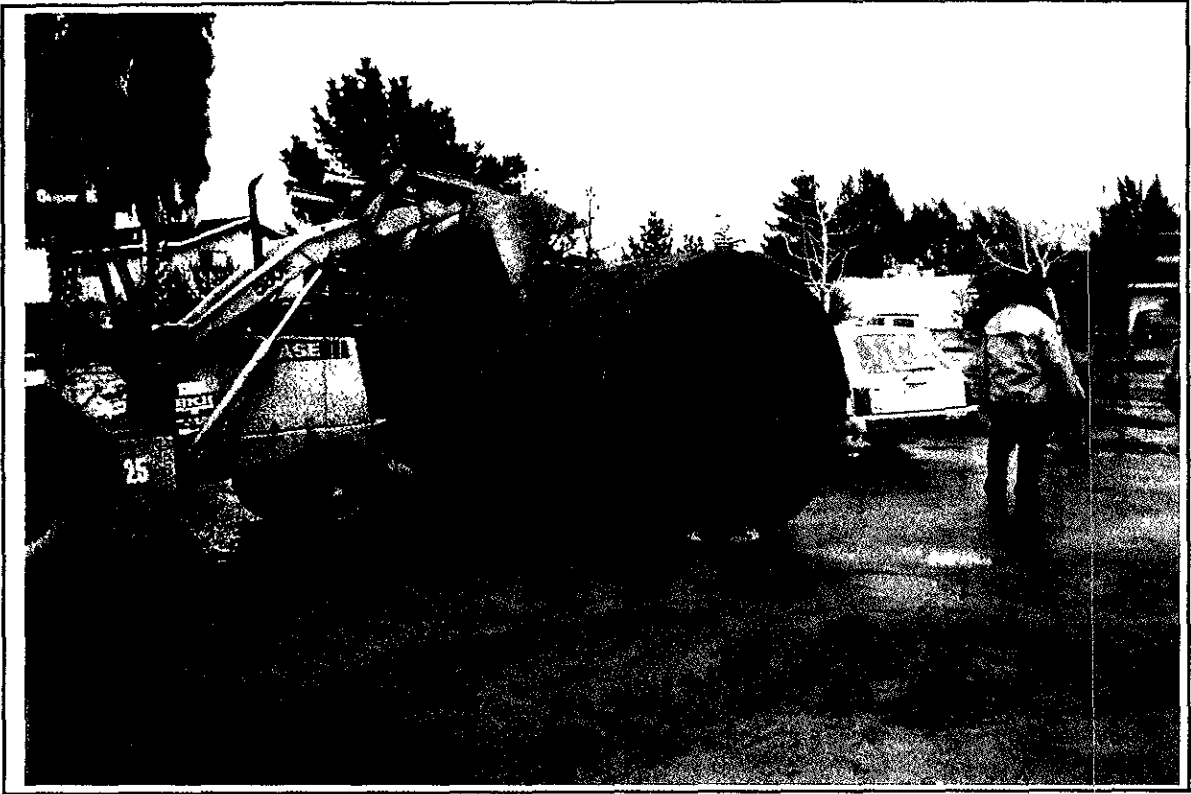
December 17, 1992: East end of UST immediately following removal

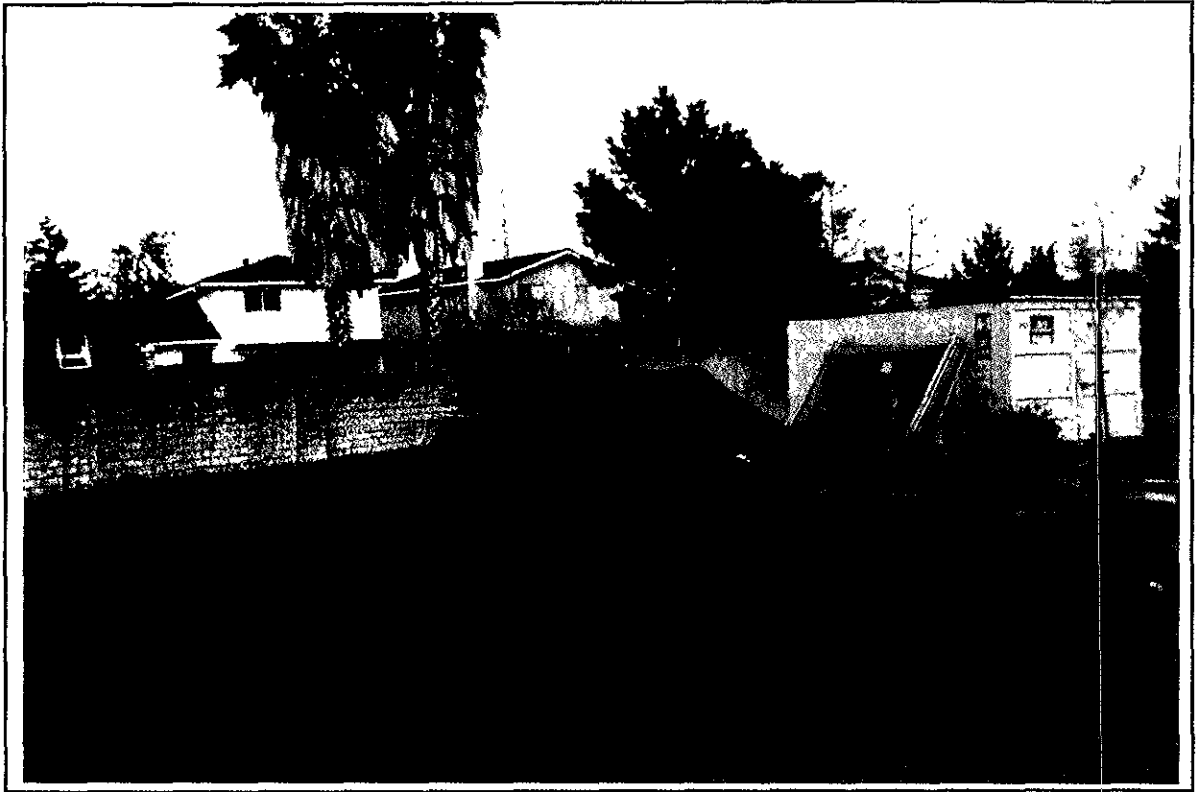
Approximately 50 cubic yards of excavated material (fill and soil) was stockpiled at the southeast corner of the site. A four-point composite sample, SP1-ABCD, was collected from this stockpile. At each sample point, a clean brass tube was driven into the stockpiled soil manually, with the aid of a mallet. As with the closure samples, the ends of the filled tube were covered and capped. The samples were submitted to the analytical laboratory (MPELI)

December 17, 1992: Stockpiled soil at east corner of site

Approximately 50 cubic yards of excavated soil was stockpiled and covered with plastic. The stockpiled soil was sampled and analyzed for waste characterization purposes. The excavation was resurfaced with asphaltic concrete to match the surrounding surfaces.
