**Re: Interim Vapor Intrusion Mitigation Plan Implementation**

Former Young's Cleaners  
10700 MacArthur Boulevard, Oakland, California  
AEI Project No. 261829  
Toxics Case No RO0002580

## **Interim Vapor Intrusion Mitigation Plan Implementation**

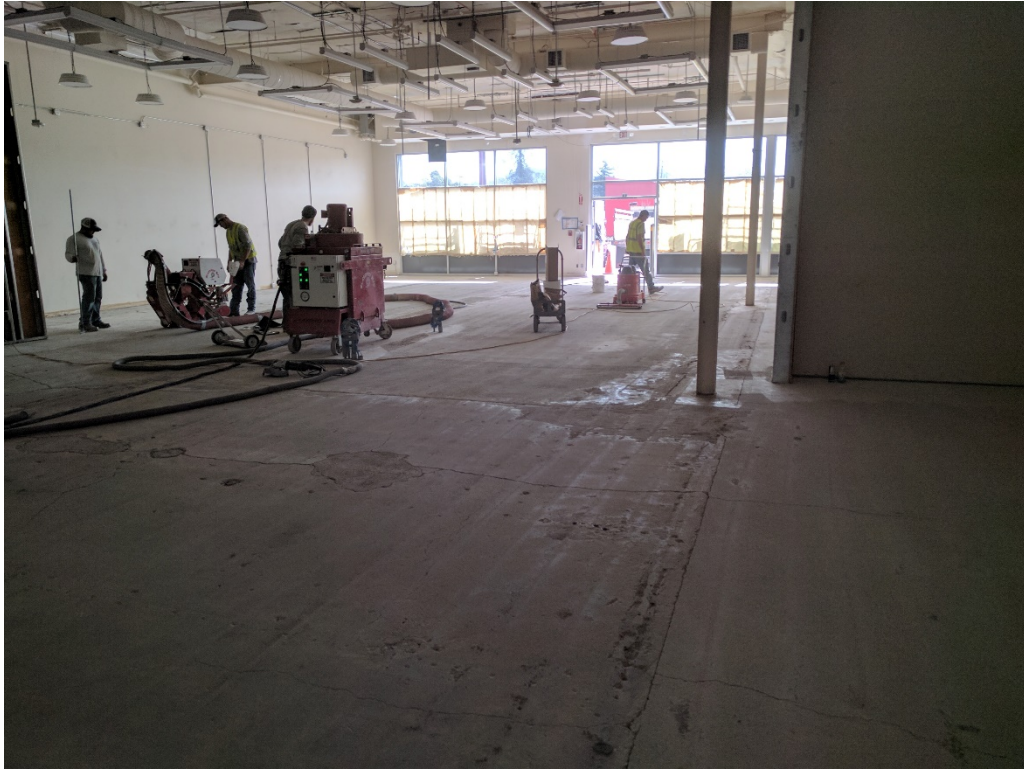
4. Surface abrasion using shot blaster and grinder. View from S corner of sales area facing N as in photo Nos 31, 46 and 97 (03/11/2017)

- Abrasive surface preparation was completed using a shot-blaster and hand held grinders as depicted in photograph numbers 4 through 8. Abrasive surface preparations were completed on March 10, 2017 except in areas where tiles were revealed. In areas where tiles were revealed, the tiles were removed and the remaining abrasive surface preparations were completed the morning of March 11, 2017.

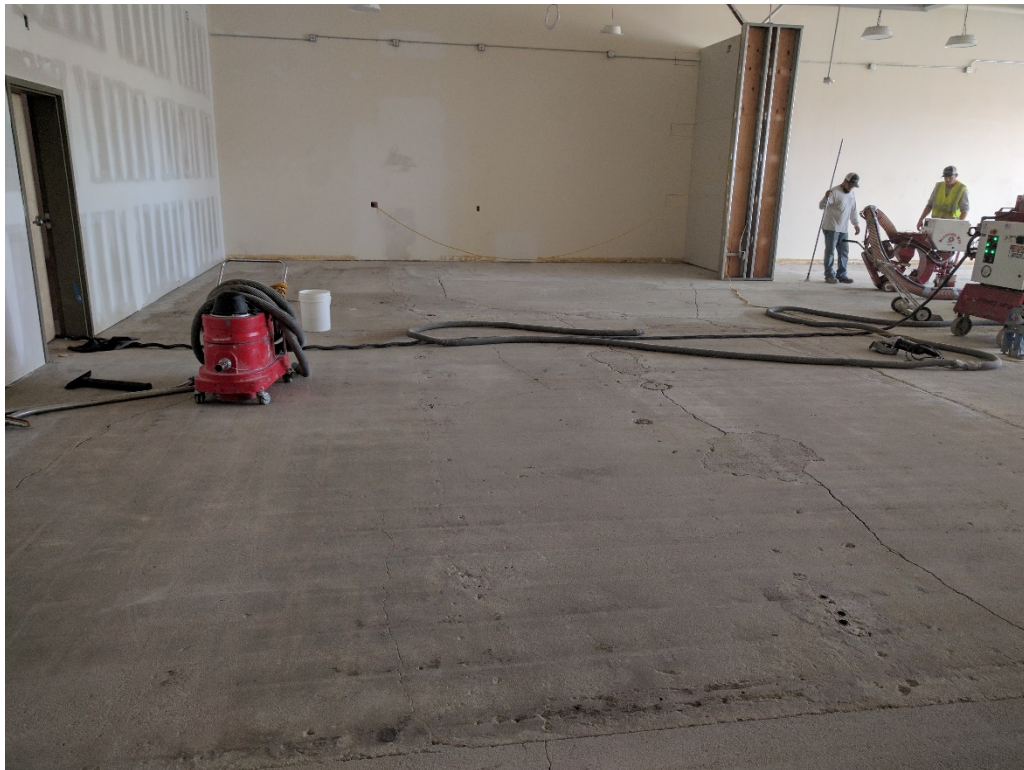
5. Surface abrasion using shot-blaster and grinder. View from W corner of sales area facing SE as in photo Nos 69 and 95 (03/11/2017)

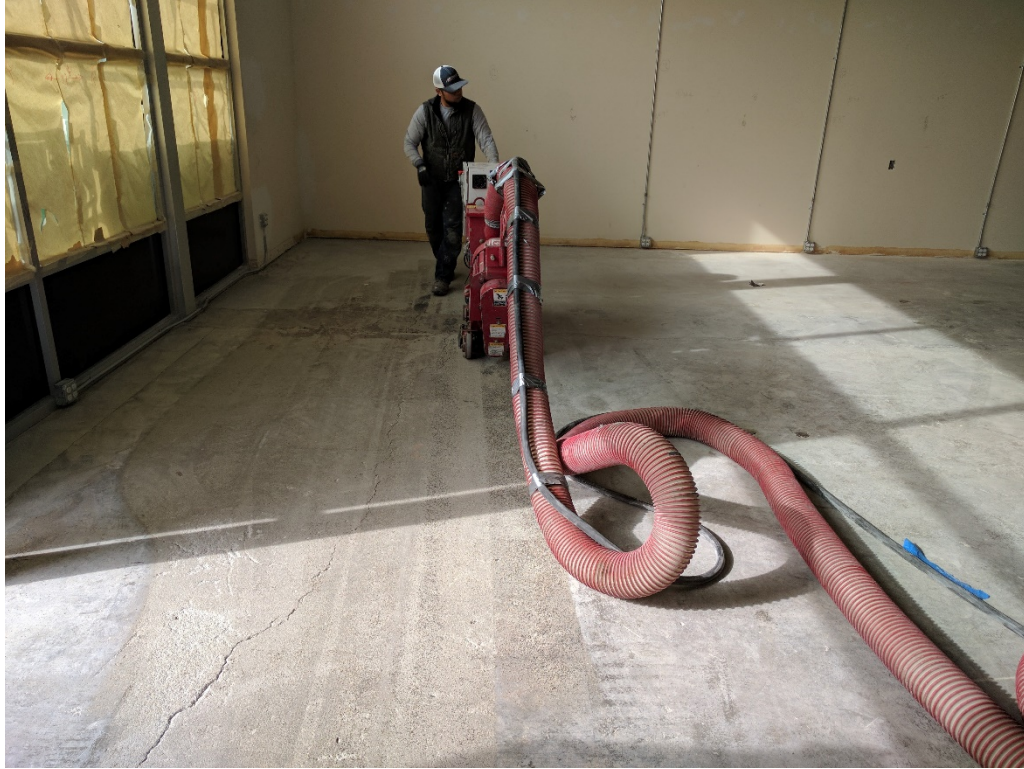
6. Surface abrasion using shot-blaster and grinder. View from W corner of sales area facing NE as in photo Nos 70 and 96 (03/11/2017)

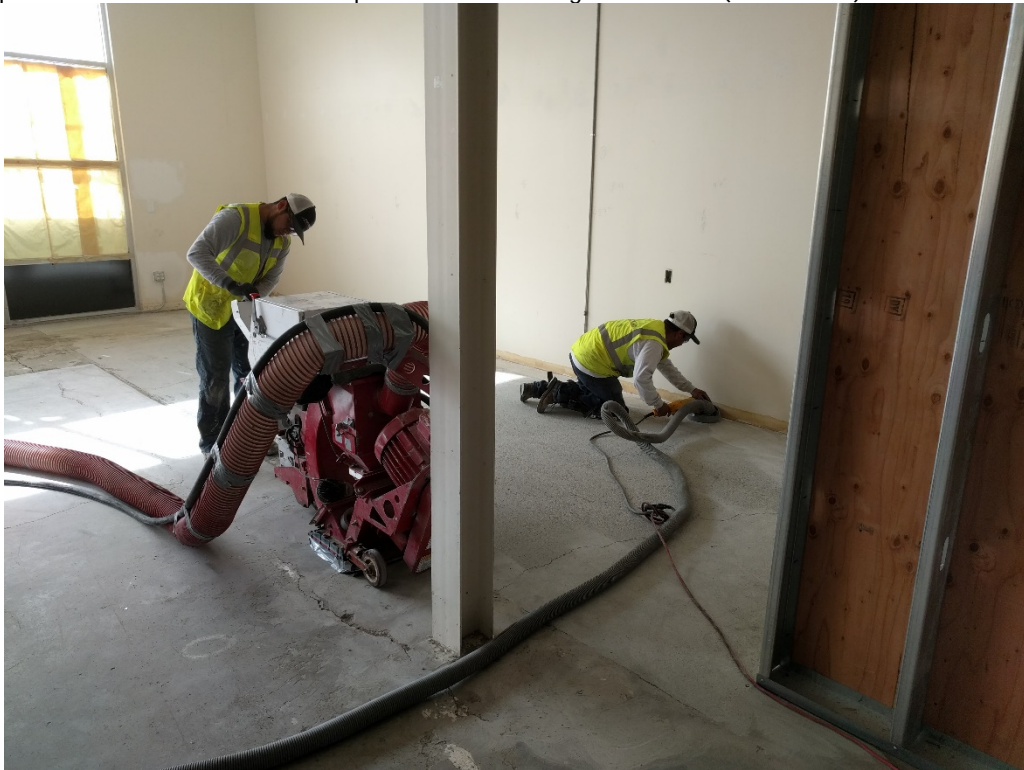
7. Surface preparations of Shoe Palace tenant space sales floor using shot blaster (03/10/2017)

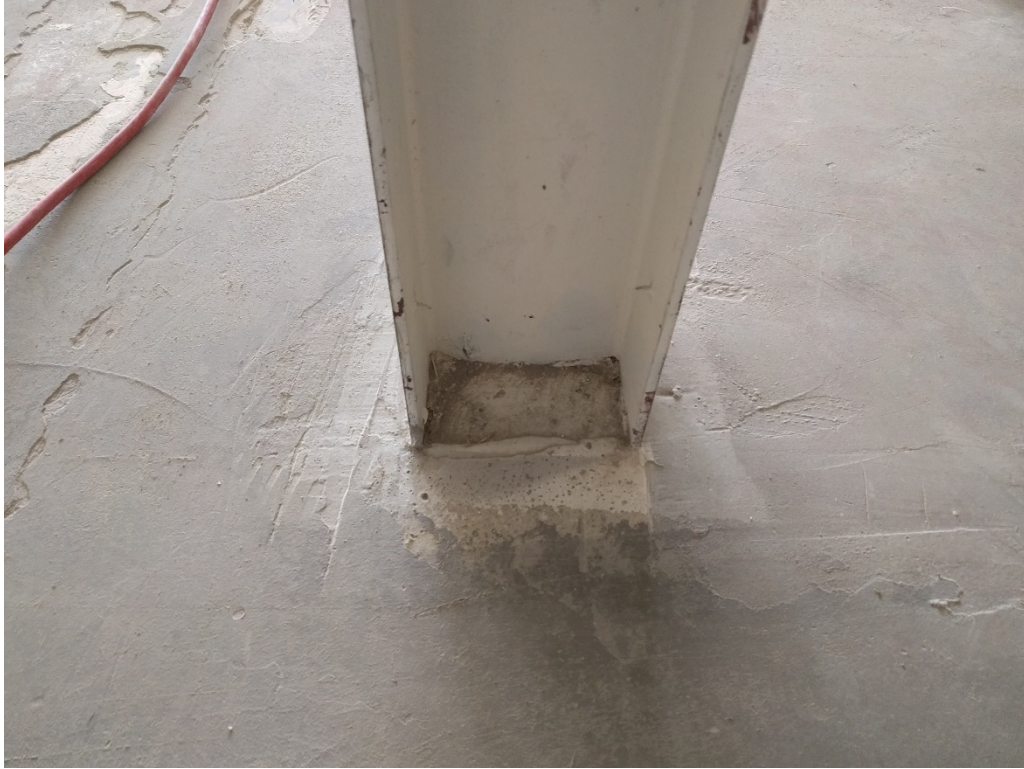
8. Surface preparations of Shoe Palace tenant space sales floor using shot blaster and grinder (03/10/2017)

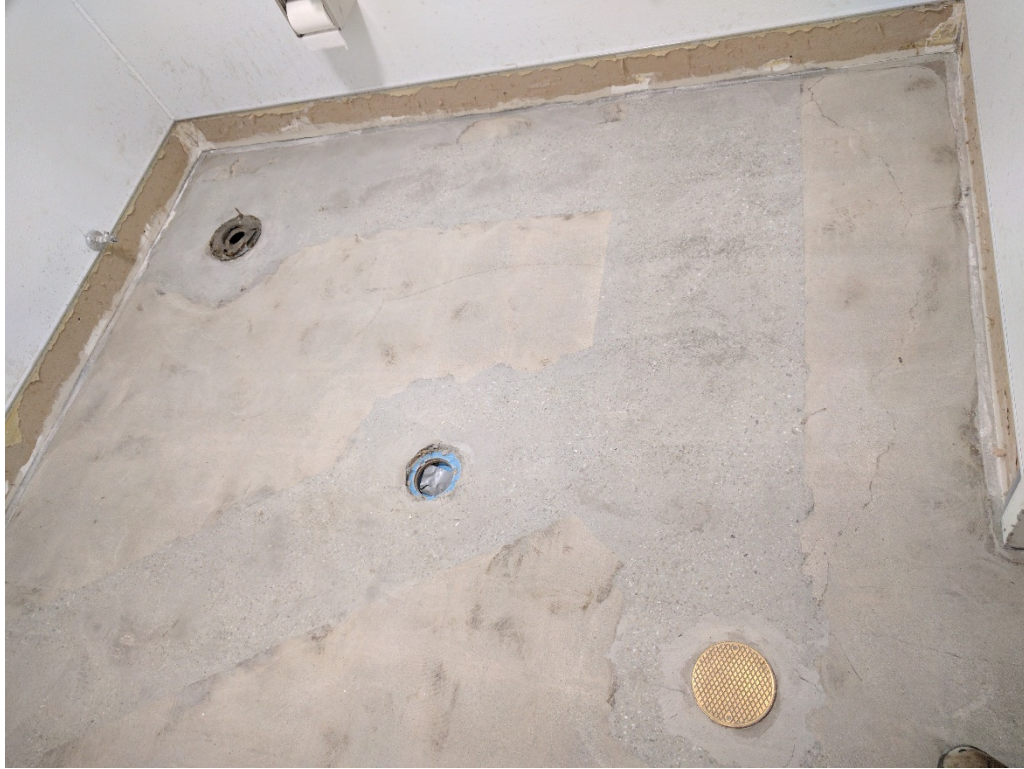
14. Women's restroom, post surface preparation as in photo Nos 45, 67, and 93. Location of utility trenches installed as part of TI visible (3/11/2017)

- The foundation appeared to have been floated using cement grout as part of historical tenant improvements. Abrasive surface preparations removed grout which had been used to repair the slab and level the surface. The removal of this grout revealed multiple cracks and penetrations to the slab which were previously not visible, including a historical electrical conduit which had been grouted over. The joint between the structural grade beam and the slab was cracked along the length of the grade beam. Additionally, the northern third of the sales floor was covered in vinyl floor tiling which was not visible prior to surface preparation. A sample of the tile was submitted to a laboratory and found not to contain asbestos above the reporting limit. No cracks larger than 1/2-inches in width were observed. Representative cracks and penetrations identified after the abrasive surface preparations are depicted in photographs 12 through 26.

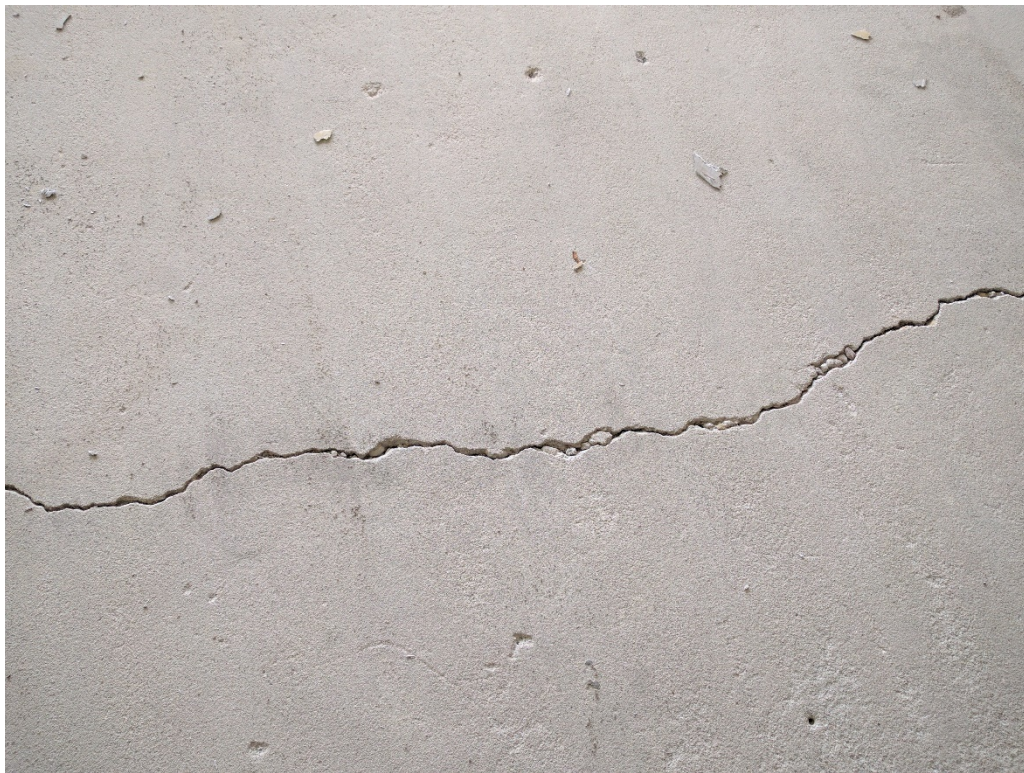
17. Representative cracks post surface preparation (03/11/2017)

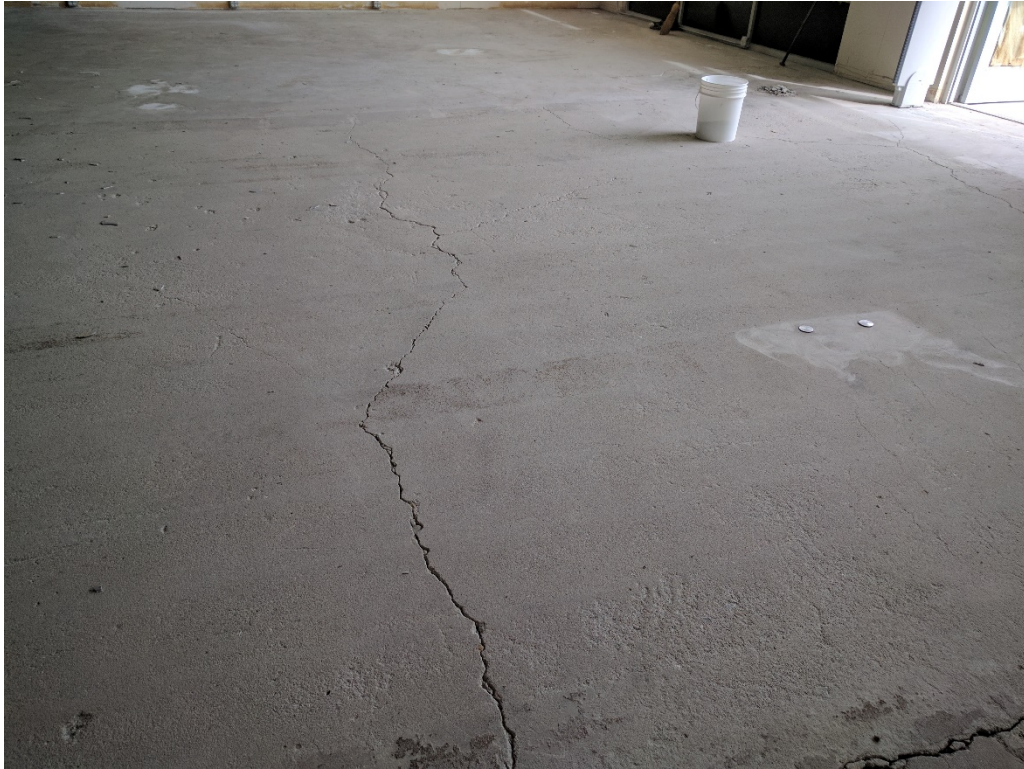
18. Representative cracks post surface preparation (03/11/2017)

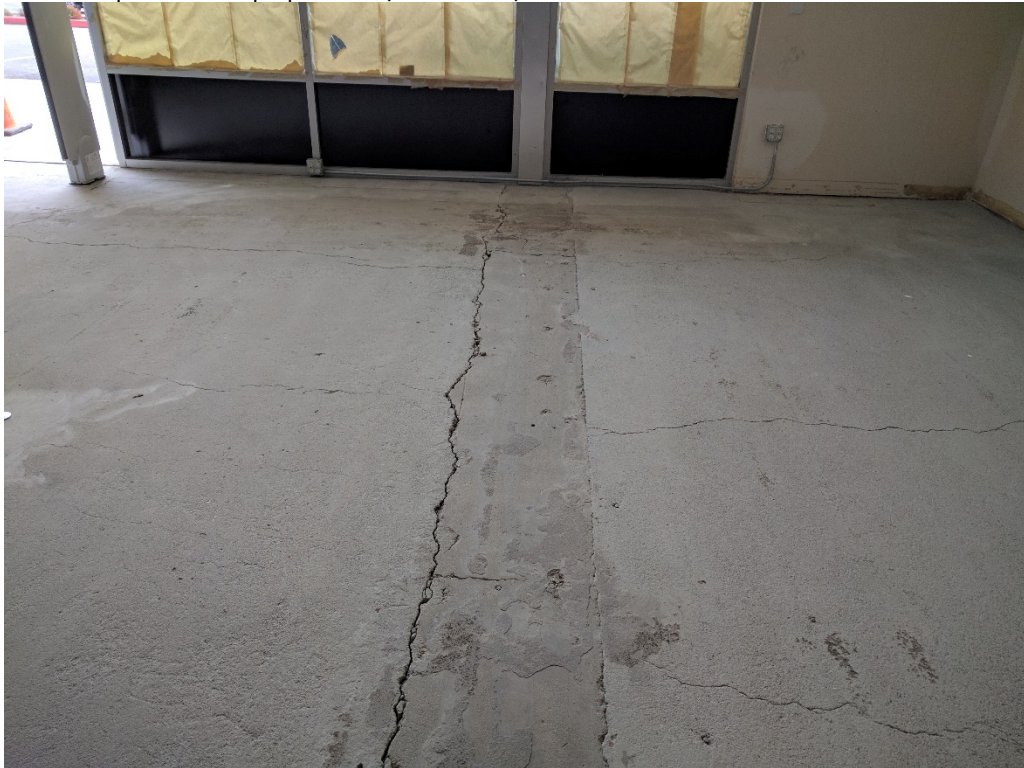
19. Representative cracks post surface preparation (03/11/2017)

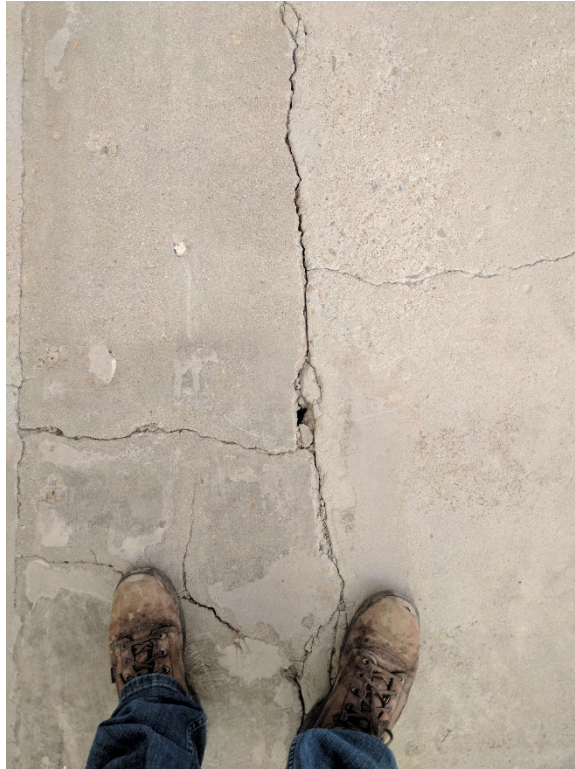
20. Cracks along grade beam, post surface preparation (03/10/2017)

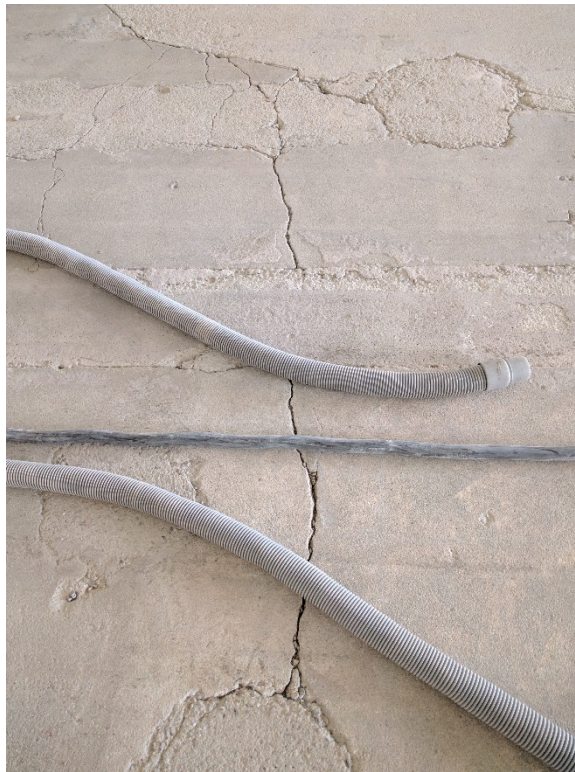
21. Cracks along grade beam, post surface preparation (03/10/2017)

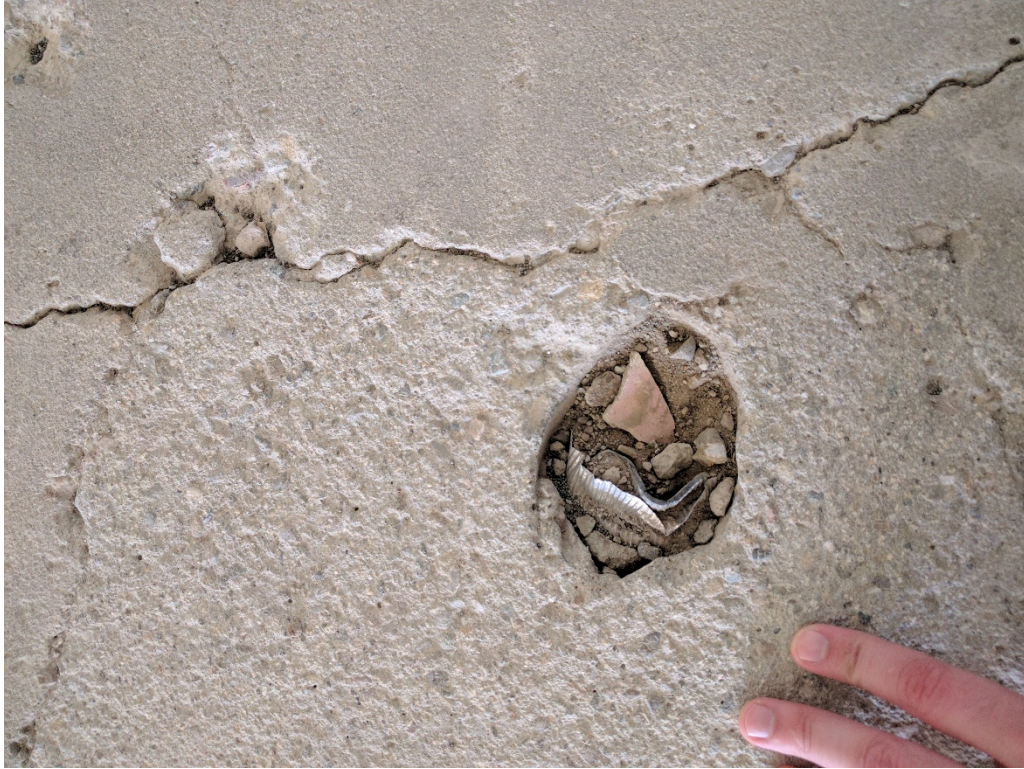
22. Representative cracks along historic penetrations and trenches. (03/10/2017)

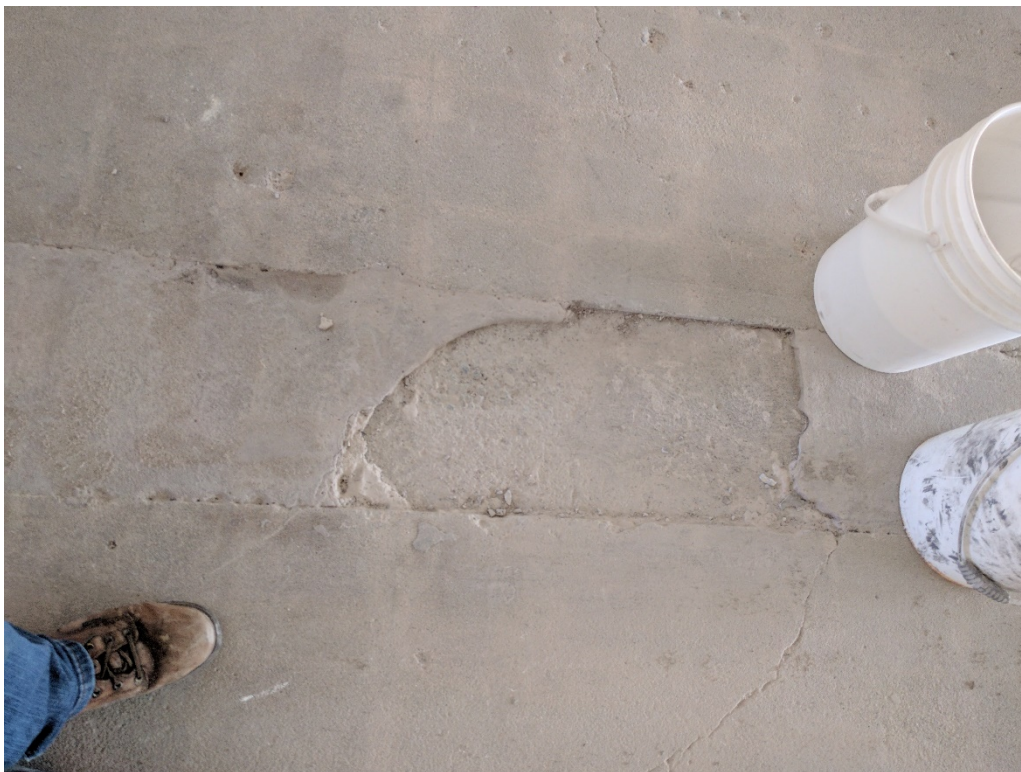
25. Northern corner of sales area. Note extent of tiles is visible along the prepared area. (03/10/2017)

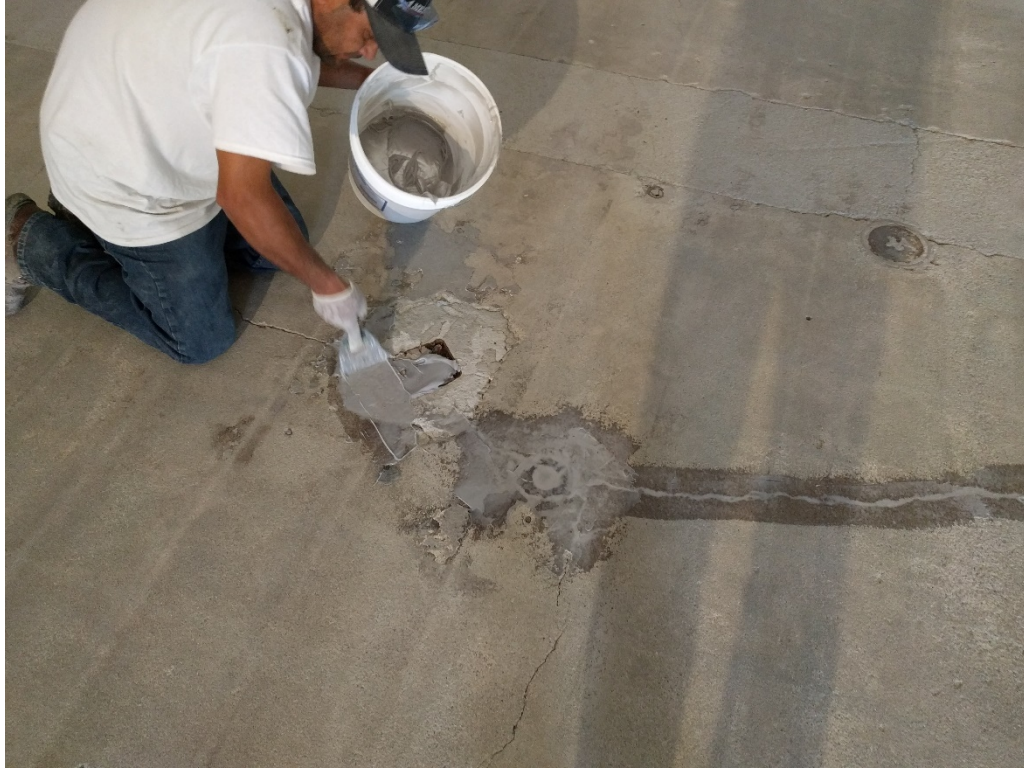
26. Damage to trenching between sales area and stock area as in photo No 35 (03/11/2017)

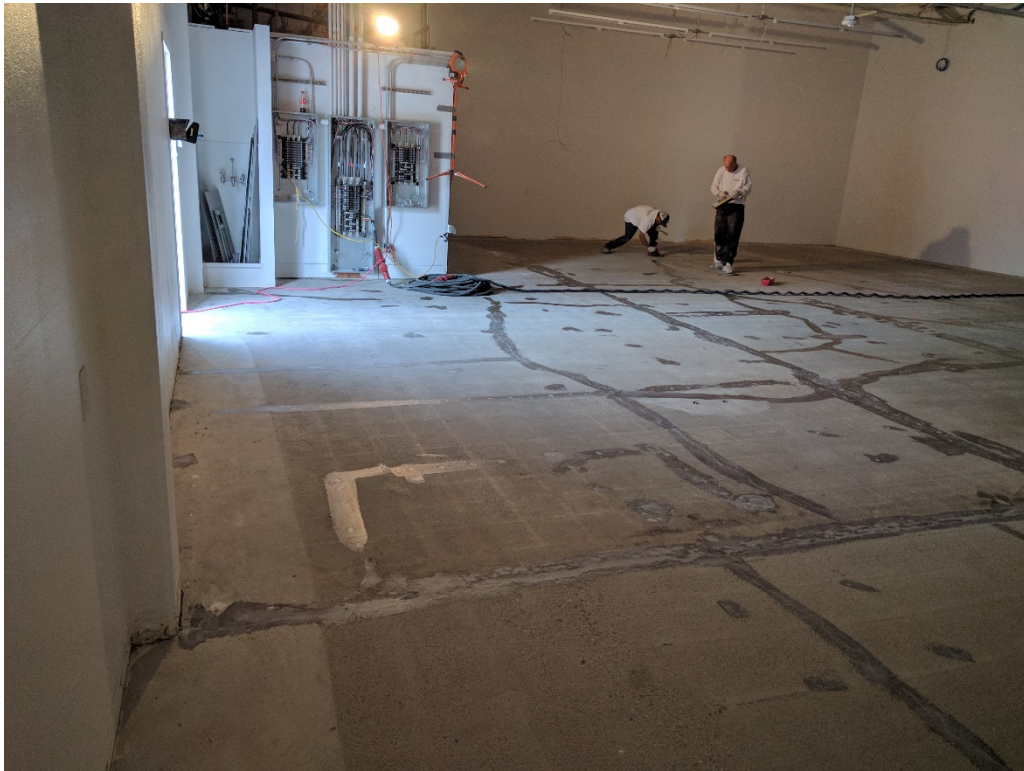
27. Application of Retro-coat Gel post abrasive surface preparation, but prior to primer application (03/11/2017)

- Cracks, penetrations, and indentations in the slab post surface abrasion were repaired and filled using Retro-Coat™ Gel on March 10 and 11 as depicted in photographs 27 through 37.

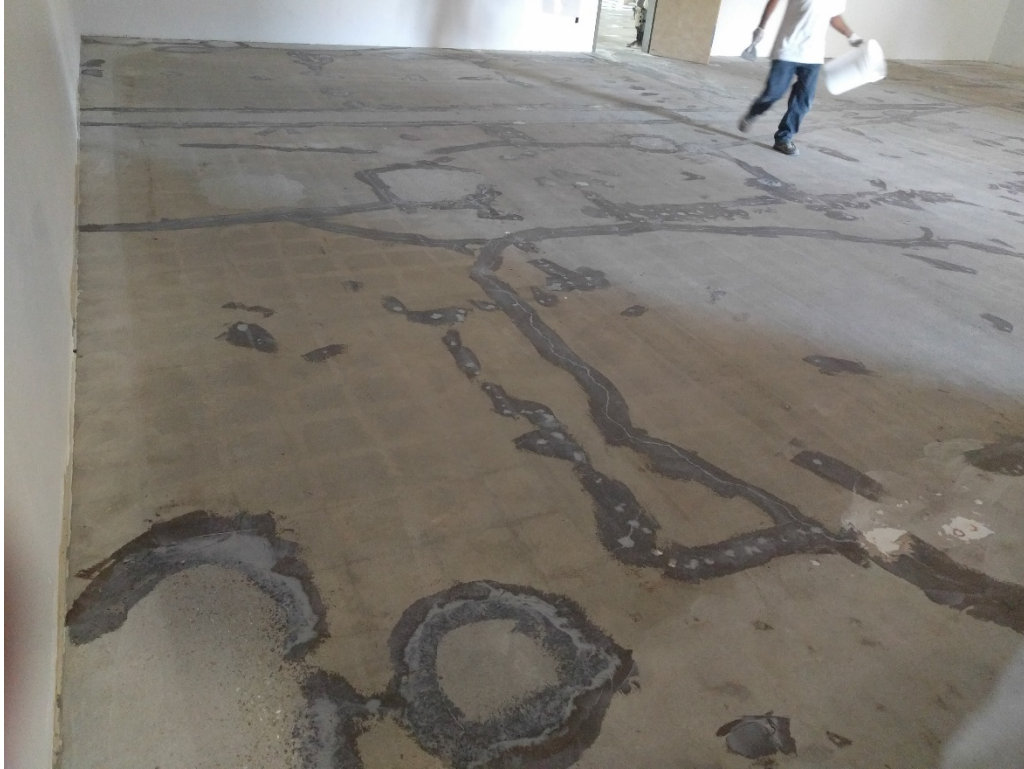
28. Application of Retro-coat Gel to seal cracks post surface preparation, but prior to primer application. Photo taken from W corner of stock room facing N as in photo Nos 42, 69, and 88 (03/11/2017)

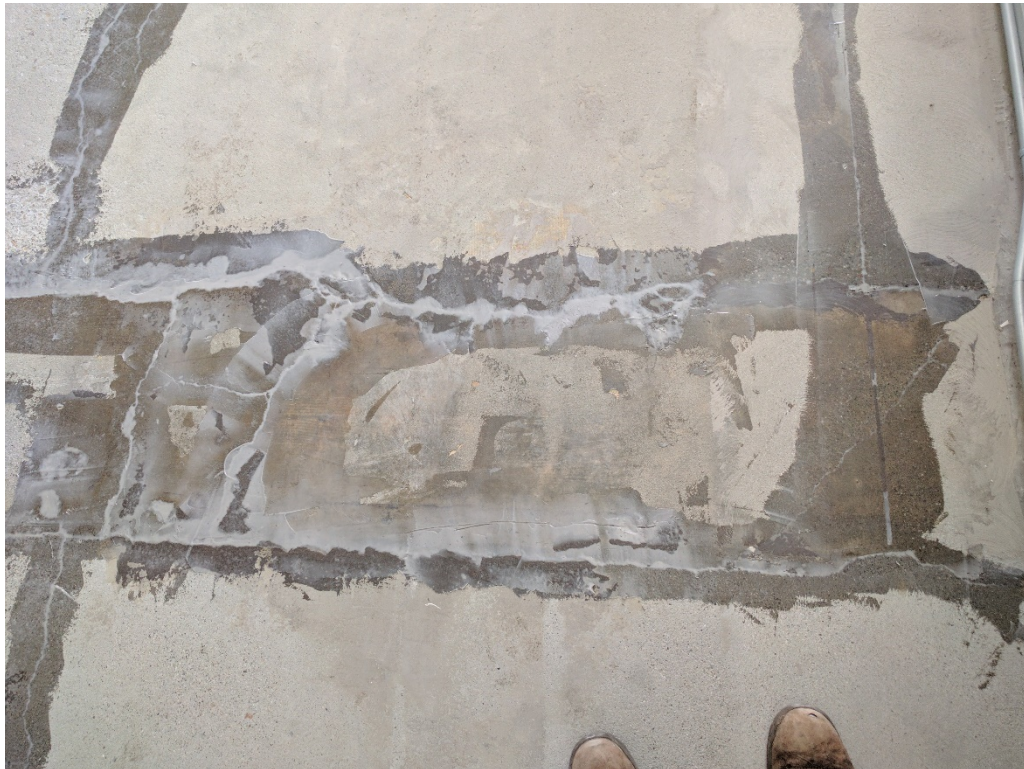
29. Application of Retro-coat Gel to seal cracks post surface preparation, but prior to primer application. Photo taken from N corner of stock room facing SE (03/11/2017)

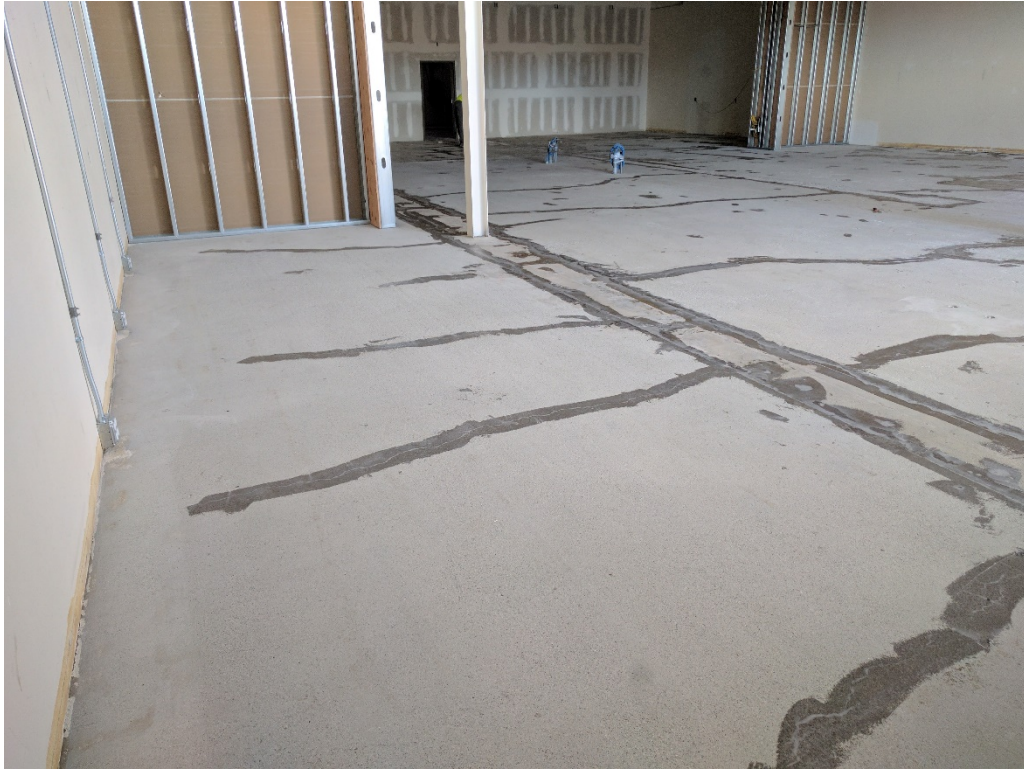
30. Representative Retro-coat Gel application (03/11/2017)

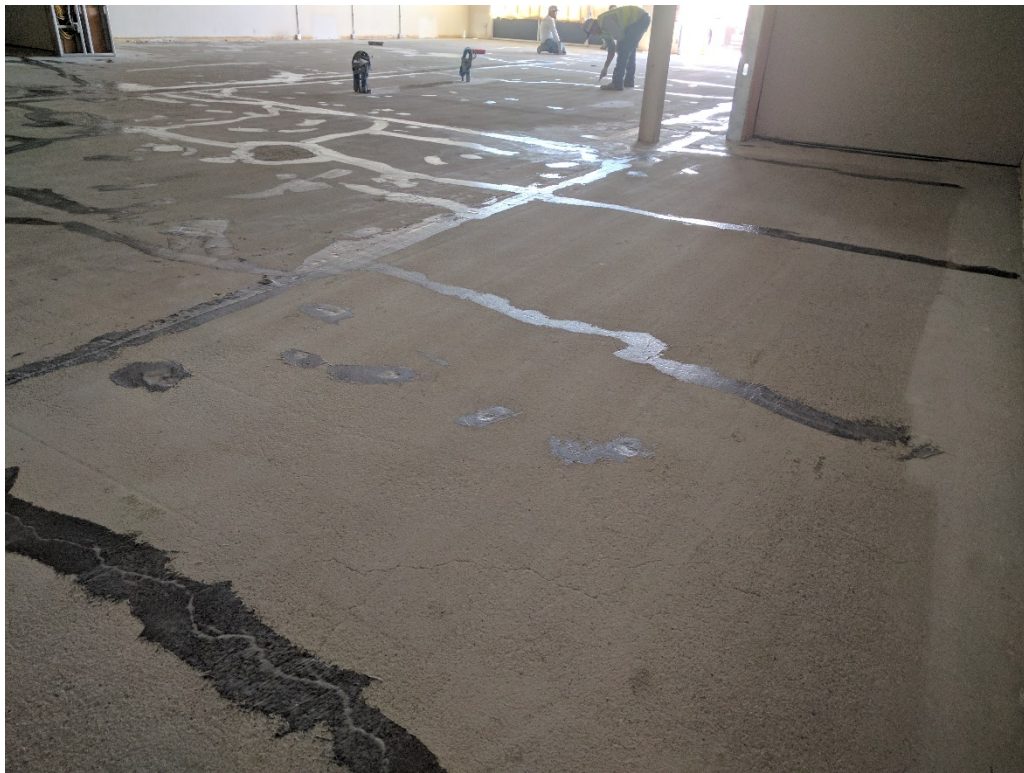
31. Retro-coat Gel application. View from S corner of sales area facing N as in photo Nos 4, 46, and 97 (03/11/2017)

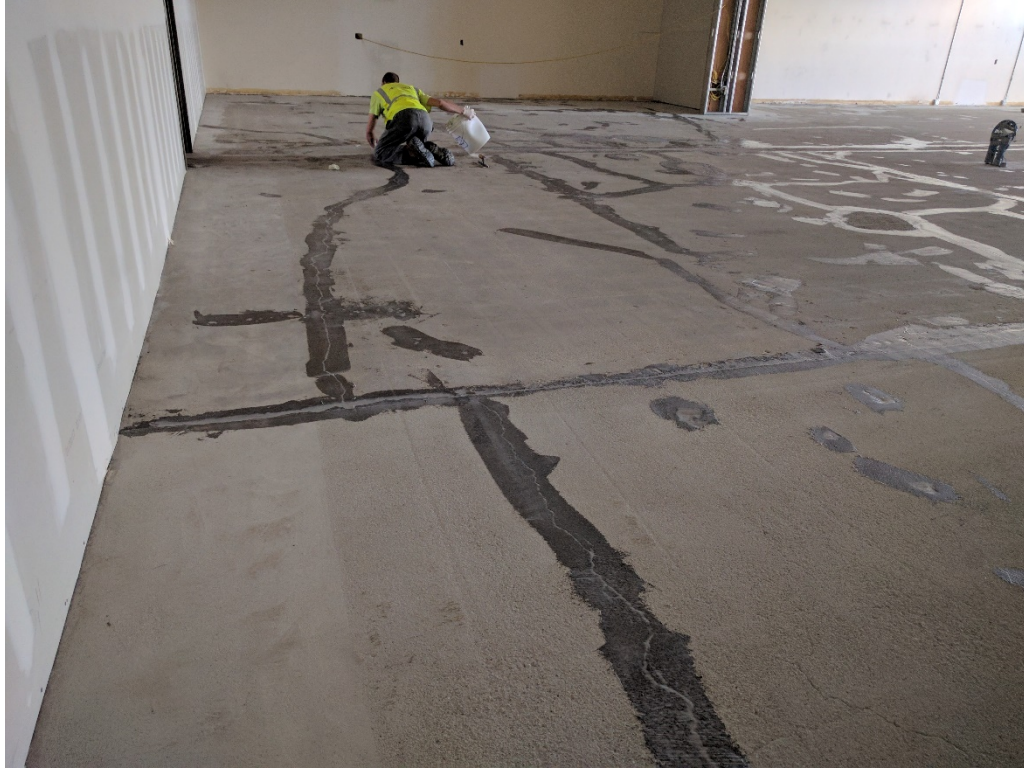
32. Retro-coat Gel application. View from W corner of sales area facing SE as in photo Nos 5, 69, and 95 (03/11/2017)

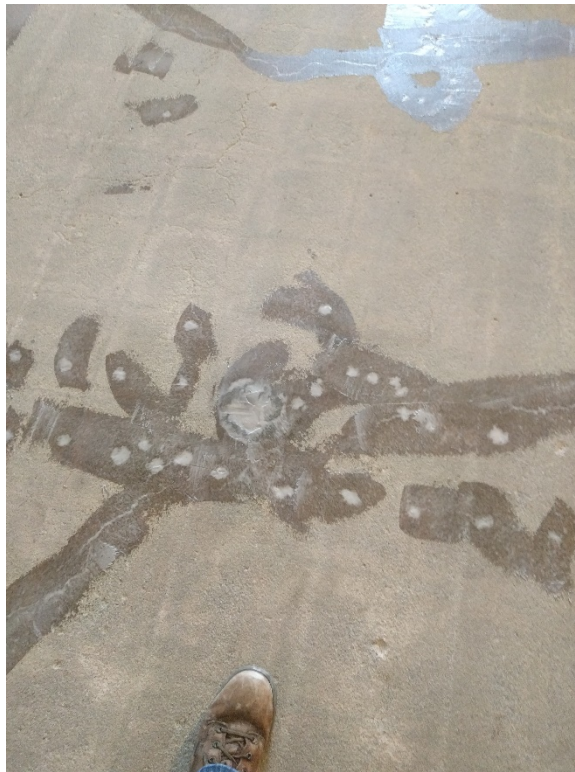
33. Retro-coat Gel application. View from W corner of sales area facing NE as in photo Nos 6, 70, and 96 (03/11/2017)

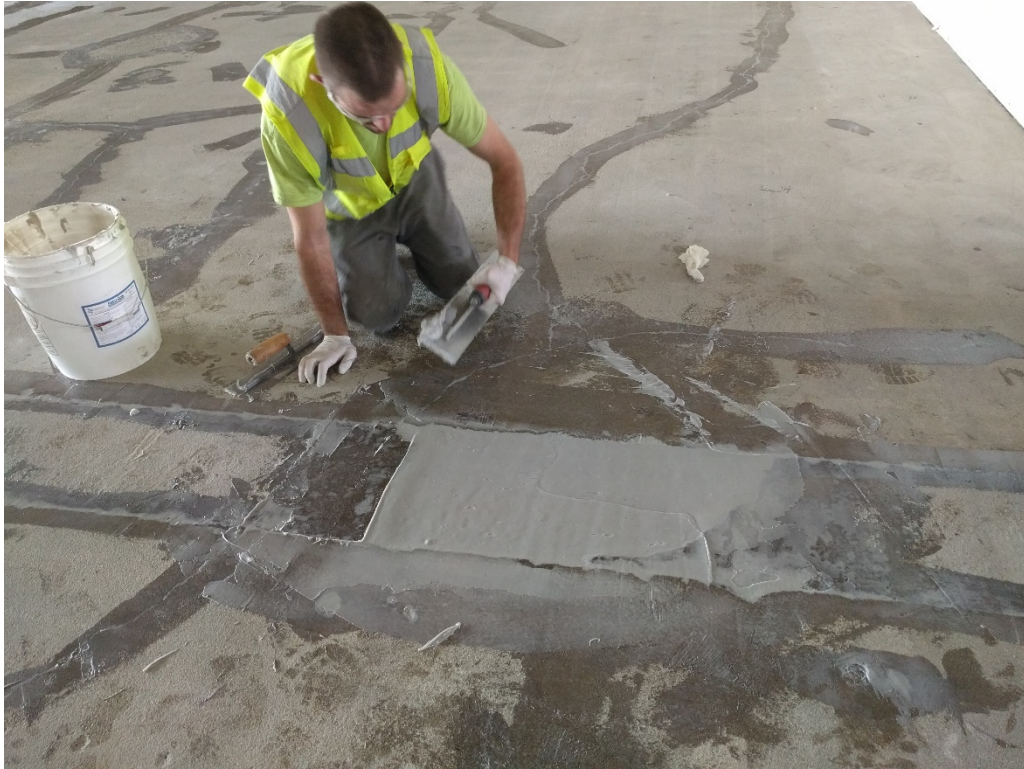
34. Representative close up of concrete repairs using Retro-coat Gel, pre primer application (03/11/2017)

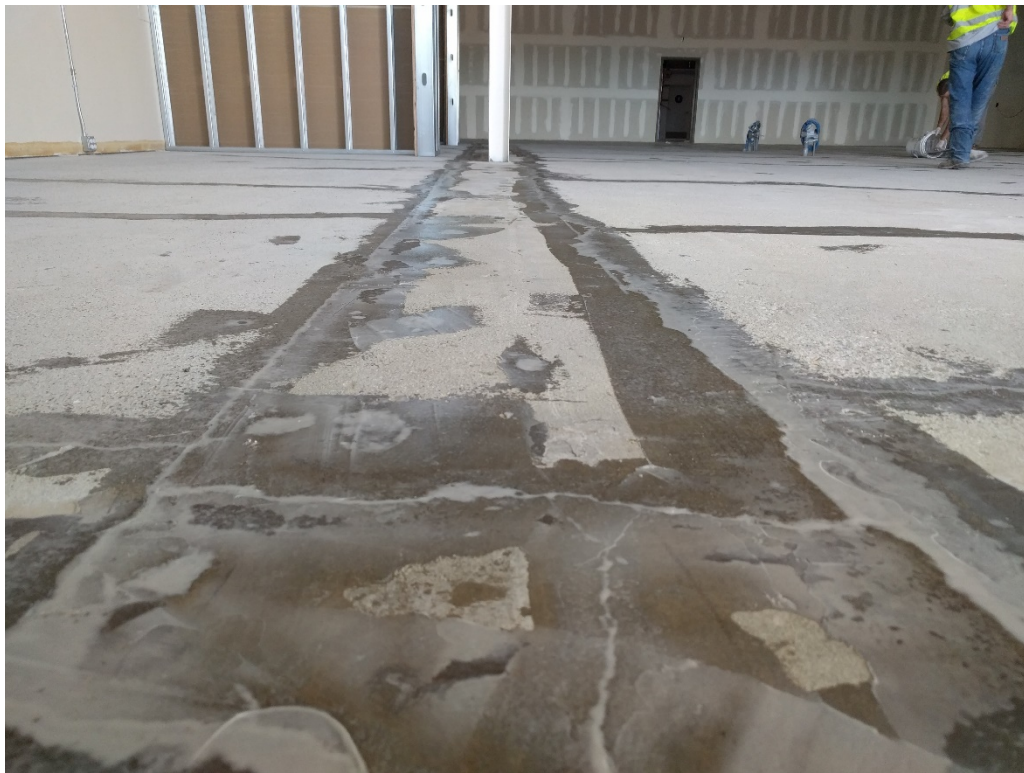
35. Floating of damaged trench area in sales area (see photo No. 26) using Retro-coat Gel (03/11/2017)

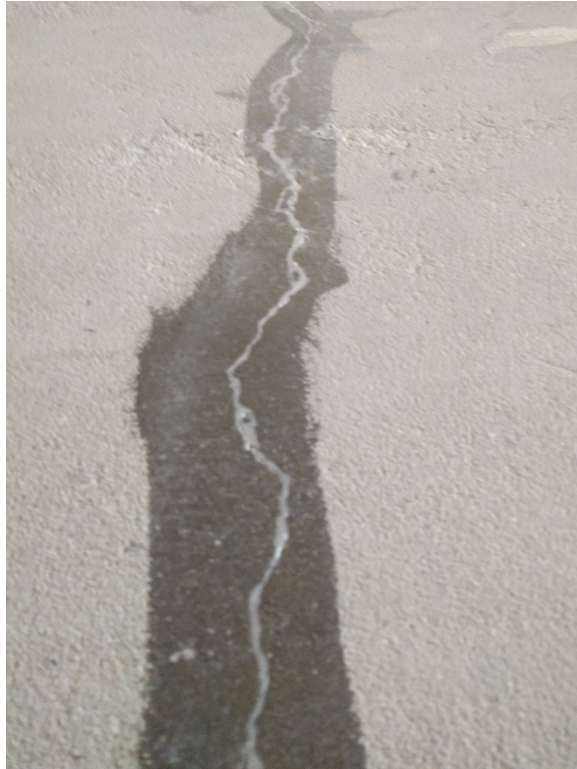
36. Close up of Retro-coat Gel application along grade beam. Photo taken from SE portion of sales area facing NW (03/11/2017)

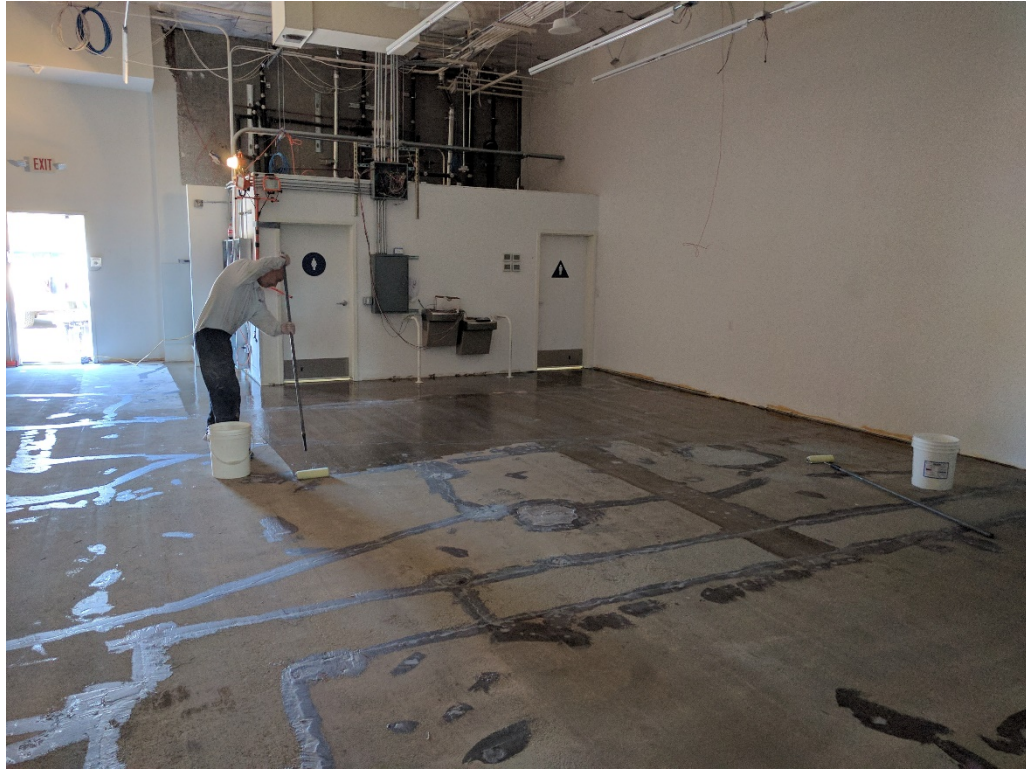
40. Representative application of Retro-coat Primer around vertical terminations using brush (03/11/2017)

- Retro-Coat™ Primer was applied to a thickness of approximately 6-mil on March 11, 2017 as depicted in photographs 38 through 41.
- AEI was present to inspect the preparation of the primer and to oversee representative application of the primer in the stock area and restrooms.

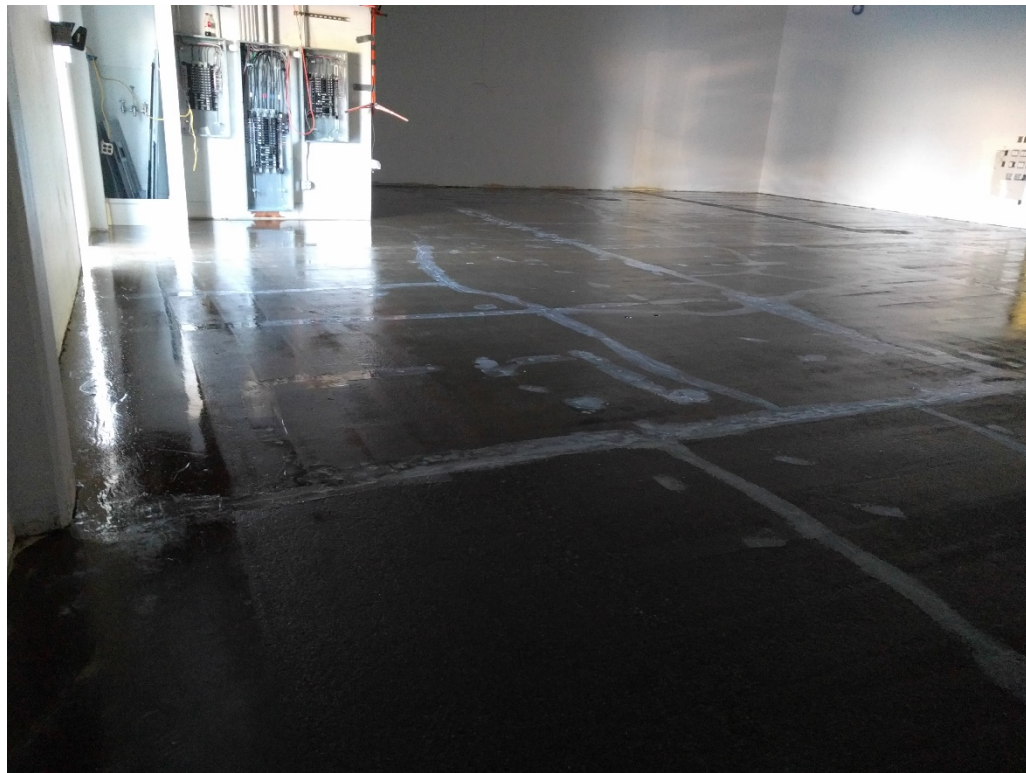
41. Representative application of Retro-coat Primer to an  $\approx 6$  mil thickness as in photo Nos 65 and 91 (03/11/2017)

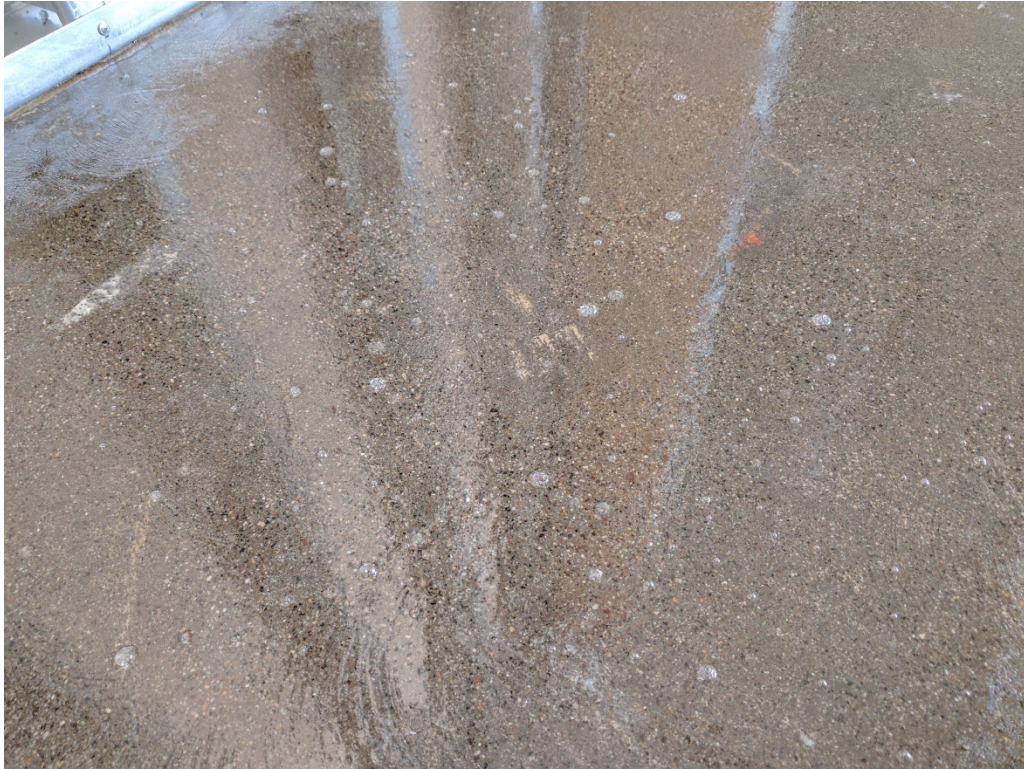
48. Representative close up of cured primer application (03/12/2017)

- AEI inspected the cured primer application on the morning of March 12, 2017 prior to the application of the first layer of Retro-Coat™ Core as depicted in photographs 42 through 57. The following deficiencies were identified and corrected:

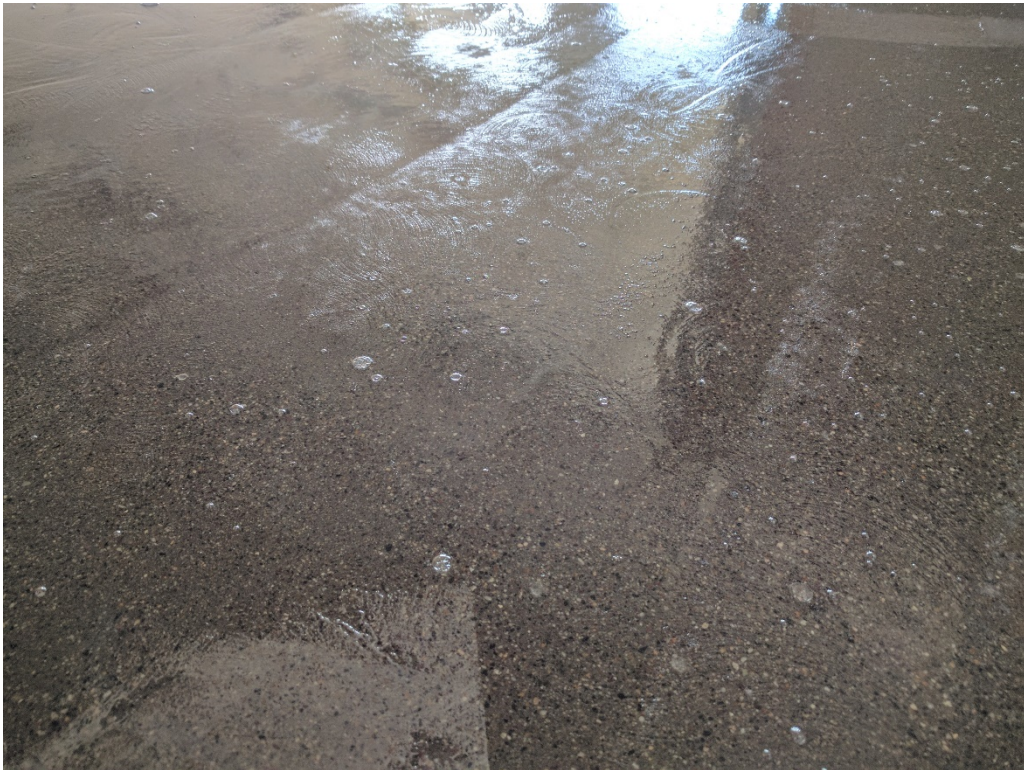
49. Air bubbles in cured primer (03/12/2017).

- Air bubbles were observed in various areas throughout the tenant space as depicted in photographs 49 through 52. Air bubbles were predominantly in areas where concrete was particularly porous. According to the installer, the presence of bubbles is typically an indicator that the primer was applied too thick and displaced air while it infiltrated the concrete. In areas where air bubbles were only occasionally present, air bubbles were popped and smoothed during the squeegee application of Retro-Coat™ Core layer one. In areas where multiple air bubbles were present, the surface was smoothed prior to application using a fine grit disc sander.
