**Re: Interim Vapor Intrusion Mitigation Plan Implementation**

Former Young's Cleaners  
10700 MacArthur Boulevard, Oakland, California  
AEI Project No. 261829  
Toxics Case No RO0002580

## **Interim Vapor Intrusion Mitigation Plan Implementation**

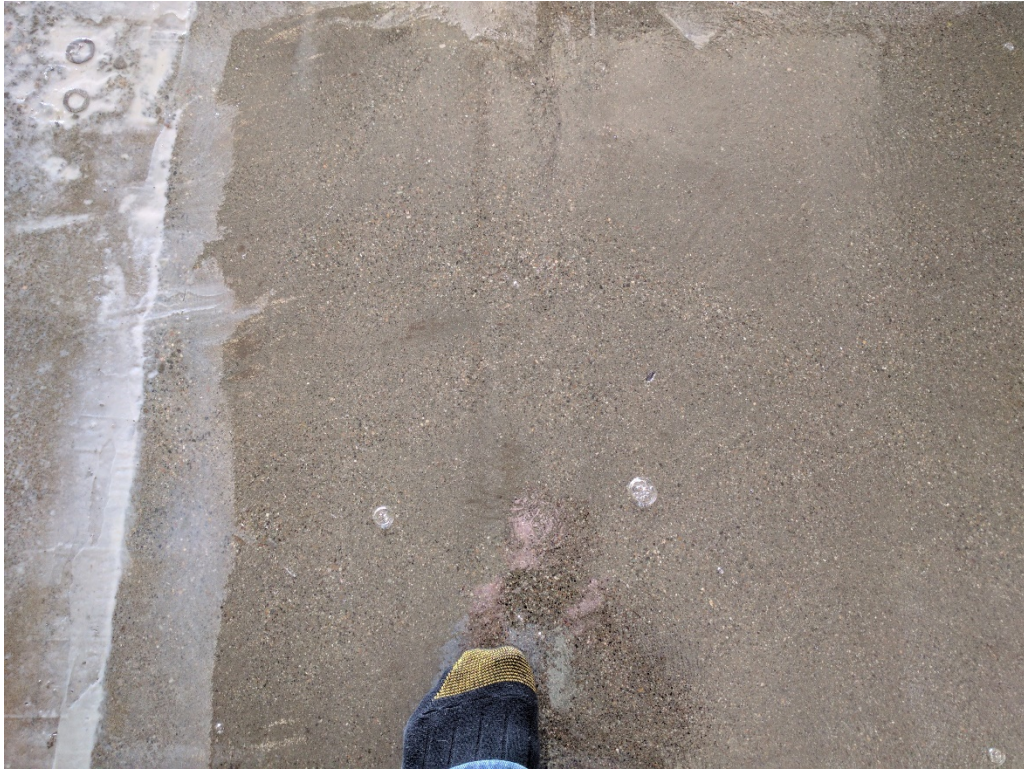
50. Air bubbles in cured primer (03/12/2017)

- Air bubbles were observed in various areas throughout the tenant space as depicted in photographs 49 through 52. Air bubbles were predominantly in areas where concrete was particularly porous. According to the installer, the presence of bubbles is typically an indicator that the primer was applied too thick and displaced air while it infiltrated the concrete. In areas where air bubbles were only occasionally present, air bubbles were popped and smoothed during the squeegee application of Retro-Coat™ Core layer one. In areas where multiple air bubbles were present, the surface was smoothed prior to application using a fine grit disc sander.

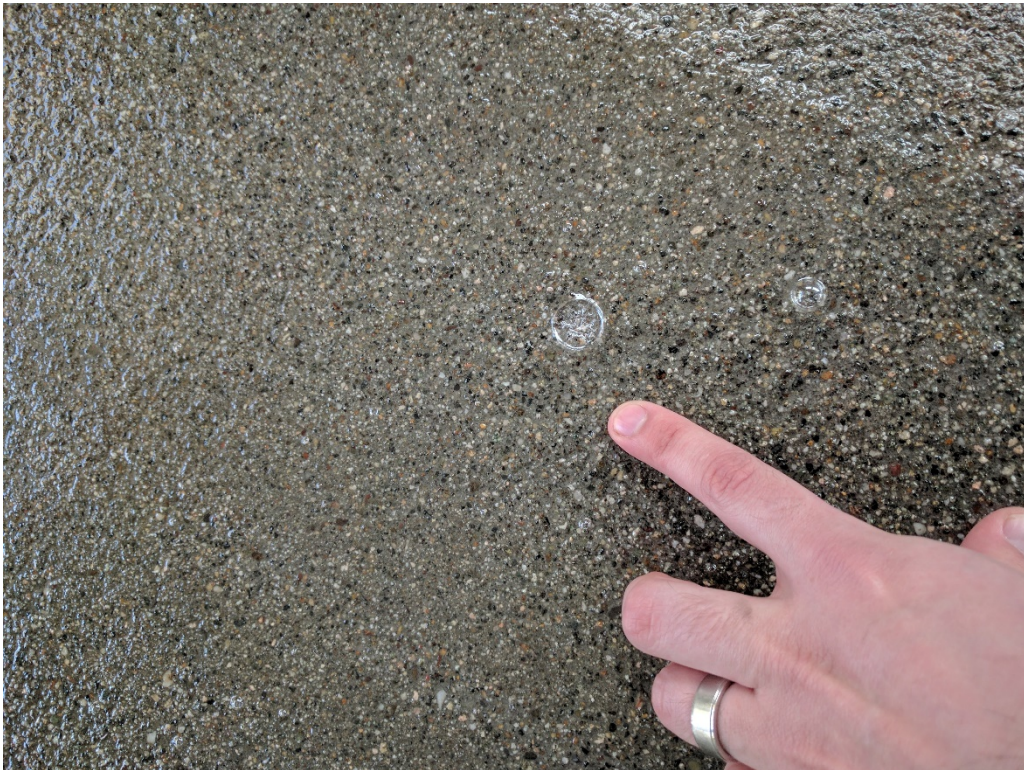
51. Close up of air bubbles in cured primer (3/12/2017)

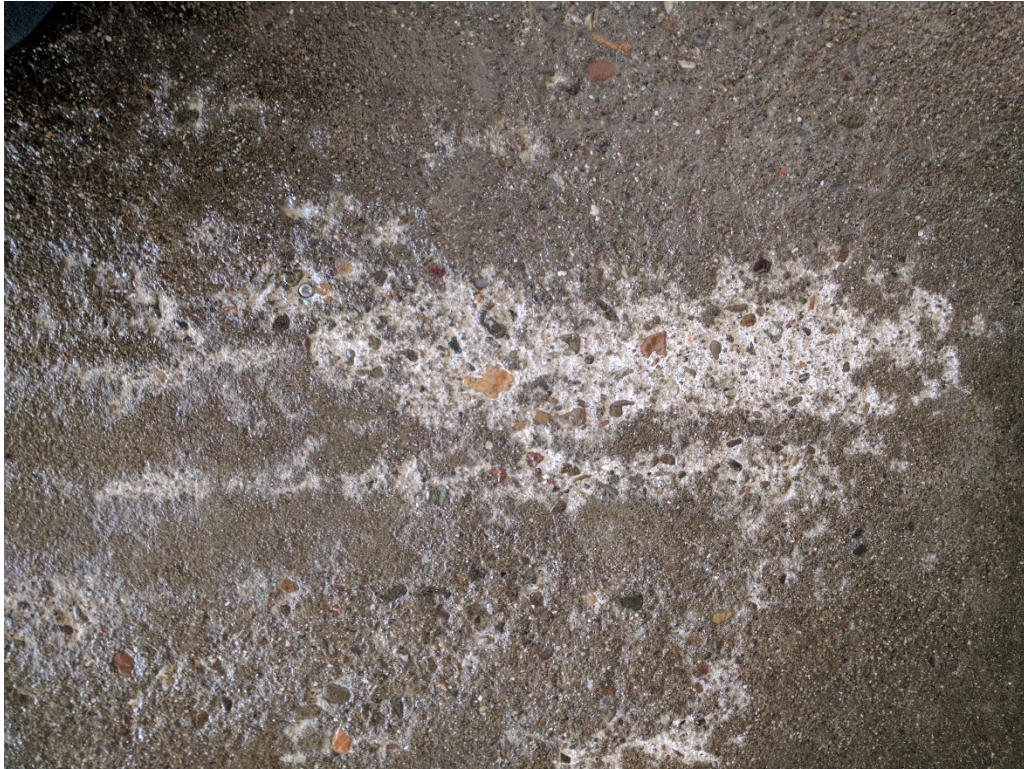
54. Aggregate in cured primer (03/12/2017)

- Loose aggregates that had been bonded to the surface of the primer were identified in two areas. Aggregates were removed and the resulting spurs were sanded with a fine grit sand paper

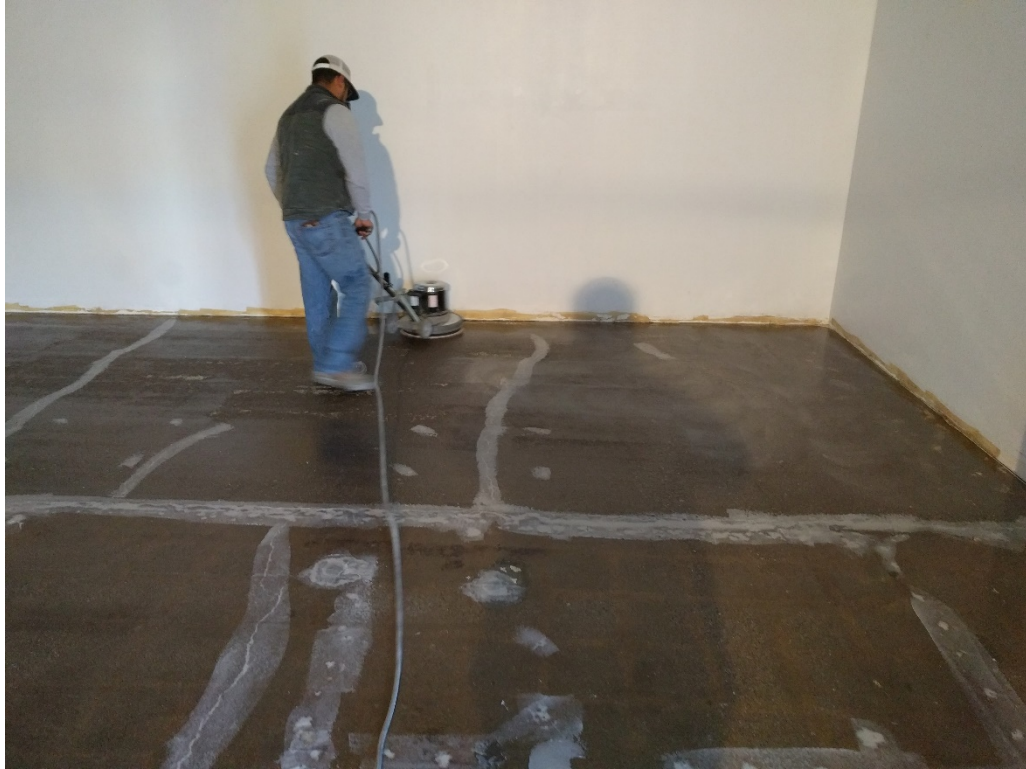
56. Area of primer percolation in high porosity concrete (03/12/2017)

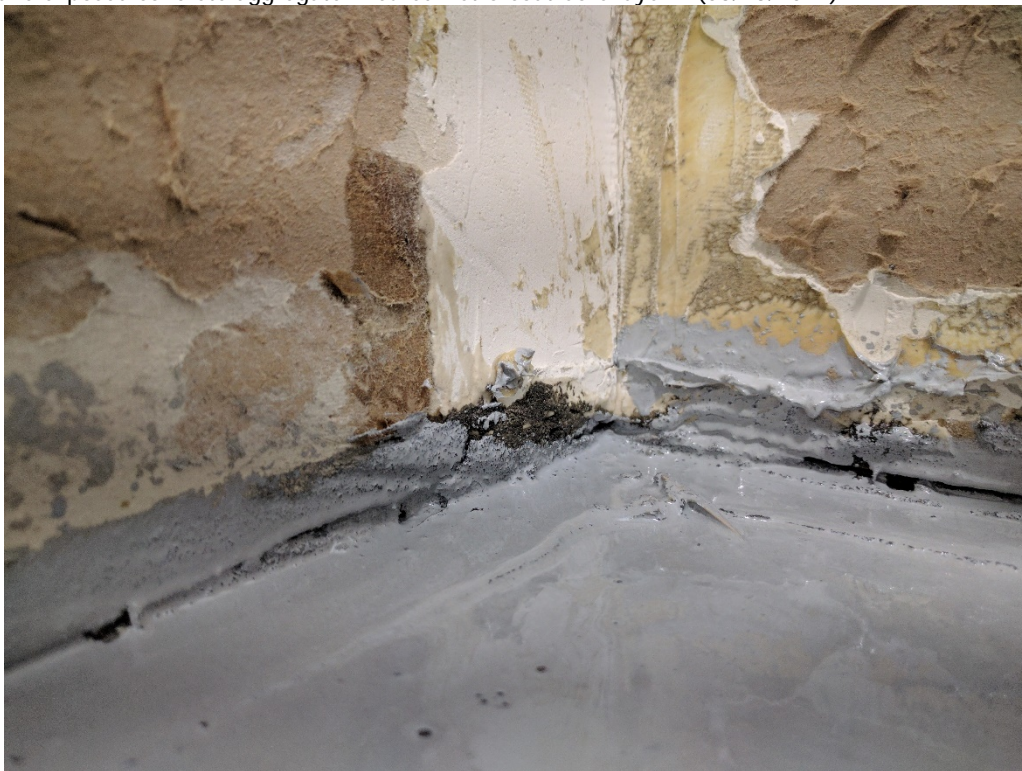
- In areas that were previously identified as having significant primer adsorption, the Retro-Coat™ Core percolated through the concrete resulting in areas of exposed aggregates as depicted in photographs 78 and 79. AEI noted these deficiencies and requested that the second layer of Retro-Coat™ Core be applied to an additional thickness of 15-mil in these areas.

79. Representative exposed concrete aggregate in cured Retro-coat Core layer 1 (03/13/2017)
