Subject: Addendum to Remedial Soil Excavation
5565 Tesla Road,
Livermore, California
Fuel Leak Case #RO0002585

On behalf of Mr. Aris Krimetz, authorized representative for the property located at 5565 Tesla Road, Livermore, California (the Site), SOMA Environmental Engineering, Inc. (SOMA) has prepared this letter report documenting post excavation backfilling activities. This letter is an addendum to the Remedial Excavation Report dated November 1, 2007.

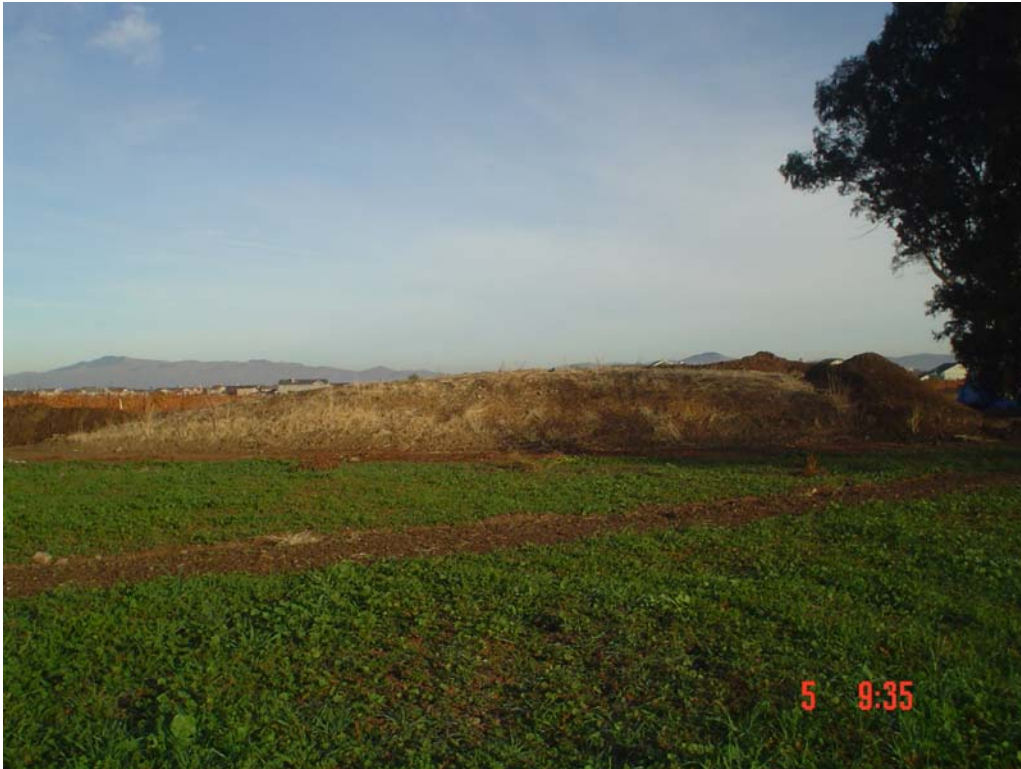
Plate 1: Clean fill stockpile (view north)

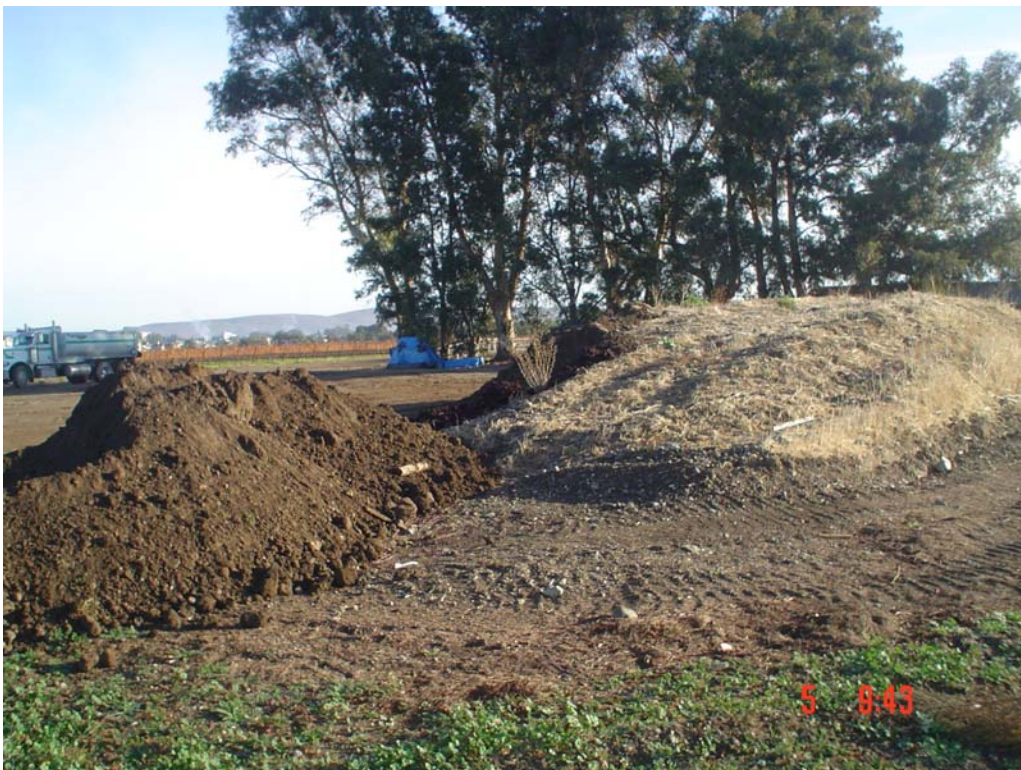
soil used in the backfilling activities was collected from the area opposite of sample Stockpile 1. Figure 1 illustrates the location of the clean fill used for the backfilling activities.

Plate 2: Clean fill stockpile, the side that was used for backfill (view northeast)

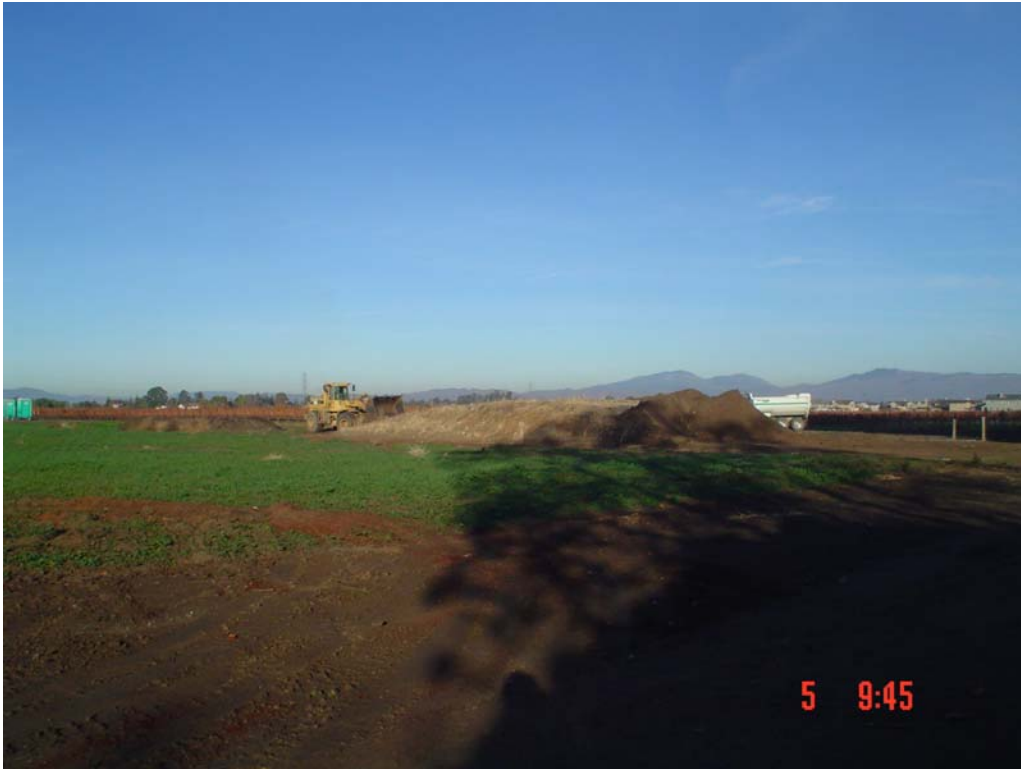
Plate 3: Clean fill being loaded for the transport (view west)

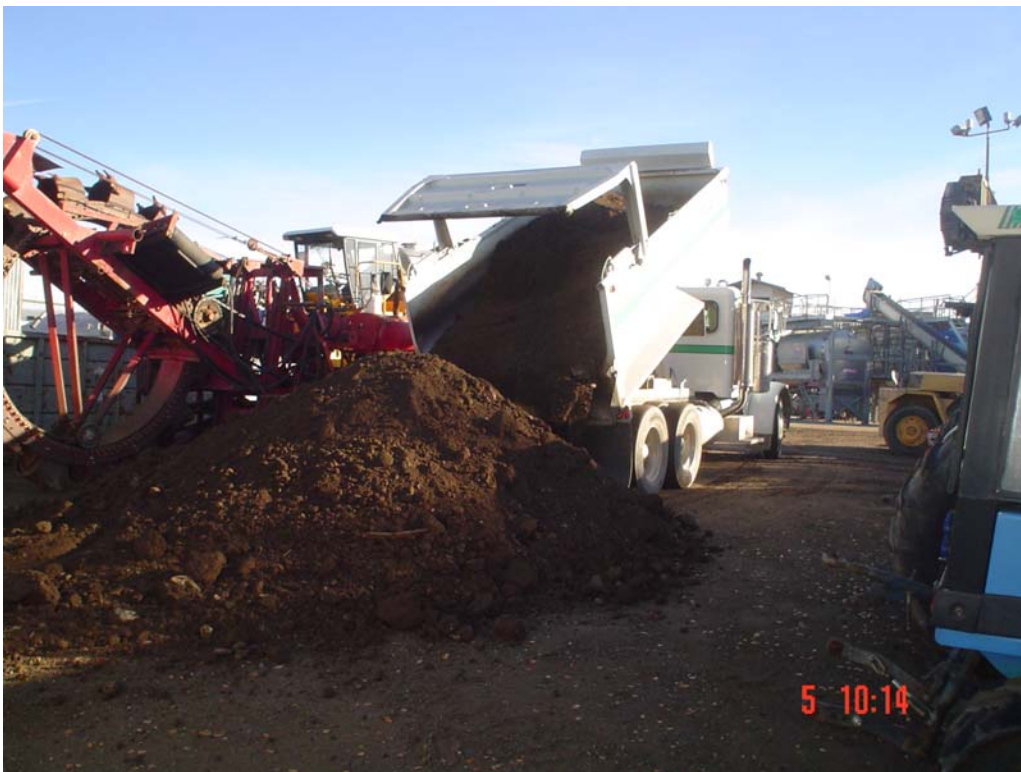
Plate 4: Clean fill stockpile, adjacent to the Area 4

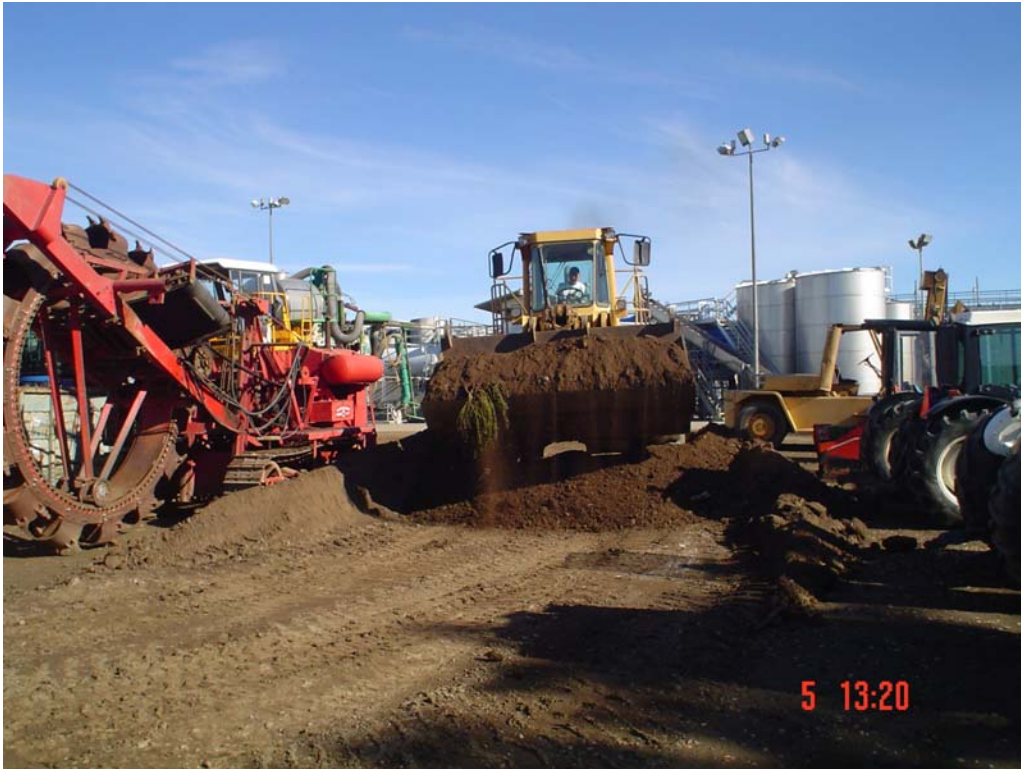
Plate 5: Clean fill being moved to the excavation areas

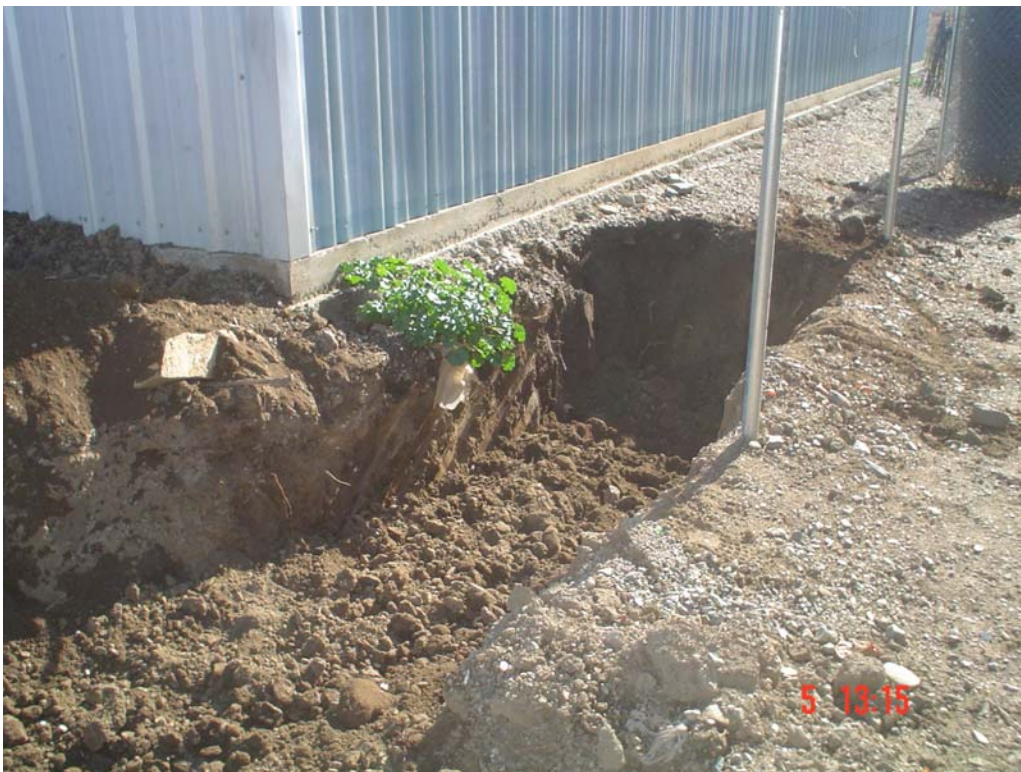
Plate 6: Area 4 backfilled 1/3 of the way (view south)

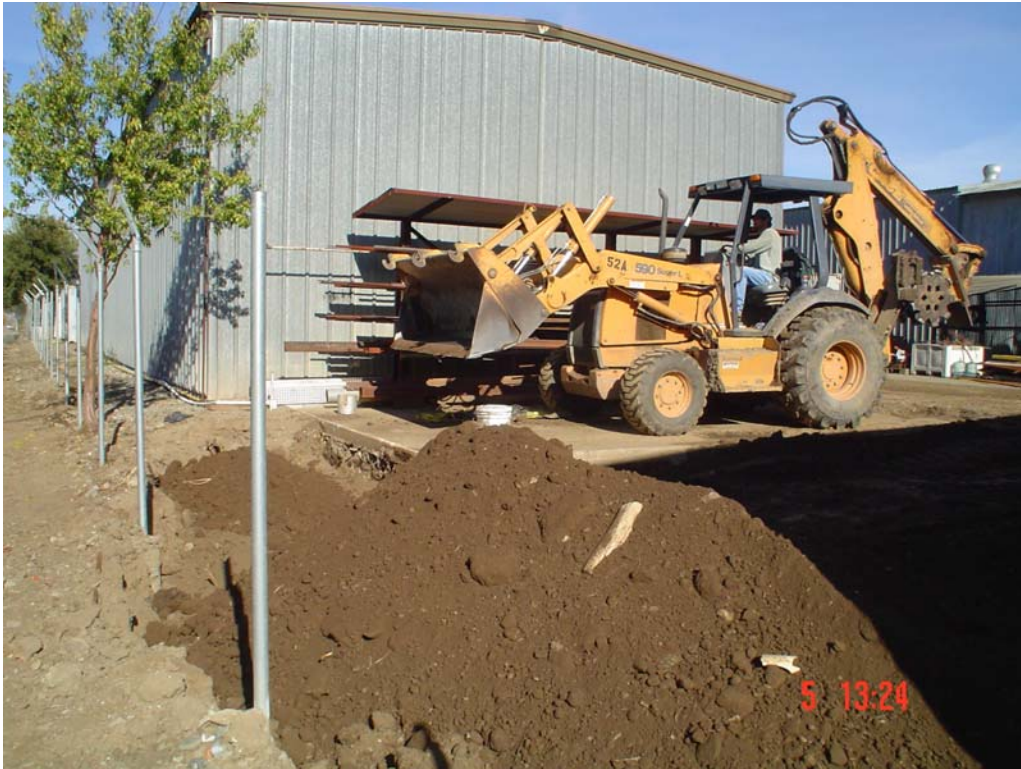
Plate 7: Area 4 being backfilled (view north)

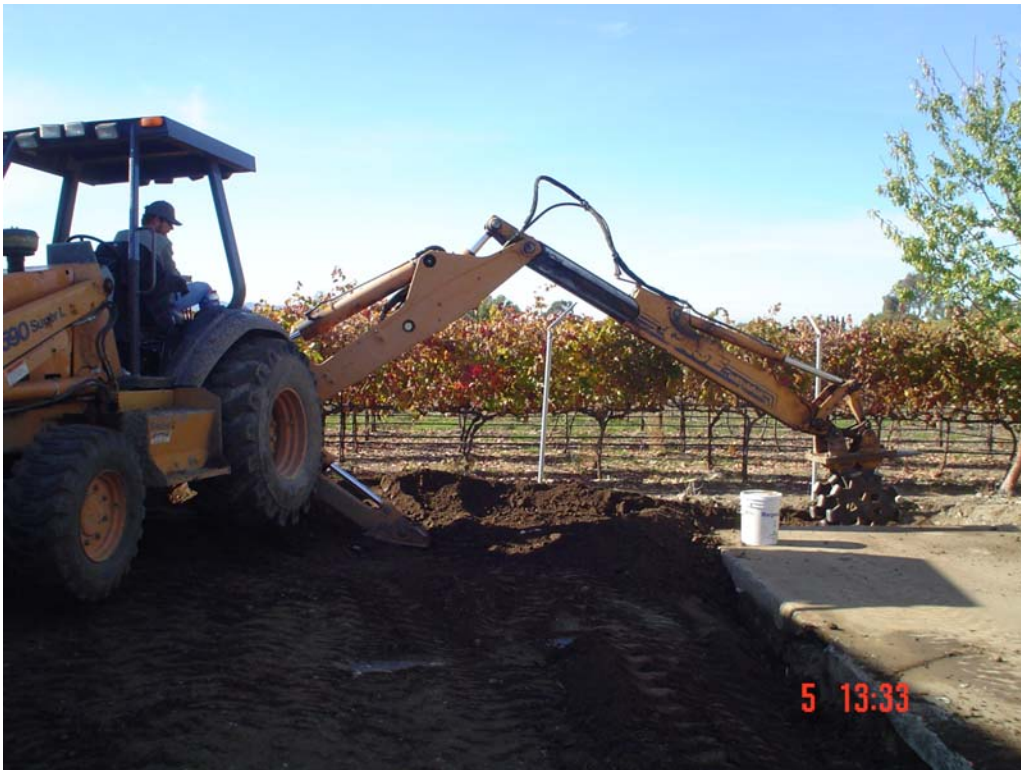
Plate 8: Area 4 being compacted (view west)

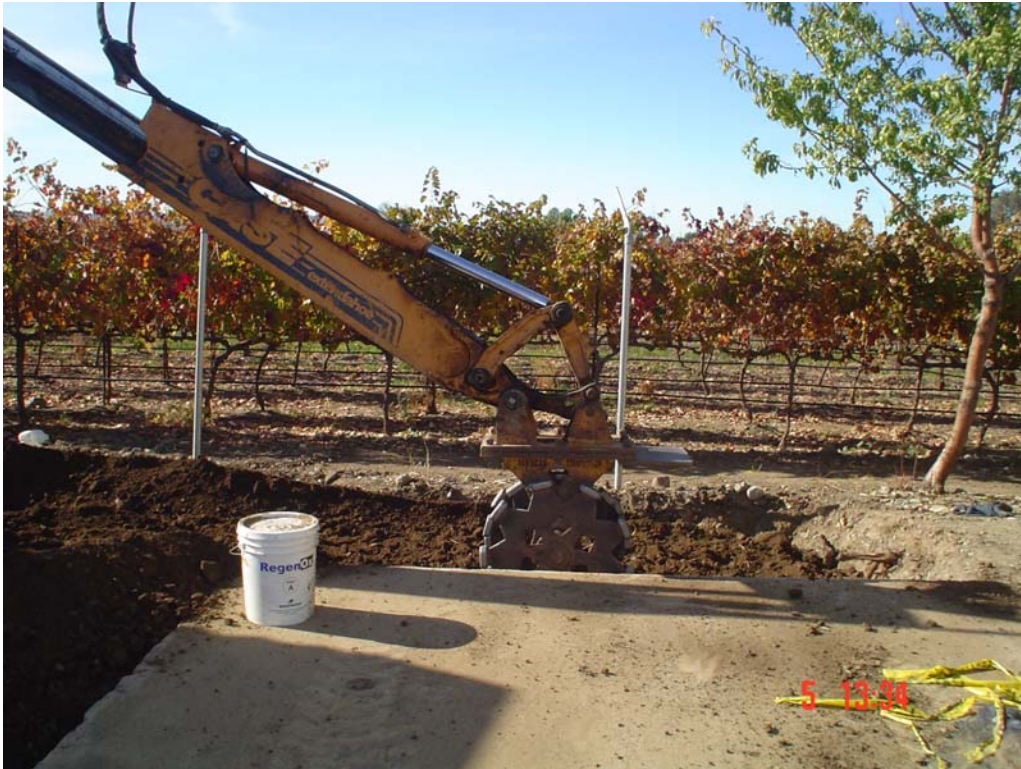
Plate 8: Area 4 being compacted (view west)

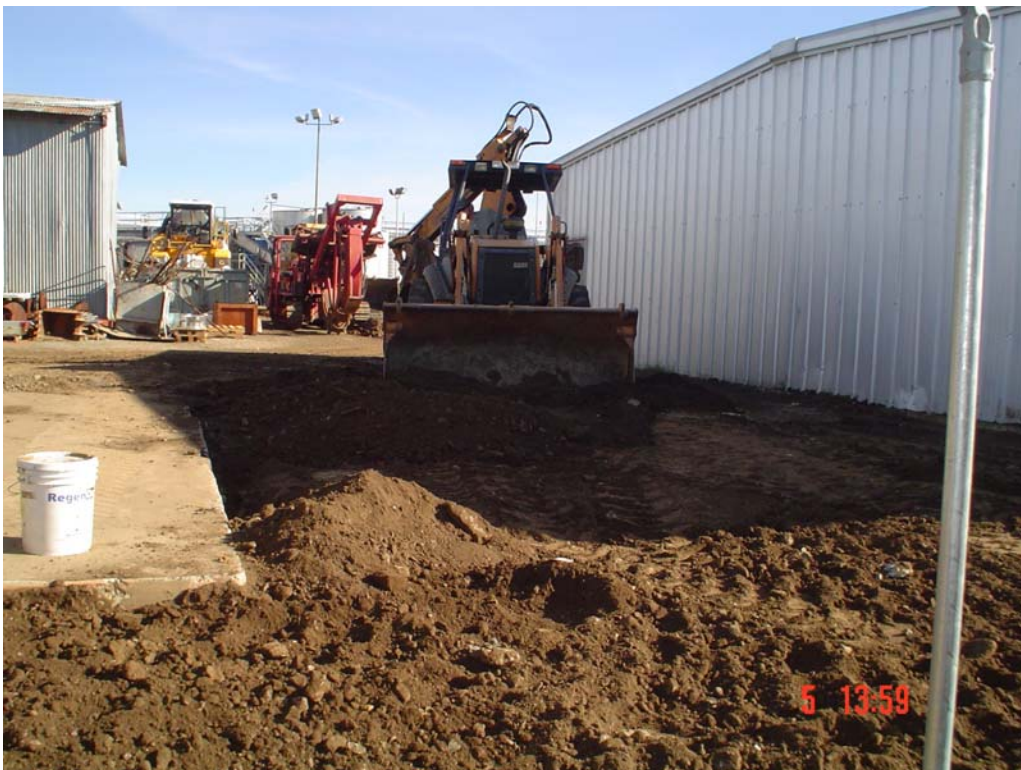
Plate 8: Final grading and re-compaction (view east)
