**Francis Plating Assessment
and Removal Report**
Oakland, California
Volume I

TDD No.: 09-9902-0017
PAN No.:0397-FPRS-XX
Contract No.: 68-W6-0100

Prepared by:
Cheong-Tseng Eng
Ecology and Environment, Inc.
Superfund Technical Assessment and Response Team

Prepared for:
United States Environmental Protection Agency, Region 9

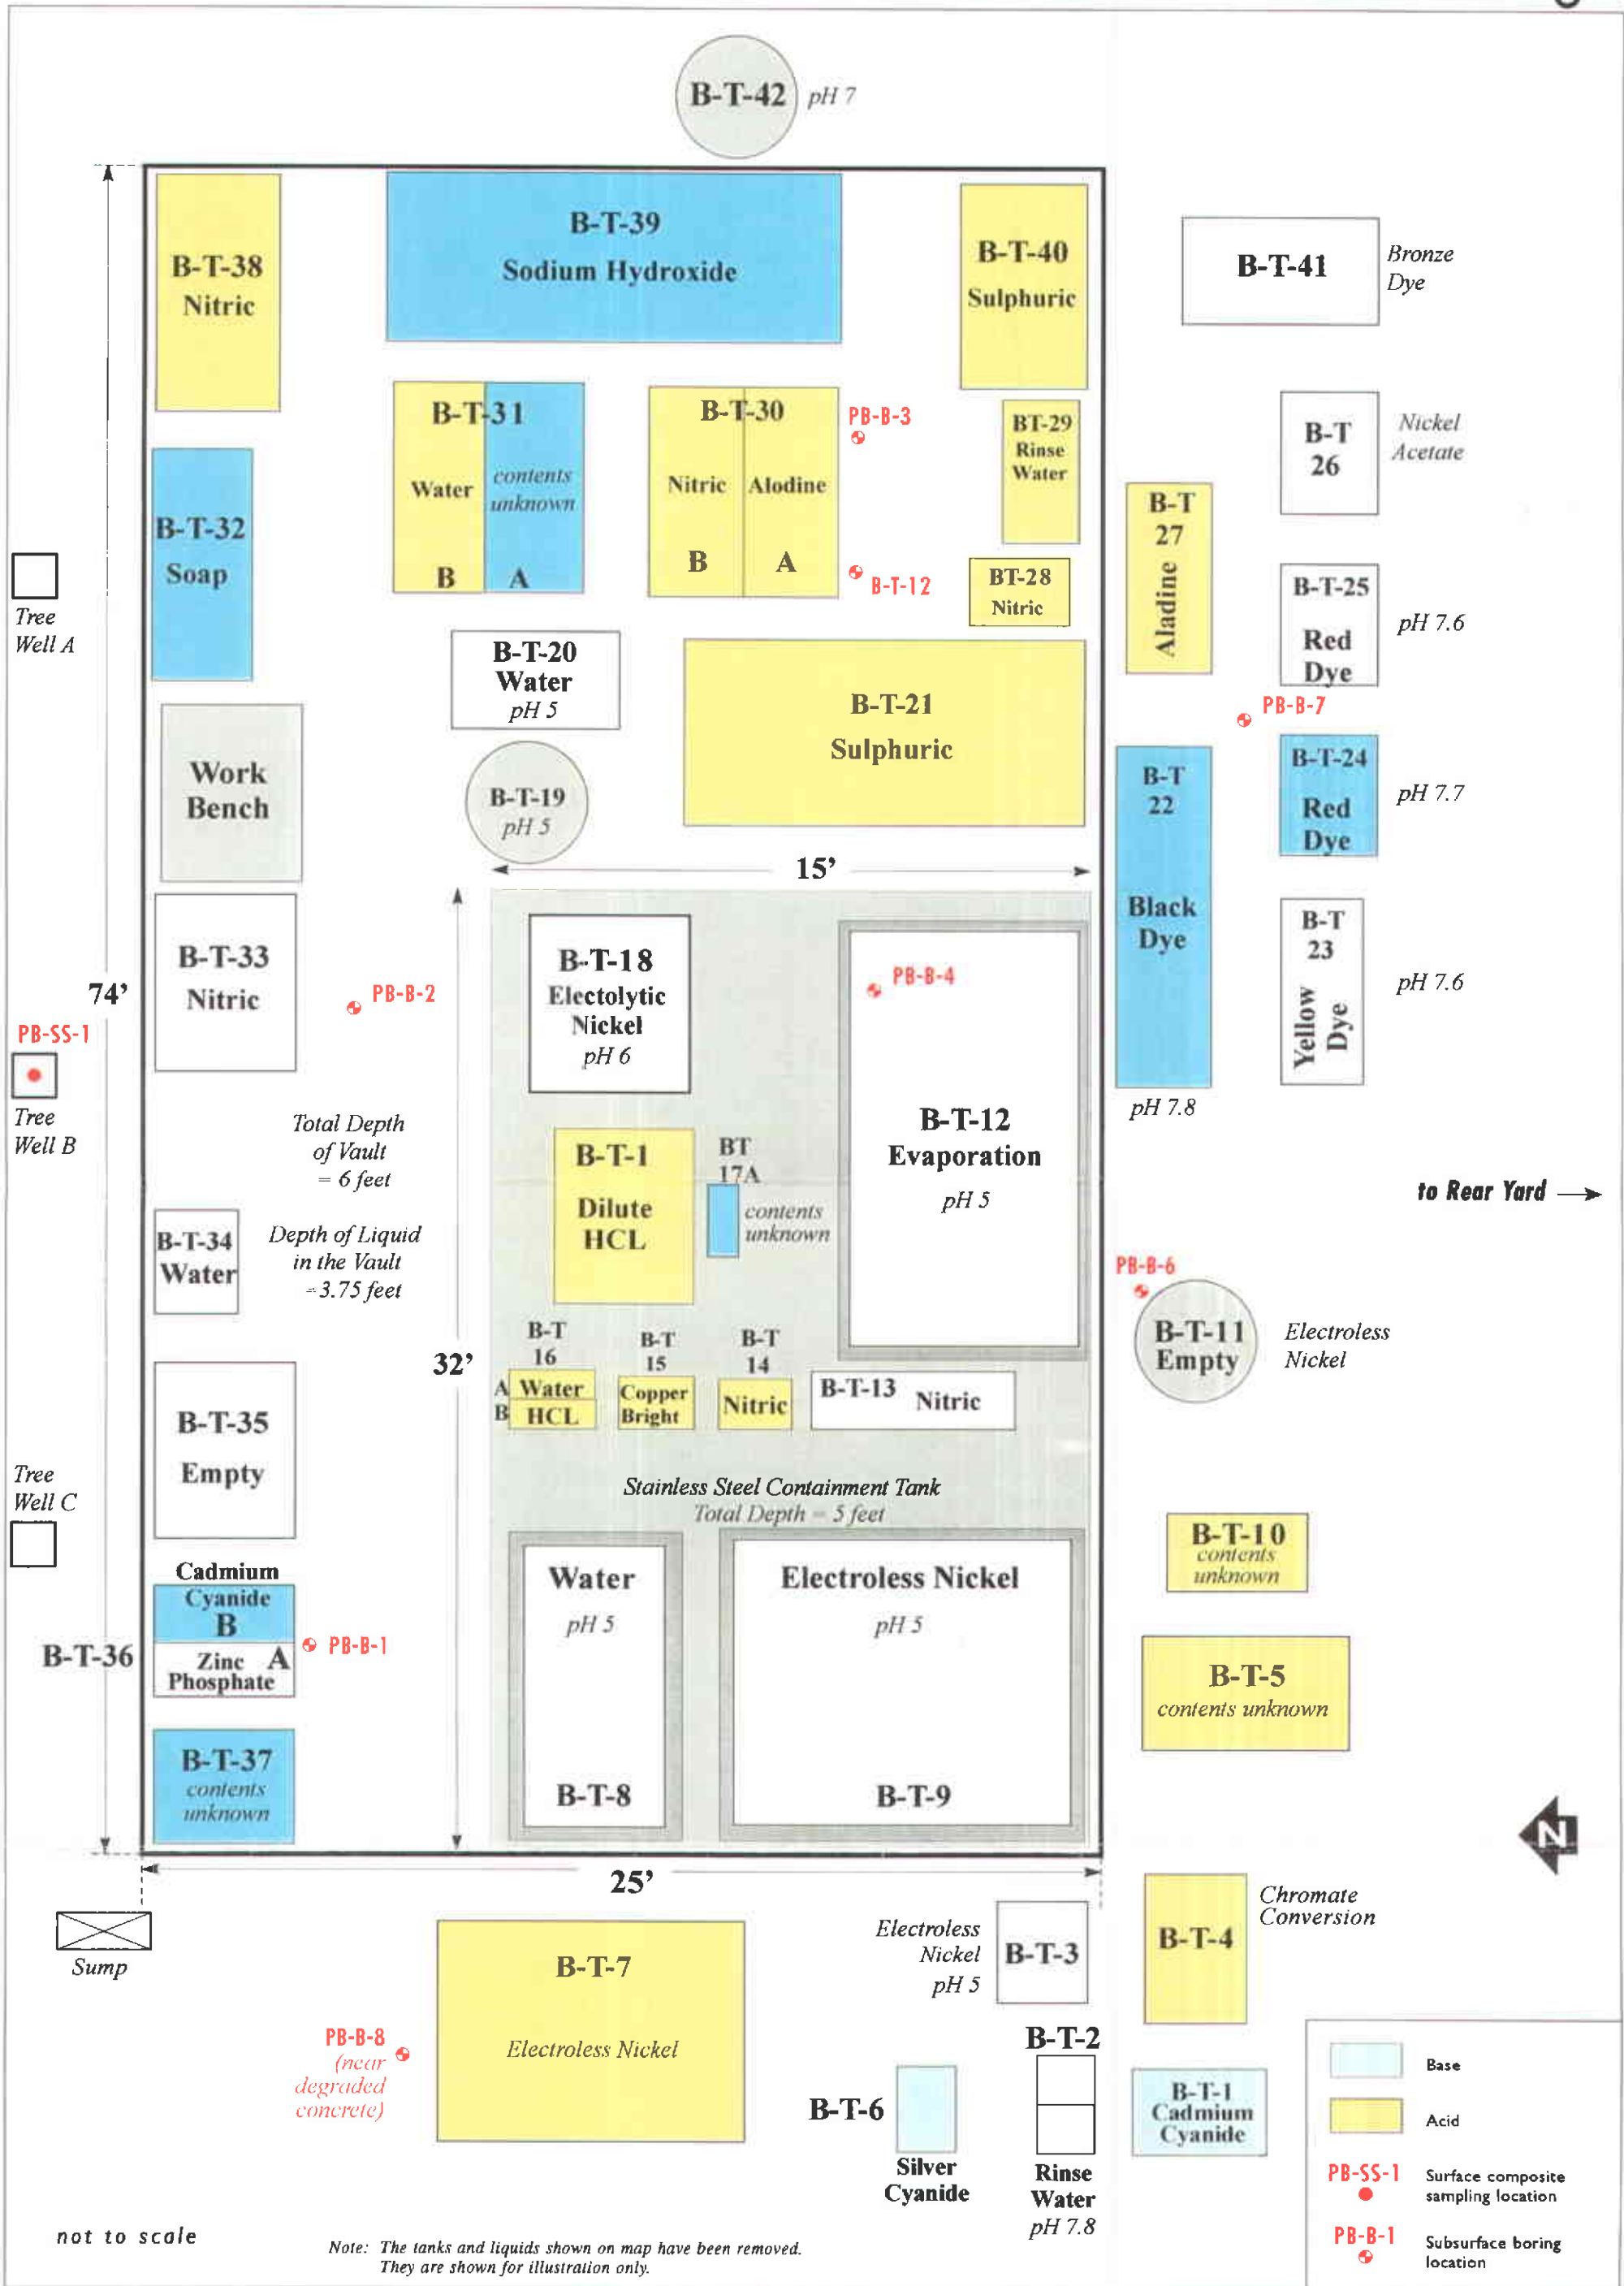
Figure 4-1a
Sampling Location Map – Plating Building
SUBSURFACE INVESTIGATION – JULY 1999
 Francis Plating Shop, Oakland, California

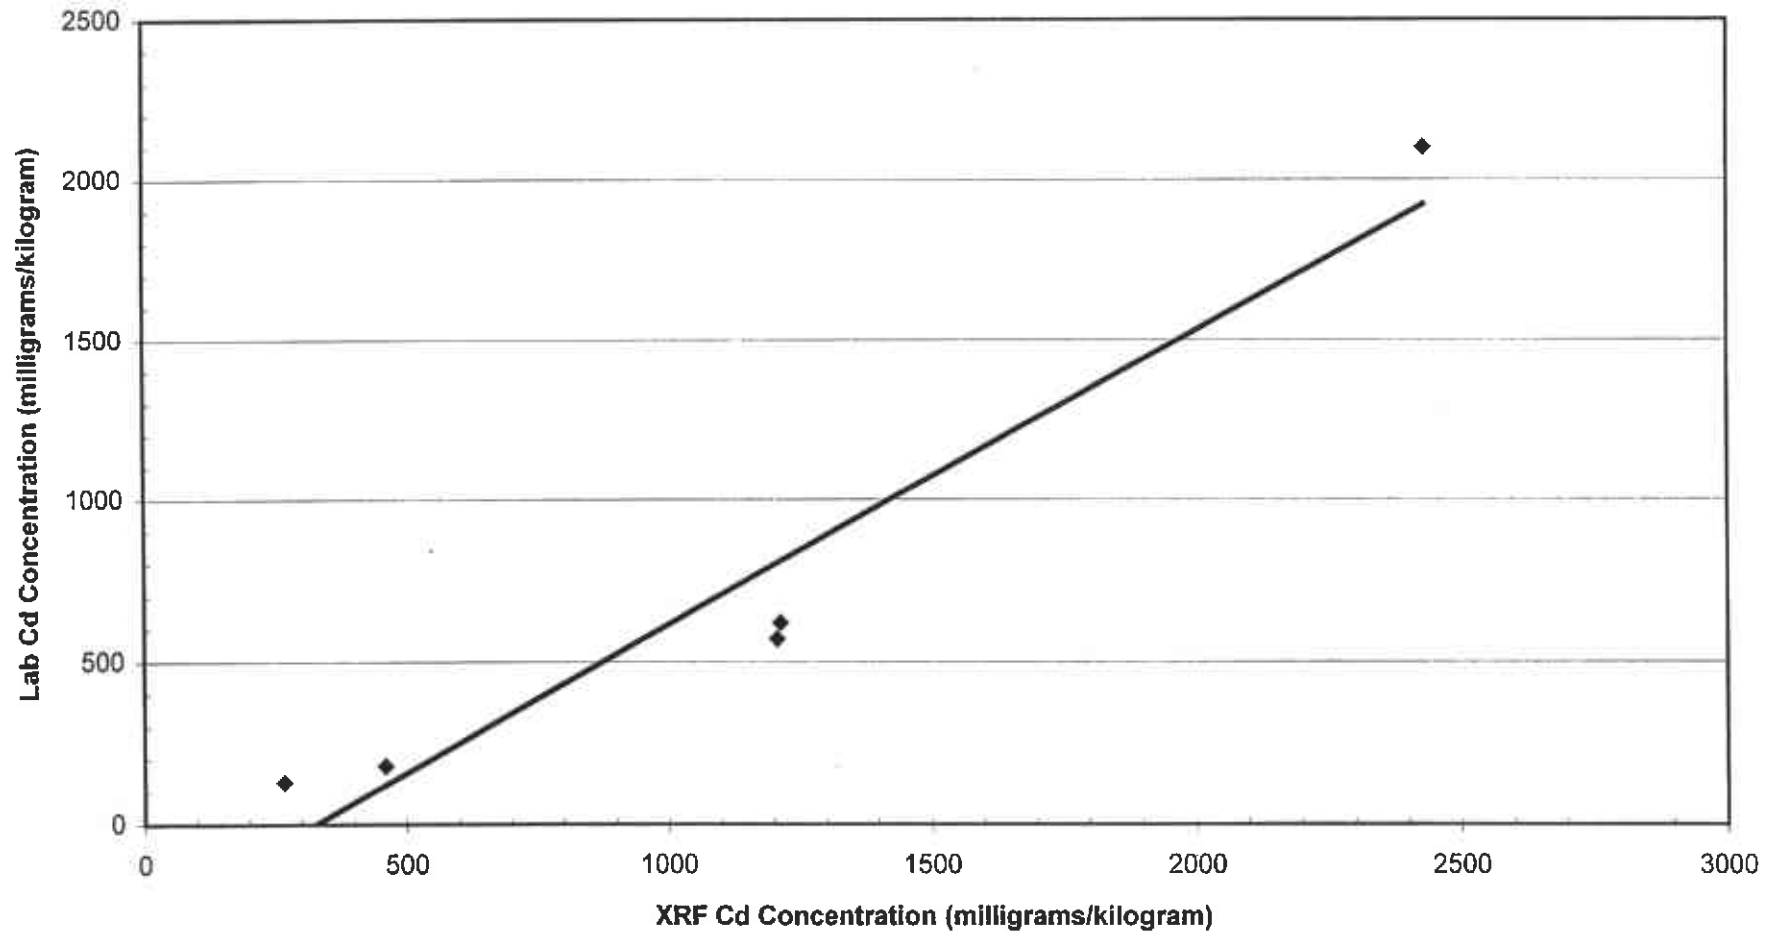
Relationship between XRF and laboratory data for cadmium (Cd) for the Subsurface Investigation.

$R^2 = 0.938$

Because at least two of the criteria were satisfied for the cadmium, copper, lead, nickel, and zinc correlations, all the XRF and lab data for these metals qualified for use as Screening Plus 10% Definitive Category Data. As a result of the strong correlation between XRF and laboratory data, all non-definitive and definitive analytical data for these metals were considered when making project decisions.

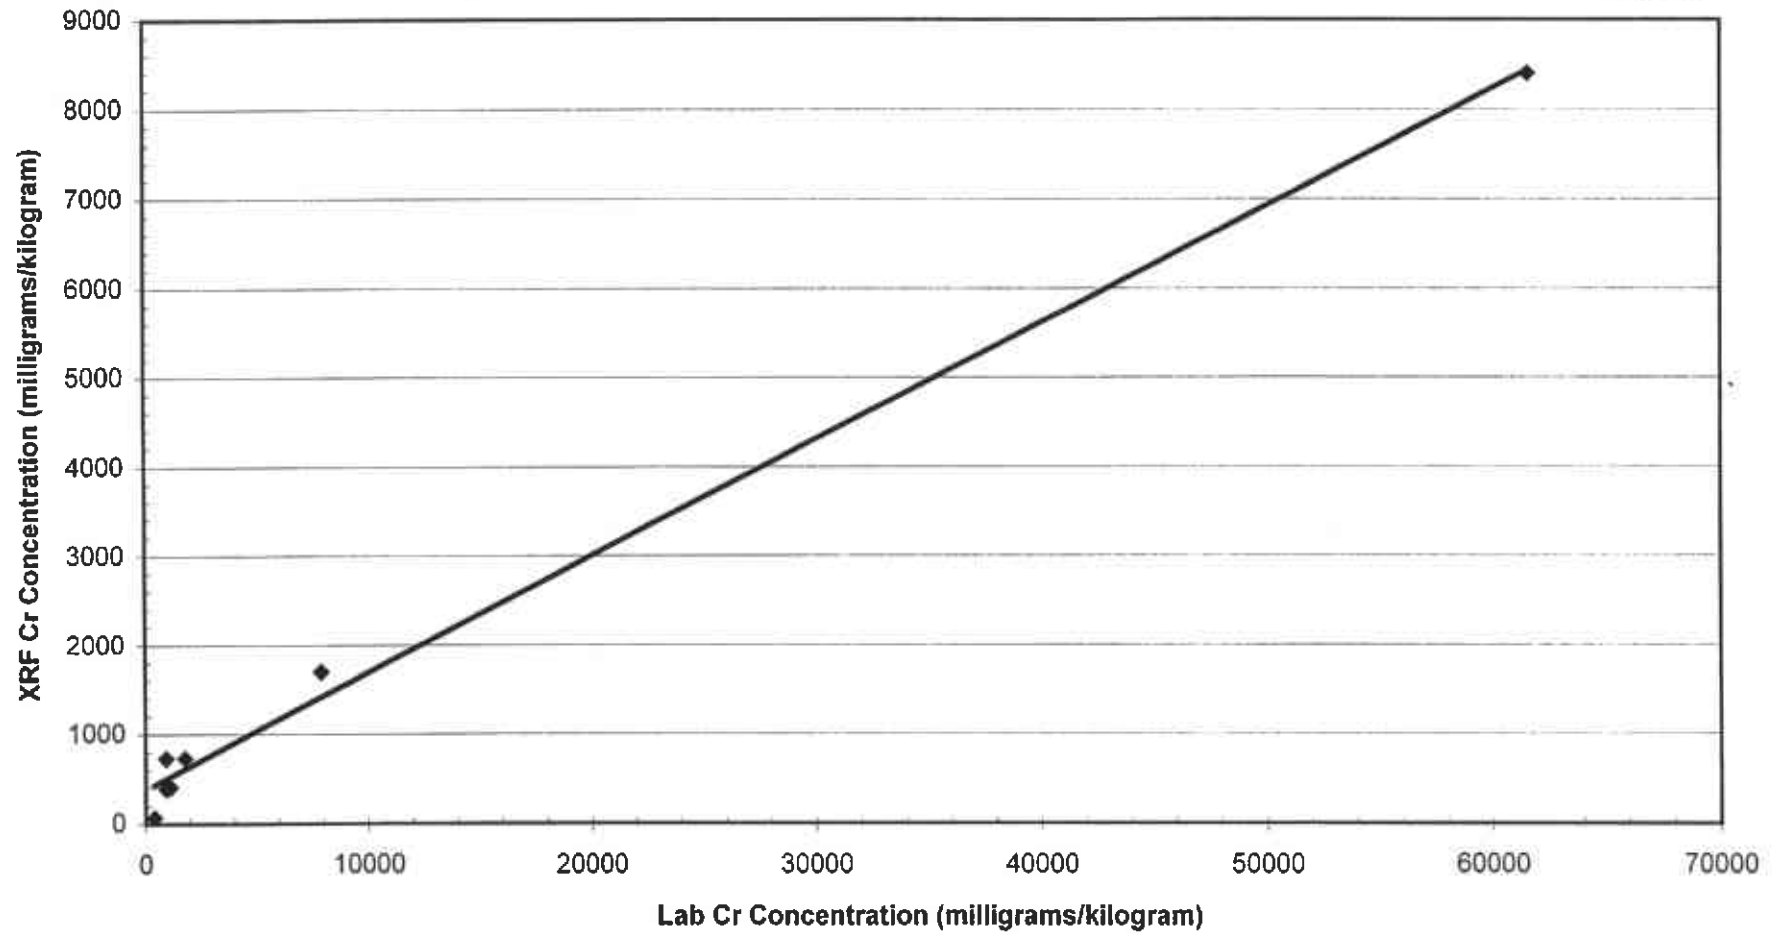
Figure 4-3

Relationship between XRF and laboratory data for total chromium (Cr) for the Subsurface Investigation.

$R^2 = 0.9942$

Regression analysis showed a weak correlation between XRF and laboratory data for total chromium, and only the first criterion was satisfied. The weak correlation may have been due to interferences from other metals and/or matrix effects. However, the correlation indicated that definitive laboratory chromium concentrations were significantly less than XRF concentrations. Although the correlation was weak, no corrective action was necessary since the XRF results were conservative measurements and thus protective of human health and the environment.

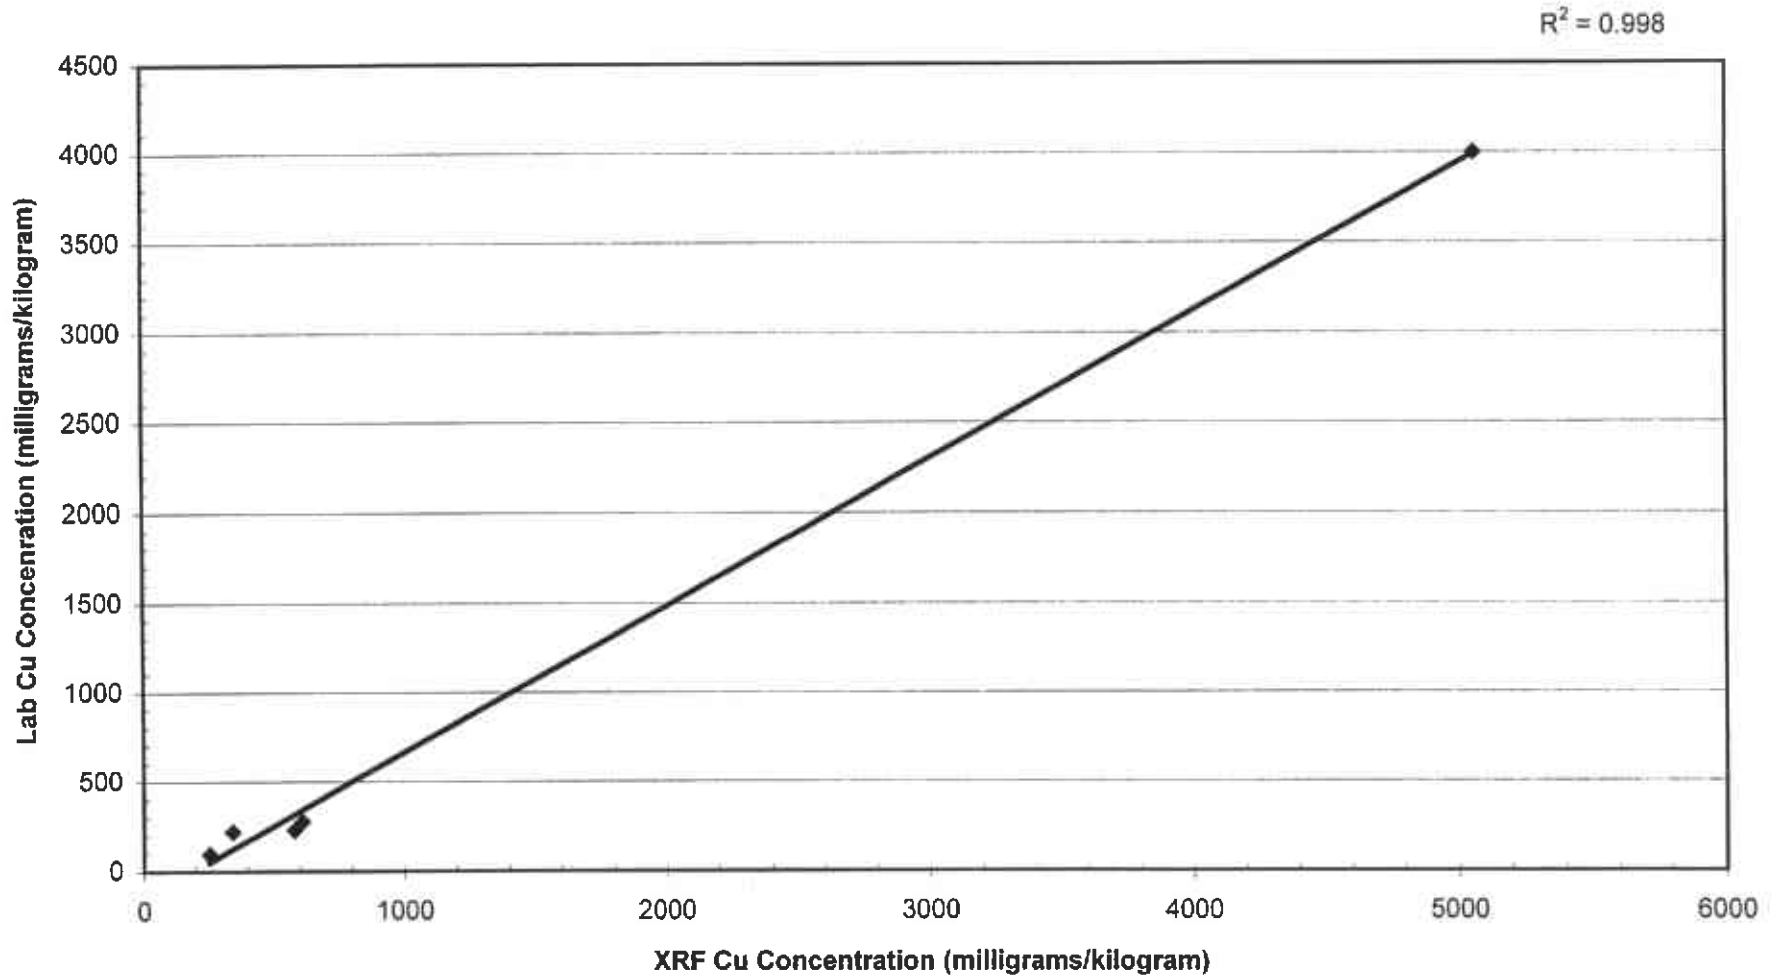
Figure 4-4

Relationship between XRF and laboratory data for copper (Cu) for the Subsurface Investigation.

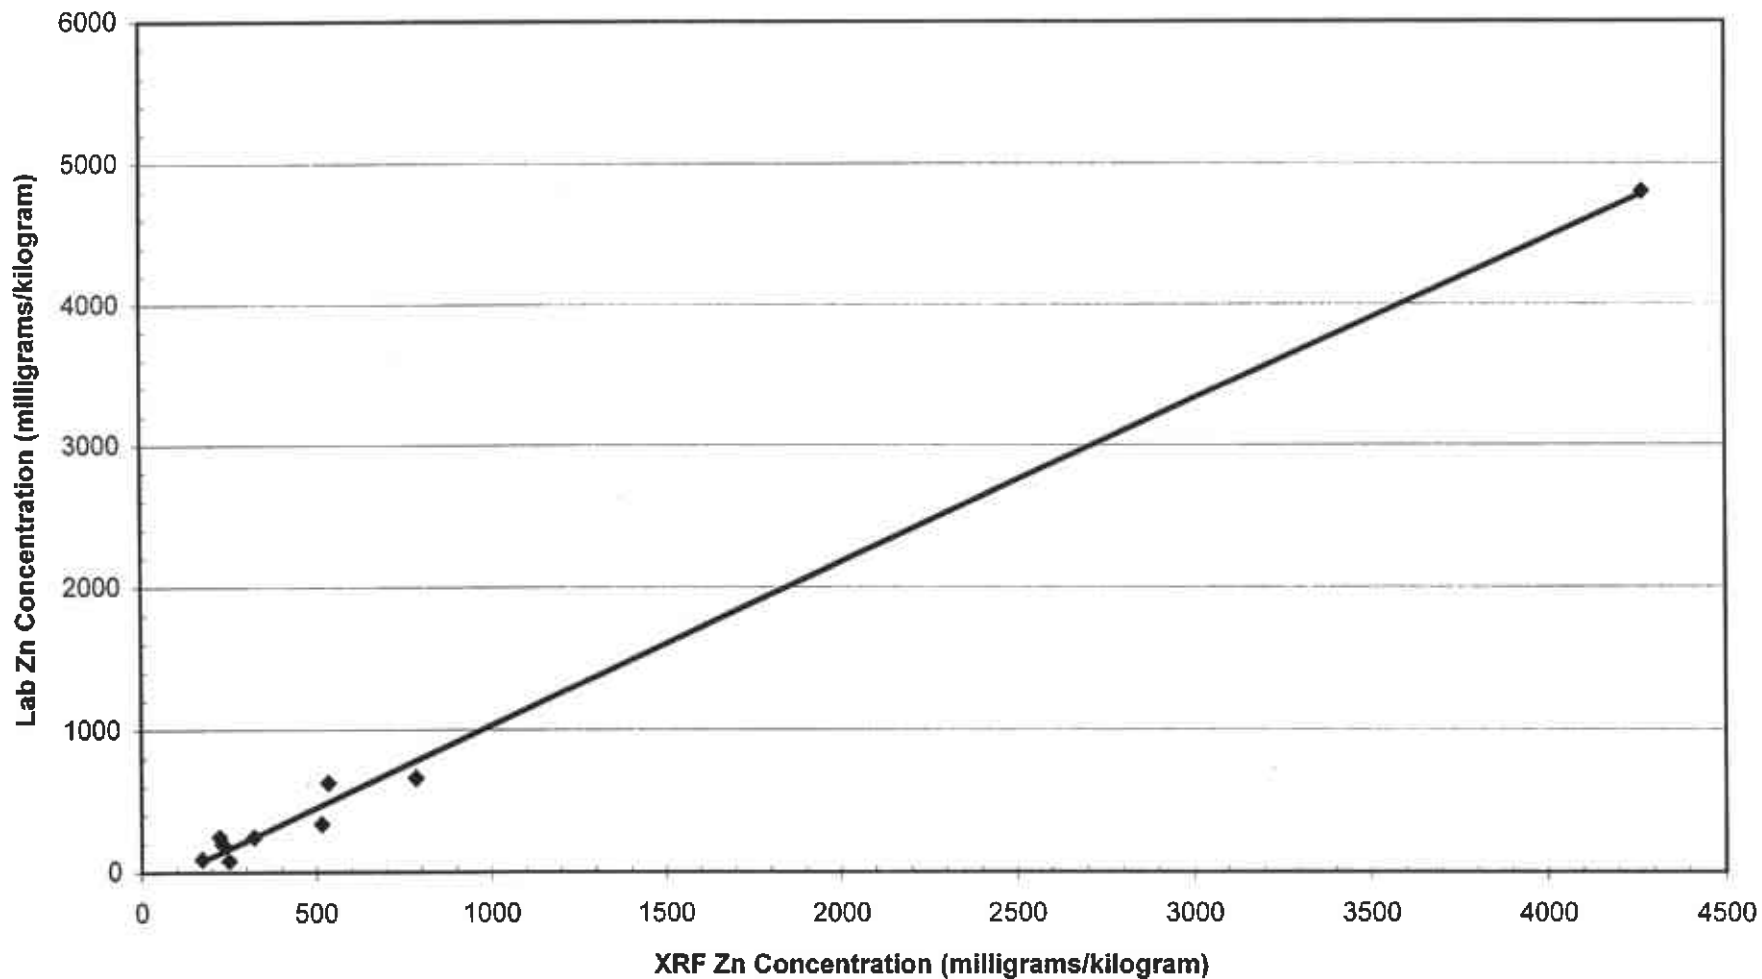
Figure 4-5

Relationship between XRF and laboratory data for zinc (Zn) for the Subsurface Investigation.

$R^2 = 0.9959$

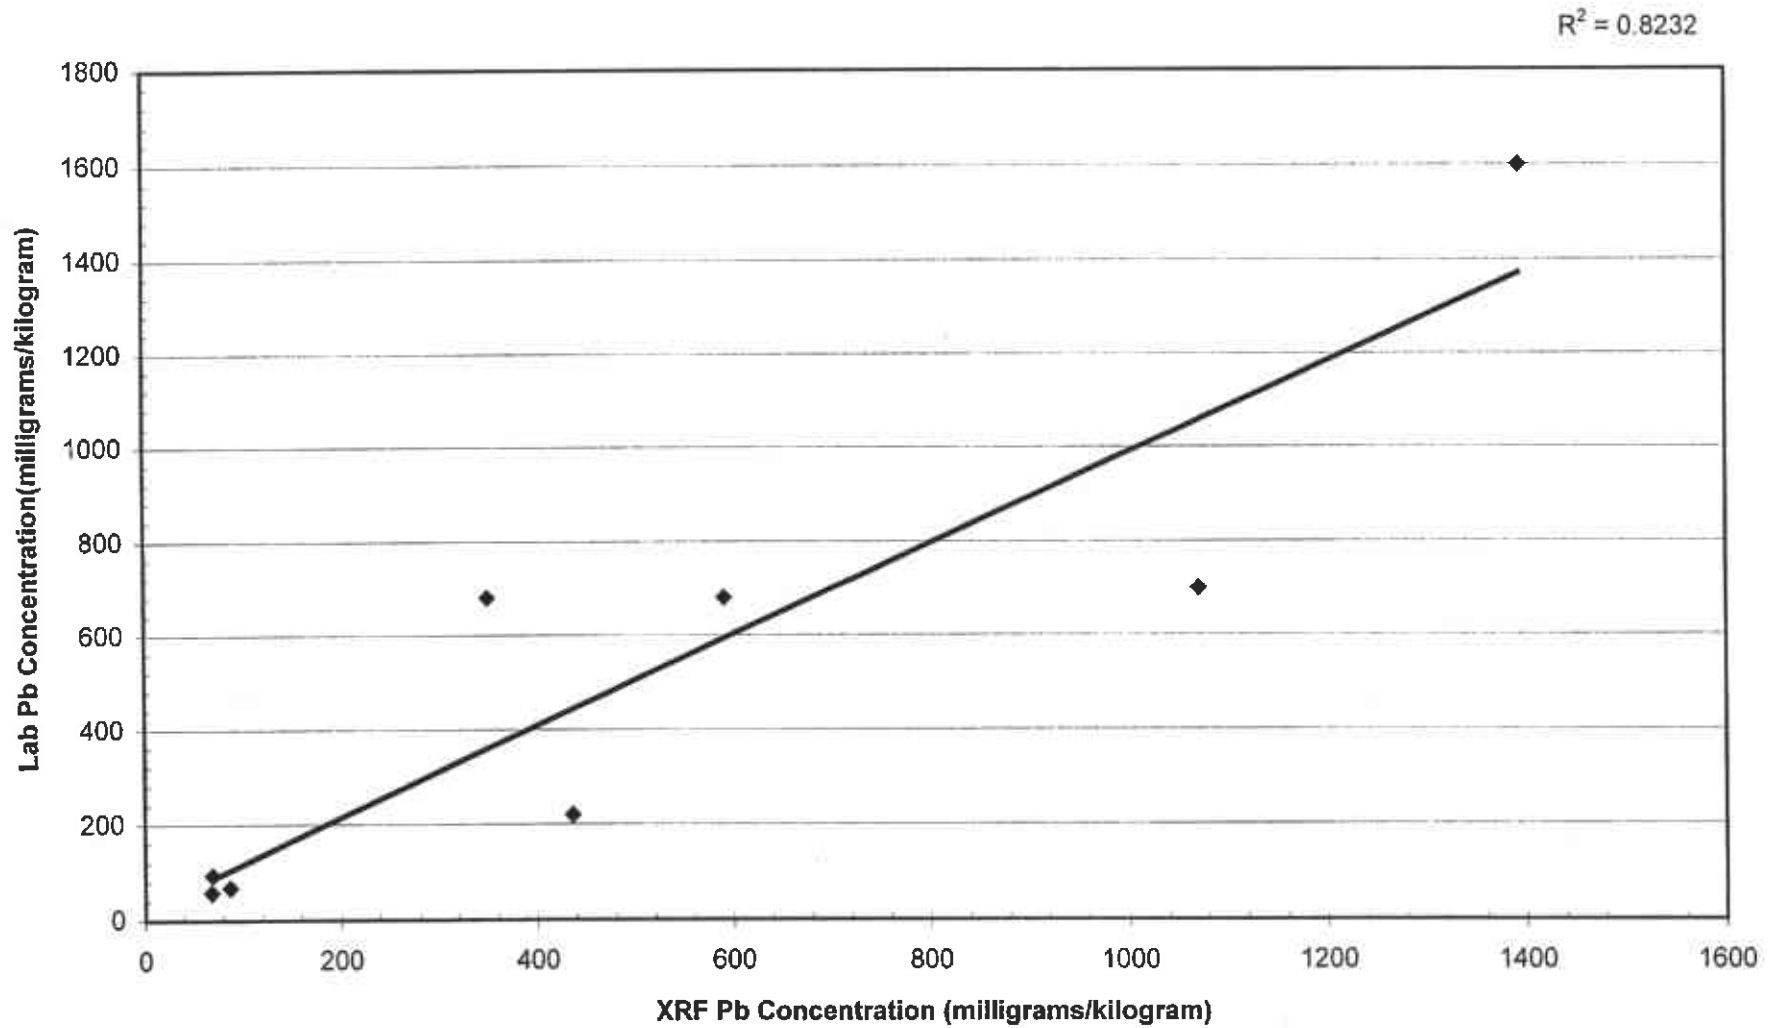
Figure 4-6

Relationship between XRF and laboratory data for lead (Pb) for the Subsurface Investigation.

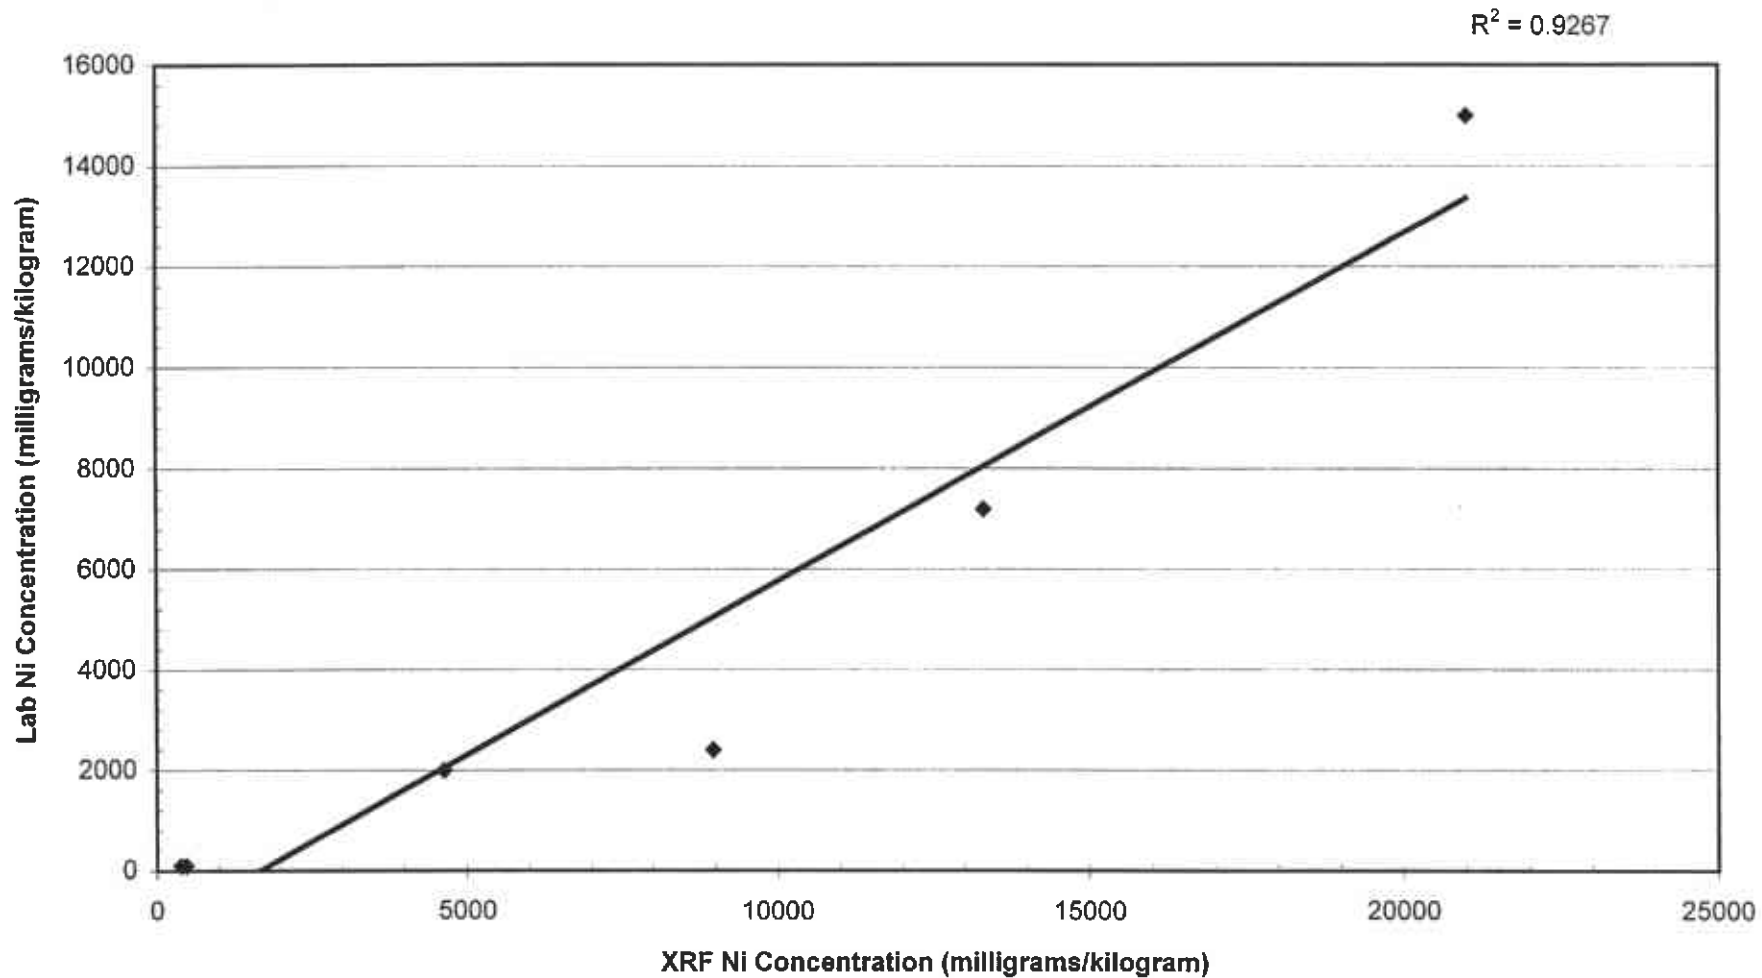
Figure 4-7

Relationship between XRF and laboratory data for nickel (Ni) for the Subsurface Investigation.

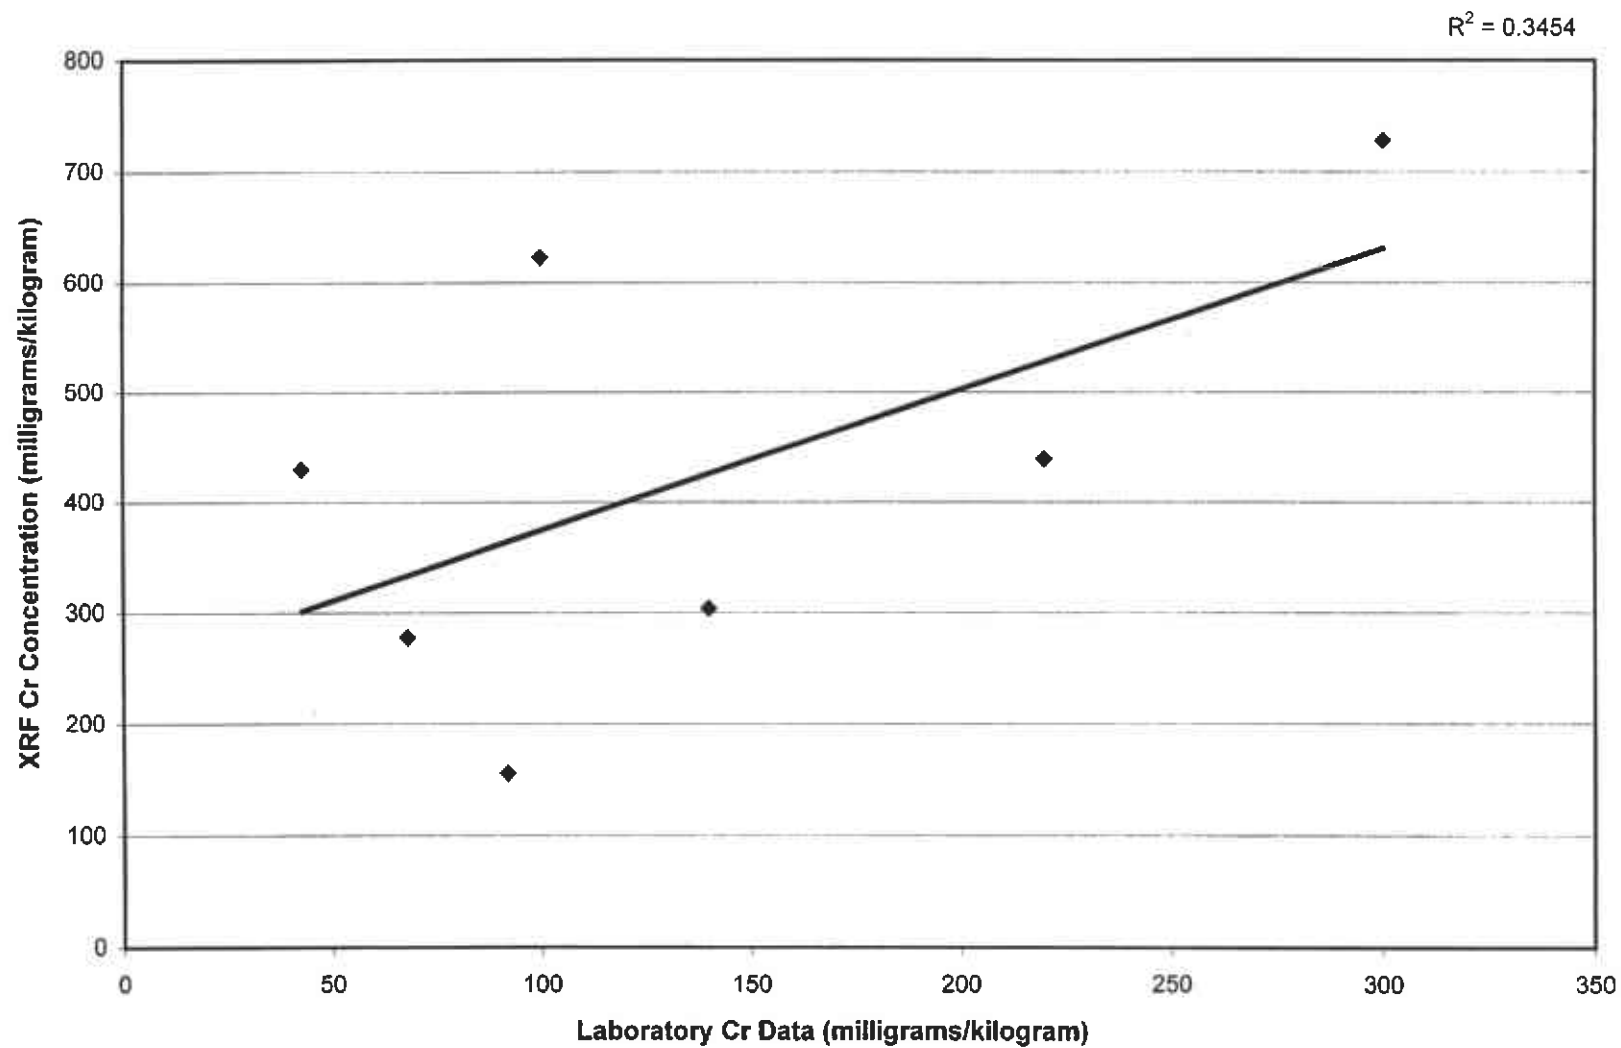
Figure 5-2

Relationship between XRF and laboratory data for chromium (Cr)
for the Subsurface Removal Effort.

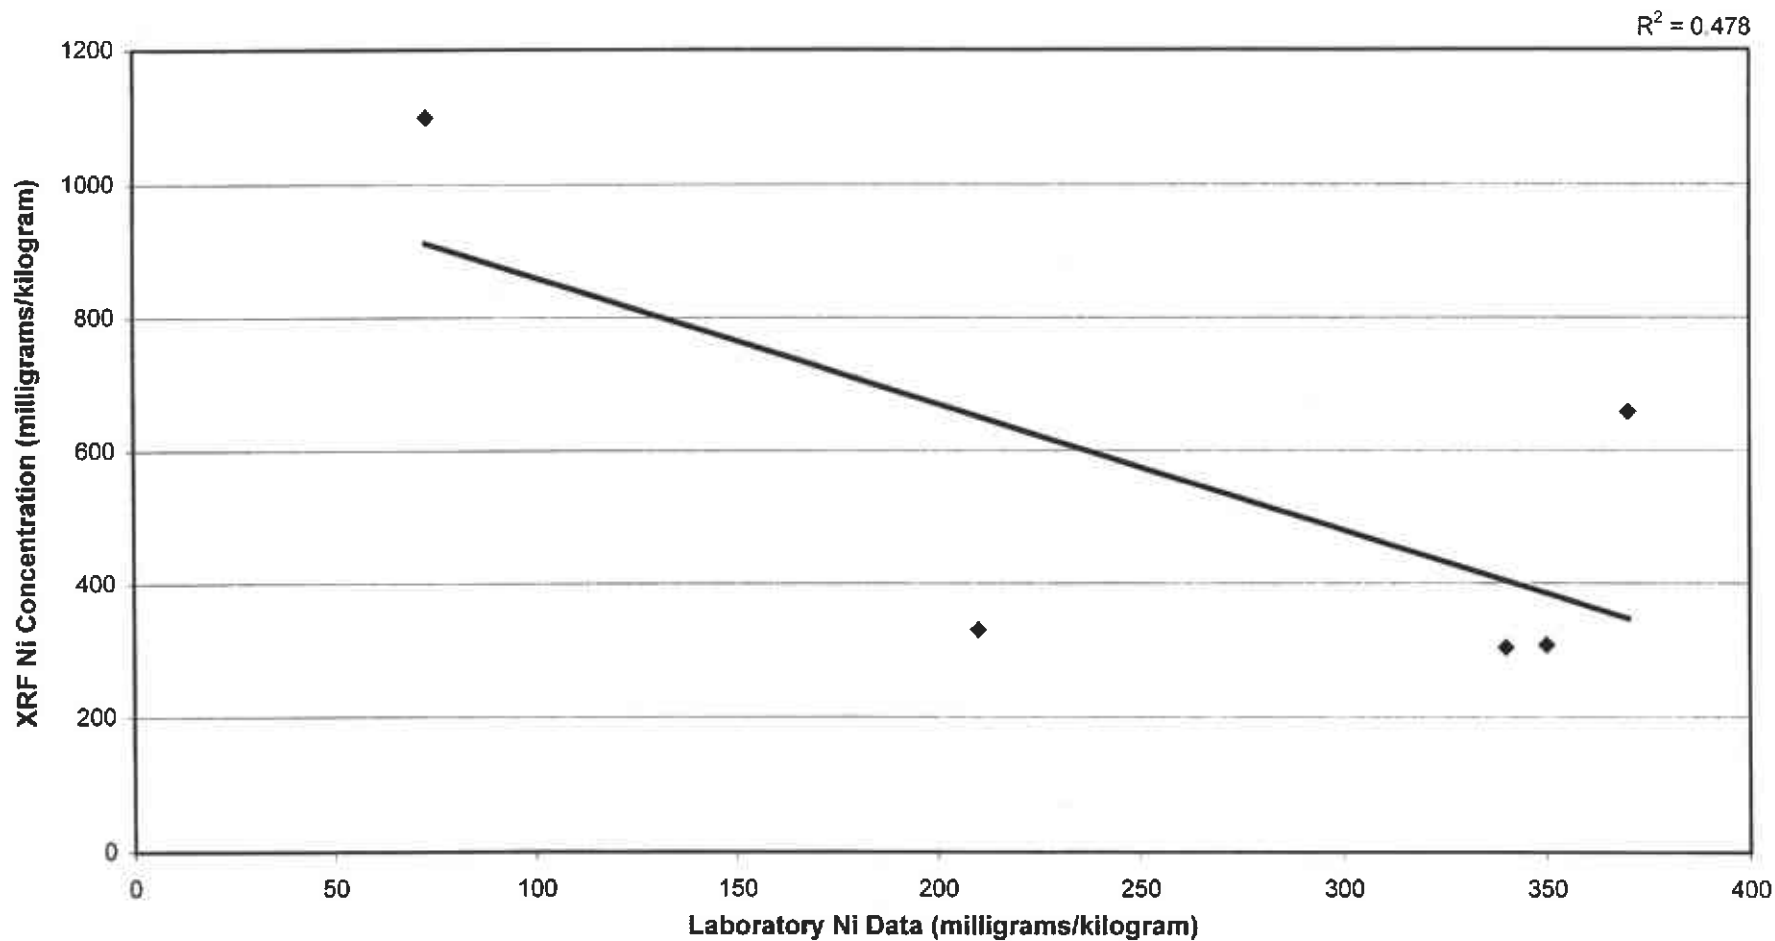
Figure 5-3

Relationship between XRF and laboratory data for nickel (Ni)
for the Subsurface Removal Effort

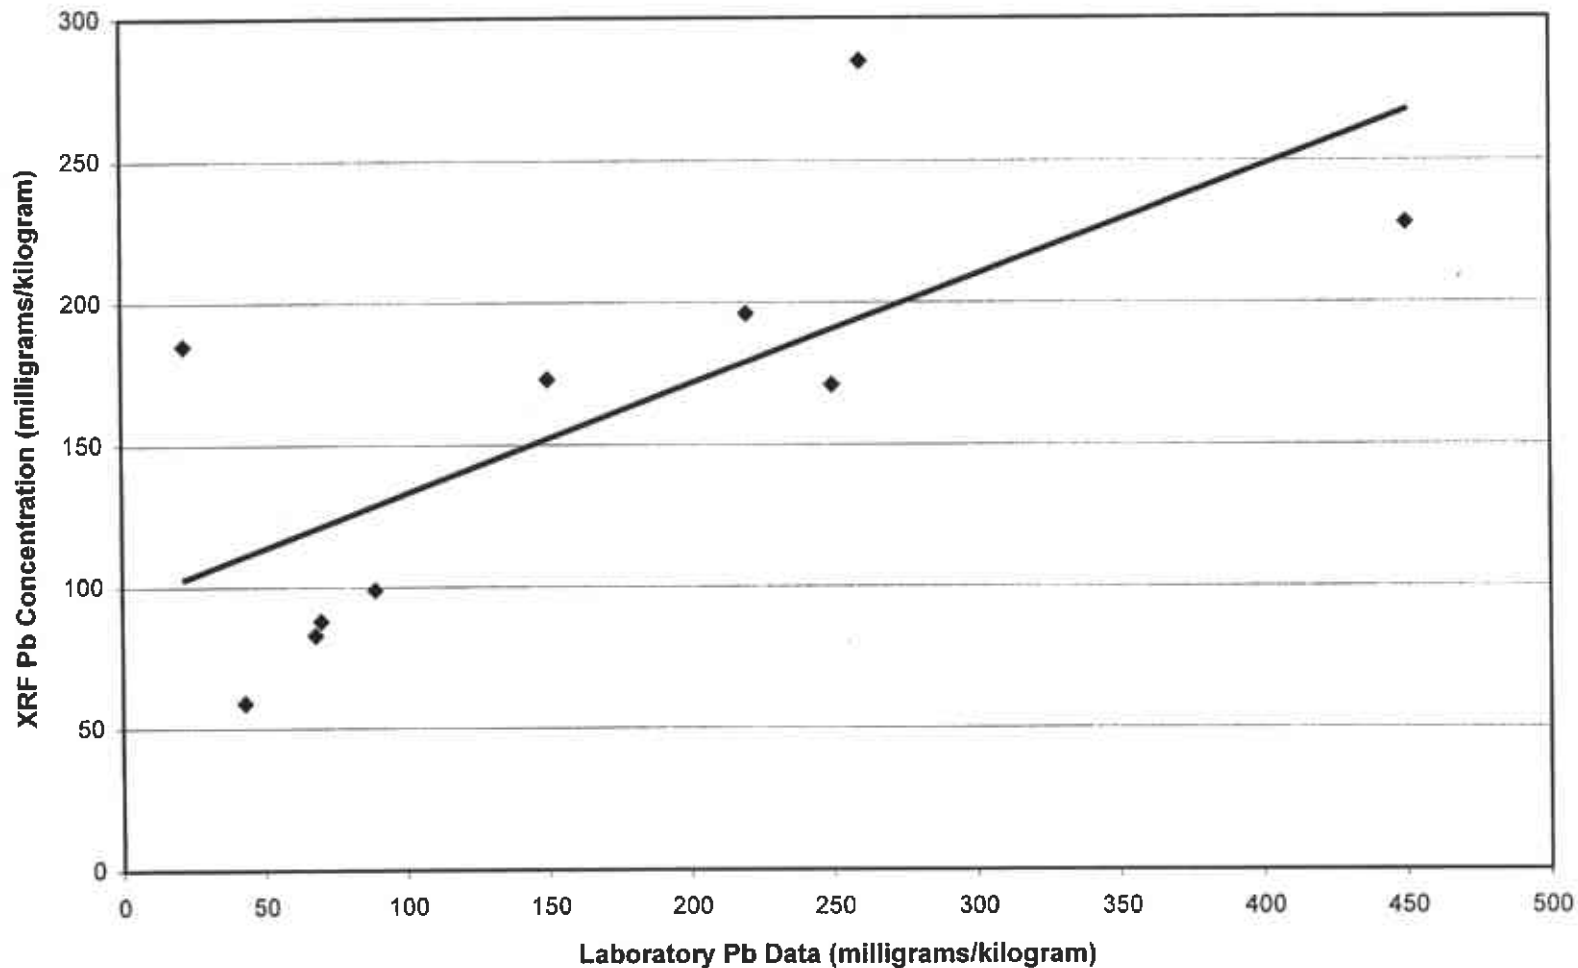
Figure 5-4

Relationship between XRF and laboratory data for lead (Pb)
for the Subsurface Removal Effort.

$R^2 = 0.4995$

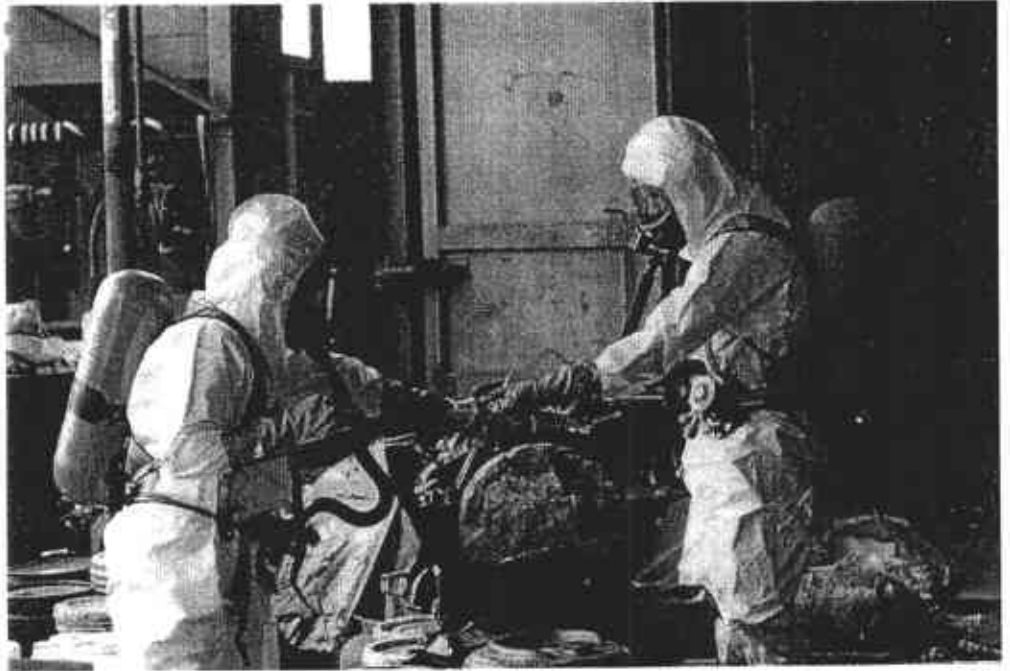
Photo Number:
4

Subject:
Debris in the Fore Yard before the
initiation of the removal effort.

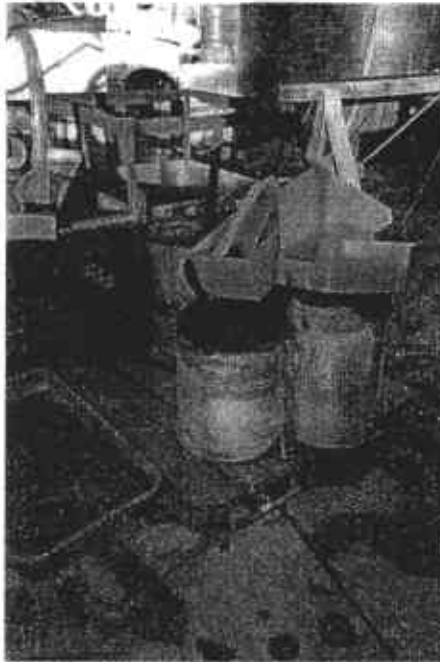
Photo Number:
6

Subject:
START member investigating
the interior of the norther
Sealand container.

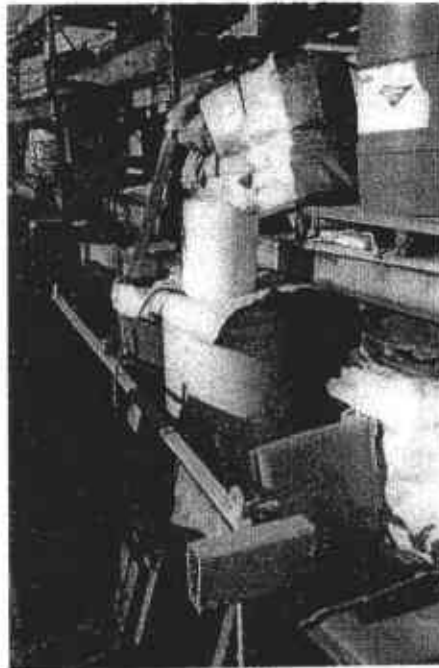
Photo Number:
8

Subject:
Concrete affected by leakage from
overhead HCL tank (pH label on
tank was incorrect).

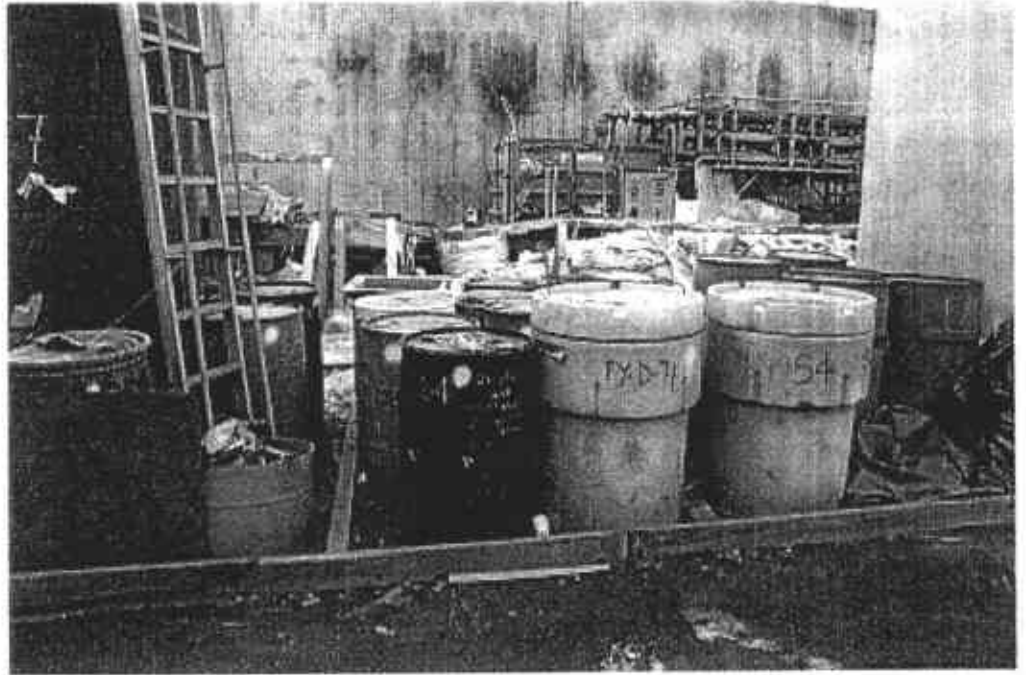
Photo Number:
10

Subject:
Miscellaneous debris and drums
on the grating over the
Frog Pond in the Rear Yard.

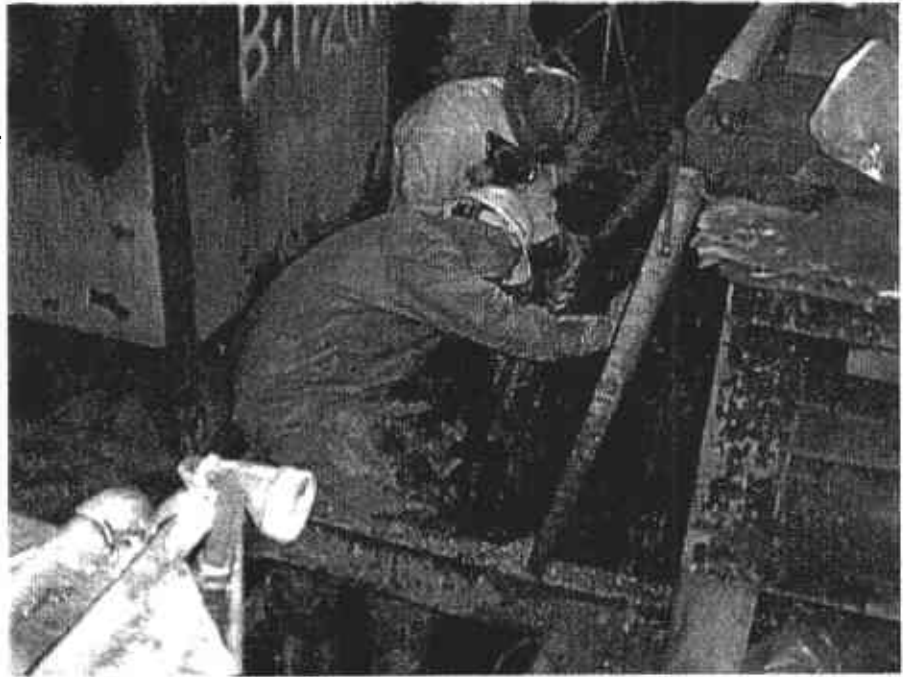
Photo Number:
20

Subject:
ERRS contractor removing sludge
from the Vault.

Finally, liquid in the tanks and sludge in the Vault were evacuated with a Super Sucker®. The tanks were then lifted from the Vault with a stationary crane, placed into an empty stainless steel containment tank, cut with a plasma torch and rinsed. The majority of the vats were shipped off site for disposal. Finally, the Vault was scrubbed and rinsed to remove the remaining residue.

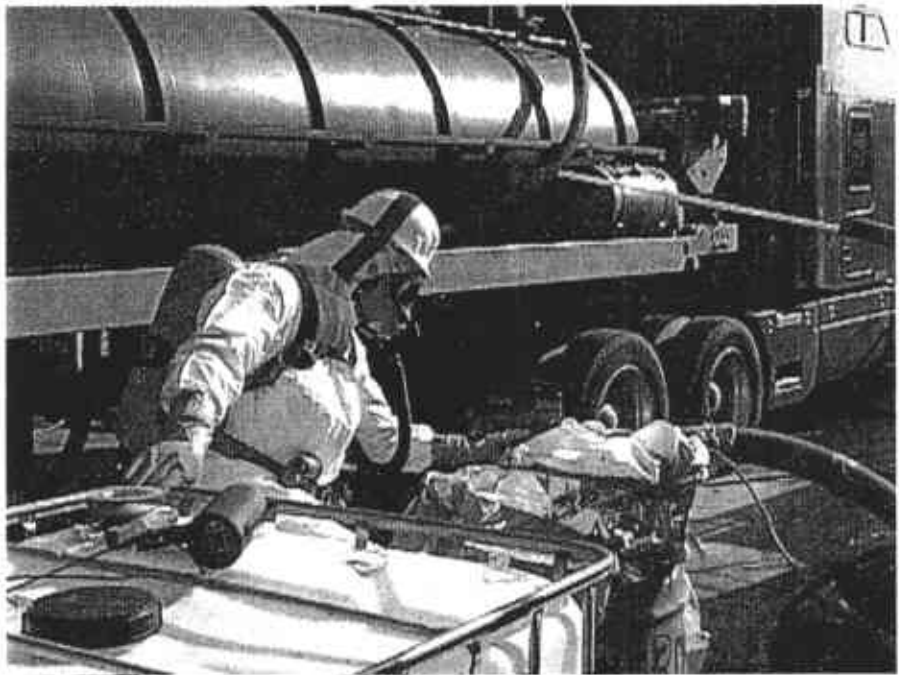
Photo Number:
24

Subject:
ERRS contractor cutting tank in
preparation for disposal.
