**Subject: Site History and Data Summary Report, 785 - 7<sup>th</sup> Street, Oakland, California**

# SITE HISTORY AND DATA SUMMARY REPORT

785 - 7<sup>TH</sup> STREET  
Oakland, California

For:  
BRUSH STREET GROUP  
Oakland, California

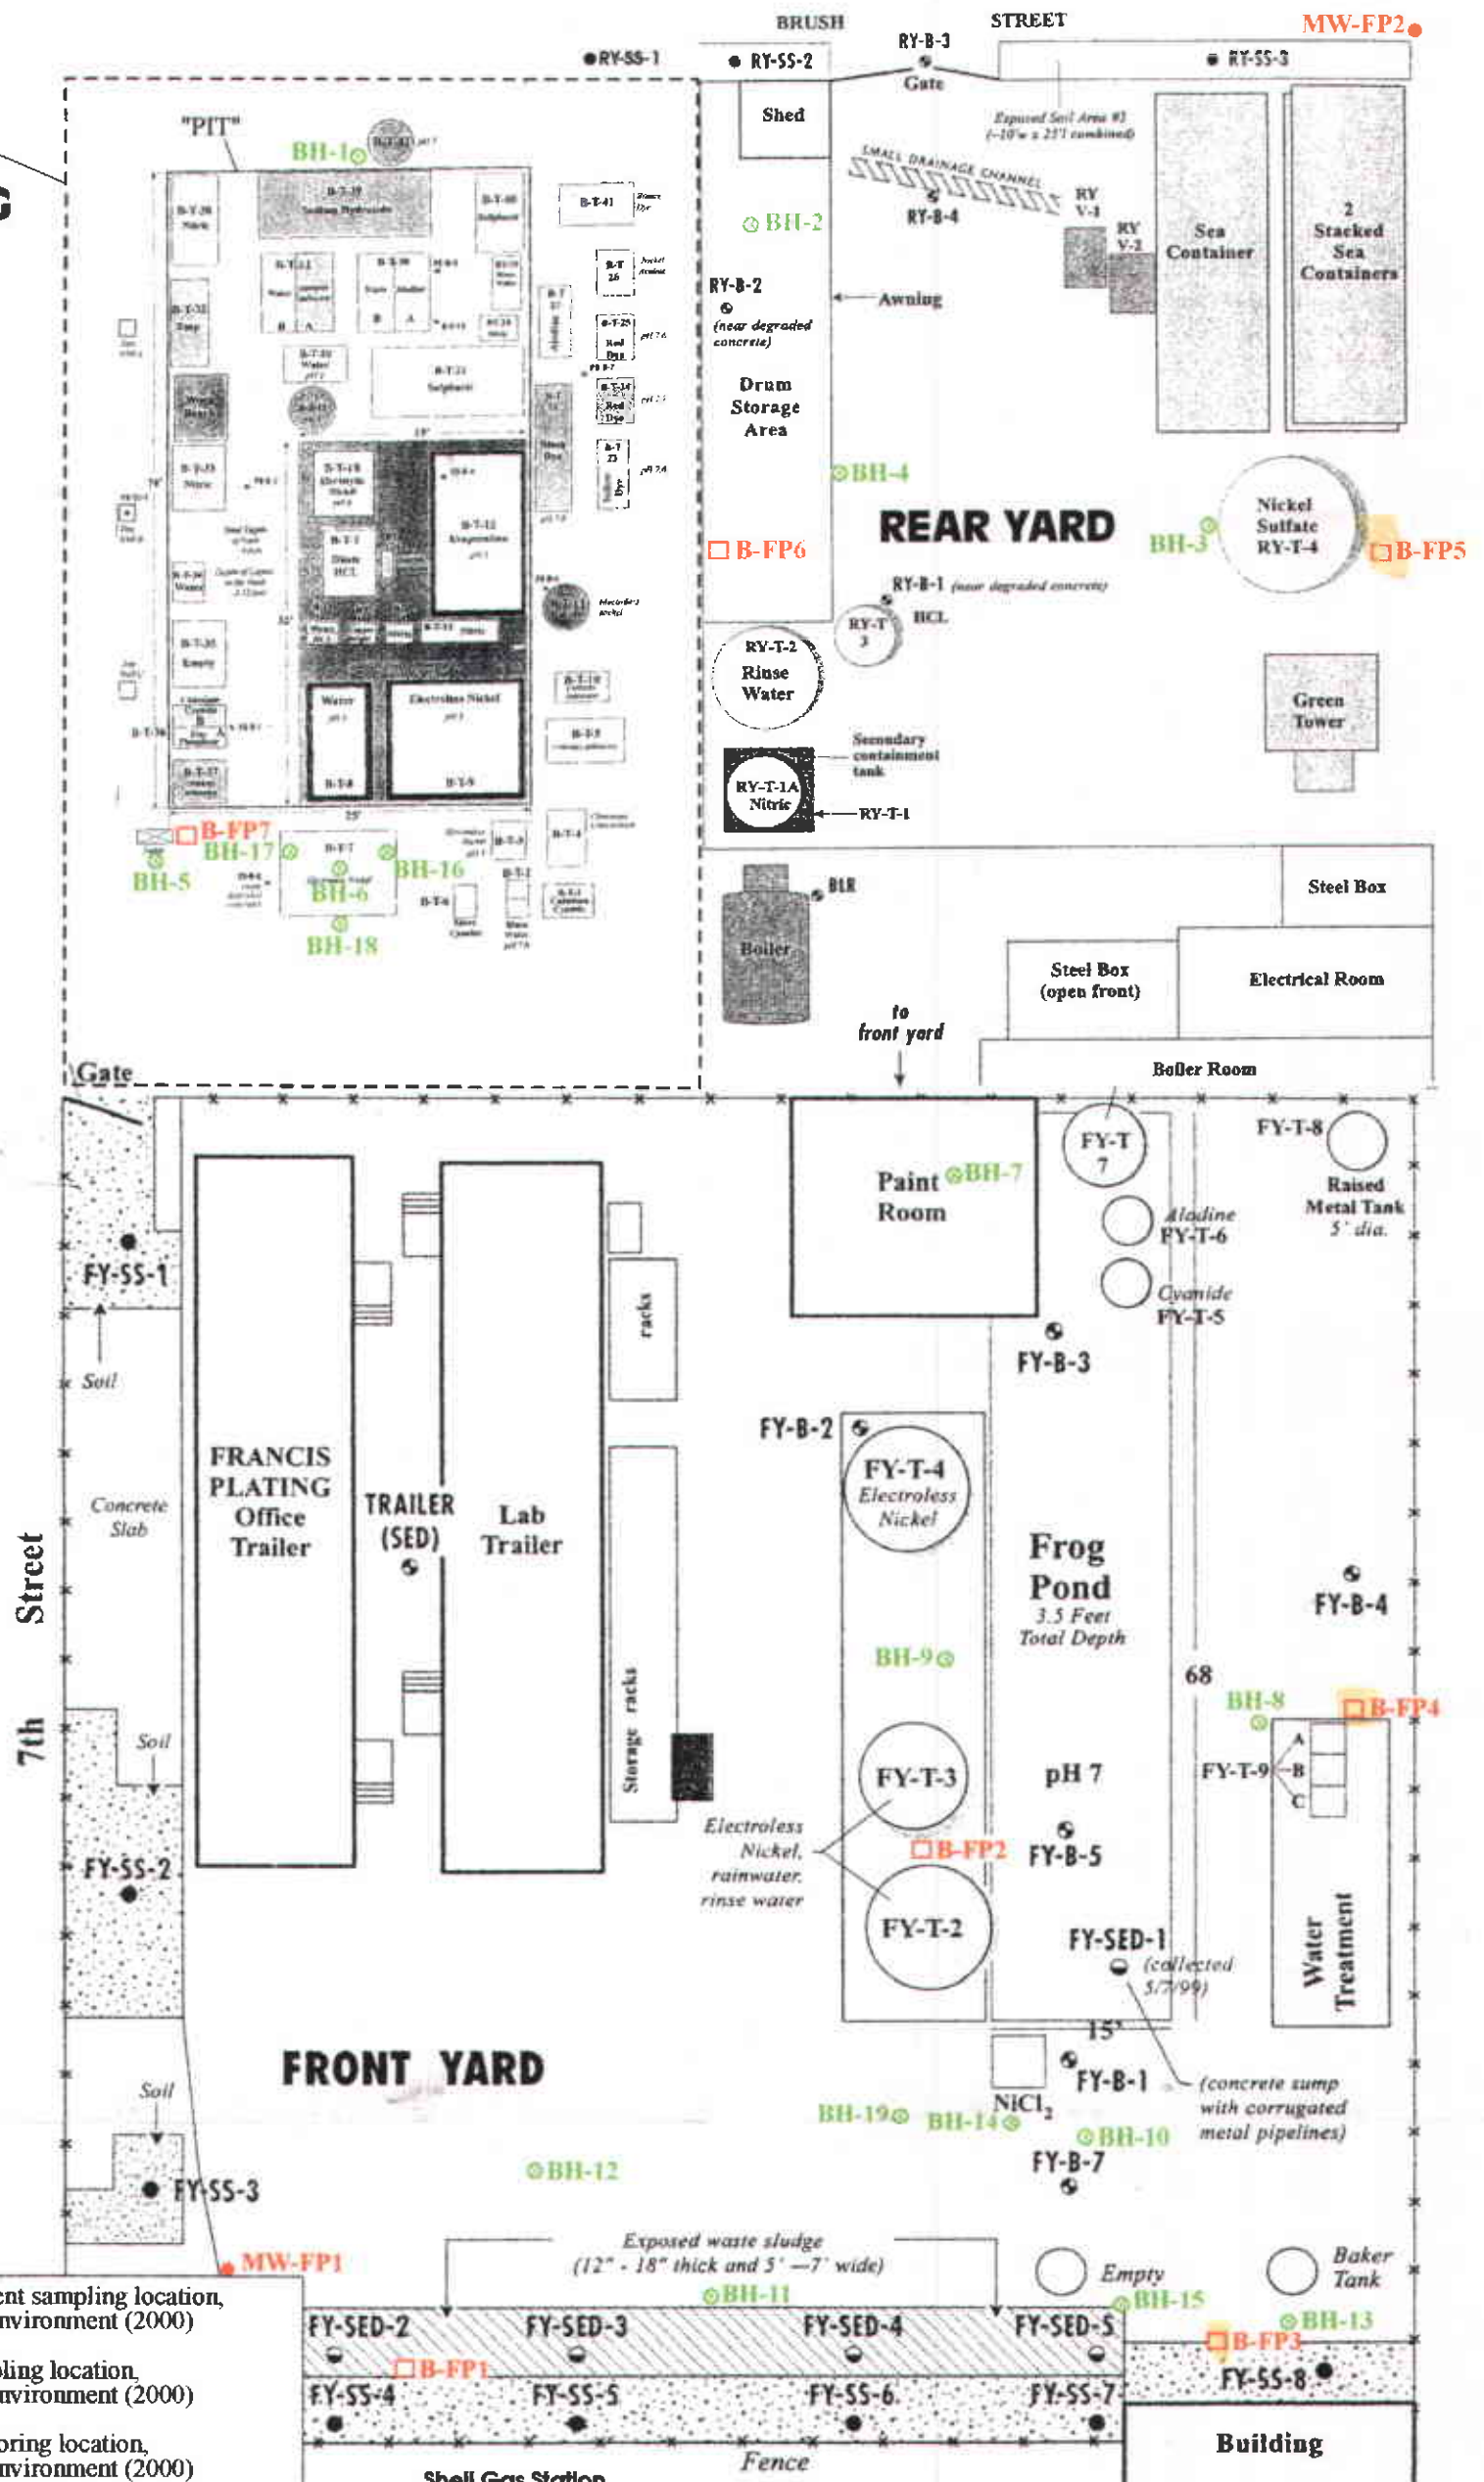
Figure 2

**Legend**

- FY-SED-2** ● Waste sediment sampling location, Ecology & Environment (2000)
- FY-SS-7** ● Surface sampling location, Ecology & Environment (2000)
- FY-B-2** ● Subsurface boring location, Ecology & Environment (2000)
- BH-5** ● Boring location, Versar (1993)
- B-FP5** □ Boring location, BASELINE (2003)
- MW-FP2** ◆ Monitoring well location, BASELINE (2003)

Since at least 1993, the site was divided into three areas: the plating building in the northeast corner, the "rear yard" in the southeast corner, and the "front yard" throughout the western half of the site (Figure 2). The site is covered with concrete except for small strips of exposed soil along the eastern (along Brush Street) and western (adjacent to the Shell Station) perimeters and the northern perimeter along 7<sup>th</sup> Street (Figure 2).

The plating building contained tanks for anodizing, acid activation, phosphate coatings, chromium conversion coating, cadmium cyanide plating, chrome plating, electrolytic nickel plating, and nitric acid stripping/passivation (Figure 2). These process tanks had secondary containment consisting of a large sump (25 feet x 70 feet) referred to as the "pit". Nickel process tanks were contained in a separate stainless steel sump in the southwestern portion of the plating building (EBMUD, 1998).

Three investigations have been performed at the site. All of these investigations included soil sampling and analysis; groundwater sampling was only performed in 2003. Boring and soil sampling locations from all three studies are shown on Figure 2, groundwater sampling locations are shown on Figure 3, and analytical results are summarized in Tables 3 and 4.

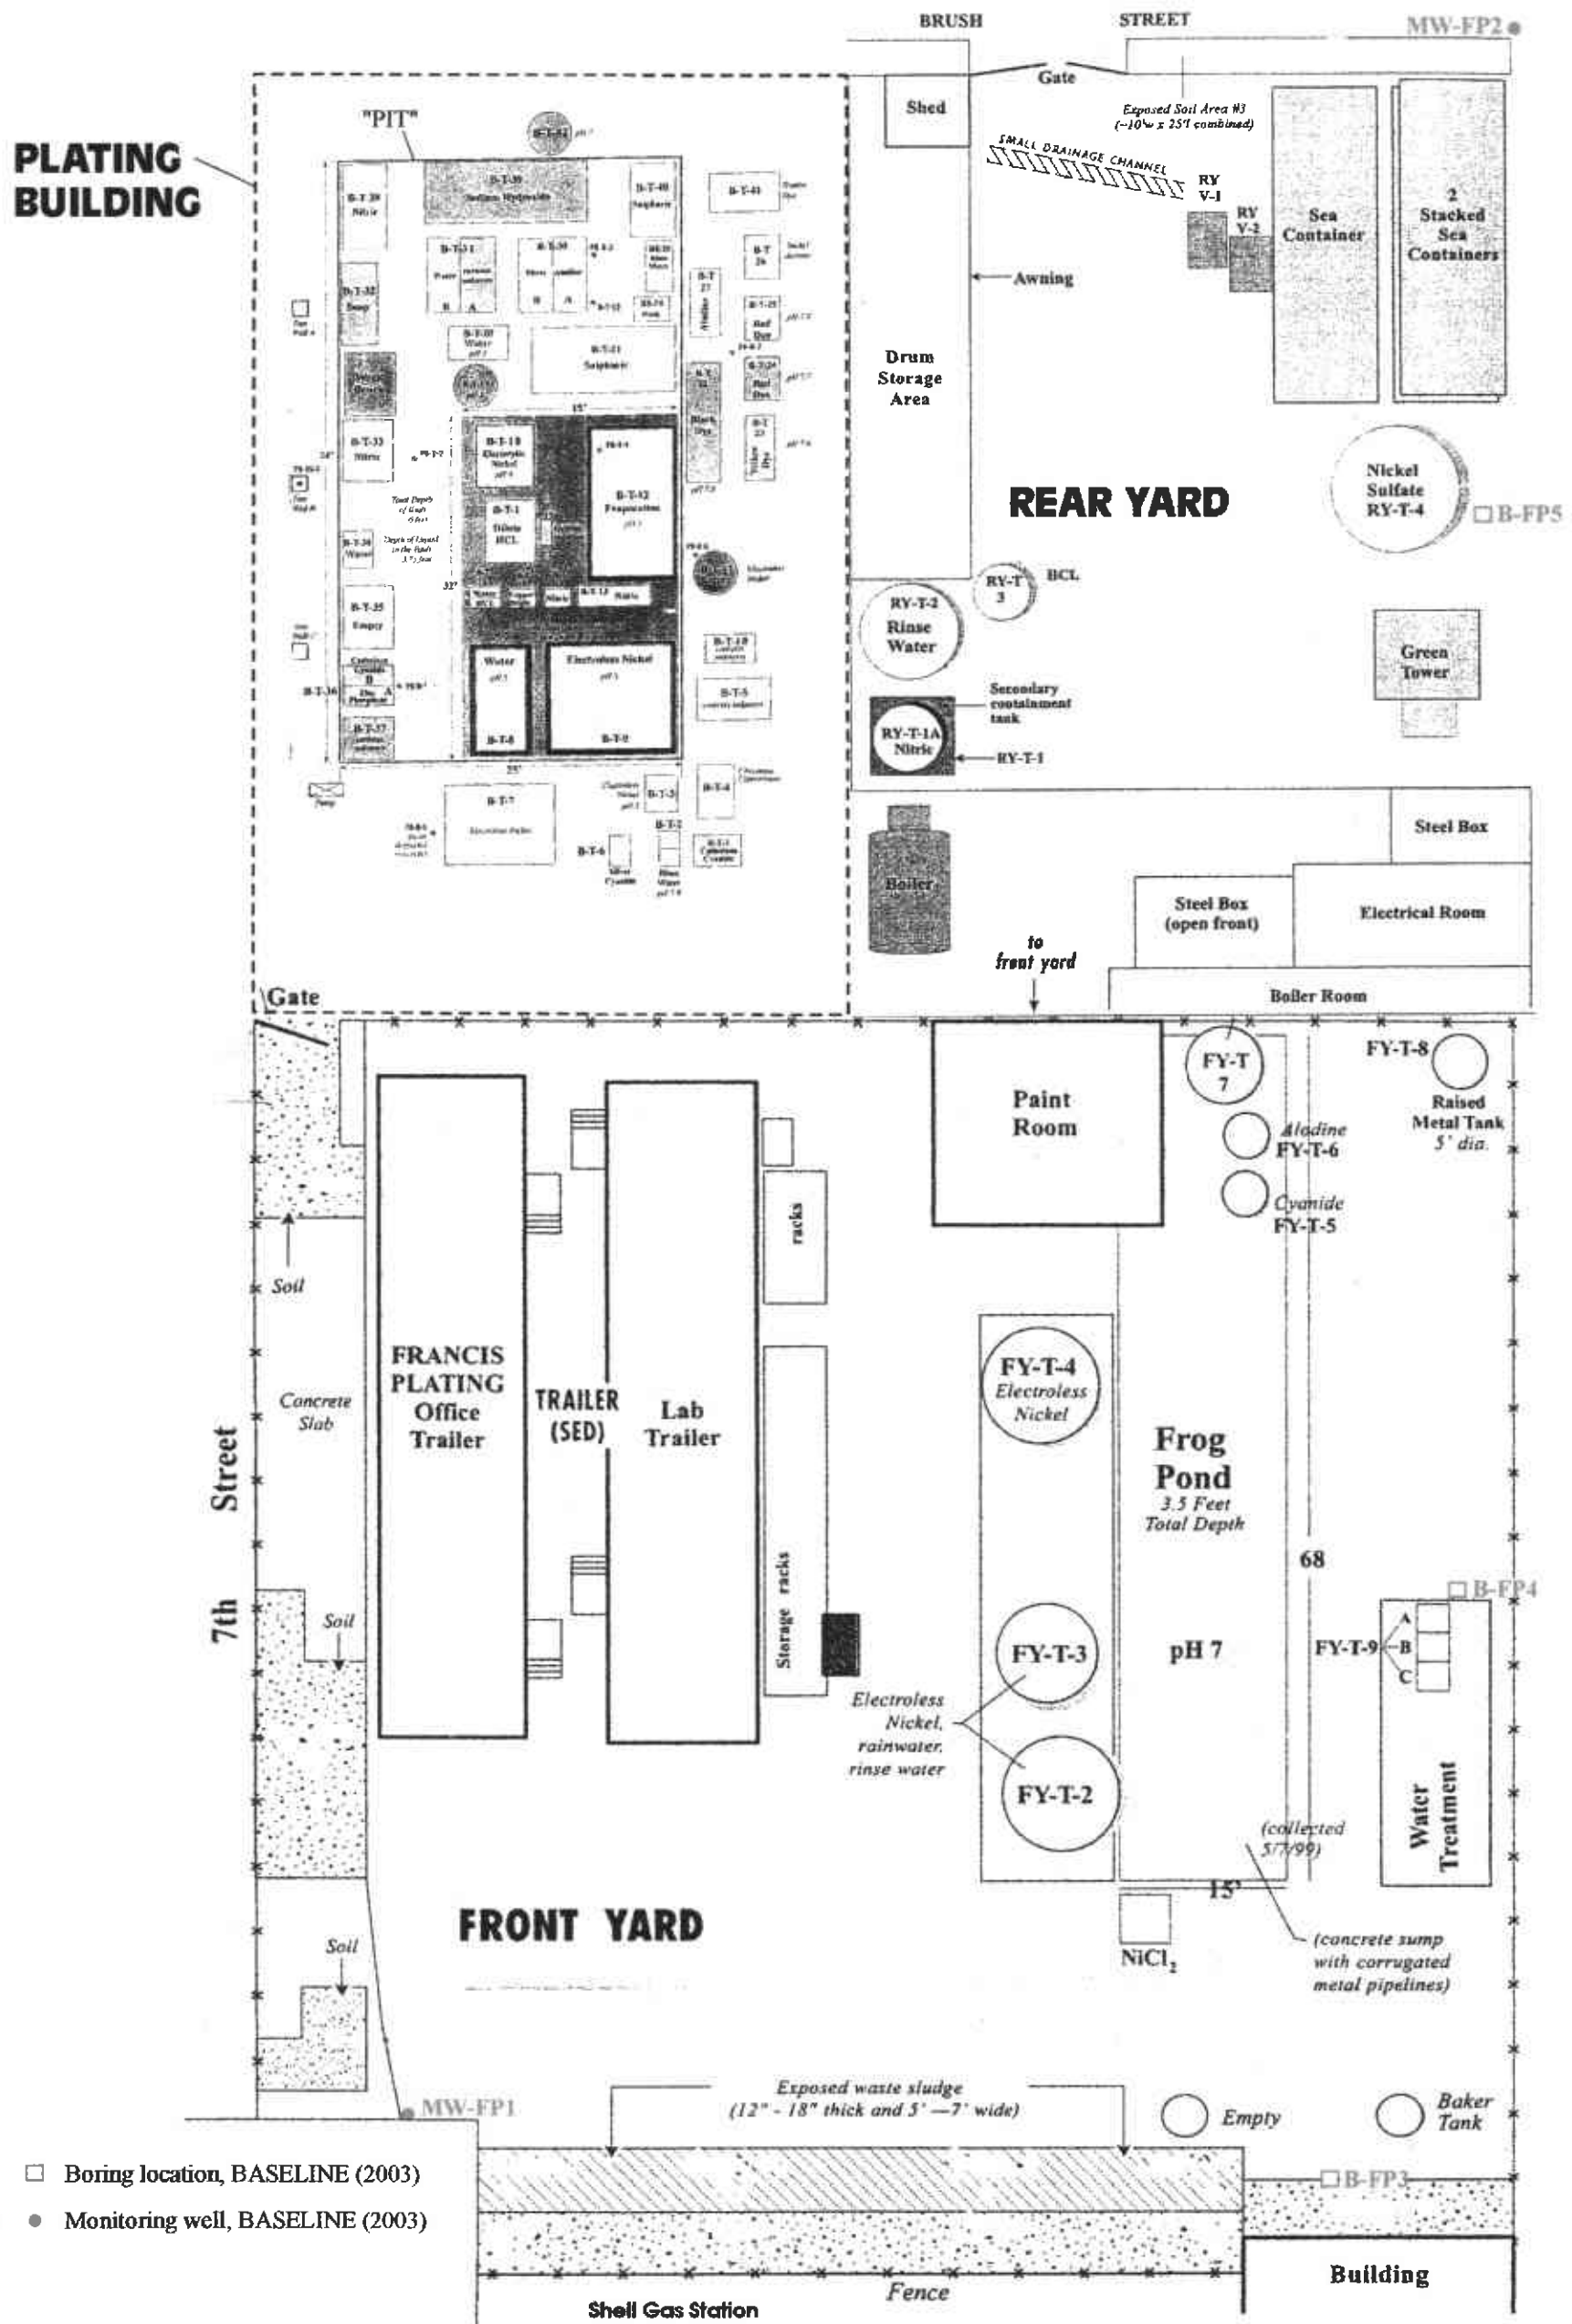
# CHEMICAL STORAGE AND GROUNDWATER SAMPLING LOCATIONS Figure 3

- Legend
- P-FP5    □ Boring location, BASELINE (2003)
  - MW-FP2    ● Monitoring well, BASELINE (2003)

Notes: All non-permanent features and all chemicals and wastes shown on this figure have been removed. They are shown for illustration only.

BASELINE performed a soil and groundwater investigation in 2003 (BASELINE, 2003). Results of subsurface soil analyses are summarized in Table 3 (soil samples) and Table 4 (groundwater samples). A total of seven soil borings were advanced by direct-push methods, using a double-barrel coring device, to depths ranging from 16 to 25 feet bgs (B-FP1 through B-FP7 in Figure 2), and two monitoring wells were installed (MW-FP1 and MW-FP2 in Figure 3).

Groundwater samples were collected from the two wells installed during the investigation (MW-FP1 and MW-FP2 in Figure 3). In addition, grab groundwater samples were collected from two boreholes to assess groundwater quality directly beneath the property (B-FP4 and B-FP5 in Figure

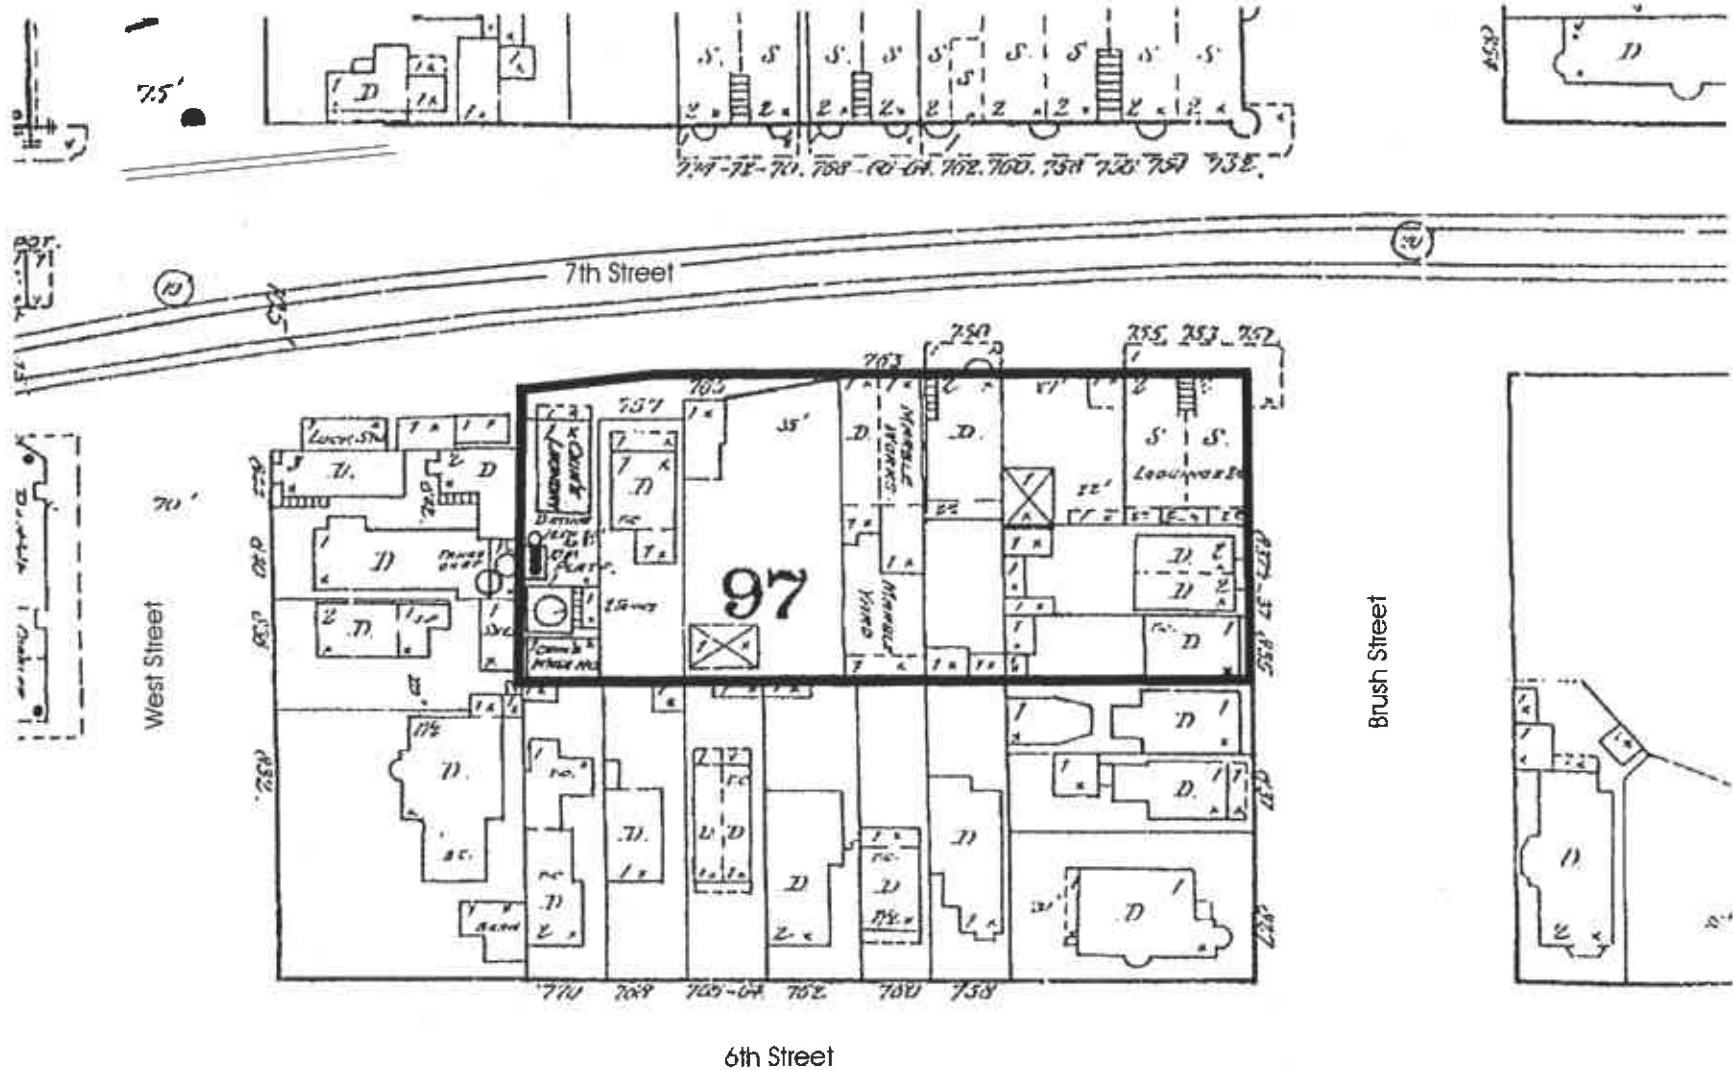
# Figure A1

# SANBORN MAP - 1889

- 1889 - 1912** The site was occupied by a number of structures identified on Sanborn Fire Insurance maps as: dwellings, Santa Fe Express Co., lodgings, Chinese laundry, Japanese laundry, marble works, stable, and other unlabeled structures (Figures A1 to A3 in Appendix A).

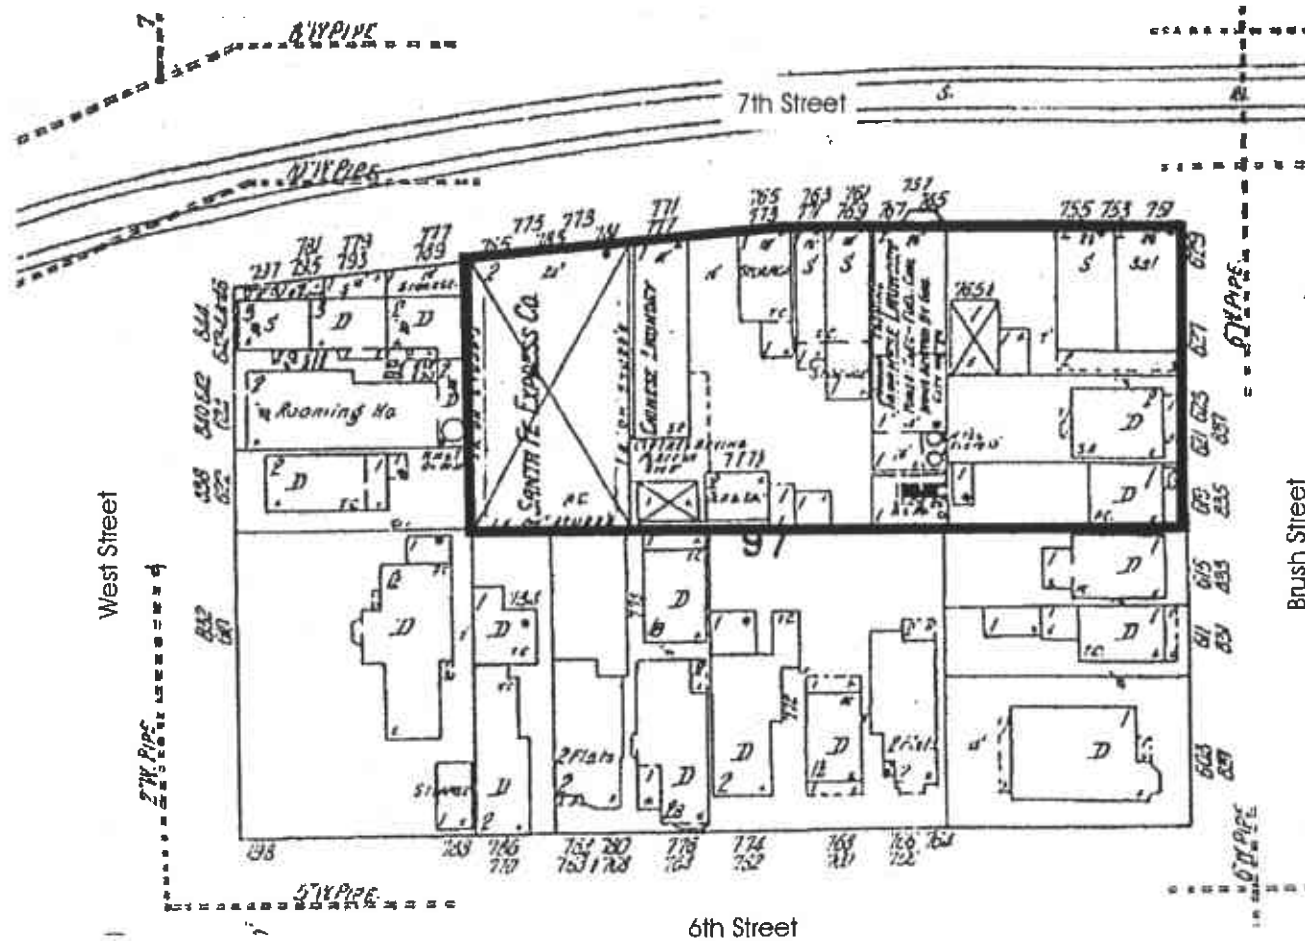
# Figure A3

# SANBORN MAP - 1912
