Subject: Certification Letter
Written Response to Letter Dated 28 October 2005 and Work Plan for
Post-Excavation Soil and Groundwater Sampling
5885 Hollis Street
Emeryville, California

30 November 2005
Project 4069.01

Subject: Response to Letter Dated 28 October 2005 and Work Plan
for Post-Excavation Soil and Groundwater Sampling
5885 Hollis Street
Emeryville, California

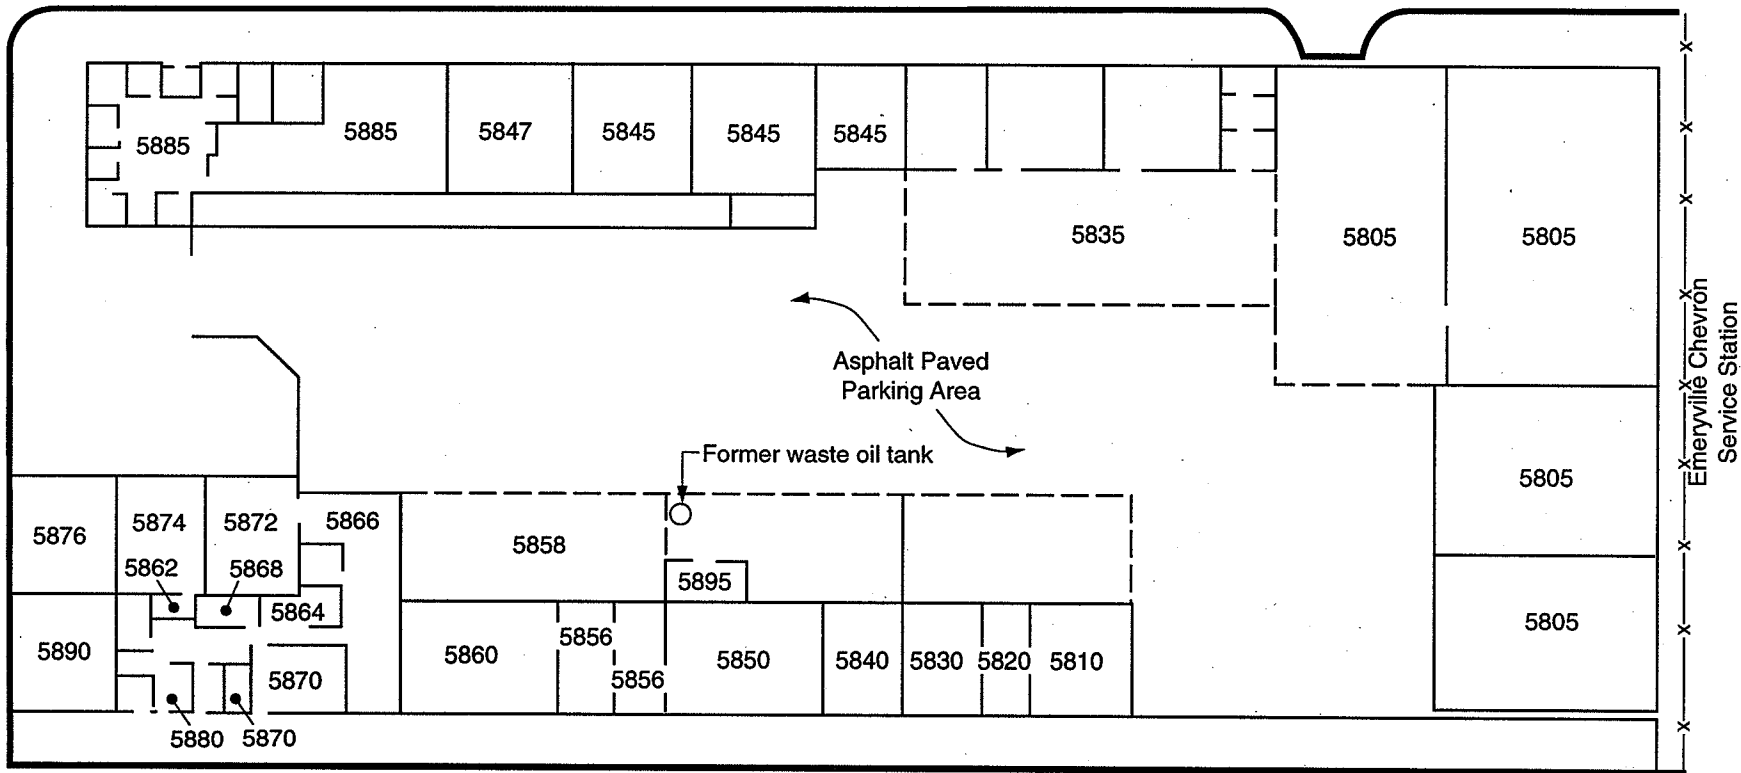
Date 05/23/05 | Project No. 4069.01 | Figure 2

SITE PLAN

The subject property (Figure 1, included in Attachment 1) has been referred to as the Emeryville Industrial Court, the 5885 Hollis Street property and the Emerystation East development. For this letter, the property and development are referred to as the Site. Figure 2 (included in Attachment 1) presents the Site Plan, which outlines the current building configurations.

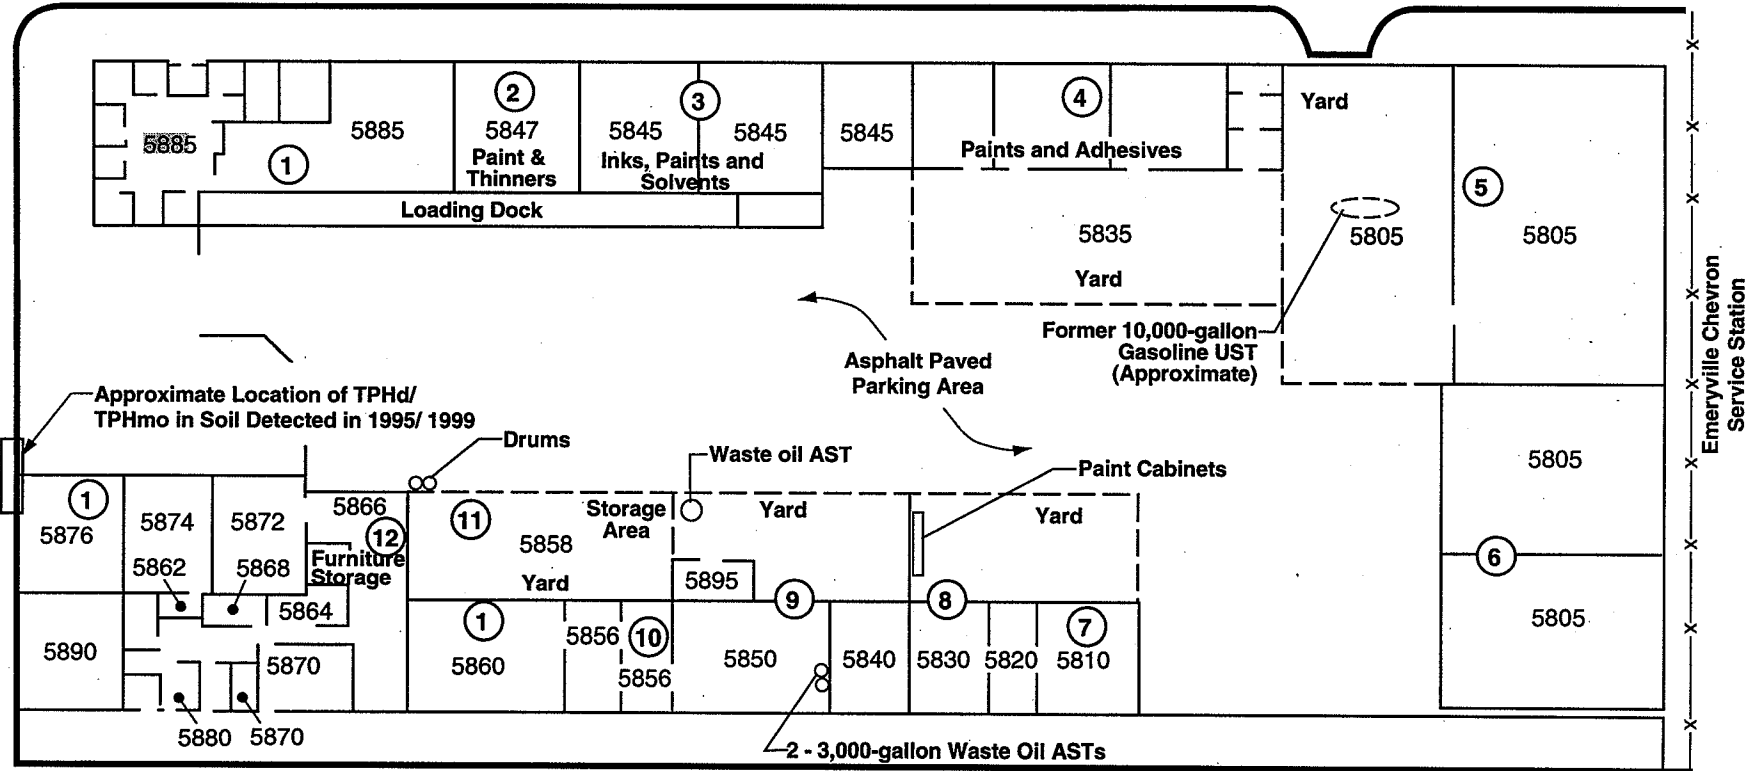
Date 11/23/05 Project No. 4069.01 Figure 3

Note: Site features from Environmental Site Assessment, March 19, 1995 (Weiss Associates)

1995 SITE USE

In addition to the potential impacts to the Site from the Union Oil of California operations, several on-site chemicals were identified during a site visit in 1995, as documented in the 1995 Phase II ESA (Weiss Associates). The locations and site features that included chemical use are presented on Figure 3 and also discussed below:

- BMP Seismic Retrofitting – located at 5847 Hollis Street and identified as Tenant 2 on Figure 3. Paints and thinners were observed at this location.
- Graphic Traffic – located at 5845 Hollis Street and identified as Tenant 3 on Figure 3. Inks, paints and solvents used in the sign production activities were observed at this location.

- S.B. Thomas – located at 5805 Hollis Street and identified as Tenant 5 on Figure 3. A former 10,000 gallon gasoline UST, used to fuel vehicles for the distribution facility, was located approximately in the middle of the yard. This UST was reportedly removed in 1990.

- Correris Cabinets – located at 5830 Peladeau Street and identified as Tenant 8 on Figure 3. Paints and associated finishing materials were stored in paint storage cabinets located in the yard area.

- Fleetcare Repair – located at 5850 Peladeau Street and identified as Tenant 9 on Figure 3. Two 3,000 gallon waste oil aboveground storage tanks (ASTs) were used to store oil from the vehicle maintenance activities. The waste oil was eventually transferred to the waste oil AST located in the yard behind the 5850 Peladeau space.

- Ellerson Weaver – located in the yard area of 5858 Peladeau Street and identified as Tenant 11 on Figure 3. Several 55-gallon drums were observed outside of the fenced salvage storage area.

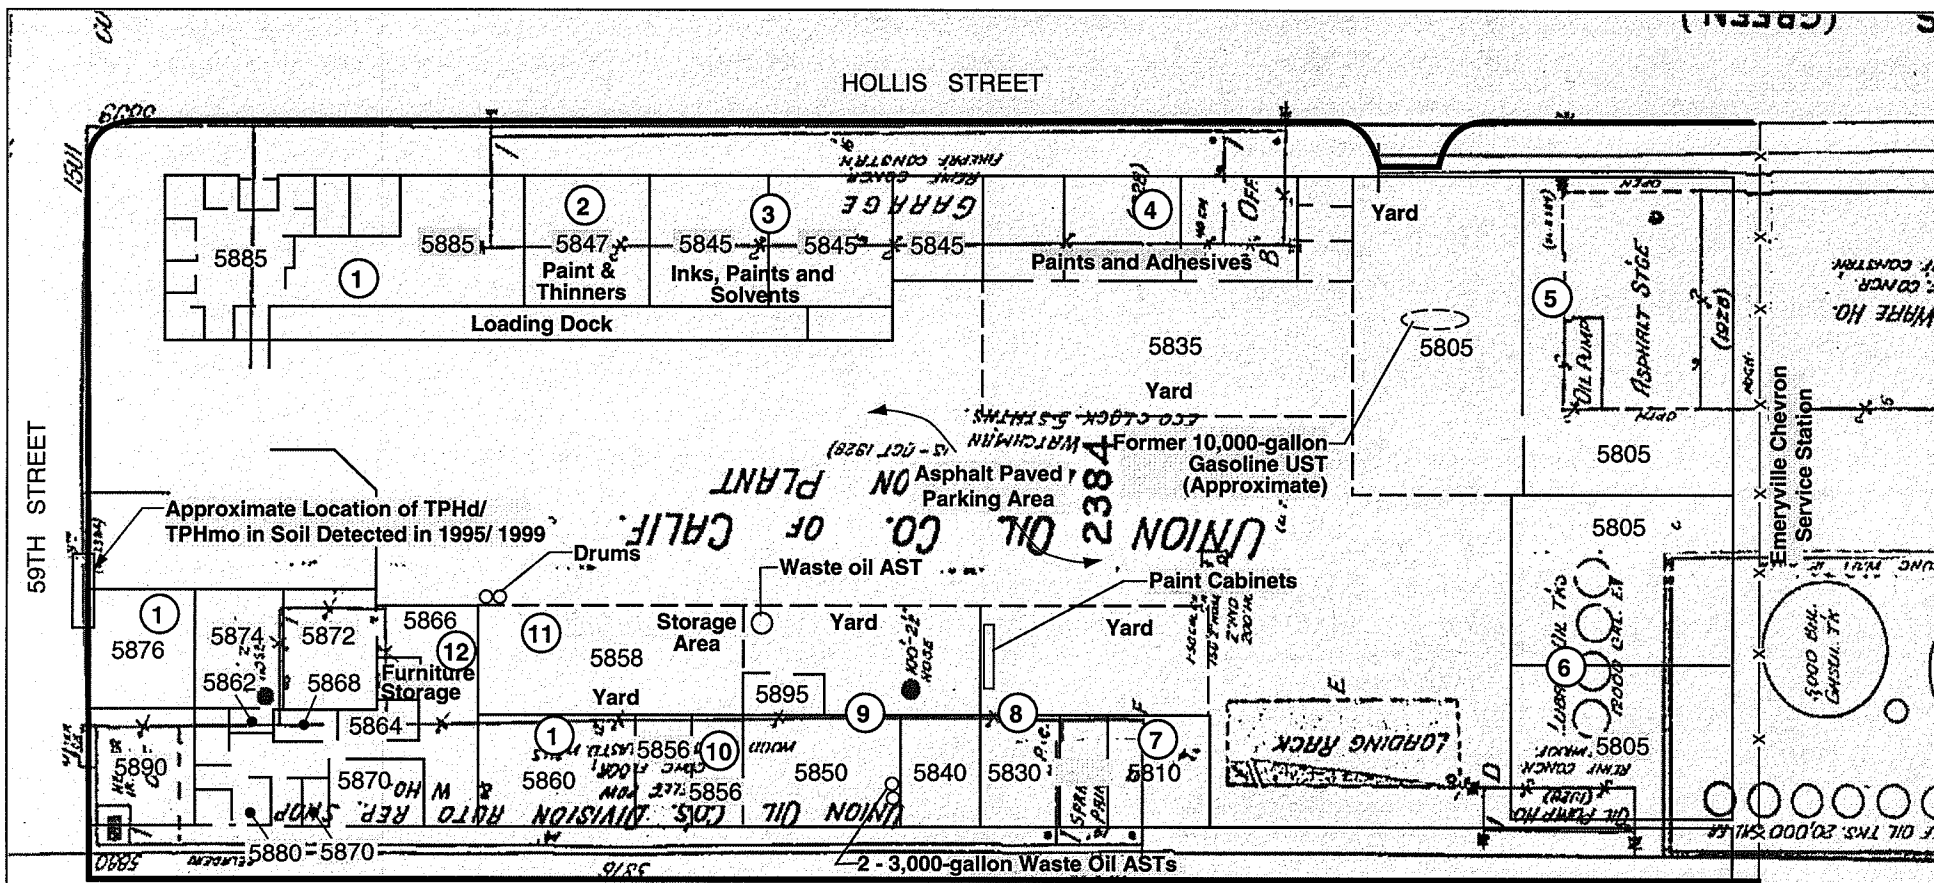
5885 HOLLIS STREET Emeryville, California		
1951 AND 1995 SITE USES		
Date 11/23/05	Project No. 4069.01	Figure 4

Note: Site features from Environmental Site Assessment, March 19, 1995 (Weiss Associates)

Union Oil of California occupied the Site and the gasoline service station to the south of the Site between 1917 and 1964. Sanborn Maps from 1951 and 1952, as well as aerial photos from 1939 and 1946 confirm the presence of multiple potential sources of petroleum contamination at the Site and gasoline service station, including aboveground storage tanks along Peladeau Street, including a 5,000-barrel (210,000 gallon) gasoline tank, a 7,000-barrel (294,000 gallon) fuel oil tank, and six 20,000 gallon oil tanks. The gasoline tank and some of the oil tanks were located along the border between the Site and the gasoline service station. The berm surrounding the multiple tanks previously extended over to the Site area. An oil warehouse was located along the west side of the property along Hollis Street. A loading rack was present Peladeau Street. An auto repair shop was located along Peladeau Street and a garage was present along Hollis Street. Figure 4 (included in Attachment 1) presents an overly of the 1995 site features and the 1951 Sanborn Map (Comment 4).

- Canova Marble – located at 5835 Hollis Street and identified as Tenant 4 on Figure 4. Paints and adhesives used in the marble installation activities were observed at this location

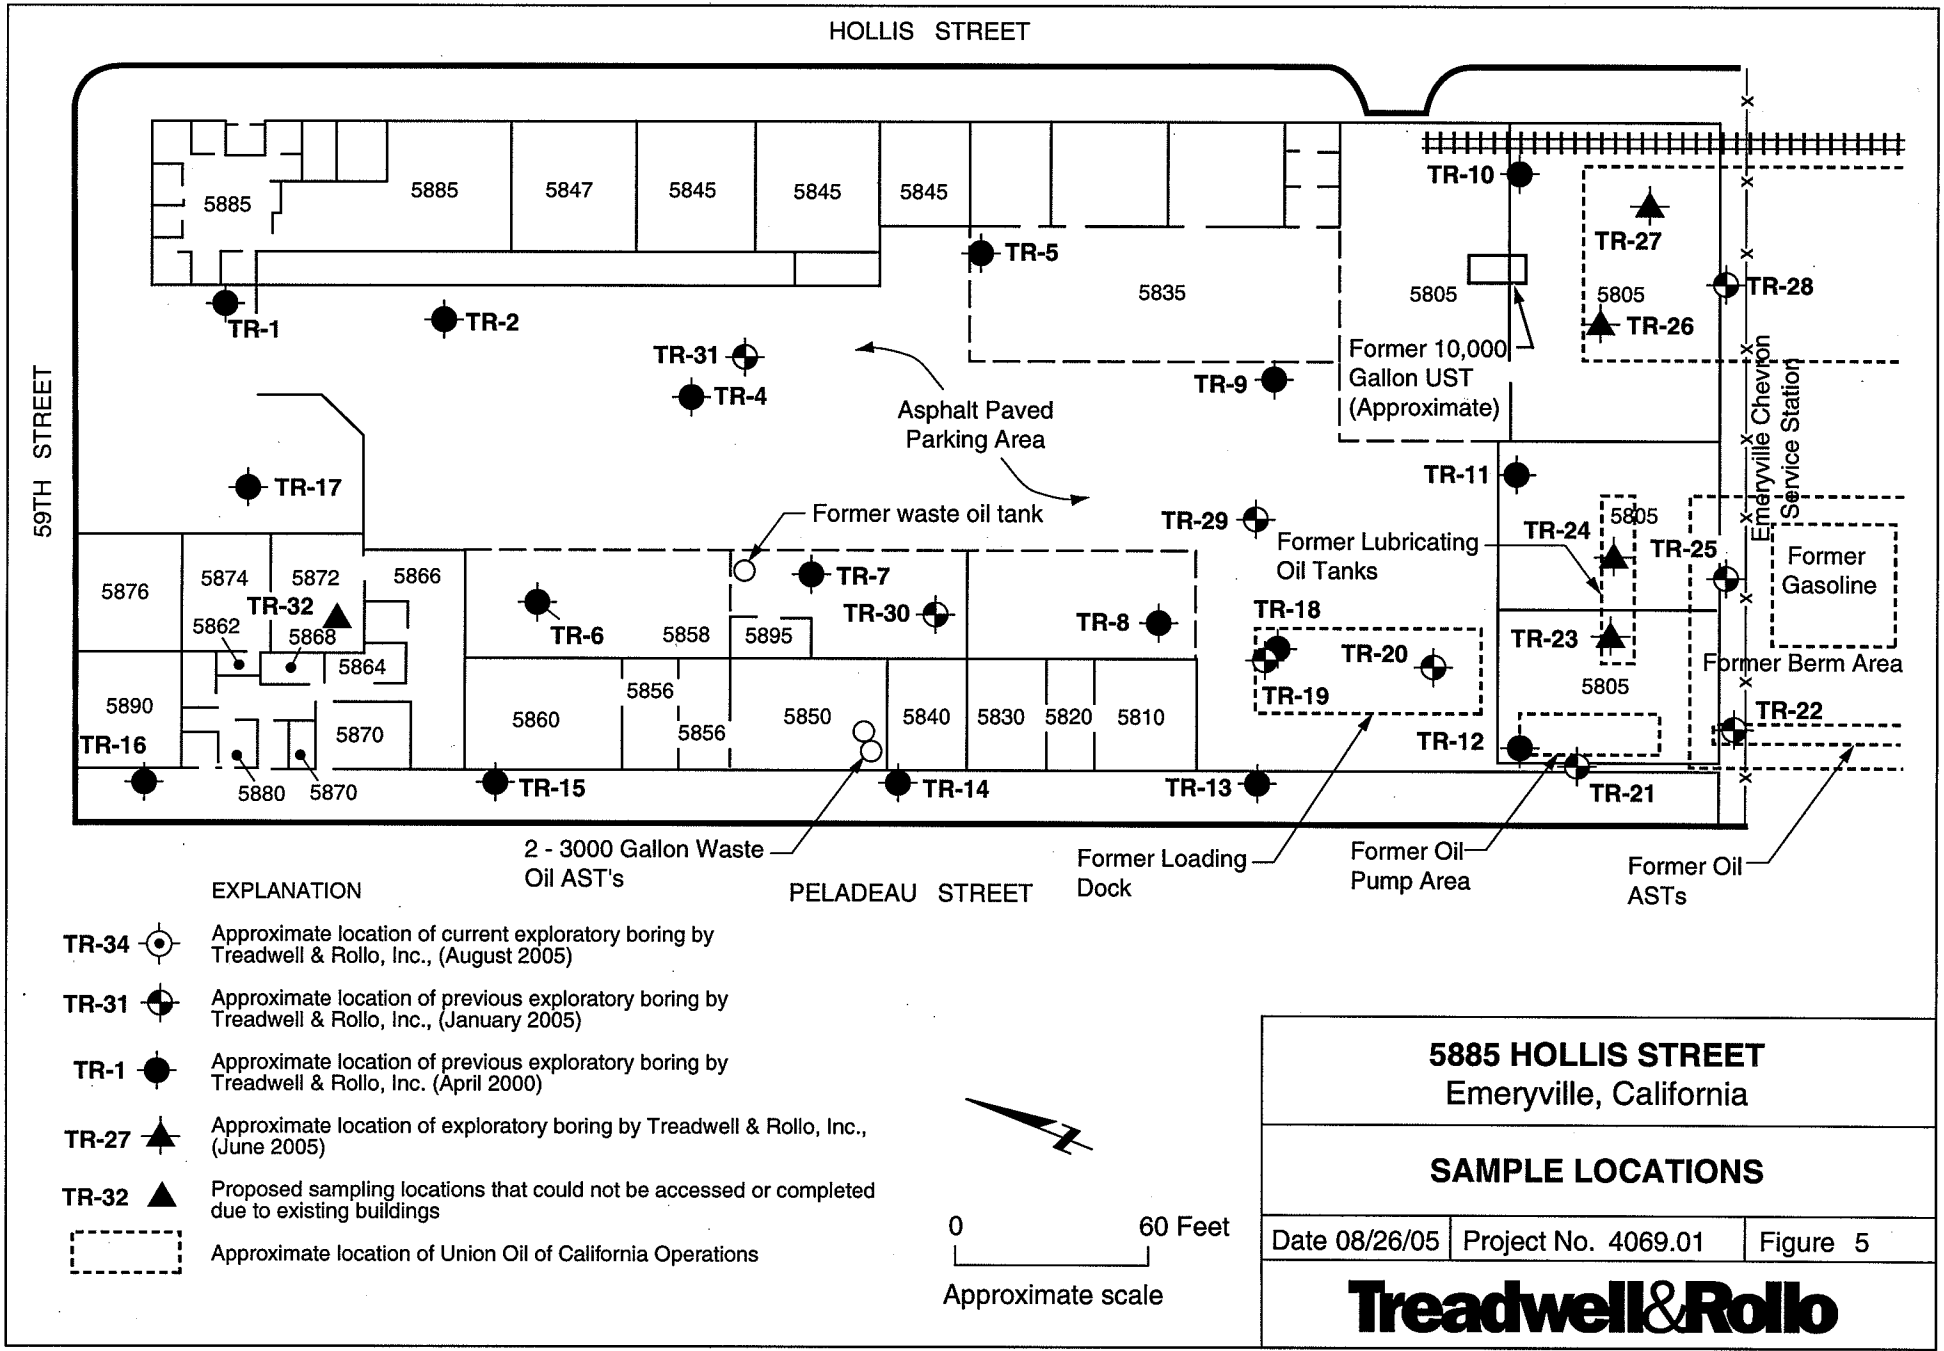
5885 HOLLIS STREET Emeryville, California		
SAMPLE LOCATIONS		
Date 08/26/05	Project No. 4069.01	Figure 5
Treadwell & Rollo

- TR-34 Approximate location of current exploratory boring by Treadwell & Rollo, Inc., (August 2005)
- TR-31 Approximate location of previous exploratory boring by Treadwell & Rollo, Inc., (January 2005)
- TR-1 Approximate location of previous exploratory boring by Treadwell & Rollo, Inc. (April 2000)
- TR-27 Approximate location of exploratory boring by Treadwell & Rollo, Inc., (June 2005)
- TR-32 Proposed sampling locations that could not be accessed or completed due to existing buildings
- Approximate location of Union Oil of California Operations

As noted in the SMP, soil and groundwater investigations conducted by Treadwell & Rollo indicated TPHg was detected in soil and groundwater near the southwest corner of the Site at TR-23, TR-24 and TR-25 (Figure 5). At TR-25, TPHg was detected at 2,100 mg/kg at 6 feet bgs. The grab groundwater samples collected from TR-25 had TPHg at 150,000 µg/L and benzene at 2,500 µg/L. The grab groundwater samples collected from borings TR-23 and TR-24 indicated the presence of TPHd at 8,400 µg/L and 6,800 µg/L, respectively. TPHg was detected at 28,000 µg/L at TR-23 and 91,000 µg/L at TR-24. Benzene was also detected at 4,300 µg/L in TR-23 and 2,500 µg/L in TR-24. These three locations are near the former 5,000-barrel (210,000 gallon) gasoline AST associated with the former Union Oil of California operations. At this time, it is unclear whether the presence of TPHg and benzene at this area of the Site is due to the current and/or previous gasoline service station activities at 1400 Powell Street or due to the Union Oil of California operations across both the Site and the gasoline service station property.

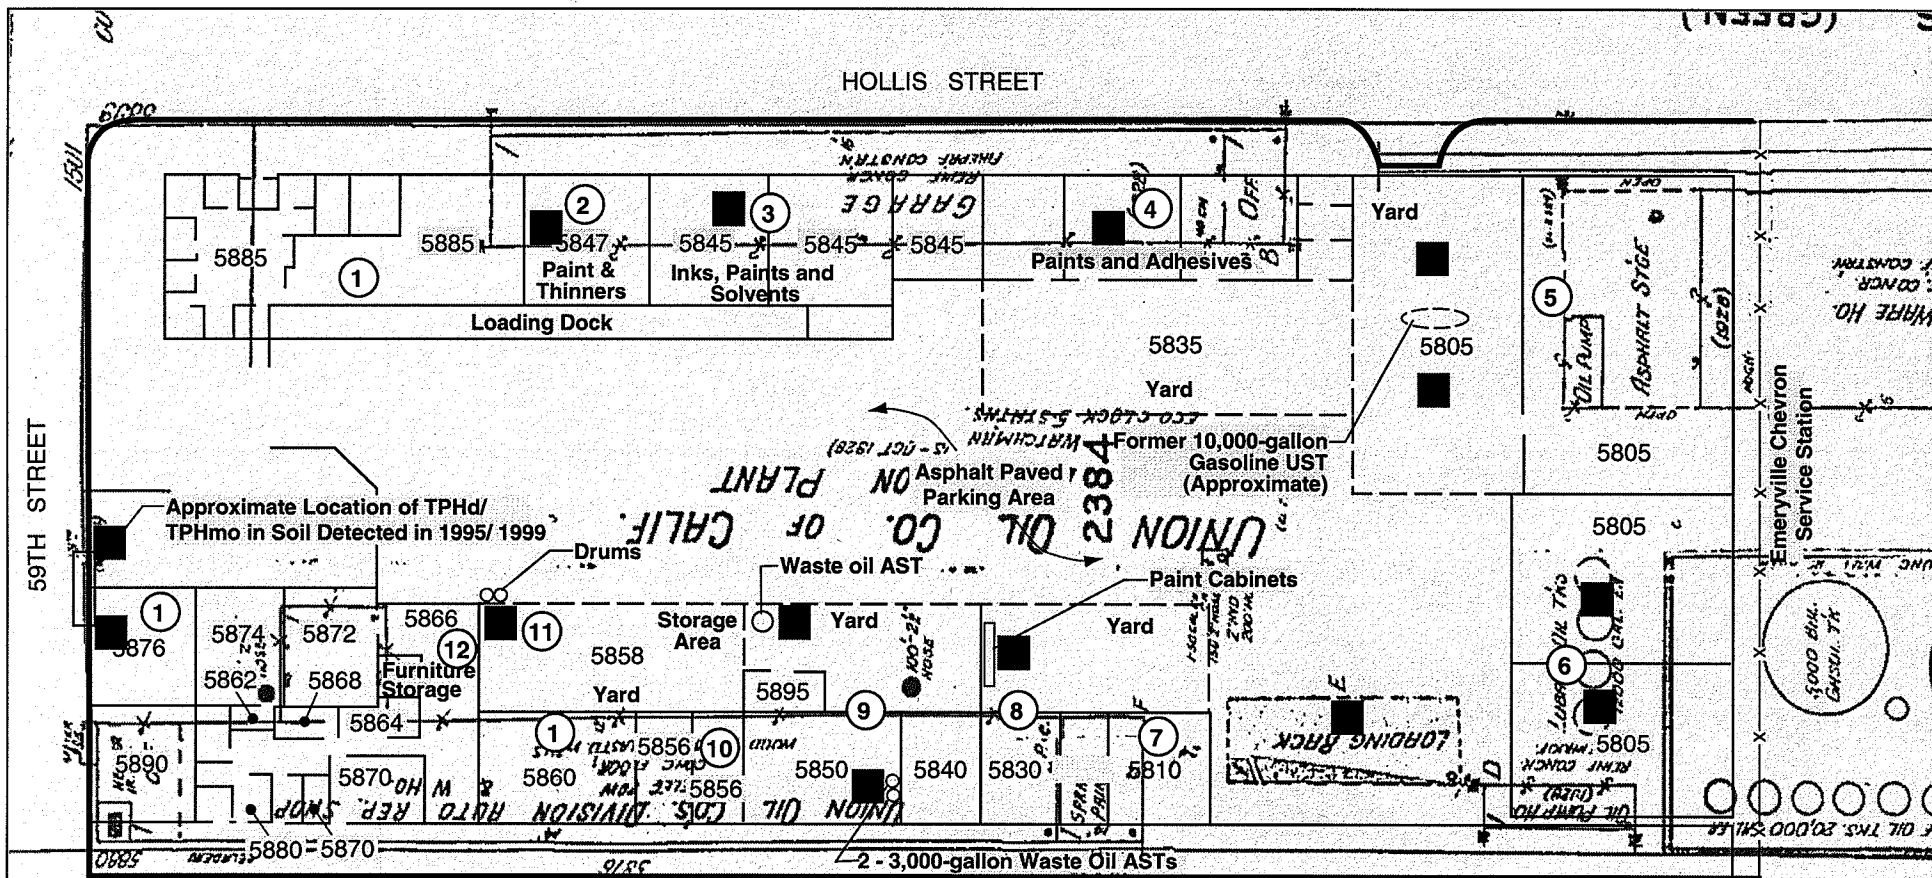
5885 HOLLIS STREET Emeryville, California		
PROPOSED POST EXCAVATION SOIL SAMPLE LOCATIONS		
Date 11/29/05	Project No. 4069.01	Figure 6

■ Approximate location of Post Excavation Soil Sample

Figure 6 present proposed locations for the collection of soil samples. Based upon the Site characterization information presented above, soil samples will be collected from the base of the excavation in the following areas (Figure 6) during soil excavation activities:

- BMP Seismic Retrofitting – one sample will be collected from this the area to evaluate the potential presence of paint thinners in soil. The sample will be analyzed for TPHg and VOCs.
- Graphic Traffic – one sample will be collected from this area to evaluate the potential presence of solvents. The sample will be analyzed for TPHg and VOCs.
- Canova Marble – one sample will be collected from this area to evaluate the potential presence of solvents associated with paints and adhesives. The sample will be analyzed for TPHg and VOCs.
- S.B. Thomas – two samples will be collected from this area near the former 10,000 gallon gasoline UST. The samples will be analyzed for TPHg and BTEX/MTBE.

- Correris Cabinets – one sample will be collected from the yard area near the former paint storage cabinets. The sample will be analyzed for TPHg and VOCs.

- Fleetcare Repair – one sample will be collected from the yard area near the former waste oil AST and another sample will be collected from the two former 3,000 gallon waste oil ASTs. The samples will be analyzed for TPHd/mo.

- Ellerson Weaver – one sample will be collected from the yard area near the former drum locations. The sample will be analyzed for TPHd/mo.
- Subsurface contamination detected as part of the 59th Street Widening – Two soil samples will be collected near the former area where TPHd and TPHmo were detected in subsurface soil. Samples will be analyzed for TPHd/mo.

- Southwest corner of the Site near TR-23, TR-24 and TR-25 - two soil samples will be collected from areas near TR-23, TR-24 and TR-25, which are near the former 5,000-barrel (210,000 gallon) gasoline AST and the former lubrication oil tanks. The locations may also be impacted by the gasoline service station. Samples will be analyzed for TPHg, TPHd/mo, BTEX and MTBE.

- Former Loading Rack – one sample will be collected from the area where a loading rack associated with the former Union Oil of California operations was located. The sample will be analyzed for TPHg, TPHd/mo, BTEX and MTBE.
