**SUBSURFACE INVESTIGATION
1362 AND 1384 RUUS LANE
HAYWARD, CALIFORNIA**

Project Number S40109

July 21, 1995

Subject: Further Delineation of Petroleum Hydrocarbons at 1362 and 1384 Ruus Lane, Hayward, California (RECON project number S40109)

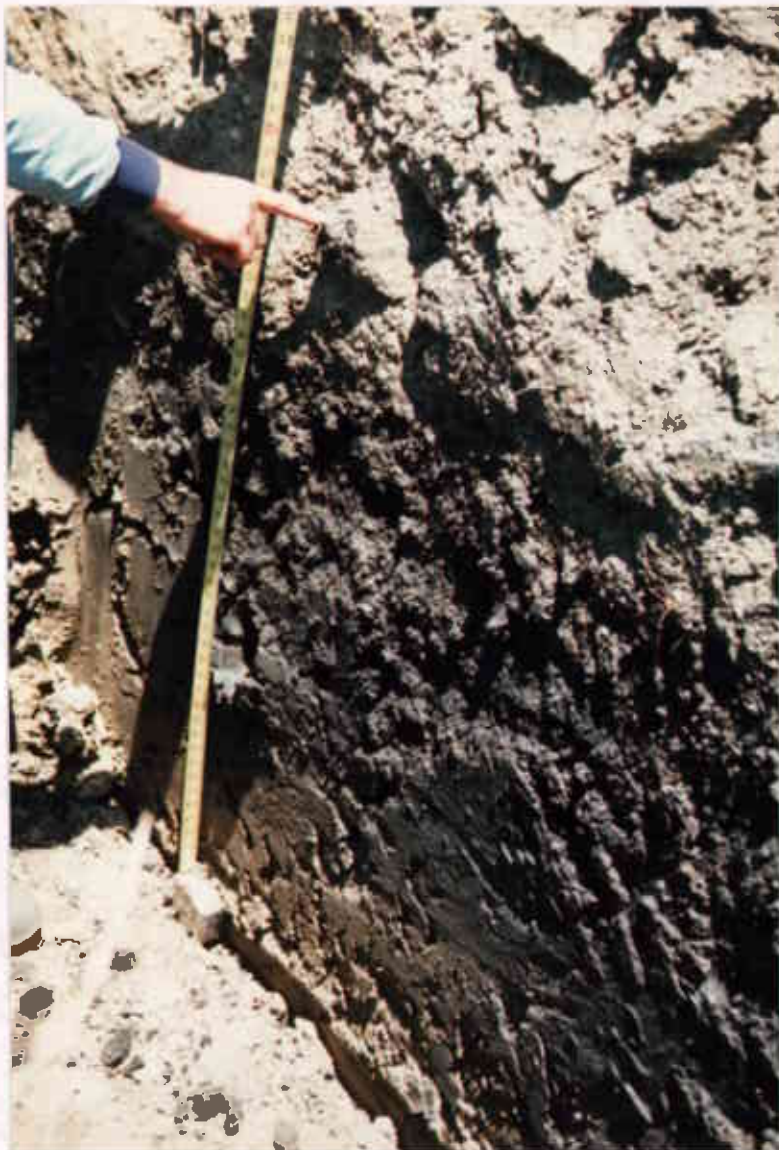
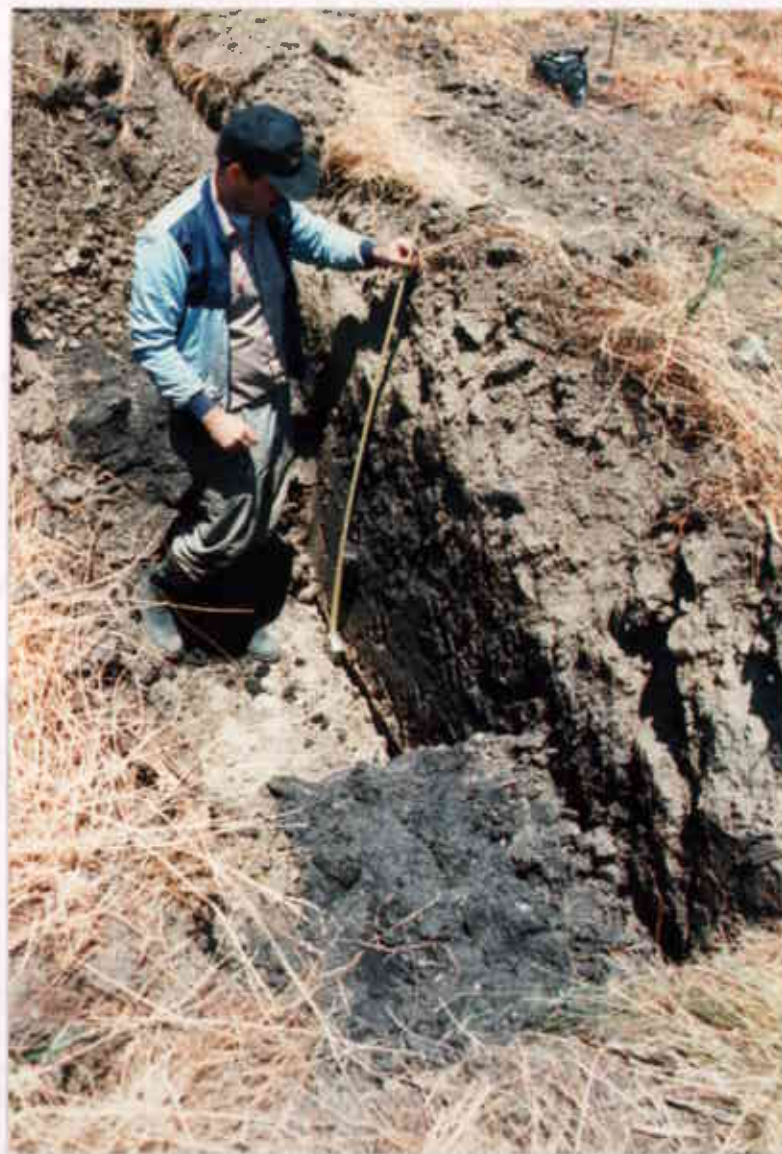
PIT A PHOTOGRAPHS

| ID | Soil Types Recorded at Depth in Inches Below Ground Surface | | | | | |
|---|---|---|--|--|---|---|
| A | | Asphalt chunks noted | Dark brown silty clay | Dark brown silty clay | Dark brown silty clay | Dark brown silty clay/Olive grey silty clay at 5 feet |

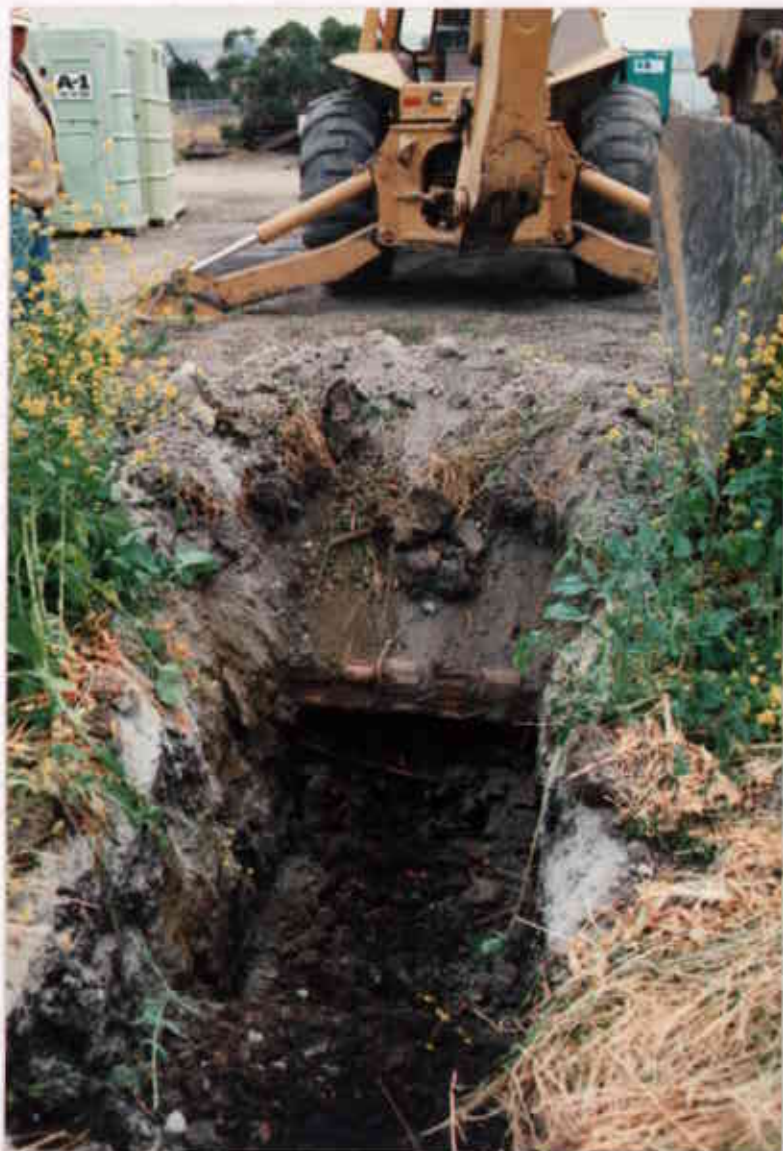
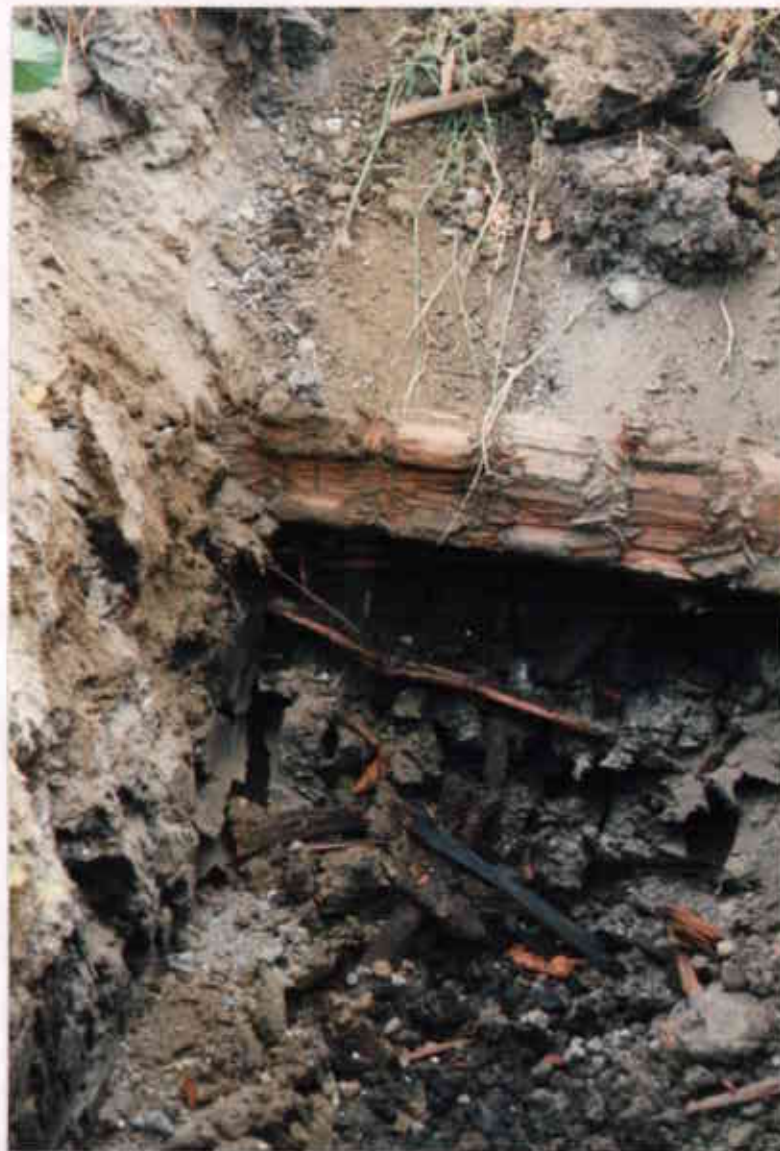
PIT G PHOTOGRAPHS

Lithologies encountered while conducting the exploratory pits were heterogeneous in the first 18 to 24 inches, and nearly uniform from pit to pit after the first 24 inches (BGS). The first approximately 18 inches were generally heterogeneous, typically logged as sandy silts with rounded gravel to 1-inch diameter. In the first 18 inches, orange-brown mottling was noted (Pits H, J, N); light grey-white fines were noted (Pits B, C, D, F, G, L, M, and N); and asphalt chunks were noted from 12 inches to the 2-foot depth BGS (Pits A, E, and H). In Pit G a buried log was noted at approximately 2 feet BGS.

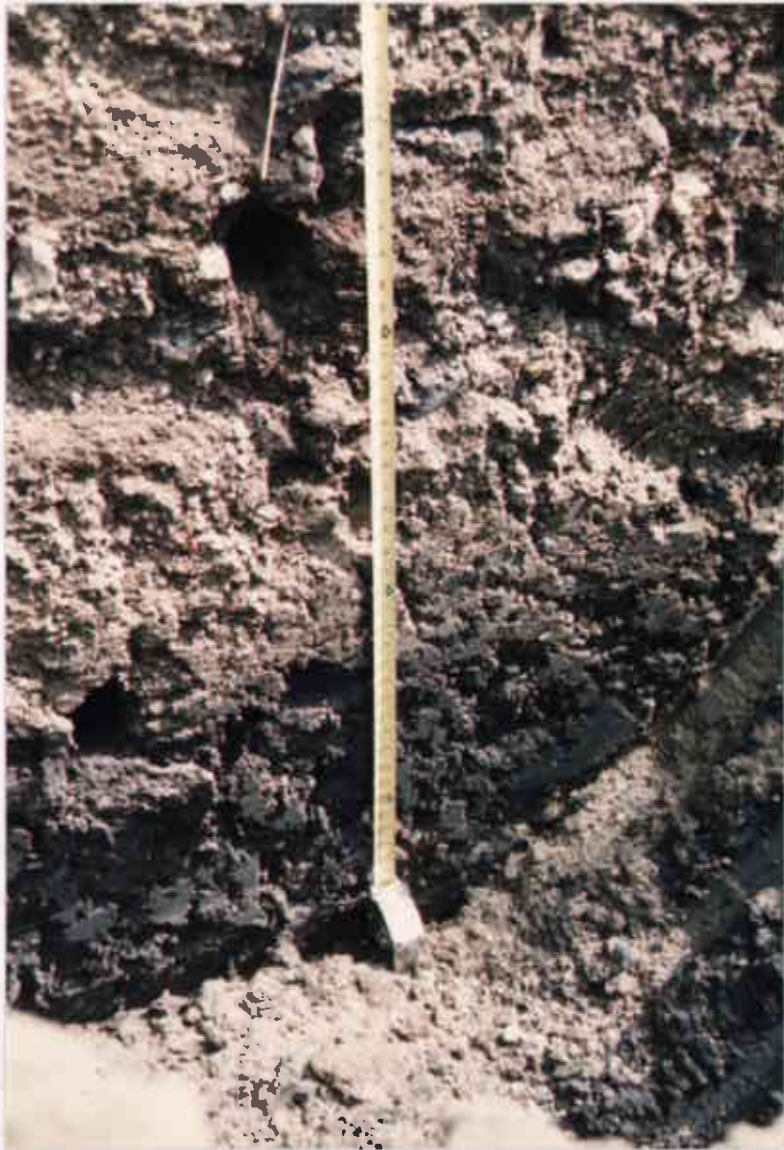
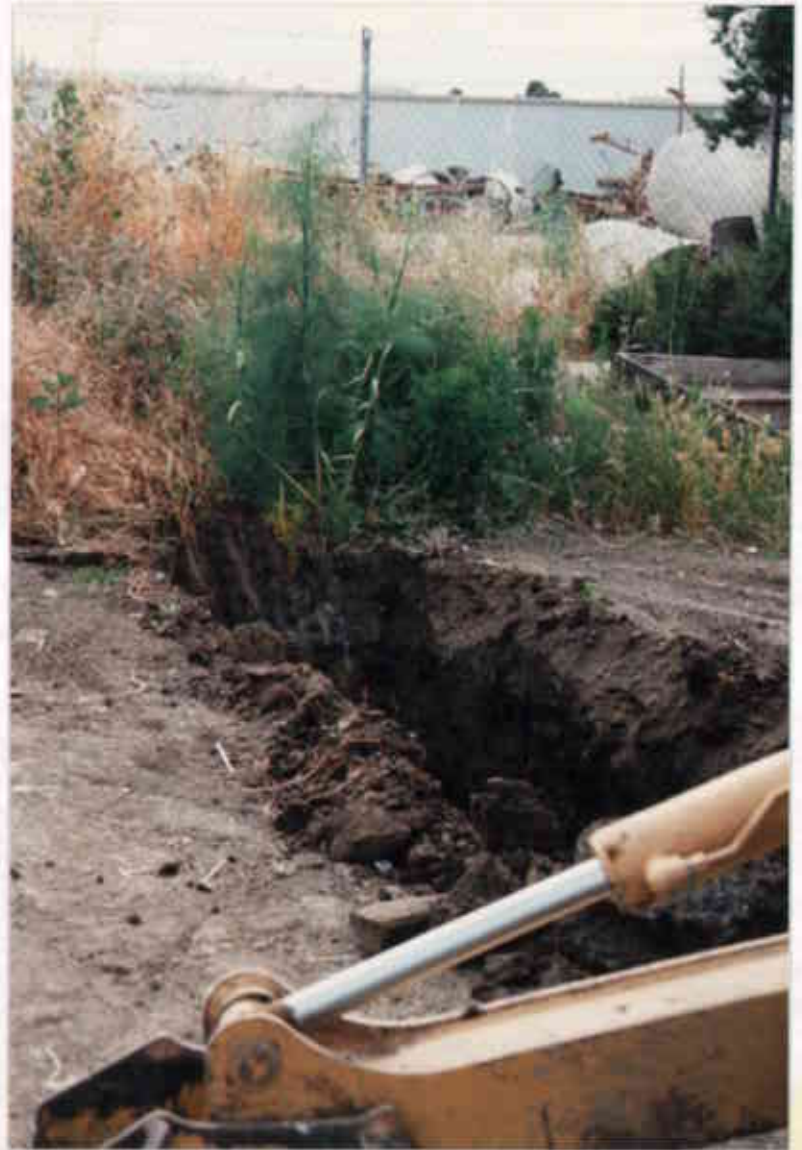
PIT H PHOTOGRAPHS

| ID | Soil Types Recorded at Depth in Inches Below Ground Surface | | | | | |
|---|---|---|--|--|---|---|
| H | | Medium brown silty sandy clay w/ orange brown mottled sand | Medium brown silty sandy clay w/ orange brown mottled sand (Asphalt noted to 2 feet) | Light brown-olive brown sandy silt with clay | Dark brown silty organic clay | Dark brown - black silty organic clay |
