From: Detterman, Mark, Env. Health
Sent: Monday, September 23, 2013 11:16 AM
To: Weston, Robert, Env. Health
Subject: Potential Former Service Station 1410 Bockman Road, San Lorenzo (C & D Auto Repair)
Attachments: C&D_Facility_Location_Map.pdf; C&D_Portion_Executive_Summary-and Photos.pdf

- C&D Auto Repair, located at 1415 Bockman Road and on the Site, is not listed under any searched databases in the EDR report. Records obtained from the County of Alameda Department of Environmental Health indicate that this facility does not have an active UST, but that it does have an oil-water separator tank in the garage floor. Records also indicate that the facility stores waste oil and waste antifreeze in 110 gallon and 55 gallon containers, respectively. Due to Site access restrictions at the time of Site reconnaissance, SECOR personnel only performed a visual inspection of the exterior of

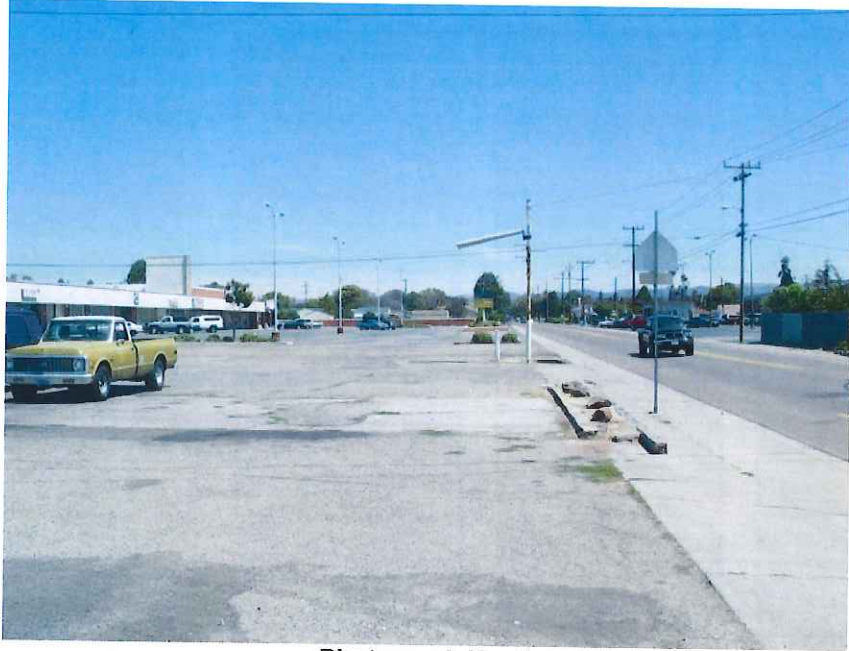
Photograph No. 5

this facility. Asphalt patch-work observed in front of this facility indicated the former location of an island, possibly a fuel dispensing location. No records were obtained from any agency, however, which indicated that the facility had once been a fueling station. SECOR recommends further investigation into the historical uses and present interior operations of this facility. SECOR recommends a limited subsurface investigation of the soils beneath the potential former fuel dispensing location. SECOR also recommends further inspection of the interior of this facility to locate the oil-water separator and any existing or former underground hydraulic lifts (or other RECs) as well as the subsequent subsurface investigation of soils adjacent to these features if present.

View from the western boundary of the Site, looking east along Bockman Road. Note the former possible fuel dispensing island in the foreground.

- According to the EDR report, groundwater monitoring well data within a one mile radius indicates that groundwater is expected to be encountered at a depth of approximately 5-20 feet below the ground surface. Due to this relatively shallow groundwater depth, SECOR recommends sampling the groundwater beneath the Site, specifically beneath the former fuel dispensers and USTs at 1210 Bockman Road and the former fuel dispenser Island at 1415 Bockman Road, for possible petroleum hydrocarbon contamination.

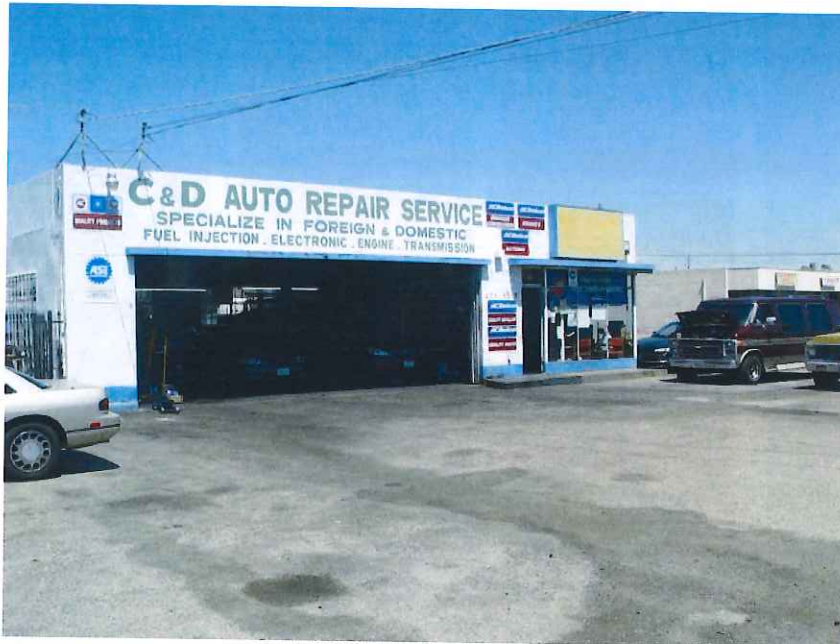
Photograph No. 6

View from the western boundary of the Site, looking northeast. C&D Auto Repair is located in the westernmost region of the Site.
