Subject: SOMA Environmental Report for Further On-site Investigation at Former Westinghouse Property Located at 5815 Peladeau Street, Emeryville, California

**Results of Additional Soil Sampling
At the Cistern Area
Former Westinghouse Electric Facility
5815 Peladeau Street
Emeryville, California**

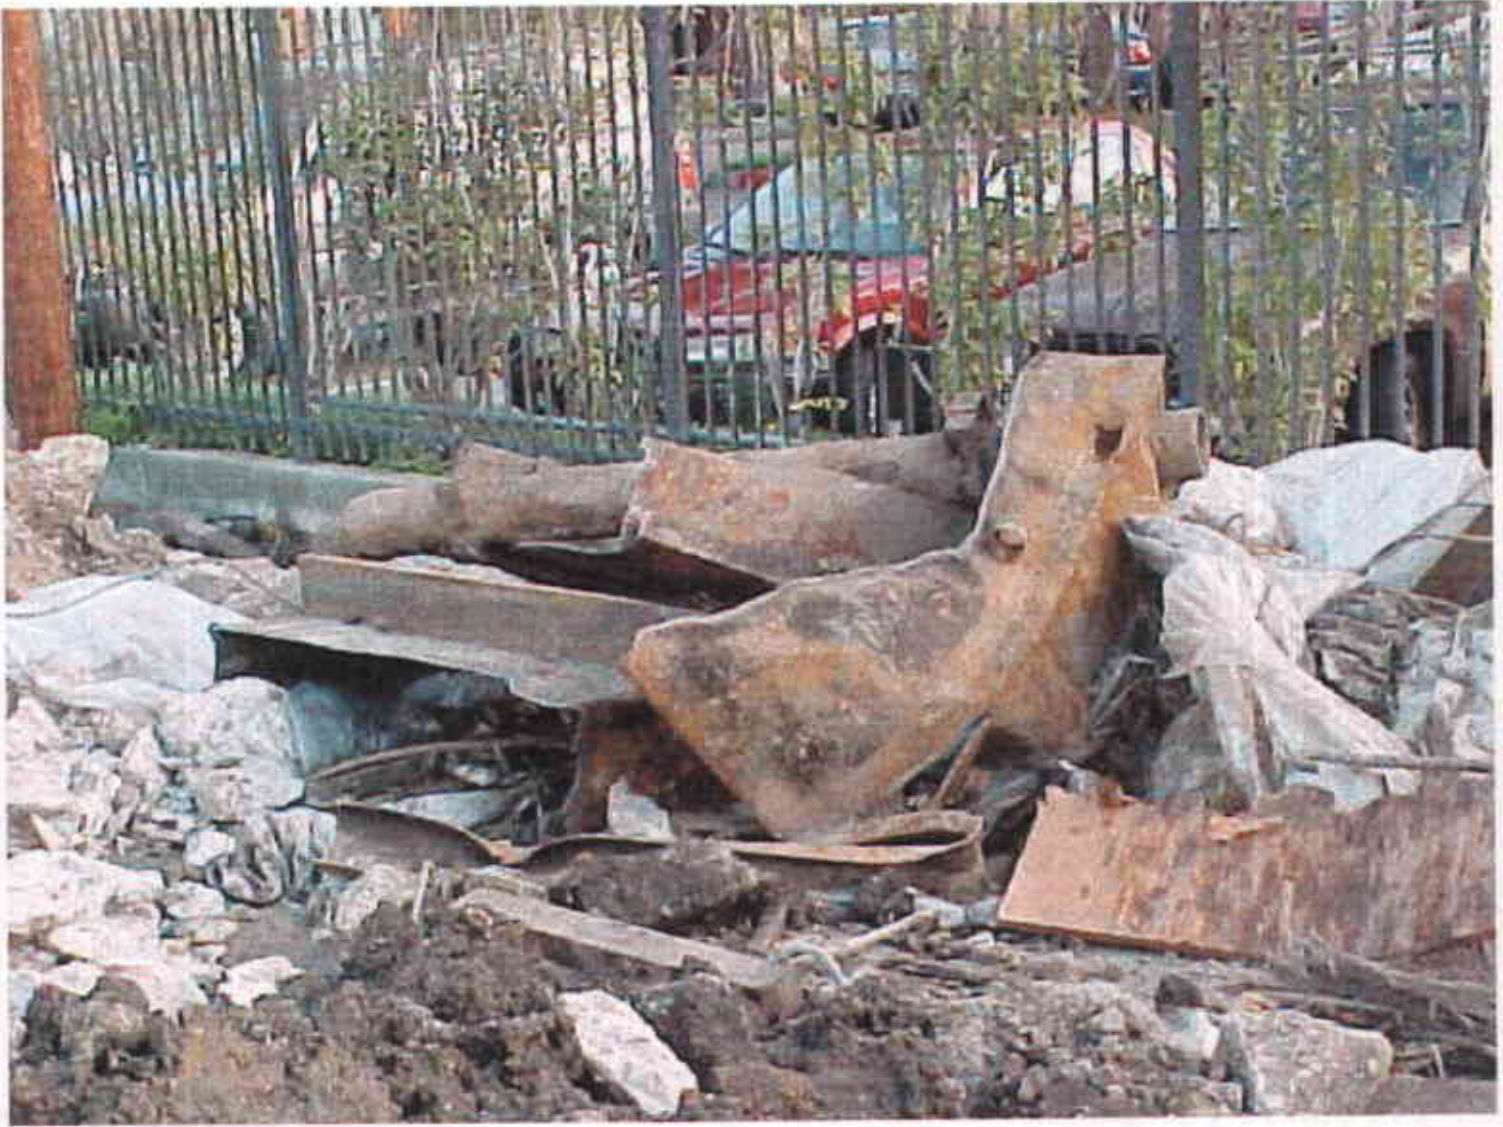
Figure 2: Excavated Cistern

On November 23, a SOMA field crew visited the Site. At the time of our visit, the cistern had already been excavated and removed by the WEBCOR construction crew, see Figure 2. The excavated steel cistern was sitting at the corner of the Site along the Peladeau Street with the approximate dimensions of 5.5 by 6 by 2 feet. Based on a discussion with a WEBCOR construction crewmember, at the time of removal, the cistern was full of sand and was discovered about two feet below the grade. The use of the cistern has not been determined however, it was apparently abandoned in place by filling it with sand. Based on our observations, the soils at the bottom and sidewalls of the excavation pit were stained and an objectionable odor was present.

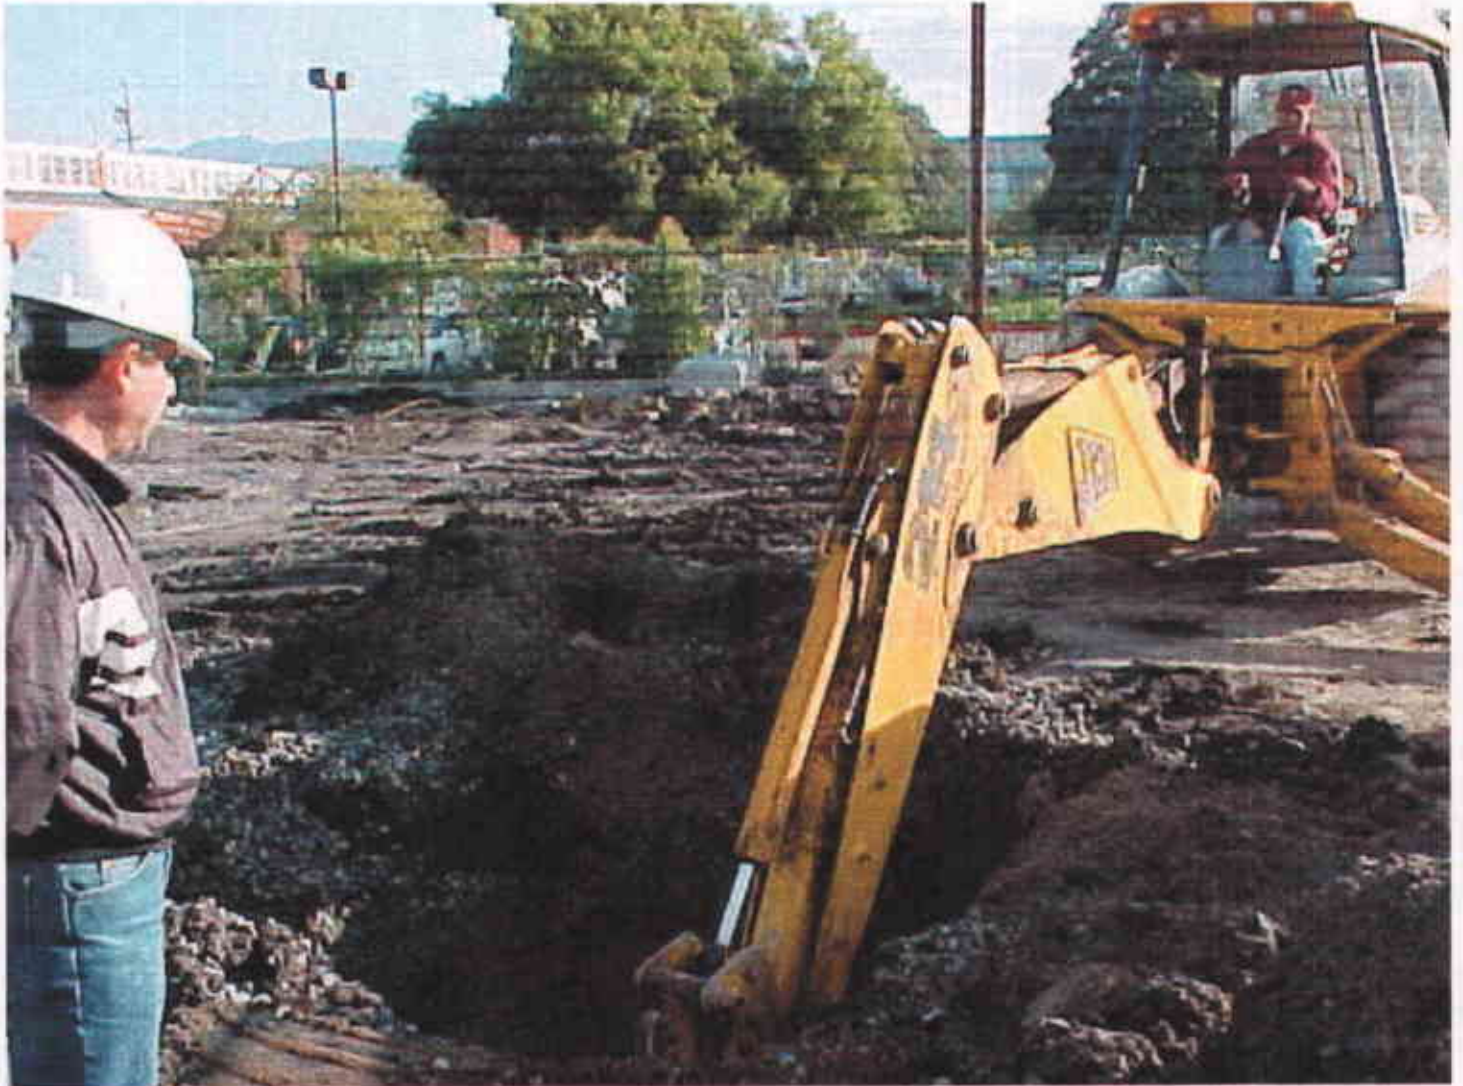
Figure 3: Excavating the Soil

Based on our evaluation and discussion with the excavation crew, the bottom of the excavated cistern was at 4 feet below the grade. To evaluate the depth of potentially impacted soils, the bottom of the excavation pit was further excavated and two soil samples were collected at five and seven feet below the grade. Figures 3 and 4 show the excavation and sampling processes. Subsequently, after collecting soil samples, the excavated soils were returned into the excavation pit and leveled to the current grade. The excavated area and its immediate vicinity were secured by wired-fences to minimize the potential for human contact with the potentially impacted soils. To prevent infiltration of rainwater into the soils, a plastic tarp was used to cover the excavated area. During the excavation and sampling processes, an objectionable odor and soil

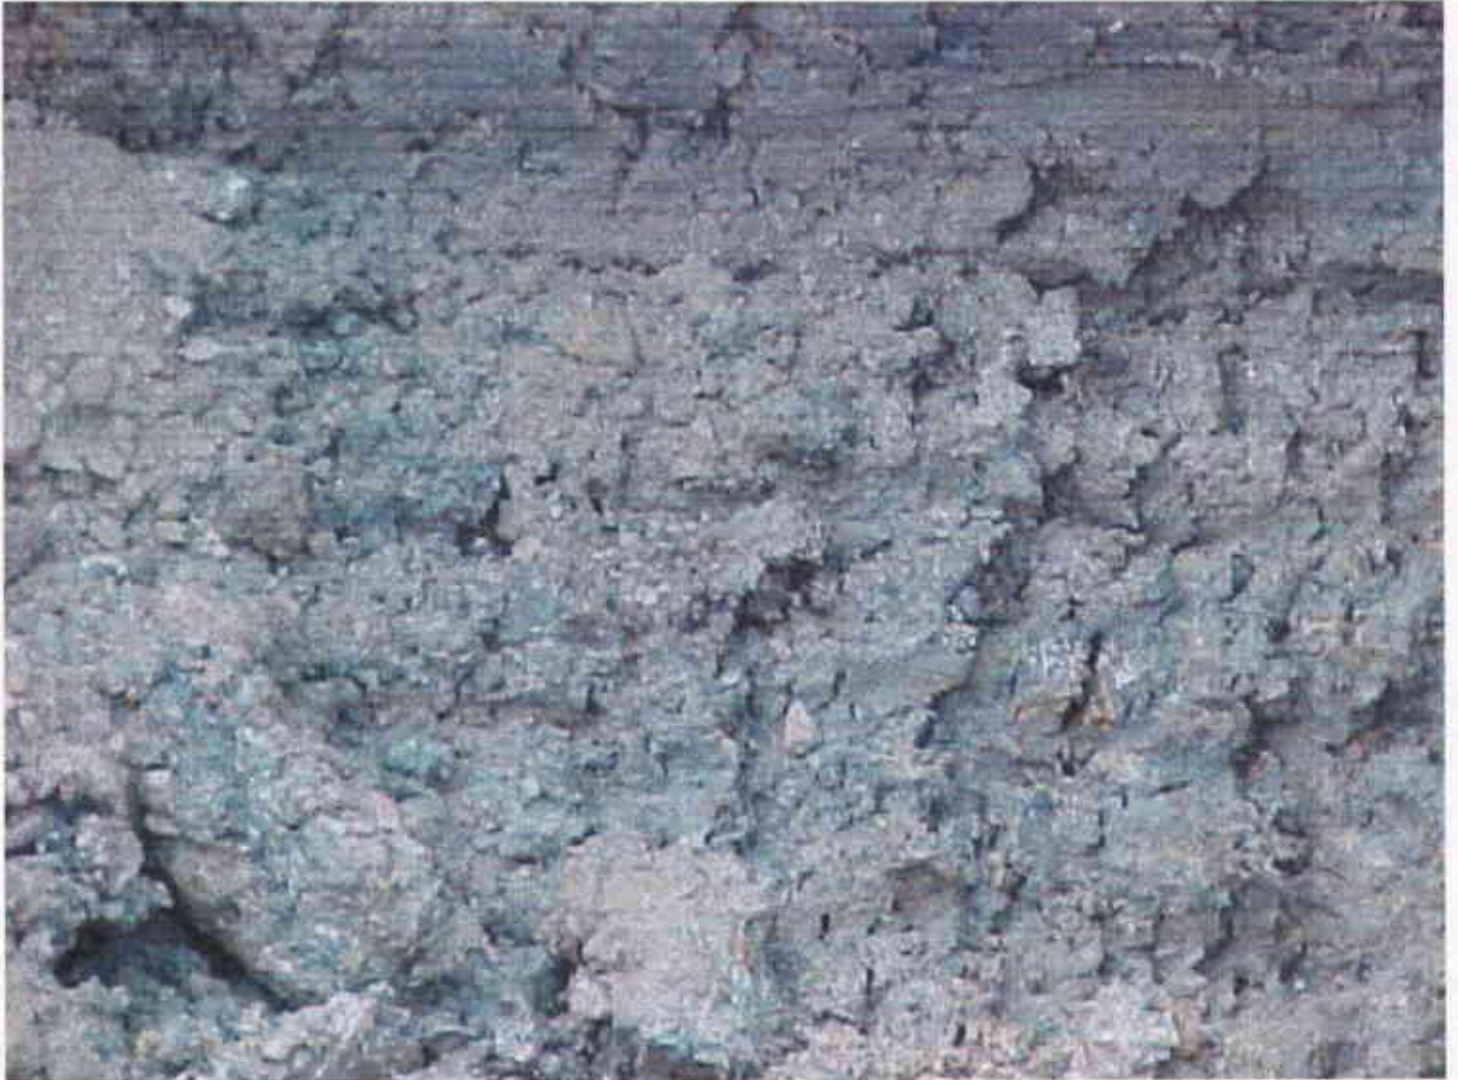
Figure 5: Close-up of Dark, Odorous Soil

staining were observed. Figure 5 shows the soil discoloration and staining along the walls of the excavation pit. The collected soil samples at five and seven feet below the grade were placed in an ice chest and delivered to DELTA Environmental Laboratories (DELTA) for analysis. Based on the CBS request, the soil samples were analyzed for polychlorinated biphenyls (PCBs) using EPA Method 8080. Later on, based on the request of Wareham Development, the current owner of Site, the soil samples were also analyzed for heavy metals (EPA Method 7000/6010), volatile organic compounds (EPA Method 8260/8240) as well as semi-volatiles (EPA Method 8270).

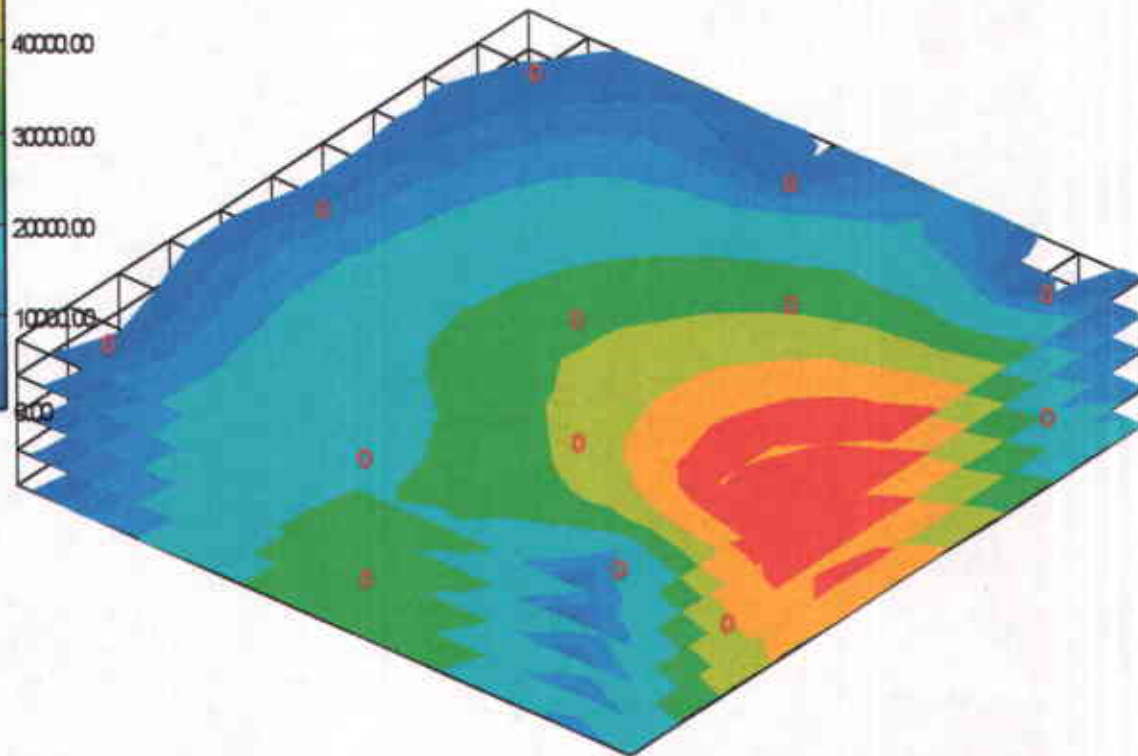
Figure 7: PCB Concentrations in Soil

PCB Concentrations in ppb
