SUBJECT: PHASE II SUBSURFACE INVESTIGATION AT ANOTHER TREE
DEVELOPMENT IN THE CITY OF EMERYVILLE, CALIFORNIA

**PHASE II SUBSURFACE INVESTIGATION
ANOTHER TREE DEVELOPMENT
EMERYVILLE, CALIFORNIA**

Project No. A901749A

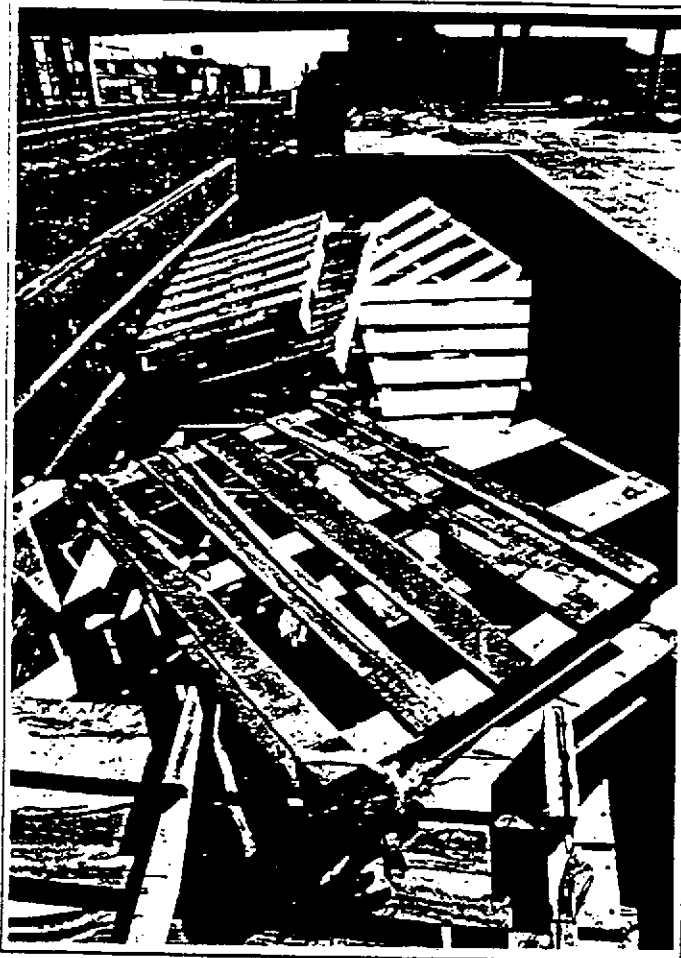
FIGURE 5A. WOODEN PALLETS AND PAPER INSIDE A TRASH CONTAINER

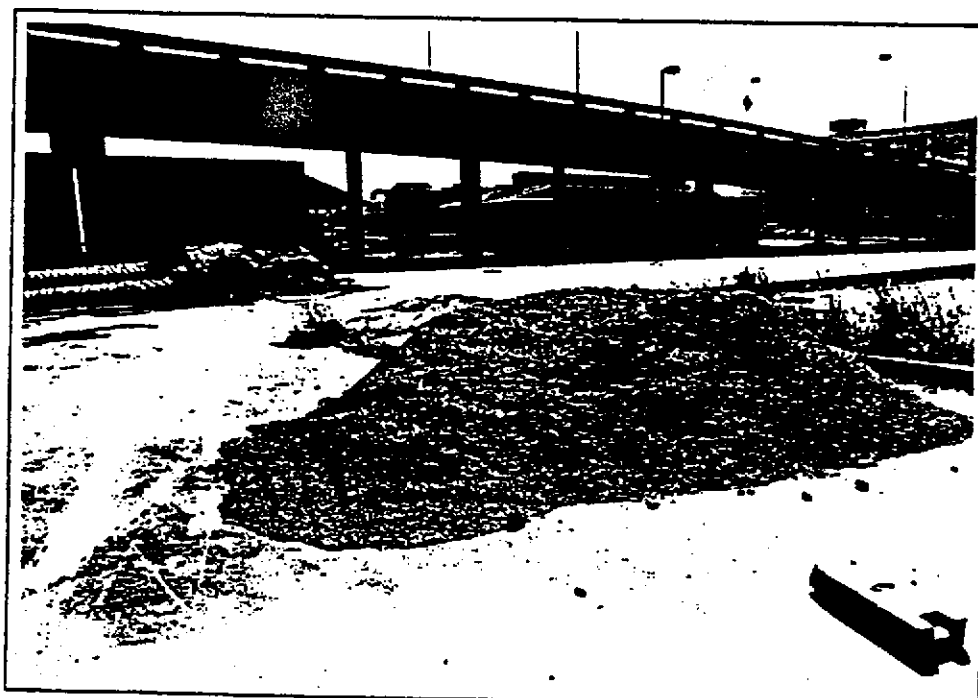
FIGURE 7B. APPROXIMATELY 9 CUBIC YARDS OF REDWOOD MULCH. PALM TREES IN THE BACKGROUND

The southeast corner of the site is shown in Figures 7a and 7b. The structure in the background in both figures is the Powell Street overpass. The asphaltic pavement in the photoprints

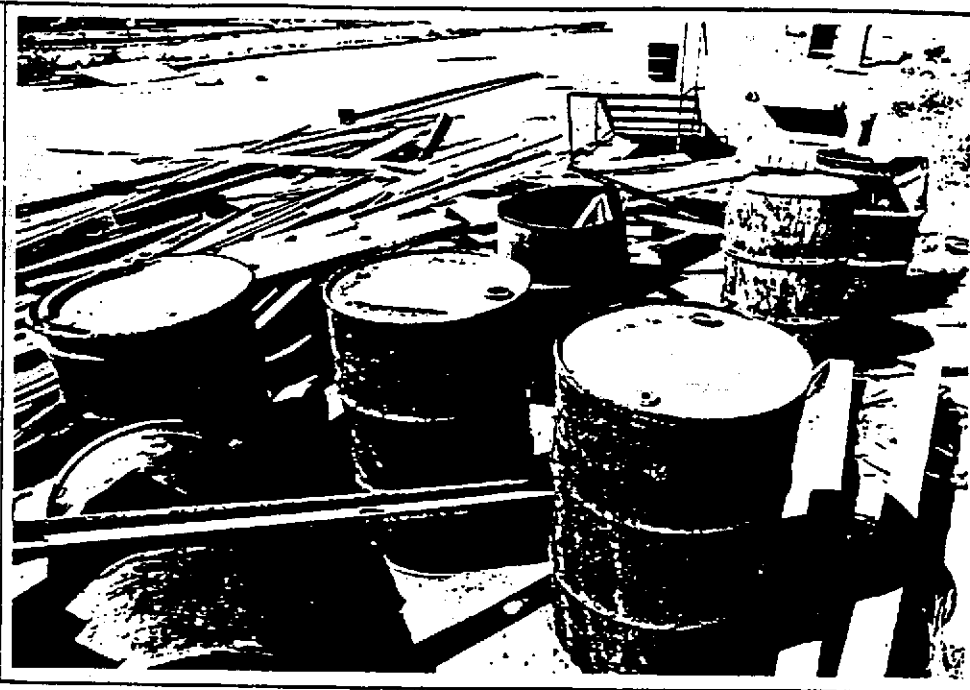
FIGURE 8A. DRUMS LOCATED IN SOUTHEAST CORNER OF THE SITE

- o Samples from the liquid in the drums were to be obtained with a dipper. The samples were to be transferred to laboratory-supplied containers in a manner that minimized potential volatilization. As noted previously, the drums were no longer present on the site. Therefore, samples could not be obtained of the contents of the drums.

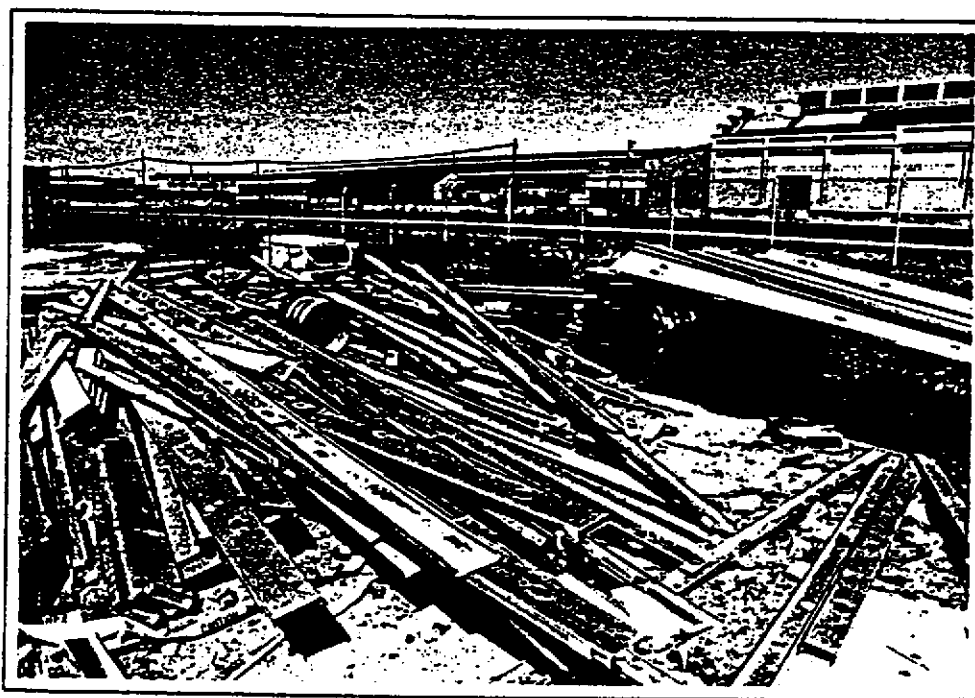
Figure 8b shows numerous aluminum studdings for interior walls and other assorted aluminum beams. These materials are most likely abandoned construction materials from the development of The MarketPlace and adjacent office buildings.

FIGURE 8B. INTERIOR WALL STUDDINGS

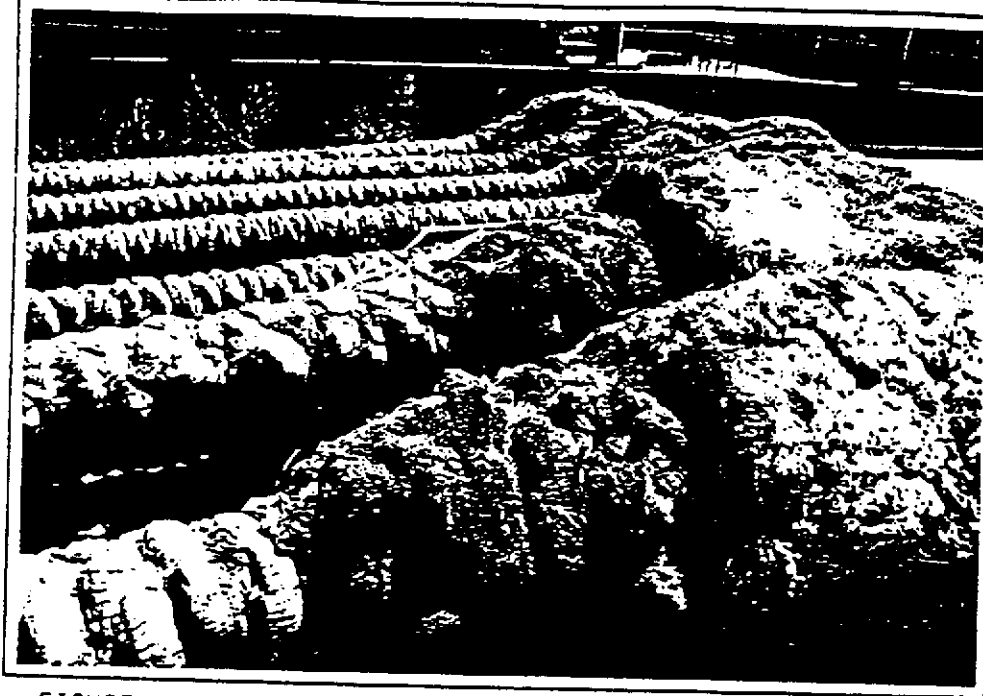
The photoprint in Figure 9a shows 12 palm trees that had been rooted up (or never planted on the site) and were lying on their sides. (During a subsequent site visit, it was observe that an irrigation system had been installed at the roots of the trees.)

FIGURE 9A. TWELVE PALM TREES LYING ON THE GROUND SURFACE
