**MODIFIED PHASE ONE ENVIRONMENTAL
SITE ASSESSMENT**

KING AVENUE PROPERTIES

FREMONT, CALIFORNIA

PROJECT NO. 4216-F1

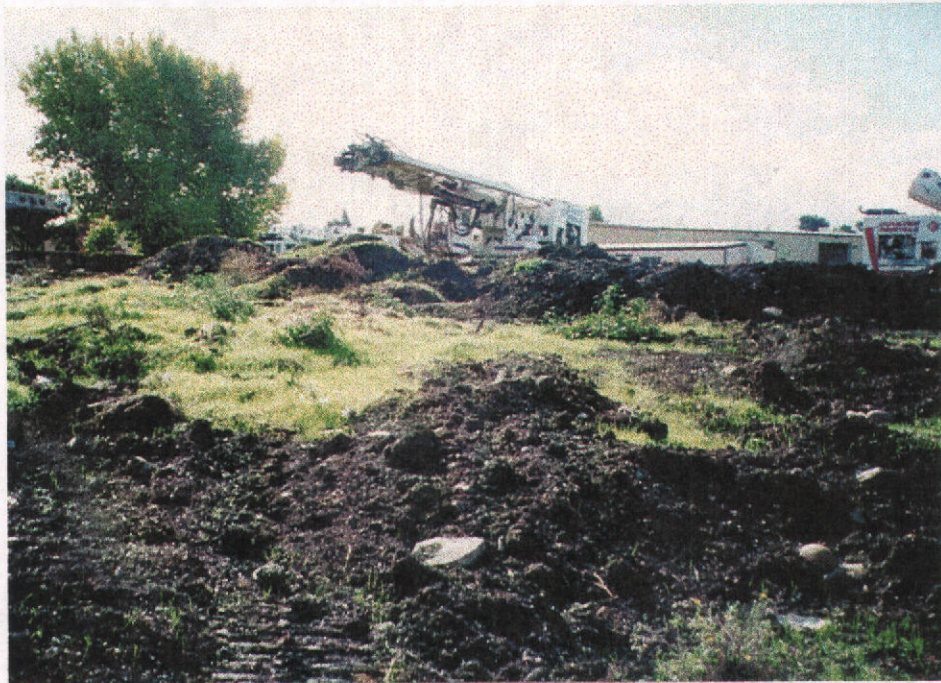
Based on the initial findings of the site assessment, ENGEO recommended that the scope of the assessment be expanded to include the recovery of two composite soil samples from the existing fill stockpiles situated on Parcels 62 and 63. The purpose of the additional study was to determine if the fill material contained potentially hazardous contaminants. The scope of the additional services included the recovery of two four-point composite stockpile samples, with laboratory analysis for petroleum hydrocarbons, volatile/semivolatile organics and metals.

FILL/DEBRIS STOCKPILES

ENGEO recommends that the property be viewed by an environmental professional during demolition and pregrading activities to observe areas of the property which may have been obscured by existing structures. The areas of petroleum hydrocarbon soil staining noted on the parcels should also be observed to confirm the scarification and removal of the soils. The scarified material, along with the fill stockpiles on Parcel 62 and 63, could most likely be used as fill outside of proposed residential pad areas.

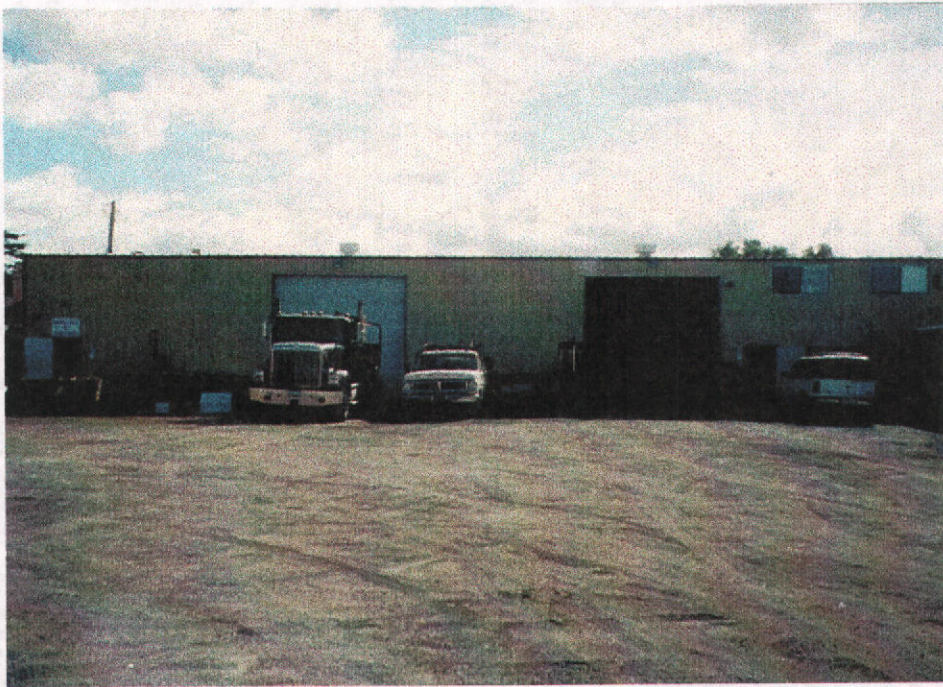
GALLEGOS TRUCKING BUILDING
