FAX TRANSMISSION

<table border="1"> <tr> <th>No.</th> <th>Date</th> <th>Revised</th> <th>Approved</th> </tr> <tr> <td> </td> <td> </td> <td> </td> <td> </td> </tr> </table>	No.	Date	Revised	Approved					<p>Henshaw Associates, Inc. Environmental Engineering Services 11875 Dublin Blvd., Suite A-200 • Dublin, California 94568</p>	<table border="1"> <tr> <td>Date:</td> <td>07/27/98</td> </tr> <tr> <td>Designed:</td> <td>OS</td> </tr> <tr> <td>Drawn:</td> <td>OS</td> </tr> <tr> <td>Checked:</td> <td>DB</td> </tr> <tr> <td>DWG file:</td> <td>3307.98</td> </tr> </table>	Date:	07/27/98	Designed:	OS	Drawn:	OS	Checked:	DB	DWG file:	3307.98	<p>STORAGE AREA TEST RESULTS Oliver Property 18905 Hesperian Blvd. Hayward, California</p>	<table border="1"> <tr> <td>Figure</td> <td>5</td> </tr> <tr> <td>Project</td> <td>160.A.01</td> </tr> </table>	Figure	5	Project	160.A.01
No.	Date	Revised	Approved																							
Date:	07/27/98

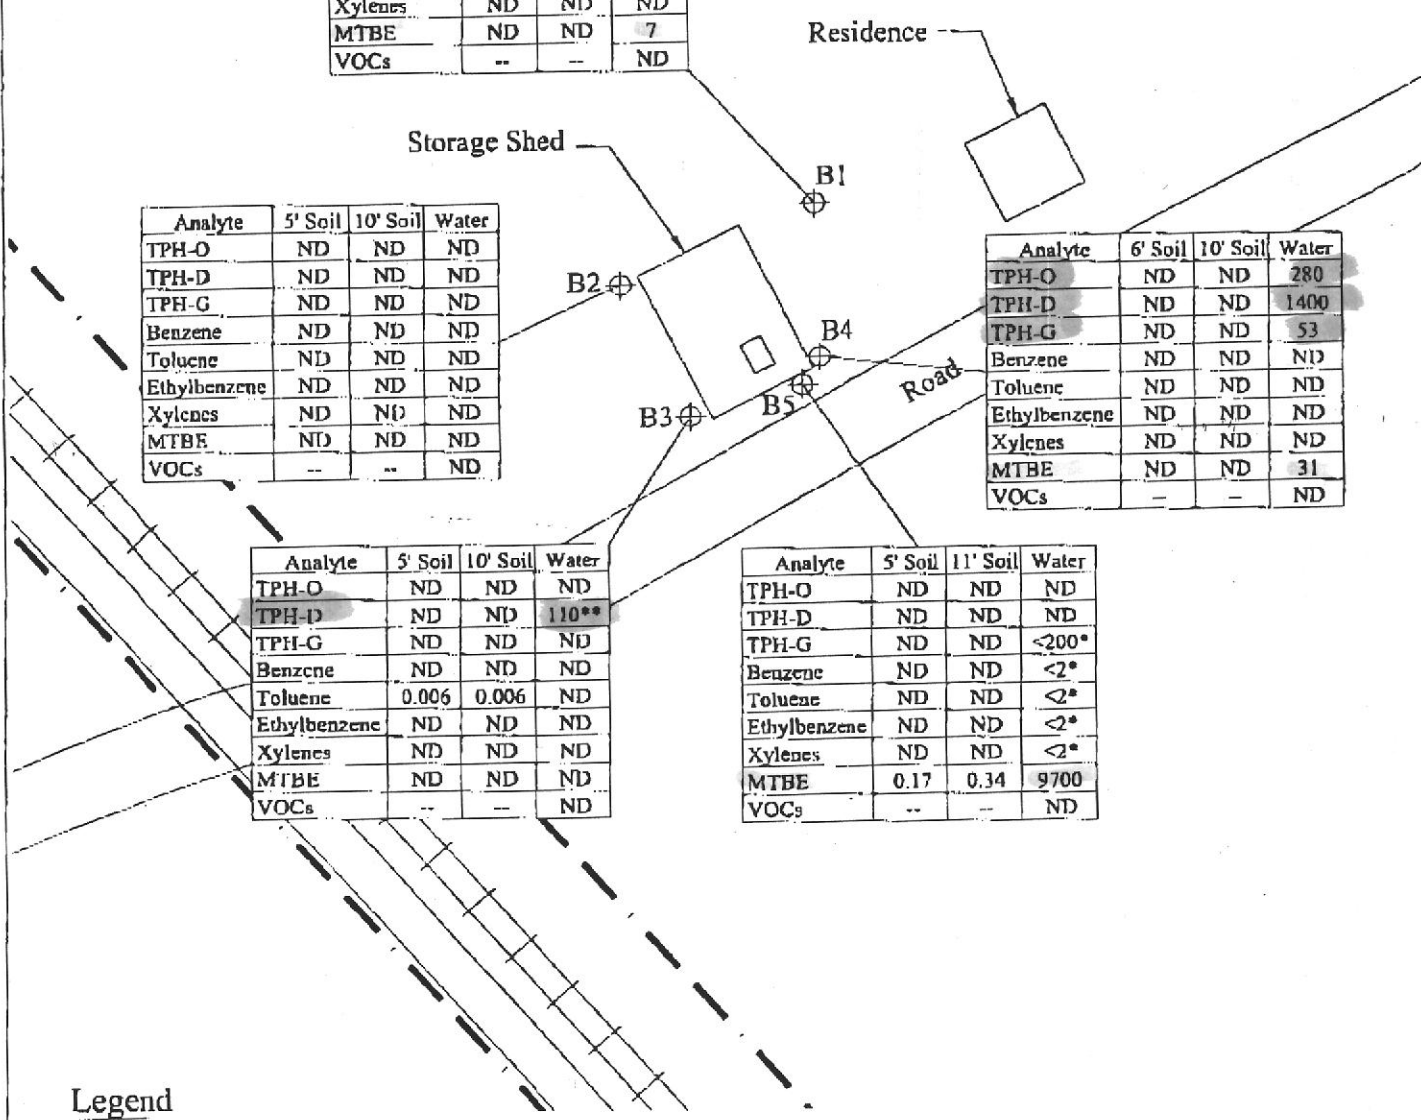
Designed:	OS																									
Drawn:	OS																									
Checked:	DB																									
DWG file:	3307.98																									
Figure	5																									
Project	160.A.01

Analyte	5' Soil	10' Soil	Water
TPH-O	ND	ND	ND
TPH-D	ND	ND	1400
TPH-G	ND	ND	ND
Benzene	ND	ND	ND
Toluene	ND	ND	ND
Ethylbenzene	ND	ND	ND
Xylenes	ND	ND	ND
MTBE	ND	ND	7
VOCs	--	--	ND

Analyte	5' Soil	10' Soil	Water
TPH-O	ND	ND	ND
TPH-D	ND	ND	ND
TPH-G	ND	ND	ND
Benzene	ND	ND	ND
Toluene	ND	ND	ND
Ethylbenzene	ND	ND	ND
Xylenes	ND	ND	ND
MTBE	ND	ND	ND
VOCs	--	--	ND

Analyte	6' Soil	10' Soil	Water
TPH-O	ND	ND	280
TPH-D	ND	ND	1400
TPH-G	ND	ND	53
Benzene	ND	ND	ND
Toluene	ND	ND	ND
Ethylbenzene	ND	ND	ND
Xylenes	ND	ND	ND
MTBE	ND	ND	31
VOCs	--	--	ND

Analyte	5' Soil	10' Soil	Water
TPH-O	ND	ND	ND
TPH-D	ND	ND	110**
TPH-G	ND	ND	ND
Benzene	ND	ND	ND
Toluene	0.006	0.006	ND
Ethylbenzene	ND	ND	ND
Xylenes	ND	ND	ND
MTBE	ND	ND	ND
VOCs	--	--	ND

Analyte	5' Soil	11' Soil	Water
TPH-O	ND	ND	ND
TPH-D	ND	ND	ND
TPH-G	ND	ND	<200*
Benzene	ND	ND	<2*
Toluene	ND	ND	<2*
Ethylbenzene	ND	ND	<2*
Xylenes	ND	ND	<2*
MTBE	0.17	0.34	9700
VOCs	--	--	ND

- B5 ⊕ Soil boring location
- * Method reporting limit was elevated due to high analyte concentrations
- ** Sample contains components in the diesel range, but the chromatogram does not match the diesel fingerprint
- ND Not detected at or above the method reporting limit
- Not analyzed
