**FIRST SEMI-ANNUAL 2014
GROUNDWATER MONITORING,
PRODUCT EXTRACTION, AND LIMITED
SUBSURFACE INVESTIGATION REPORT**

**BRIDGEWATER APARTMENTS PHASE I PARKING GARAGE
6400 CHRISTIE AVENUE
EMERYVILLE, CALIFORNIA**

**EMERYBAY COMMERCIAL ASSOCIATION
EMERYVILLE, CA 94608**

Project No. 2007-65

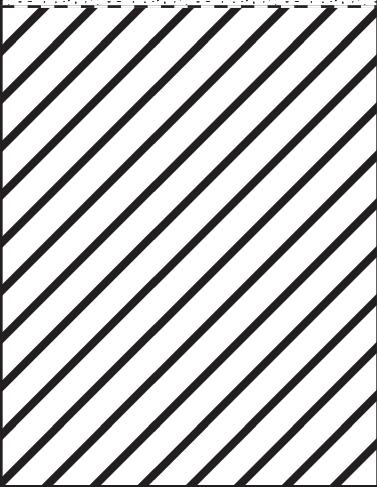
Boring B3. The concrete slab in this area of the garage is approximately 5-inches thick and is underlain by about 9 feet of clayey gravel fill containing brick, glass and metal debris. Underlying the fill layer is silty clay extending to a depth of about 18 feet bgs below which a clayey sand was encountered. No obvious hydrocarbon contamination was observed. Groundwater was encountered at about 16.5 feet bgs in Boring B3 which rose to about 11 feet bgs in the well allowing collection of sample B3-SES-W.

Clayey gravel, brick, glass, metal debris, fill	
4-8			Poor recovery 4-8'
10-16

▼ Silty clay (CL-CH), dark grey, moist, very stiff	
16		▽	
16-18			Set temporary 1" diameter PVC well casing from 10-20'. Collect B3-SES-W grab groundwater sample.
18-20

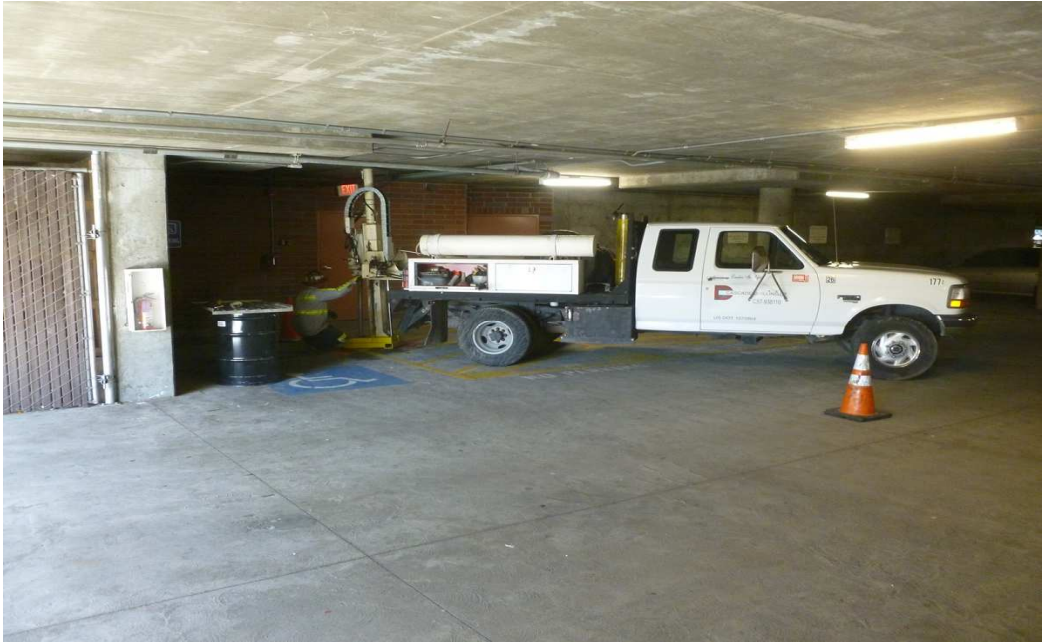
Photo No.: 01

Subject: Advancing boring B3.

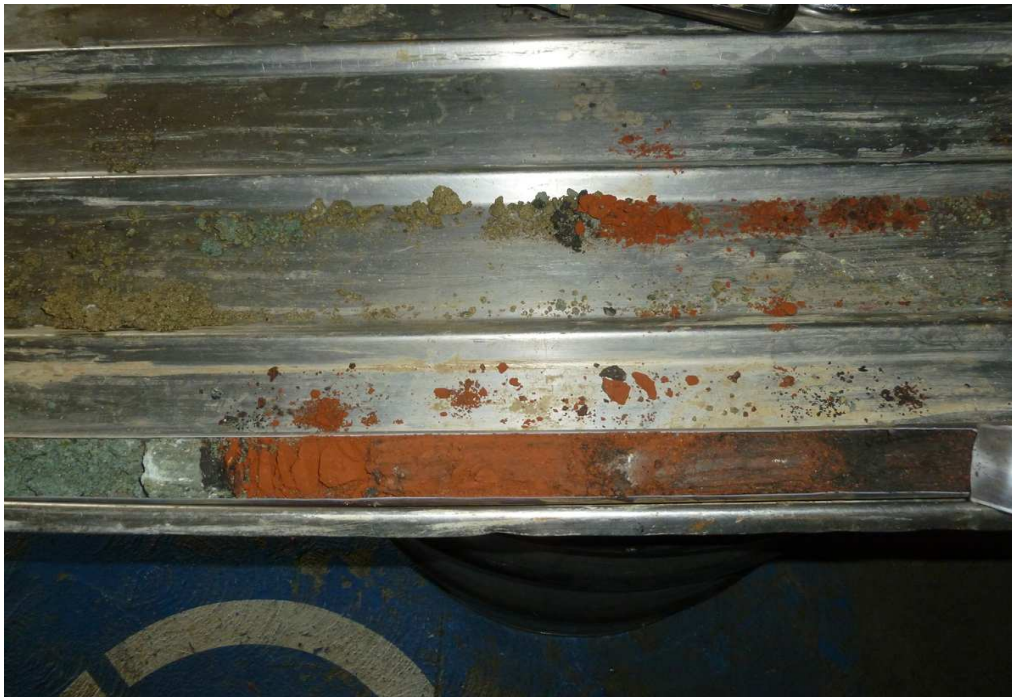
Photo No.: 02

- Based on soil and fill samples recovered during the drilling of the five borings, the composition of the upper 10 to 15 feet of subsurface materials consists of non-engineered fill that contains clay, gravel, brick, sand, glass and metal. This condition is consistent with the known history of the surrounding area of Emeryville west of the railroad right-of-way.

Subject: Typical fill material in upper 10 feet.

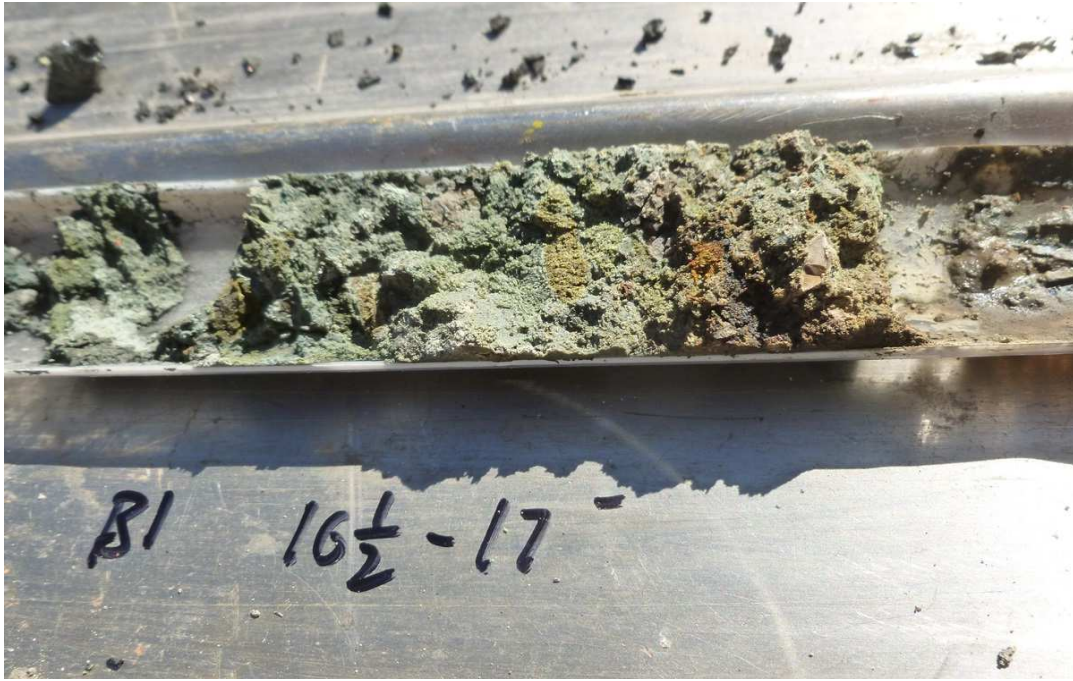
Photo No.: 01

Subject: Discoloration of water bearing zone- Boring B1

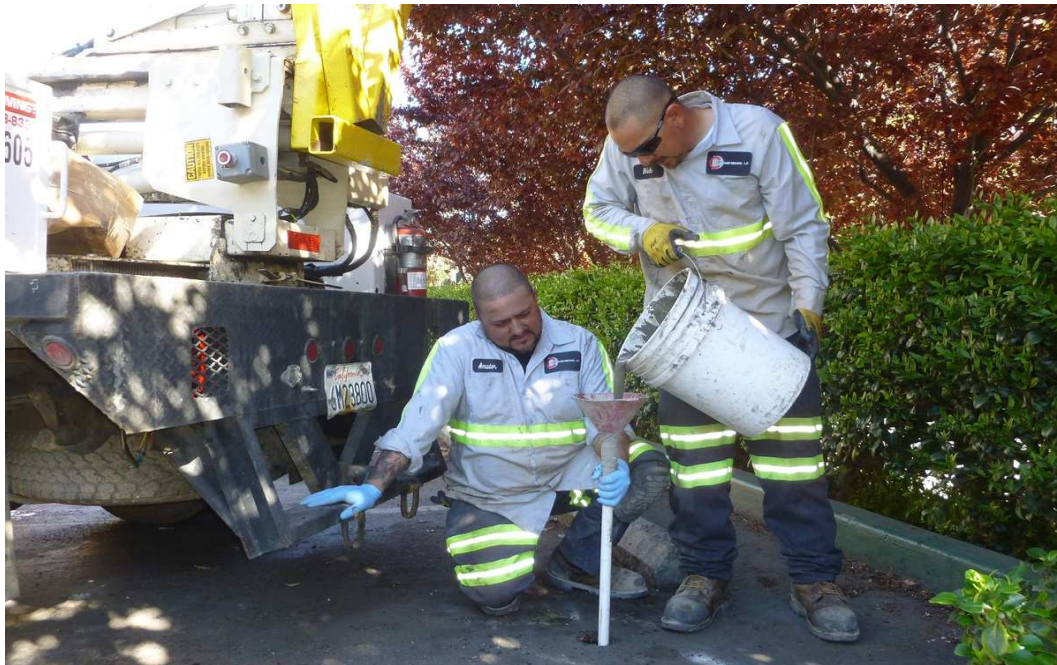
After the samples were collected, all borings were backfilled using neat cement grout to within 6-inches to the surface as required by The Alameda County Department of Public Works. Concrete

Subject: Grouting (sealing) Boring B1
