# **SECOND SEMI-ANNUAL 2014 GROUNDWATER MONITORING AND PRODUCT EXTRACTION REPORT**

**BRIDGEWATER APARTMENTS PHASE I PARKING GARAGE  
6400 CHRISTIE AVENUE  
EMERYVILLE, CALIFORNIA**

Project No. 2007-65

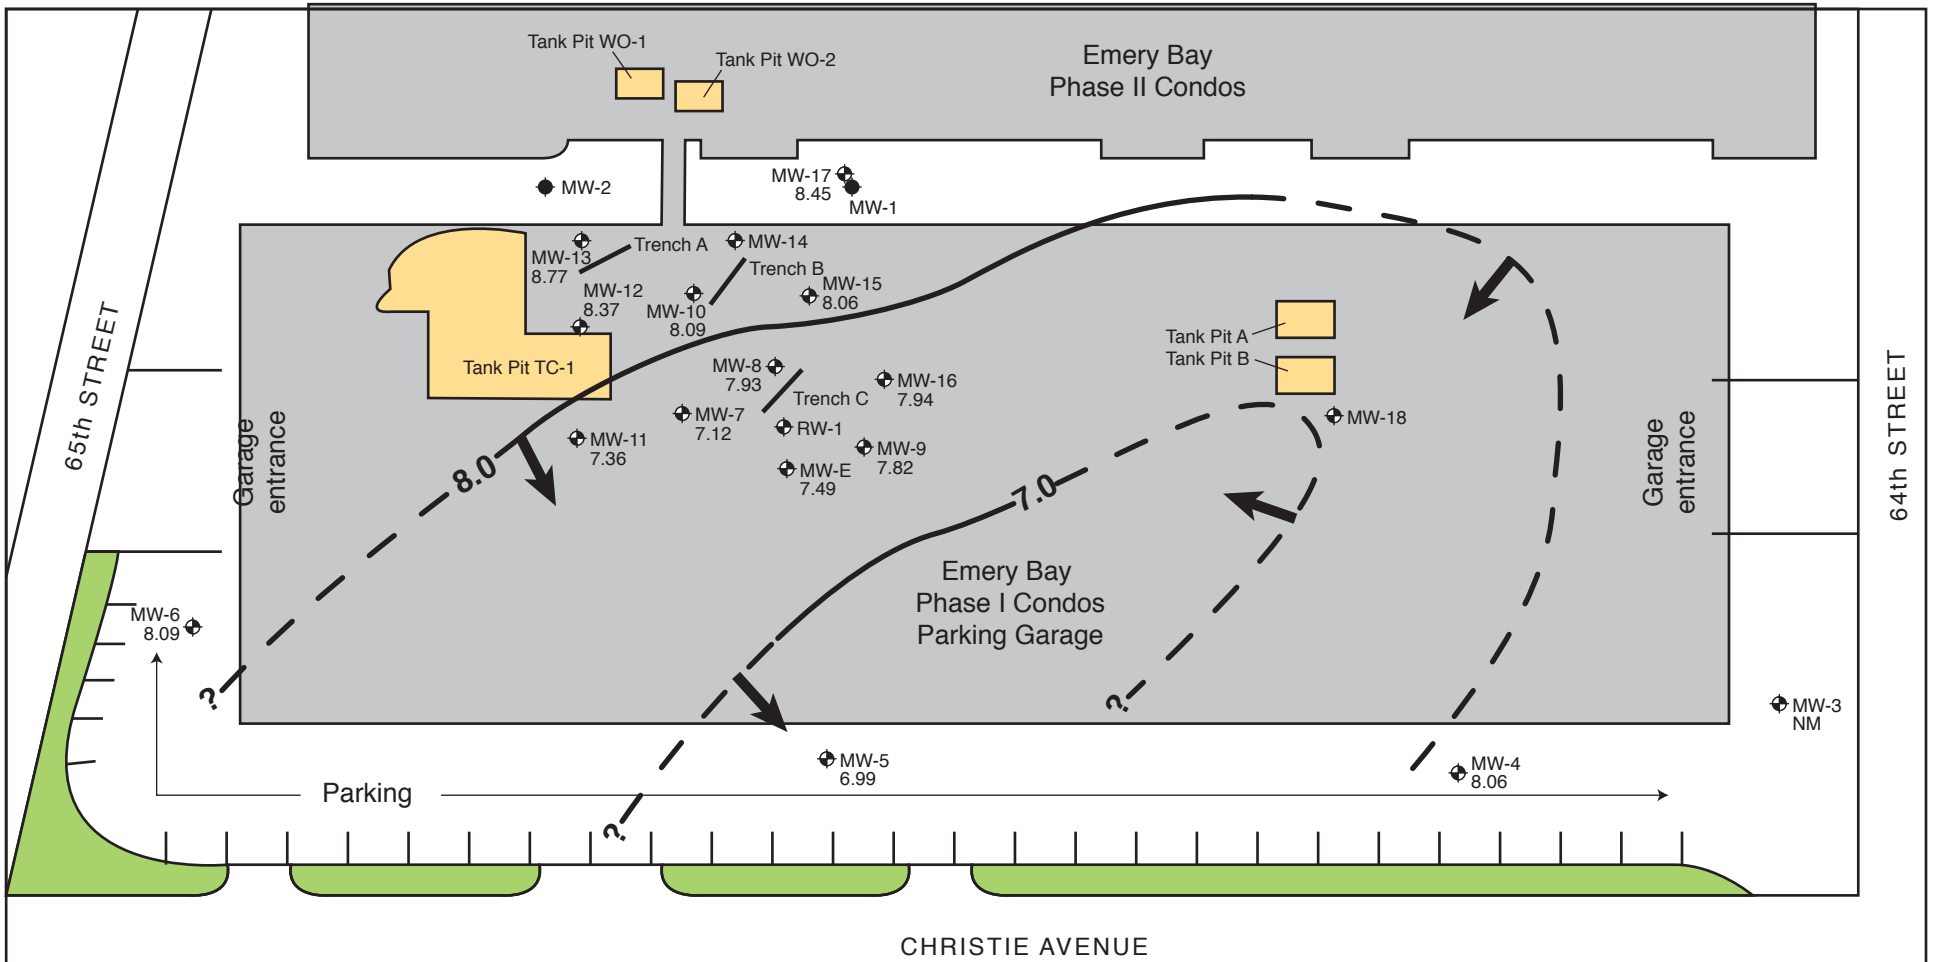
The groundwater flow direction measured during the September 2014 monitoring event was generally towards the southwest. The localized, approximately southerly direction to groundwater flow in the area of MW-3 noted in the 2013 monitoring events, thought to be the result of construction dewatering that had been occurring during 2013 at the re-development site across 64<sup>th</sup> Street, was not as pronounced for the current event, since that de-watering has been discontinued since February of 2014. According to current and historical water level data obtained from onsite monitoring wells, depth to groundwater beneath the site ranges from approximately 6 to 11 feet below ground surface (bgs). Groundwater elevations recorded during the September 2014 sampling event ranged from 5.6 feet (RW-1) to 10.79 feet (MW-18) above mean sea level. Some groundwater mounding may be occurring in area of MW-4 due to contributions from irrigation since the well box of MW-4 was filled with water. The average groundwater gradient for the current monitoring event was 0.003 foot/foot.

Figure 4 is a groundwater elevation map from the recent groundwater-monitoring event (activities discussed in Section 4.0).

- The groundwater flow direction calculated during this monitoring event was found to be generally to the southwest. Some mounding is evident in the area of MW-4 which is likely due to water accumulating from landscape irrigation leaks (MW-4 well box full of water).

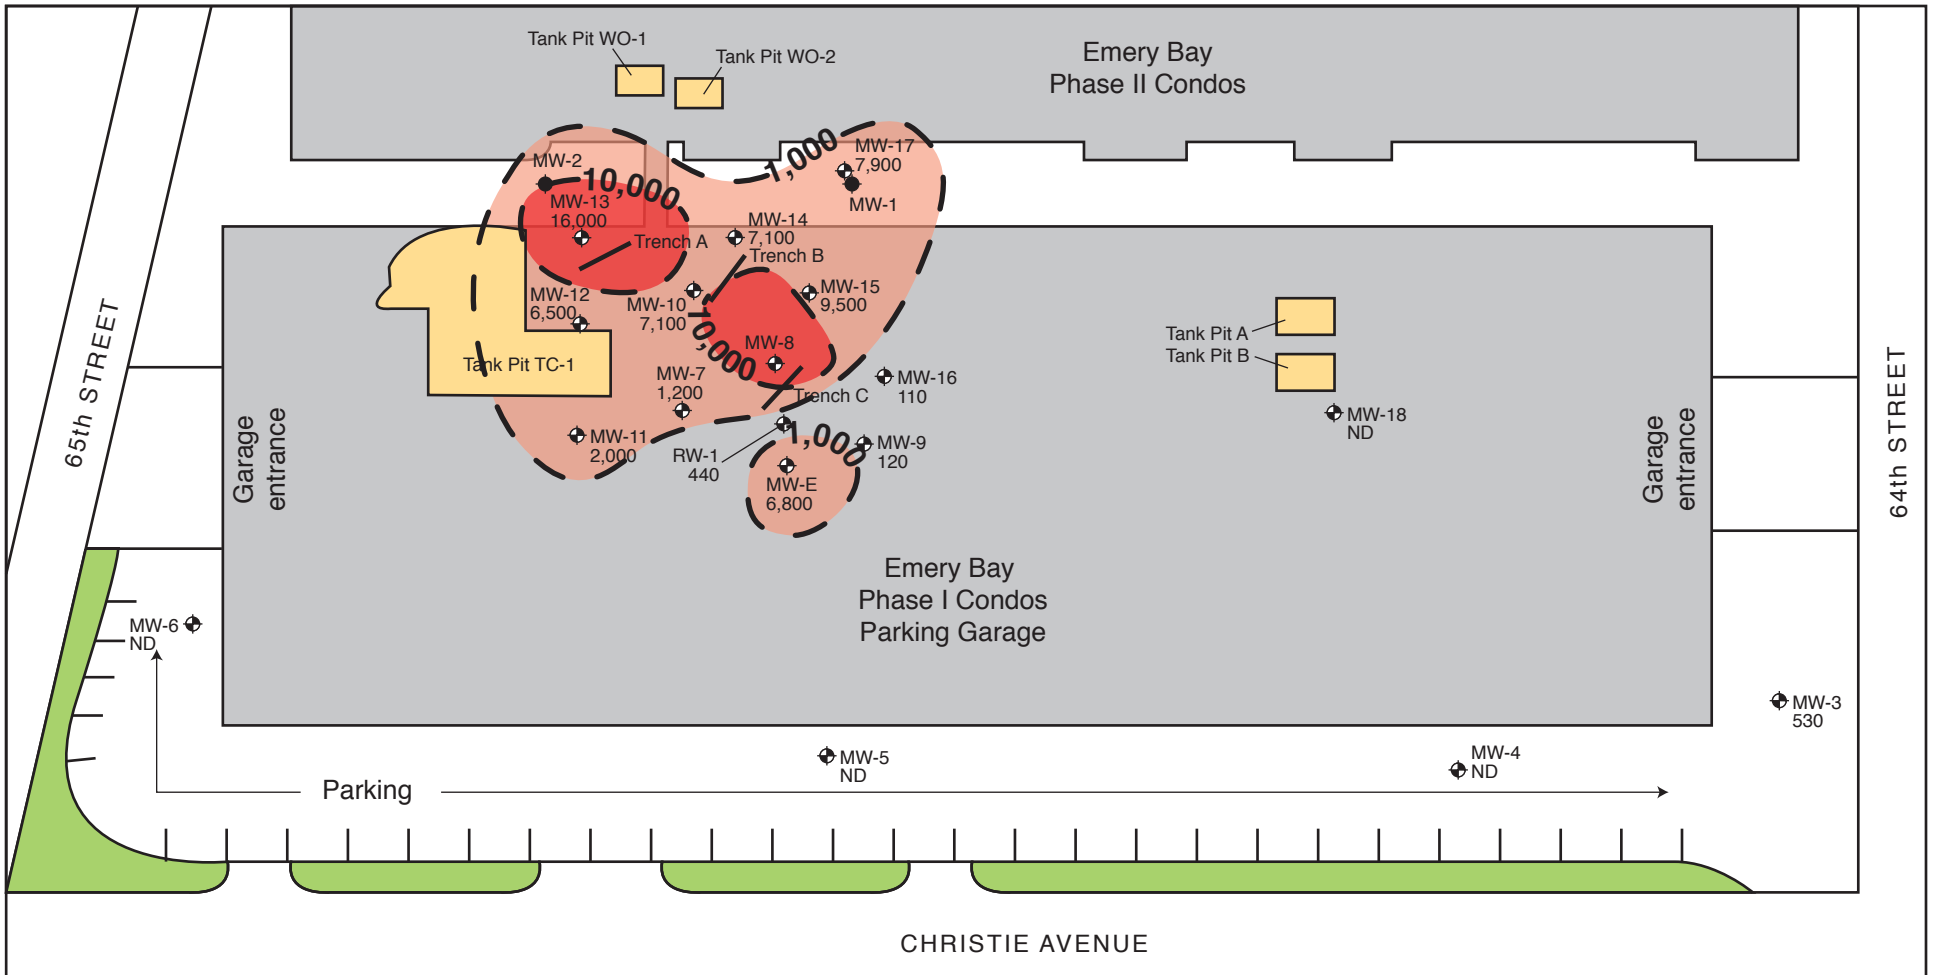
Figures 6 and 7 are isoconcentration maps of TPHg and TEHd concentrations in groundwater based on the September 2014 analytical results.

The highest concentrations of TVHg (16,000  $\mu\text{g/L}$  in MW-13) and TEHd (21,000  $\mu\text{g/L}$  in MW-3) for the current event can be compared to concentrations of 19,000  $\mu\text{g/L}$  TVHg in MW-13 and 250,000  $\mu\text{g/L}$  TEHd observed in well MW-13 in September 2013. Concentrations of hydrocarbons in well MW-13 have decreased steadily since the September 2012 sampling event, with TVHg decreasing from 60,000  $\mu\text{g/L}$  to 16,000  $\mu\text{g/L}$ , and TEHd decreasing from 7,200,000  $\mu\text{g/L}$  in 2012 to the current 11,000  $\mu\text{g/L}$ .

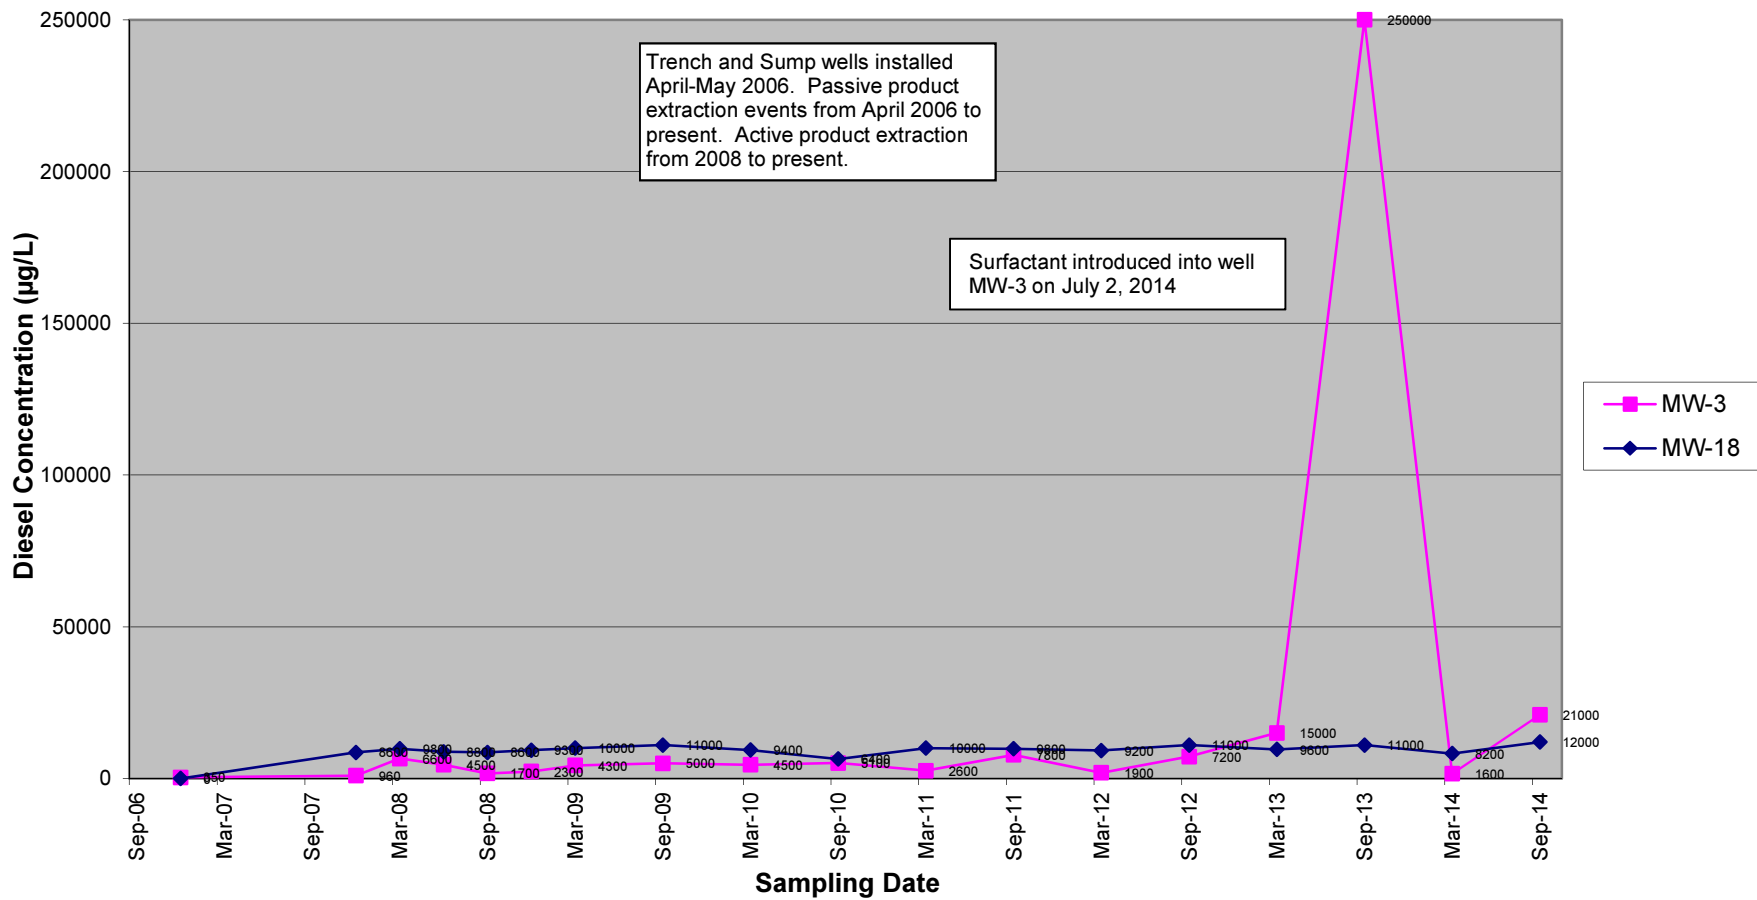
**Figure 10**  
**Historical Groundwater Analytical Results**  
**Total Petroleum Hydrocarbons as Diesel (TPHd)**  
**Crossgradient Wells MW-3 and MW-18**  
**December 2006 - September 2014**

In addition to the above factors, the decrease of diesel concentrations observed in well MW-3 after seeing increases over the past three monitoring events, is very likely due to the cessation of dewatering activities that had been on-going at the construction site across 64<sup>th</sup> Street during 2013 until early 2014 which had affected the groundwater flow direction and magnitude. In addition, the surfactant introduced into MW-3 in September 2104, likely reduced LNAPL and dissolved hydrocarbon concentrations in that well. Well MW-18, which is the closest upgradient well to MW-3, has shown a relatively stable TEHd concentration over the past four monitoring events, suggesting that an undiscovered area of residual hydrocarbon contamination may exist between MW-3 and MW-18. In general, residual hydrocarbons left in the soil after the USTs were removed from the site in the 1980's, is likely to continue to be a source of contamination to groundwater at the site. More active remediation, including introduction of bio-remedial enhancing products into selected wells may be useful to reduce the concentrations to levels acceptable to the regulatory community and to achieve eventual regulatory closure. If the surfactant applications at the site can continue to reduce the degraded product present, particularly in wells MW-3, NMW-8, MW-9, MW-10, MW-12, MW-13 and MW-14, then application of such bio-remedial remedies can better be considered.
