Figure  
**6**

1187 Solano Avenue, Albany (Former Albany 1-Hr Cleaners)

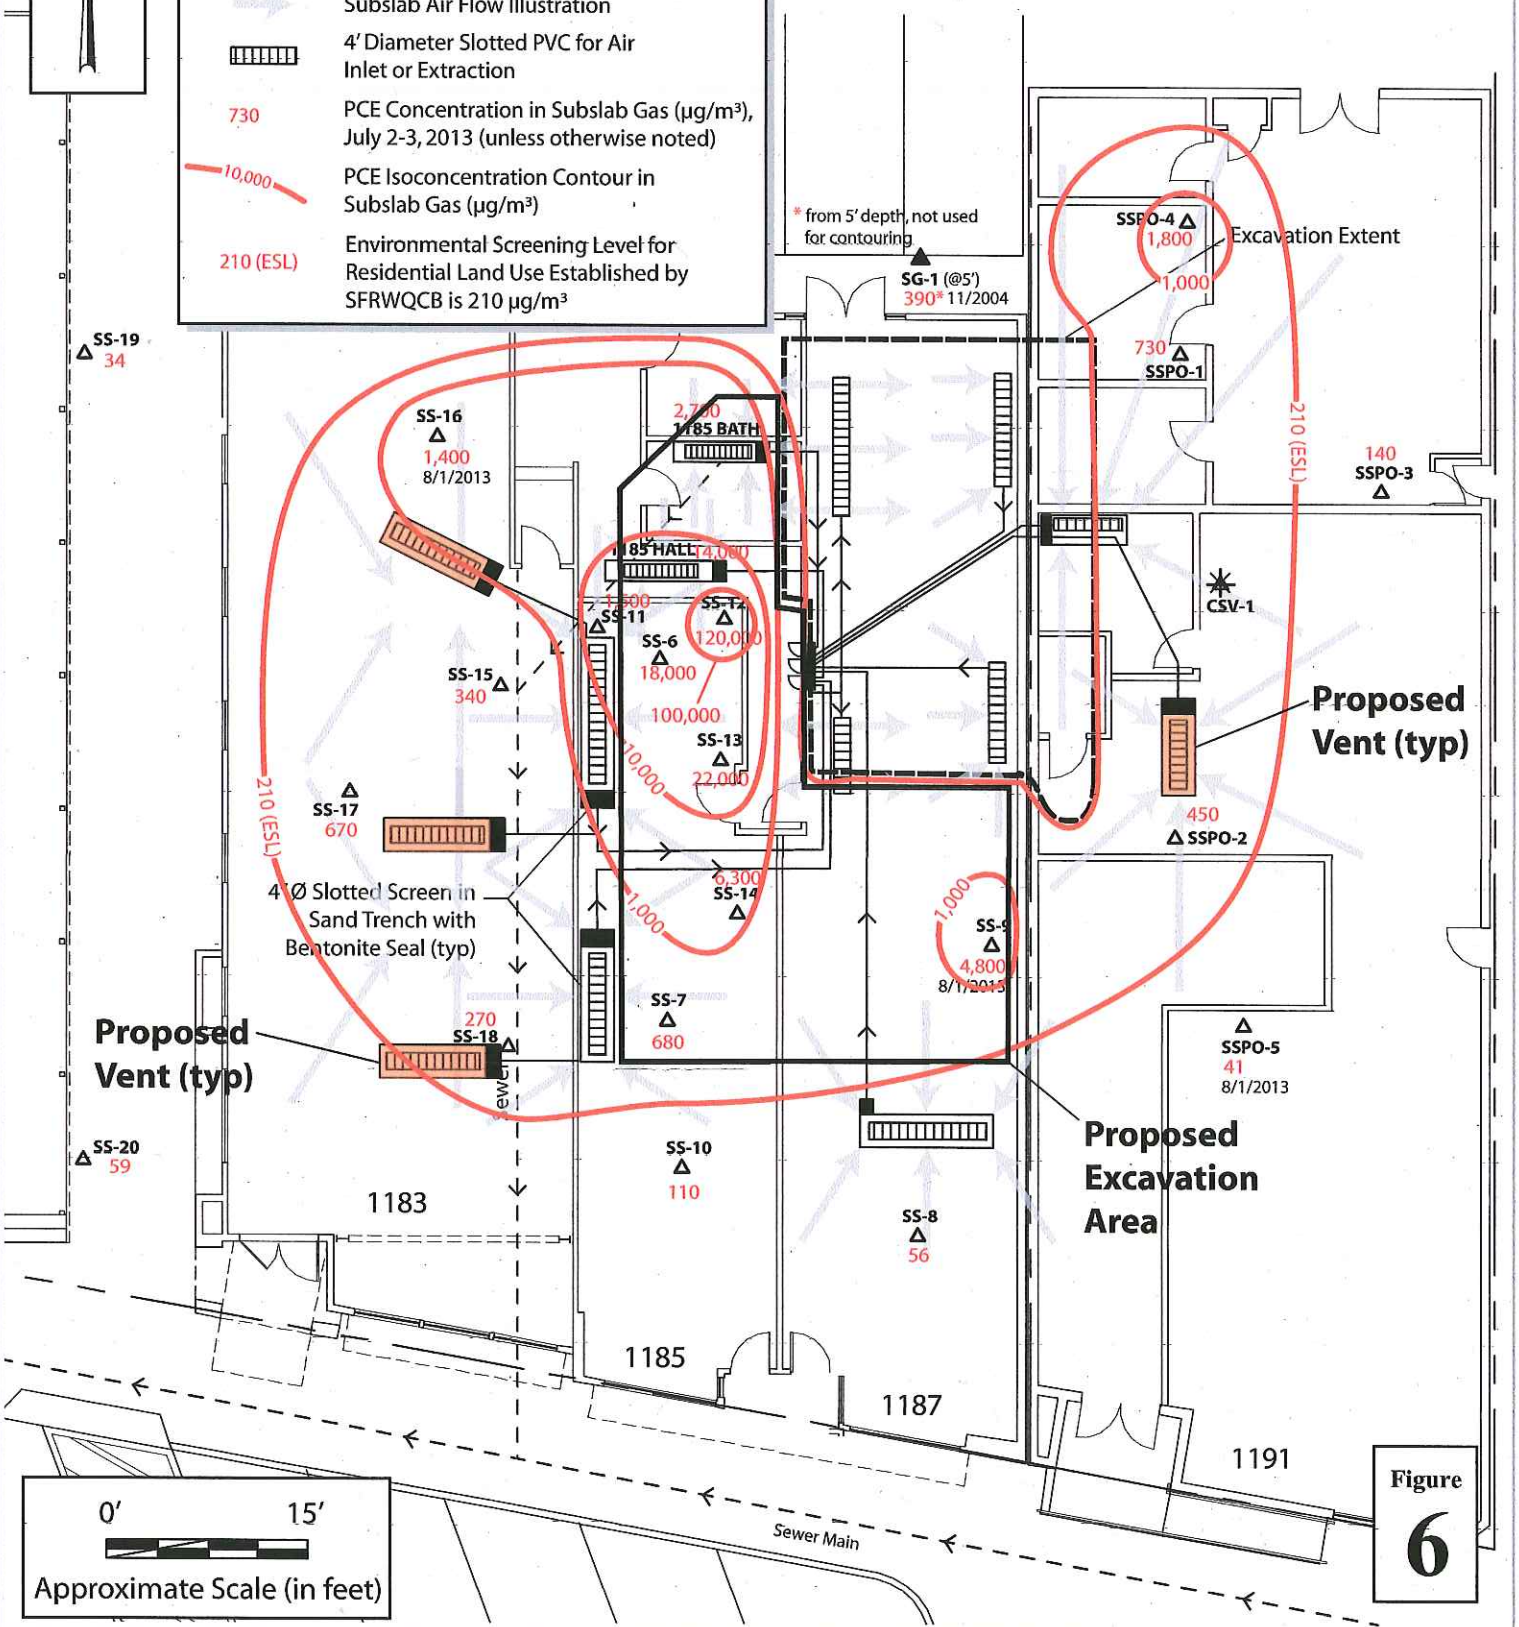
- SS-6 ▲ Subslab Soil Gas Probe Location
- CSV-1 ✱ Former Crawl Space Gas Probe Location
- SG-1 ▲ Soil Gas Probe Location
- Air Flow Direction in 2" Diameter PVC Pipe
- ⇨ Subslab Air Flow Illustration
- ▬ 4' Diameter Slotted PVC for Air Inlet or Extraction
- 730 PCE Concentration in Subslab Gas ( $\mu\text{g}/\text{m}^3$ ), July 2-3, 2013 (unless otherwise noted)
- 10,000 PCE Isoconcentration Contour in Subslab Gas ( $\mu\text{g}/\text{m}^3$ )
- 210 (ESL) Environmental Screening Level for Residential Land Use Established by SFRWQCB is  $210 \mu\text{g}/\text{m}^3$
