20 October 2006
Project 4068.01

Subject: Underground Storage Tank Removal
3,000-gallon Diesel Tank
Former Red Star Yeast Facility
1396 Fifth Street
Oakland, California

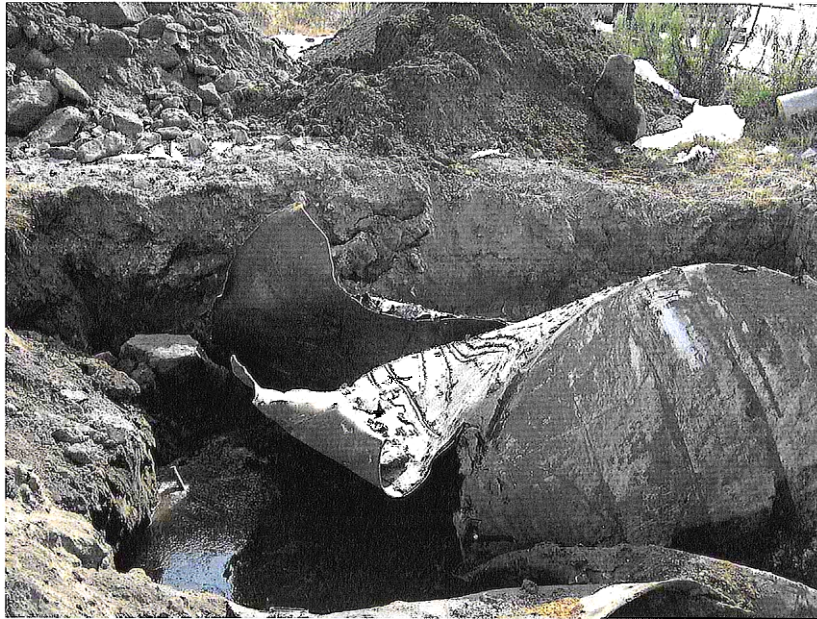
The tank consisted of single-wall steel construction and measured approximately 13 feet in length and 6.5 feet in diameter. The tank appeared to be in good condition with no visible evidence of any through-going pitting or containment failures. Photographs of the tank are presented on Photographs 1 through 3 (Appendix B). During removal of the tank, the concrete slurry material was removed from the tank. The tank was loaded onto a truck and transported to Ecology Control Industries (ECI), a certified tank destruction facility in Richmond, California. A copy of the hazardous waste manifest is provided in Appendix C.

Photograph 1 – Looking at cut opened 3,000-gallon tank and stockpiles of tank contents (concrete slurry) and excavated soil.

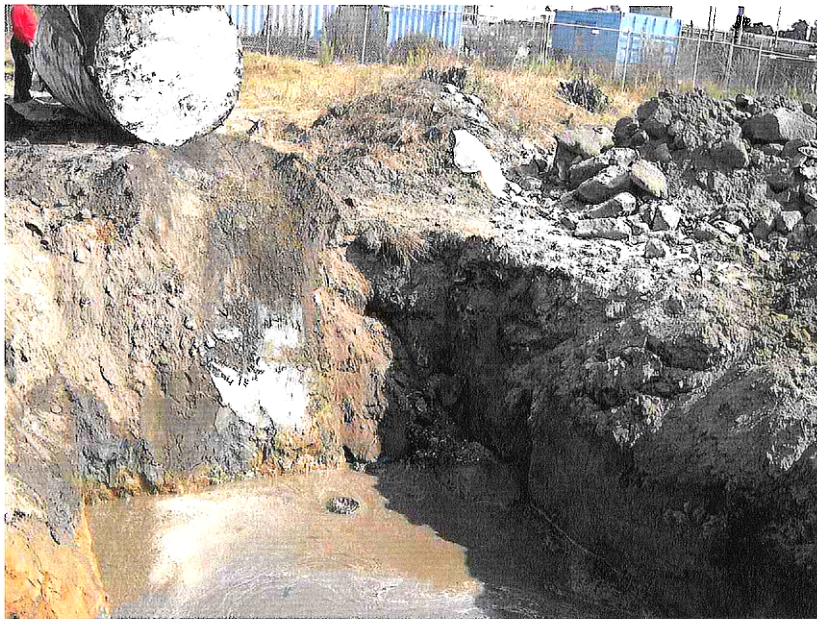
Apparent staining due to hydrocarbon contamination was encountered at the north end of the tank at the location of fill piping. Approximately 20 cubic yards of soil was excavated and placed on visqueen. A petroleum hydrocarbon sheen was observed on the groundwater surface within the excavation pit. Approximately 6,300 gallons of groundwater were pumped from the excavation pit in order to remove the potentially contaminated groundwater. The removed groundwater was pumped into a tanker truck by NRC Environmental Services and disposed of at Evergreen Oil, Inc. in Newark, California. A copy of the hazardous waste manifest is provided in Appendix B.

Photograph 2 – Looking at tank excavation pit with groundwater. Note discolored soil that was eventually overexcavated and removed.

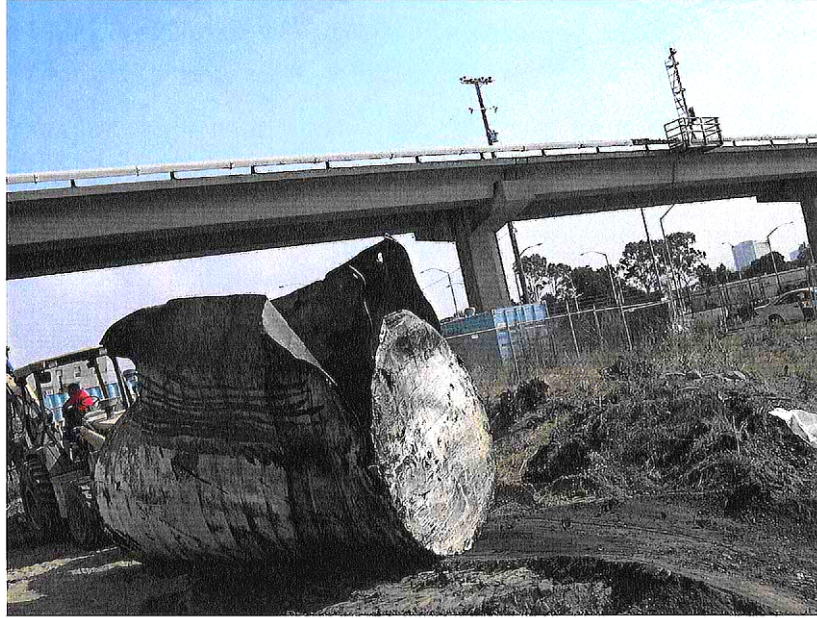
Photograph 3 – 3,000-gallon tank removed.
