UNDERGROUND FUEL STORAGE TANK- RELATED CORRECTIVE ACTION REPORT

**1001 77TH AVENUE
OAKLAND, CALIFORNIA**

**ACTS COMMUNITY DEVELOPMENT
OAKLAND, CALIFORNIA**

February 2006

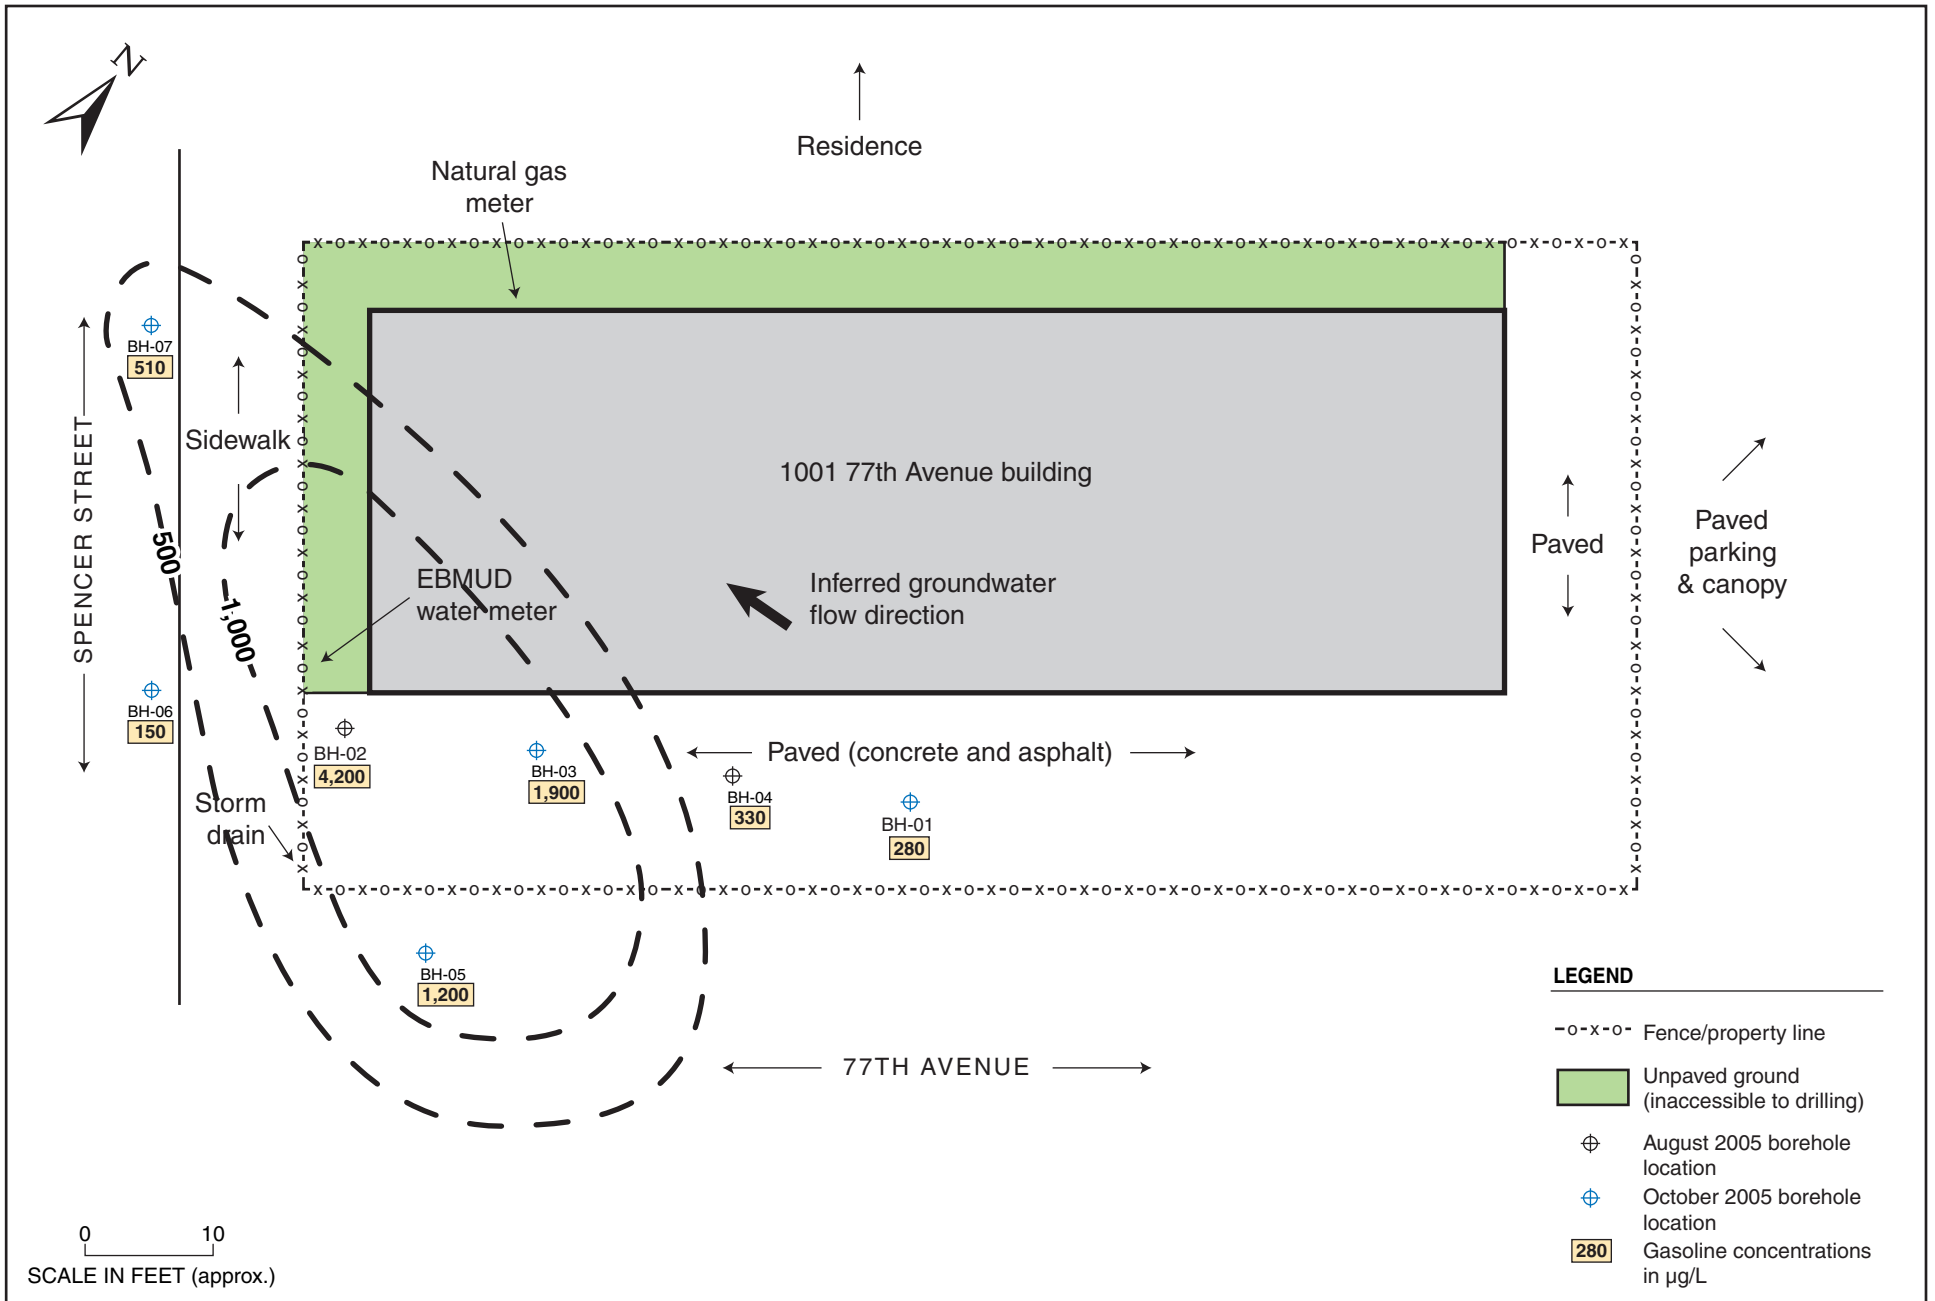
GASOLINE GROUNDWATER ANALYTICAL RESULTS

1001 77th Avenue, Oakland, CA

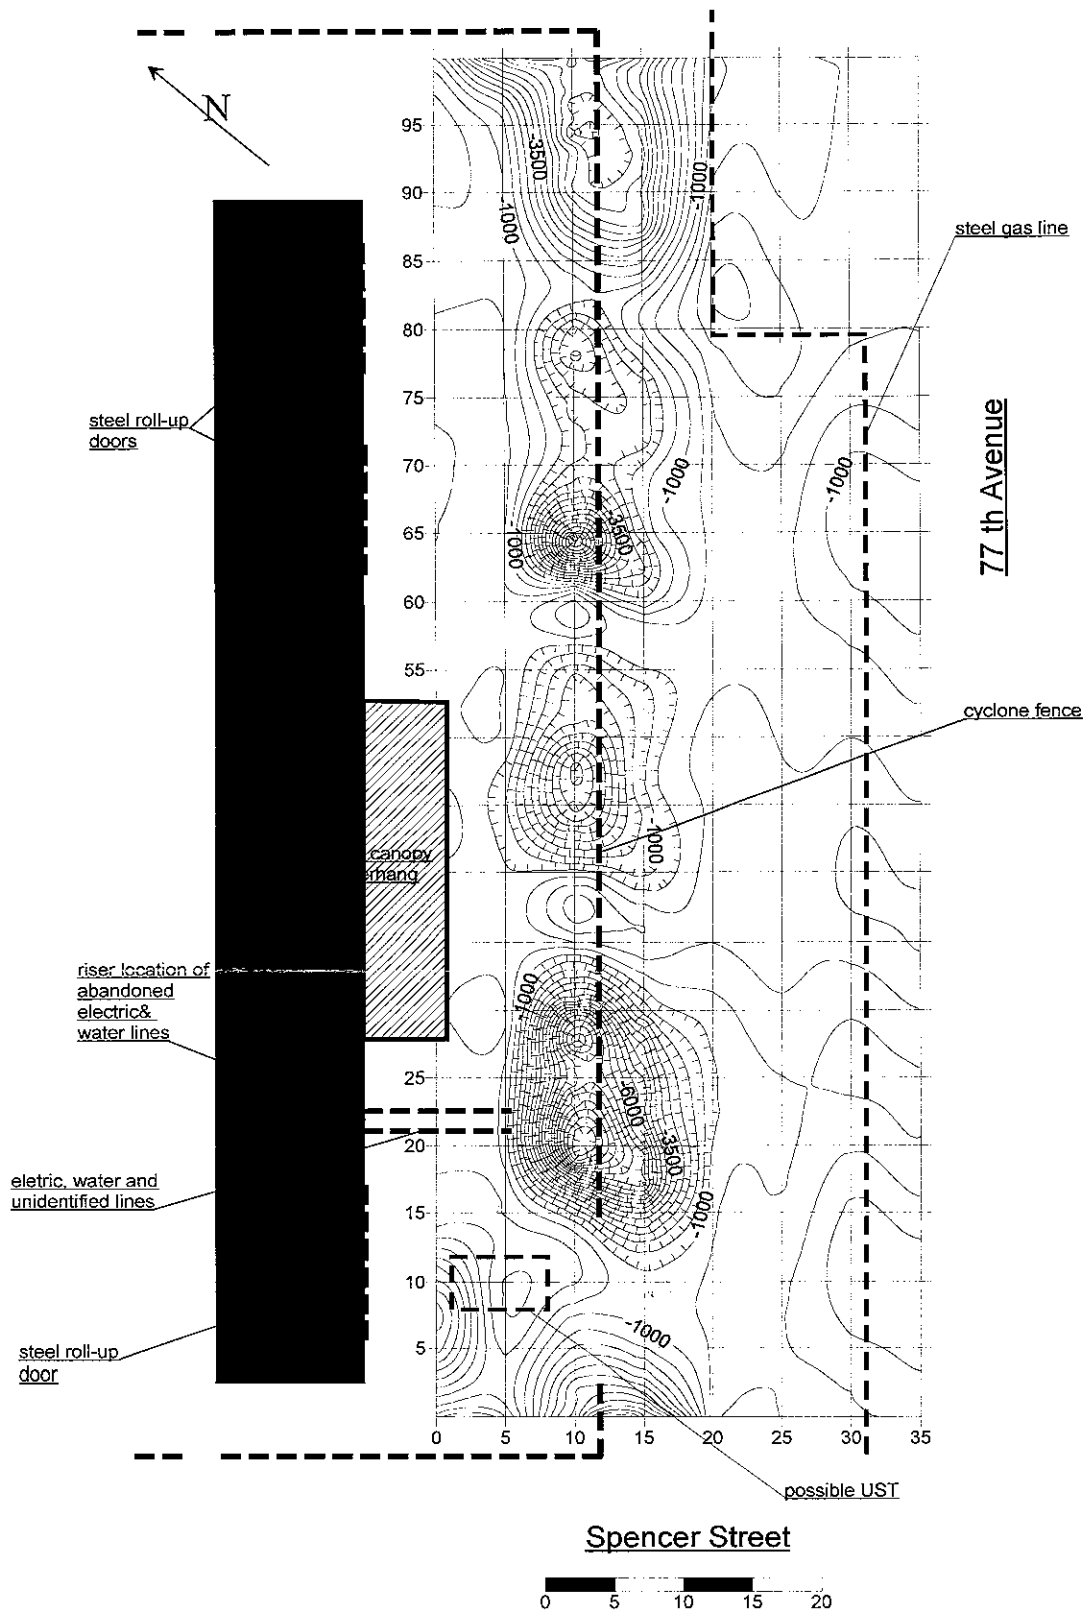
Figure 1

Contour Plot of Vertical Gradient Magnetometer Data
Site is 1001 77th Avenue
Sensor Height is 5' and 7' Above the Ground

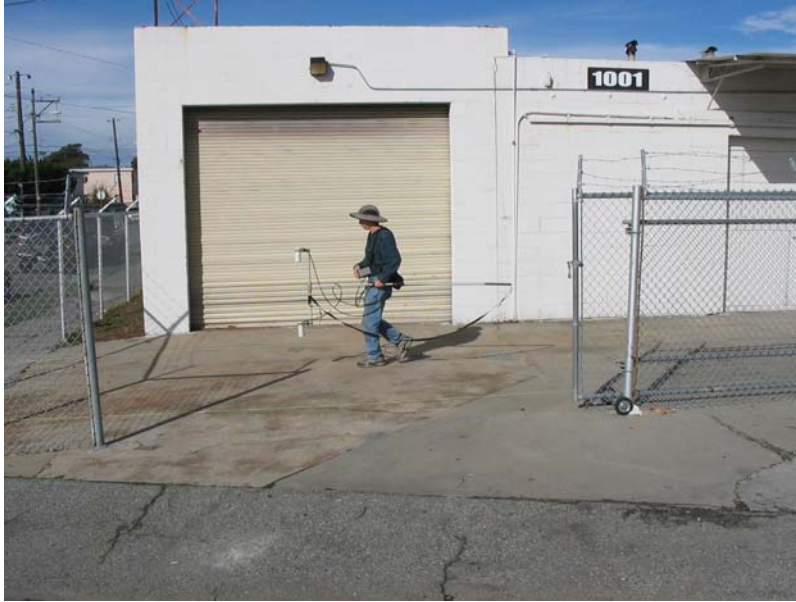
Photo No.: 01

Subject: Conducting geophysical survey, standing over area of metallic anomaly.

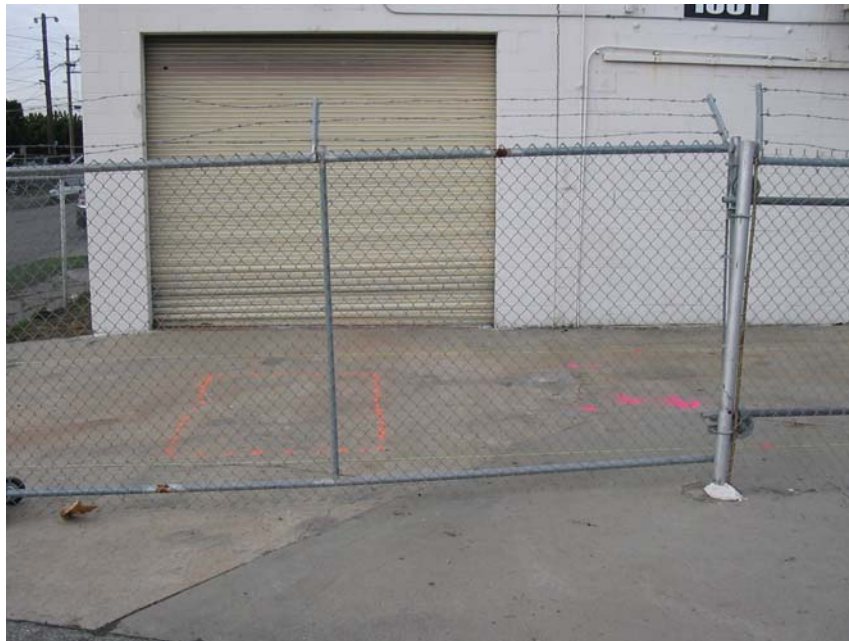
Photo No.: 02

Subject: Area of metallic anomaly (painted in orange dashes), and underground water/electrical lines (in pink).

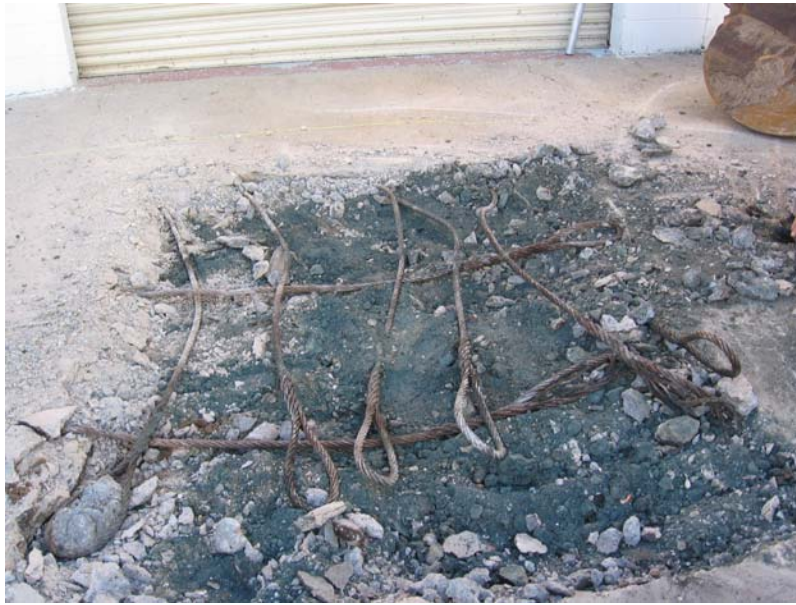
Photo No.: 03

Subject: Concrete cable mat in area of identified magnetic anomaly.

On January 9, 2006, the concrete overlying the metallic anomaly was removed, which exposed a grid of 1-inch steel cables that were apparently used as reinforcement for the concrete. Soils were then excavated with a backhoe to a depth of approximately 11 feet below grade. No UST or UST-related backfill was encountered in the area of the magnetic anomaly; however, soil contamination was evident in the east and south sidewalls, and the sidewalls were therefore extended to the east and south. After the target depth of 10 feet bgs was reached, moisture was noted in the base of the excavation; however, groundwater was not infiltrating the excavation at that time.

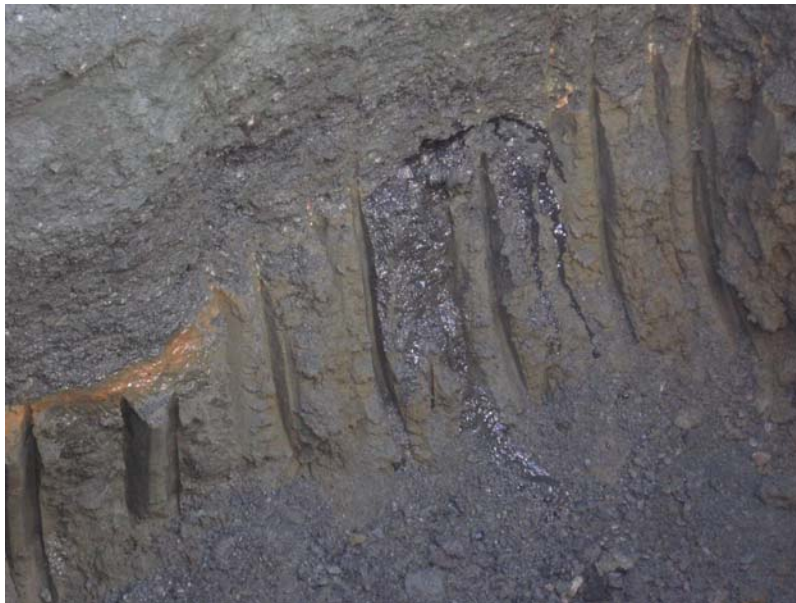
Photo No.: 04

Subject: Contaminated groundwater seeping into excavation from within sandy/gravelly lens, south excavation sidewall, depth approximately 8 feet bgs.

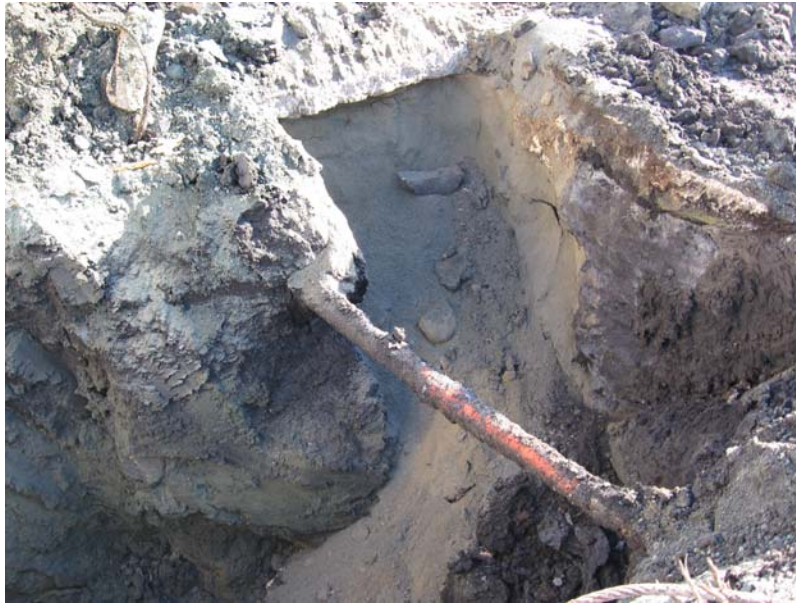
Photo No.: 05

Subject: Looking southeast, former UST excavation backfill material (tan sand), also shows abandoned natural gas line.

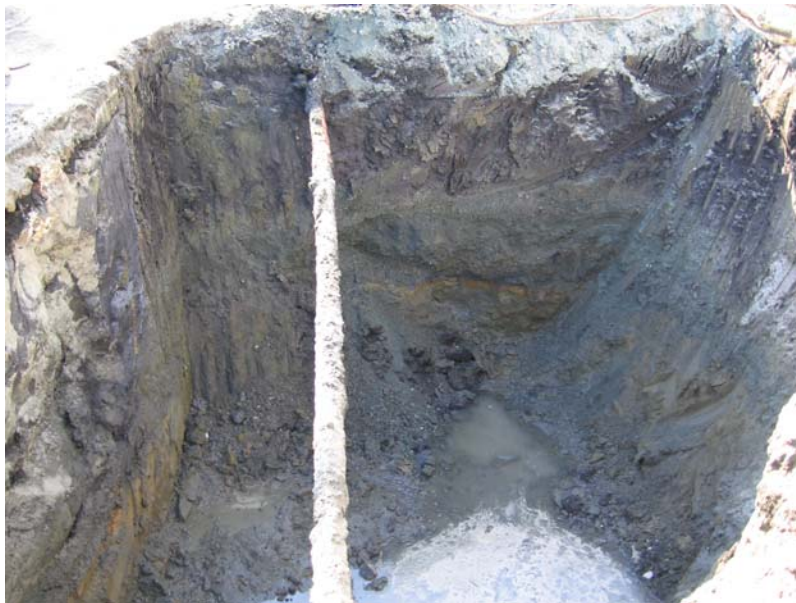
Photo No.: 06

Subject: Looking west, excavation at final depth, groundwater has begun to fill bottom of excavation.

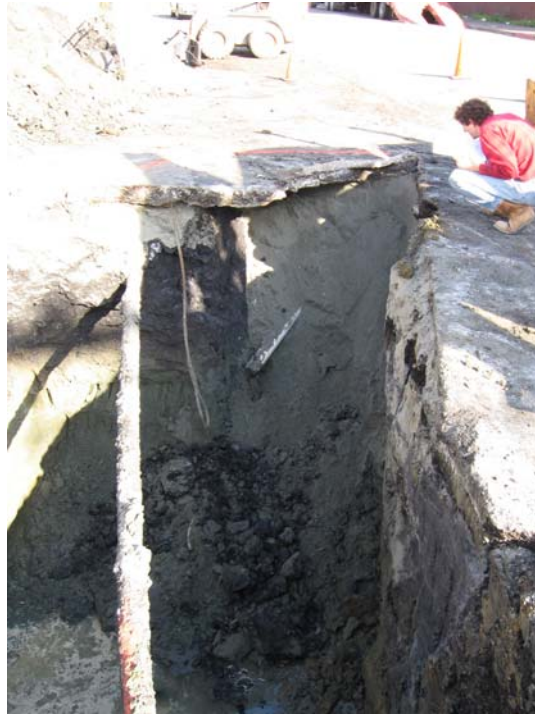
Photo No.: 07

Subject: Looking east at former UST excavation backfill material, showing former UST parts in the backfill material.

At the extreme southeast corner of the excavation, we encountered an apparent former UST excavation: an approximately 4-foot wide by 8-foot deep area of well-sorted sand fill material. In this sand backfill, we found a displaced steel dispenser riser pipe and a concrete-filled metal traffic bollard. These items were clearly not in-place, and had apparently been thrown into the former UST excavation during backfilling. We excavated approximately 4 feet into the backfill material and confirmed that no UST was present; we then halted excavation due to the public right-of-way constraint. The excavation appeared to extend to the southeast (toward 77th Avenue), but its limits were not determined.

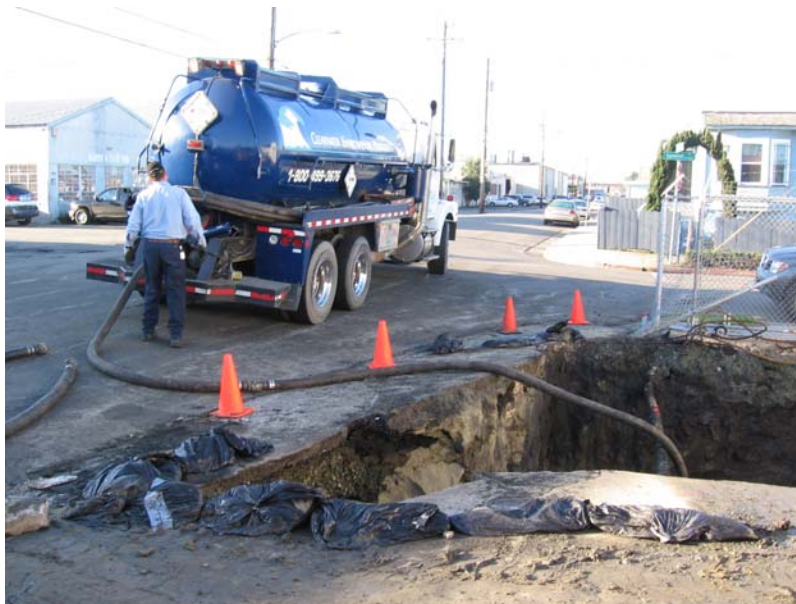
Photo No.: 08

Subject: Pumping contaminated groundwater from the excavation.

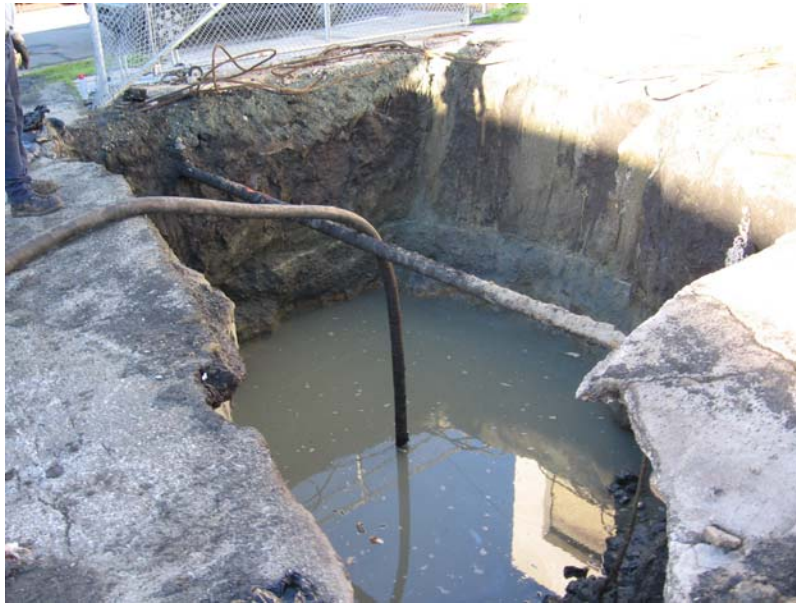
Photo No.: 09

Subject: Pumping contaminated groundwater from the excavation.

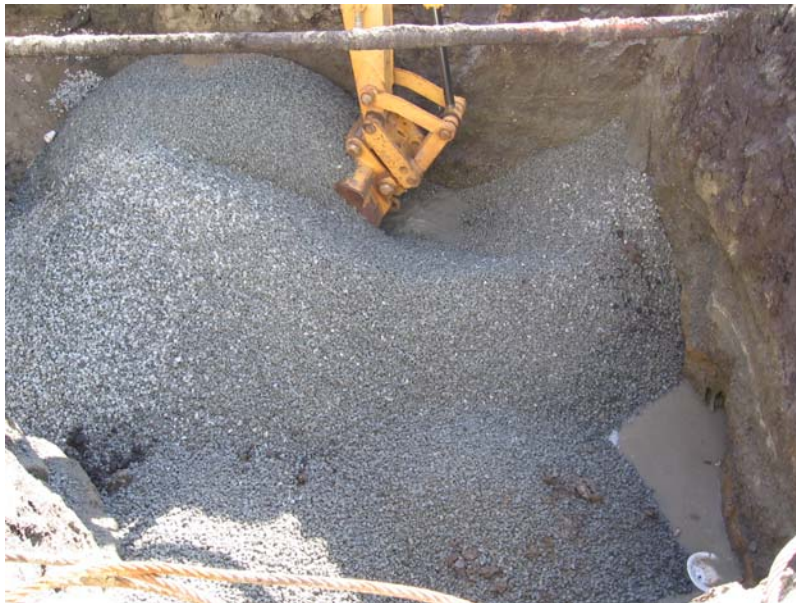
Photo No.: 10

Subject: Emplacing drain rock to bridge the groundwater in the base of the excavation.

Backfilling was conducted on January 20, 2006, immediately following removal of contaminated groundwater. Drain rock was emplaced in the base of the excavation (to bridge the groundwater), and the remainder of the excavation was backfilled with clean imported fill. The excavation was backfilled in approximately 1-foot lifts, and each lift was compacted with a whacker-type packer. The excavation was resurfaced with asphalt by Jim's Quality Paving on January 24, 2006. The site fencing will be returned to permanent condition in the near future.

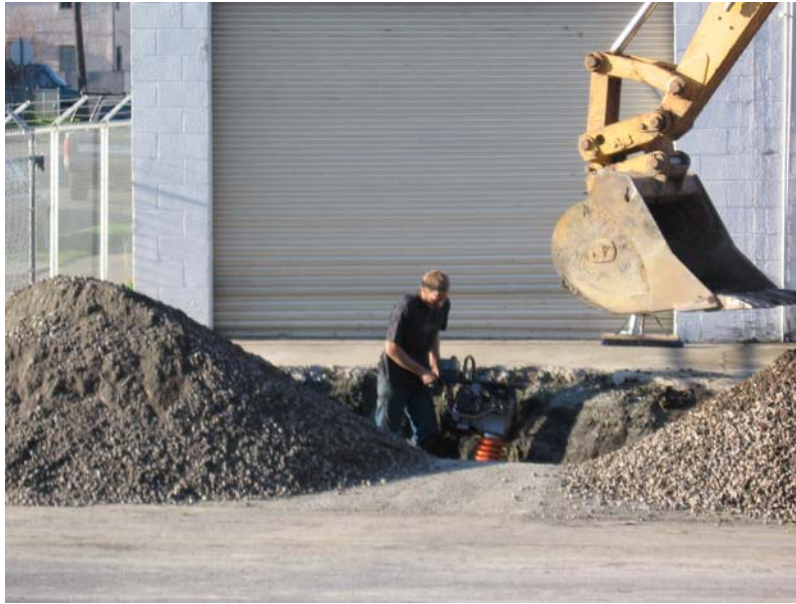
Photo No.: 11

Subject: Compacting excavation backfill material.

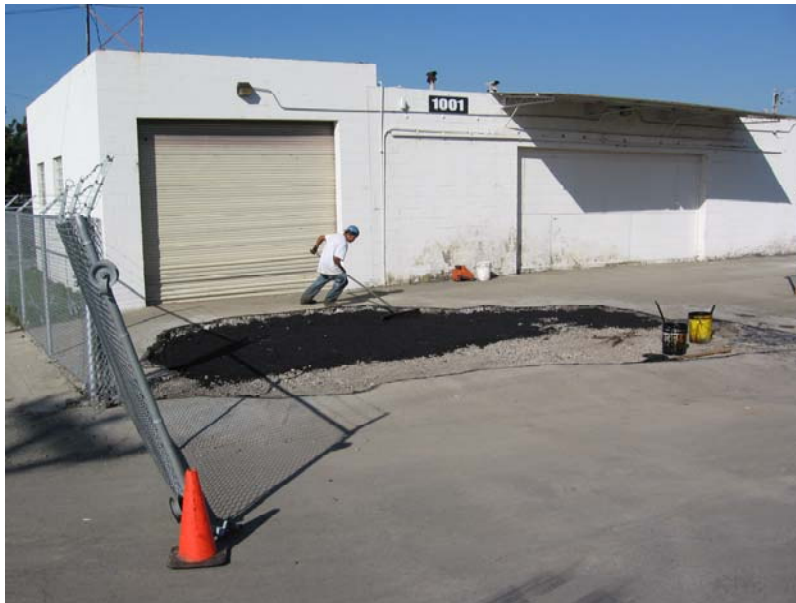
Subject: Excavation fully backfilled, prepping for asphalt resurfacing.

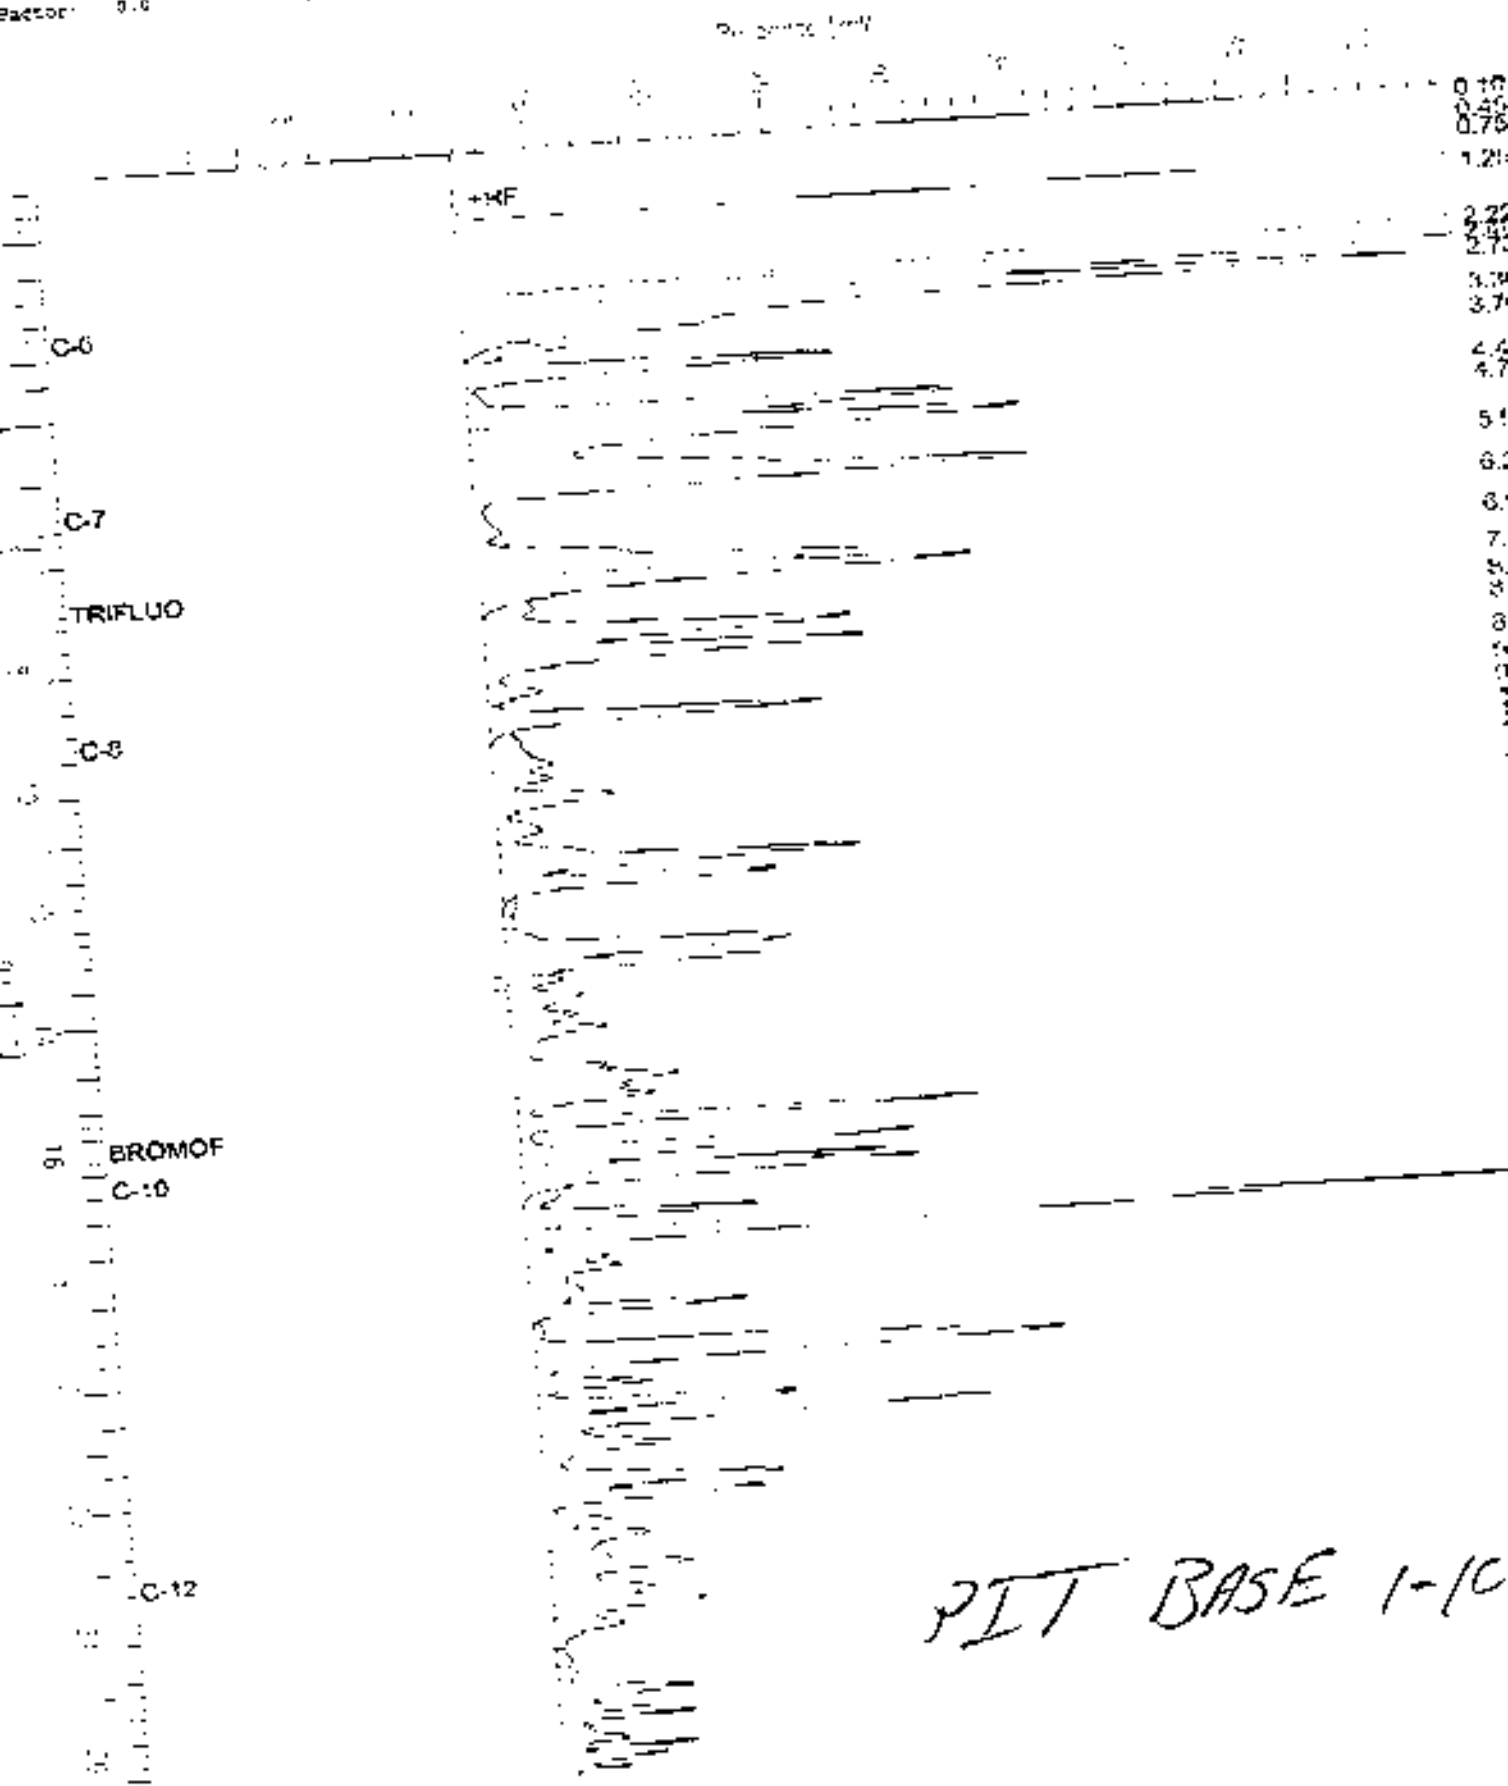
GC19 TVH 'X' Data File (FID)

Sample Name : 184212-002,109355
 FileName : C:\GC19\DATA\10\GC19.raw
 Method : TVHBTXZ
 Start Time : 9.00 min
 Scale Factor : 1.0

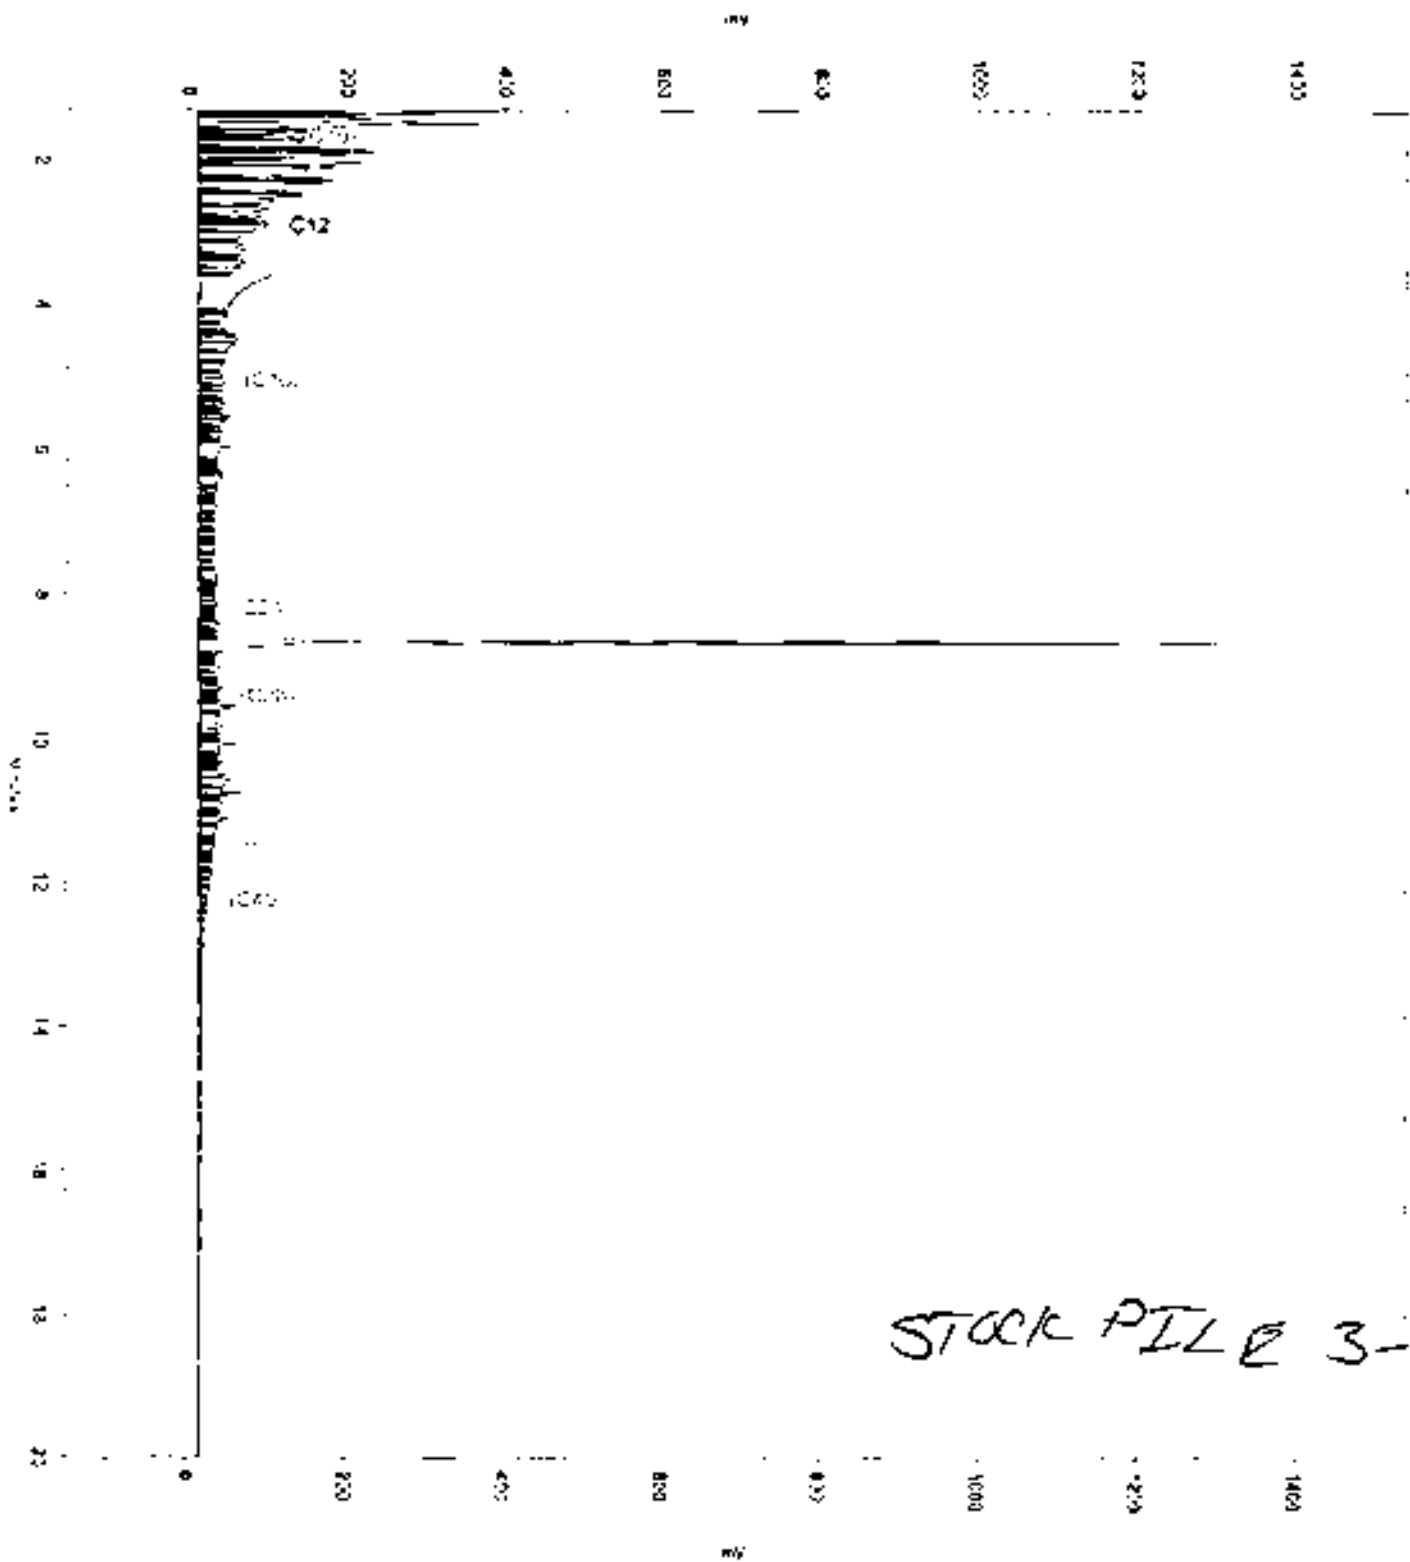
Sample Name: 184212-009,109132
Data File: TLims\gdw\exchrom\Projects\GC15B\Data\0100077
Sequence File: TLims\gdw\exchrom\Projects\GC15B\Sequence\010.seq
Software Version: 3.1.7
Method Name: GLims\gdw\exchrom\Projects\GC15B\Method\02005.met
Run Date: 1/11/2008 10:49:04 PM
Analysis Date: 1/12/2008 9:50:31 AM
Instrument: GC15B (Offline) Vial: 77 Operator: Teh Z. analyst (lms2k3@h2)
Sample Amount: 1
