September 6, 2005

Subject: Report of Findings for Limited Phase II Investigation
at 1001 77th Avenue, Oakland, California

Stellar Environmental Solutions, Inc. (SES) is pleased to submit this report of findings for the recent limited Phase II Investigation at the referenced site. The work was conducted in accordance with our July 26, 2005 proposal. We understand that Acts Community Development (the current property owner) is considering selling the property, and the potential buyer requested that this investigation be conducted.

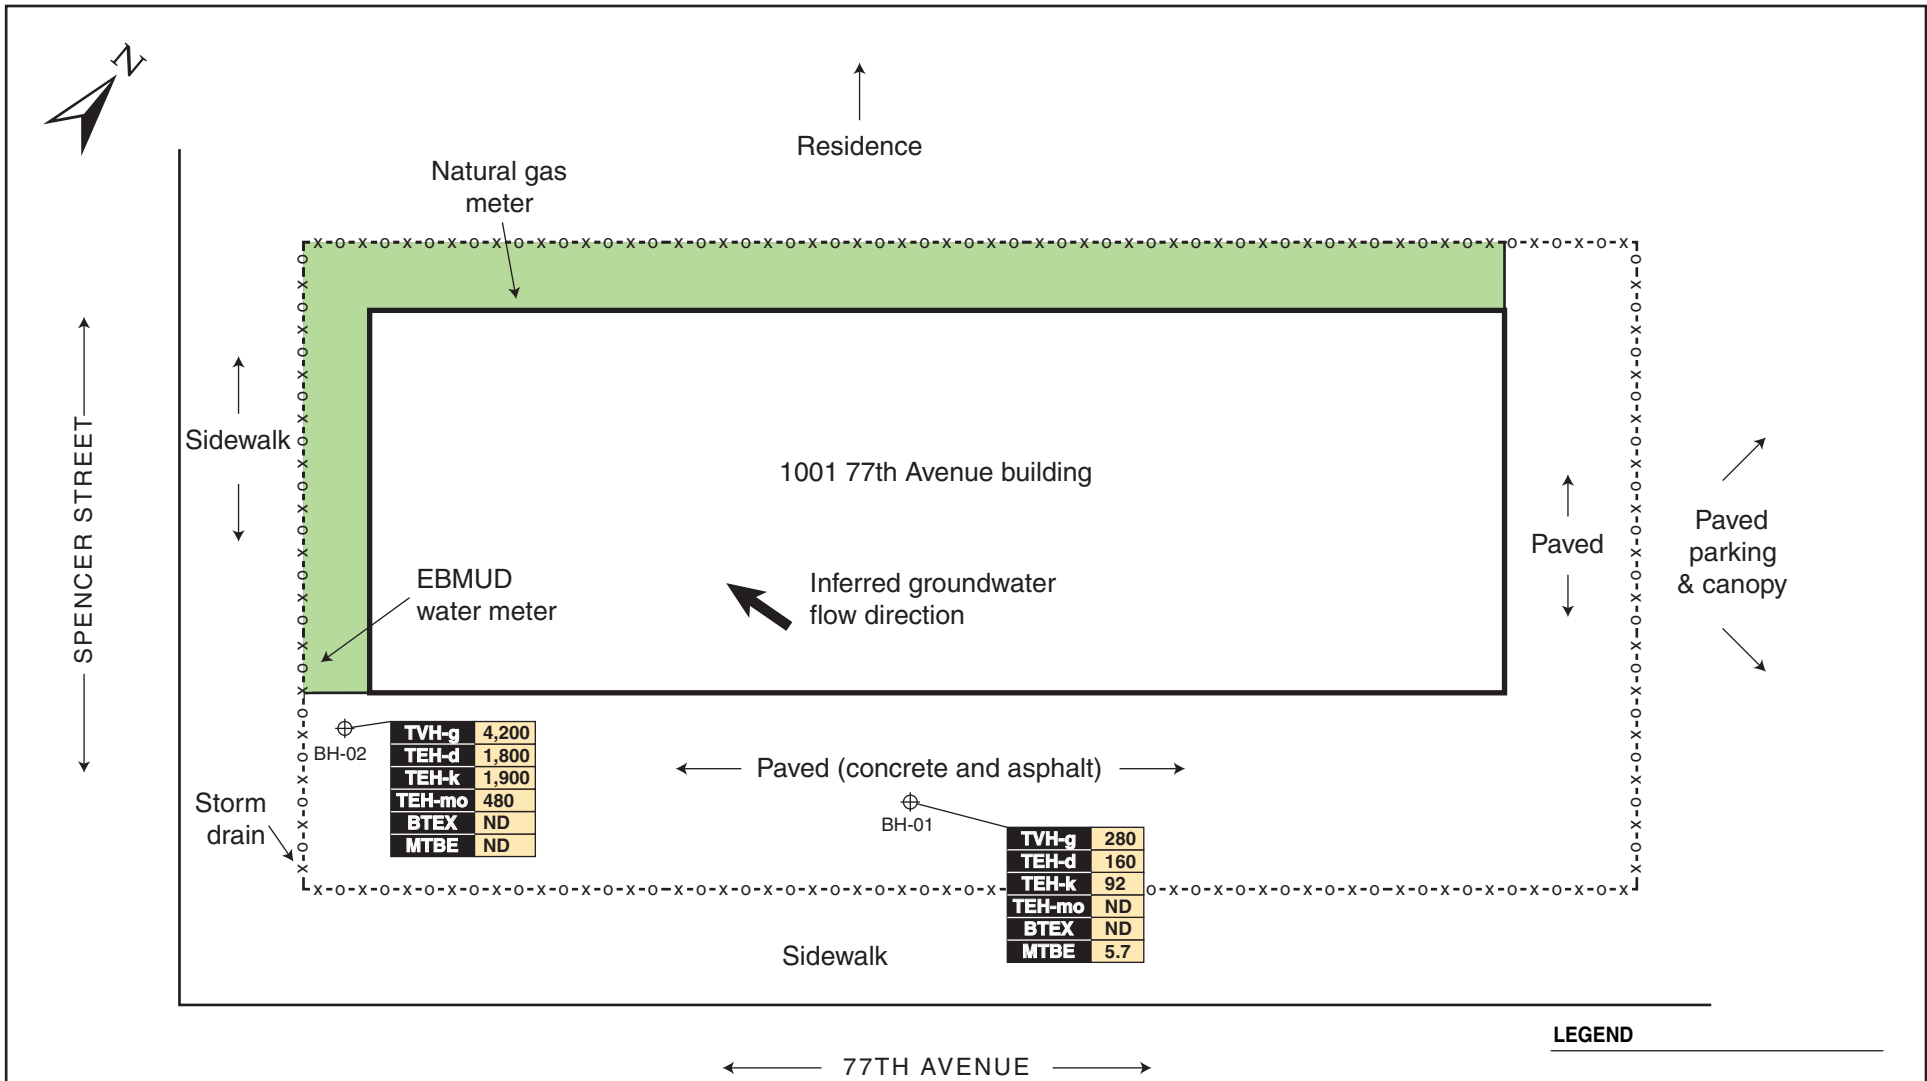
2005-51-02

If a UFST is/was present, it almost certainly was located on the subject property itself (i.e., not in the sidewalks or street), on the exterior of the building. The most likely location for the UFST would be the historically (and currently) open, paved area in front of the building. There is insufficient space on the north and west sides for installation of a UFST. Local groundwater flow direction is likely to the west (toward San Francisco Bay) following local topography. Therefore, the western edge of the subject property is the area most likely to show site-sourced contamination that migrates downgradient in groundwater. Due to site access constraints, the majority of the western portion of the subject property was inaccessible to drilling. We therefore located the two boreholes as follows (locations shown on Figure 2):

- **BH-01.** Located in the approximate east-west center of the property, in the center of the exterior paved area.
- **BH-02.** Located at the most downgradient possible location, on the western property line immediately adjacent to the building.

sleeves. Figure 2 shows the borehole locations. Attachment C contains photodocumentation of the drilling activities.

- The groundwater contamination identified suggests a likely source area in the soil somewhere between BH-01 and BH-02, and warrants further investigation to delineate the extent of contamination onsite and offsite from the subject property.

- Contamination detected in groundwater samples are indicative of a UFST release.
- SES proposes to conduct a second phase of drilling to further delineate the onsite source and offsite extent of hydrocarbon contamination. We propose the drilling of five exploratory boreholes—two boreholes to be located between the locations of BH-01 and BH-02, a third to be located immediately southeast of BH-02, and the fourth and fifth boreholes to be located in Spencer Street.

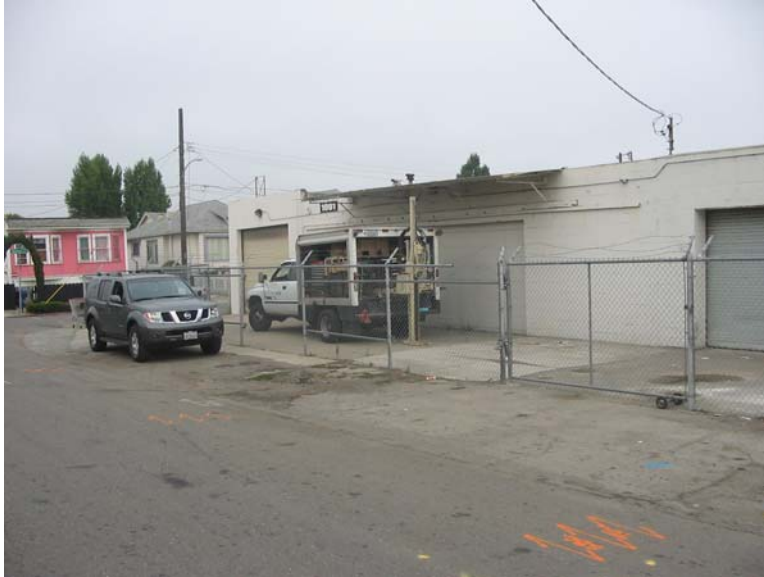
Photo No.: 01

Subject: View west, across 77th Avenue, of drill rig set up at drilling location BH-01.

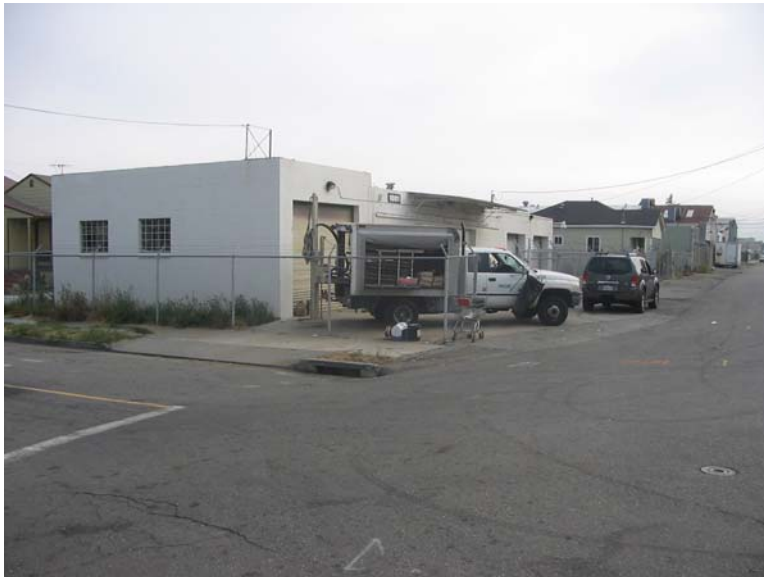
Subject: View northeast, across Spencer Street, of drill rig set up at drilling location BH-02.
