Project No.
7828.000.001

Subject: Jordan Ranch Property (Case # R00002918)
Dublin, California

ADDENDUM TO SOIL AND GROUNDWATER REMEDIATION STATUS REPORT

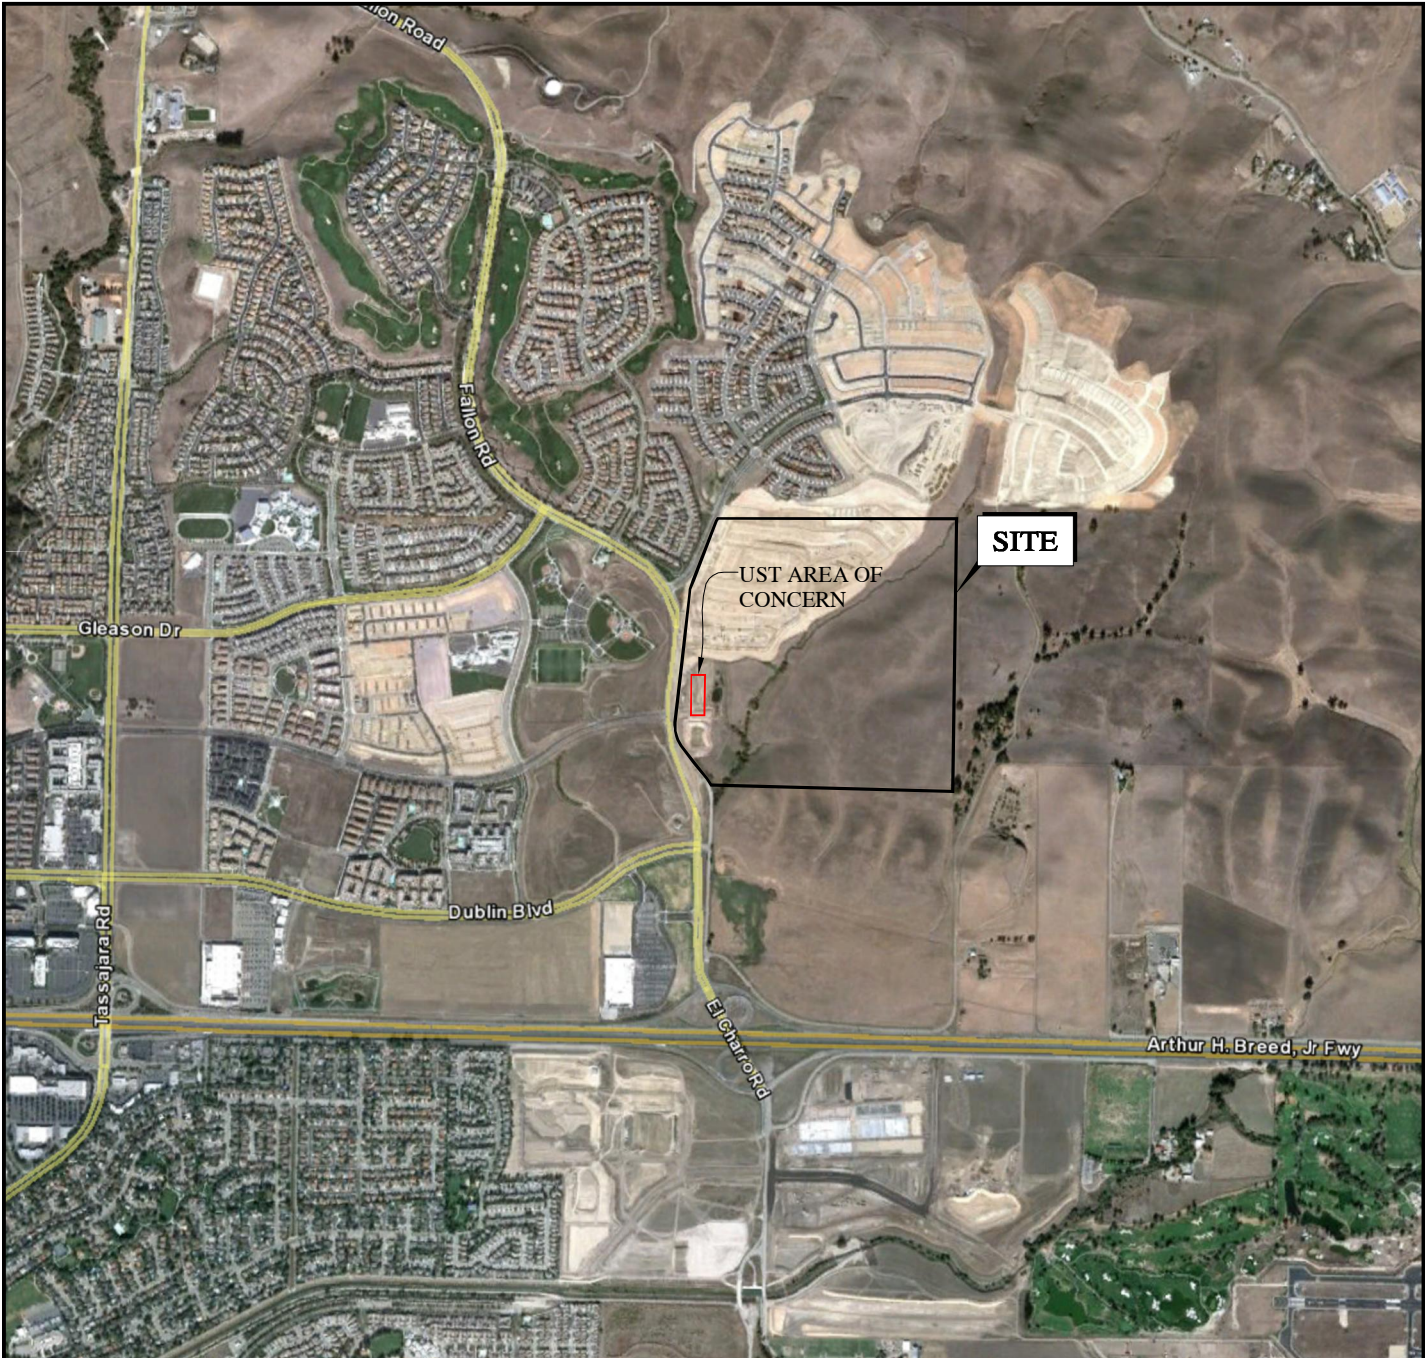
Figure 4 – Excavation Photograph

We have revised the Figures (attached) to provide additional excavation details and photo documentation. Figure 2 lists the latitude and longitude of the lateral excavation limits, depicts the distance from the excavation to the site boundaries, and shows the location of product lines encountered during the excavation. Figure 3 provides a vertical profile of the excavation, and depicts the locations of excavation confirmation samples, soil staining, and the depth to the water table. A detailed discussion of the excavation observations and activities is provided in the remediation status report.
