Project No.  
**7828.000.001**

December 9, 2014

Subject: Jordan Ranch – Parcel H (Case # R00002918)  
Dublin, California

### **STOCKPILE REUSE PLAN AND REPORTING**

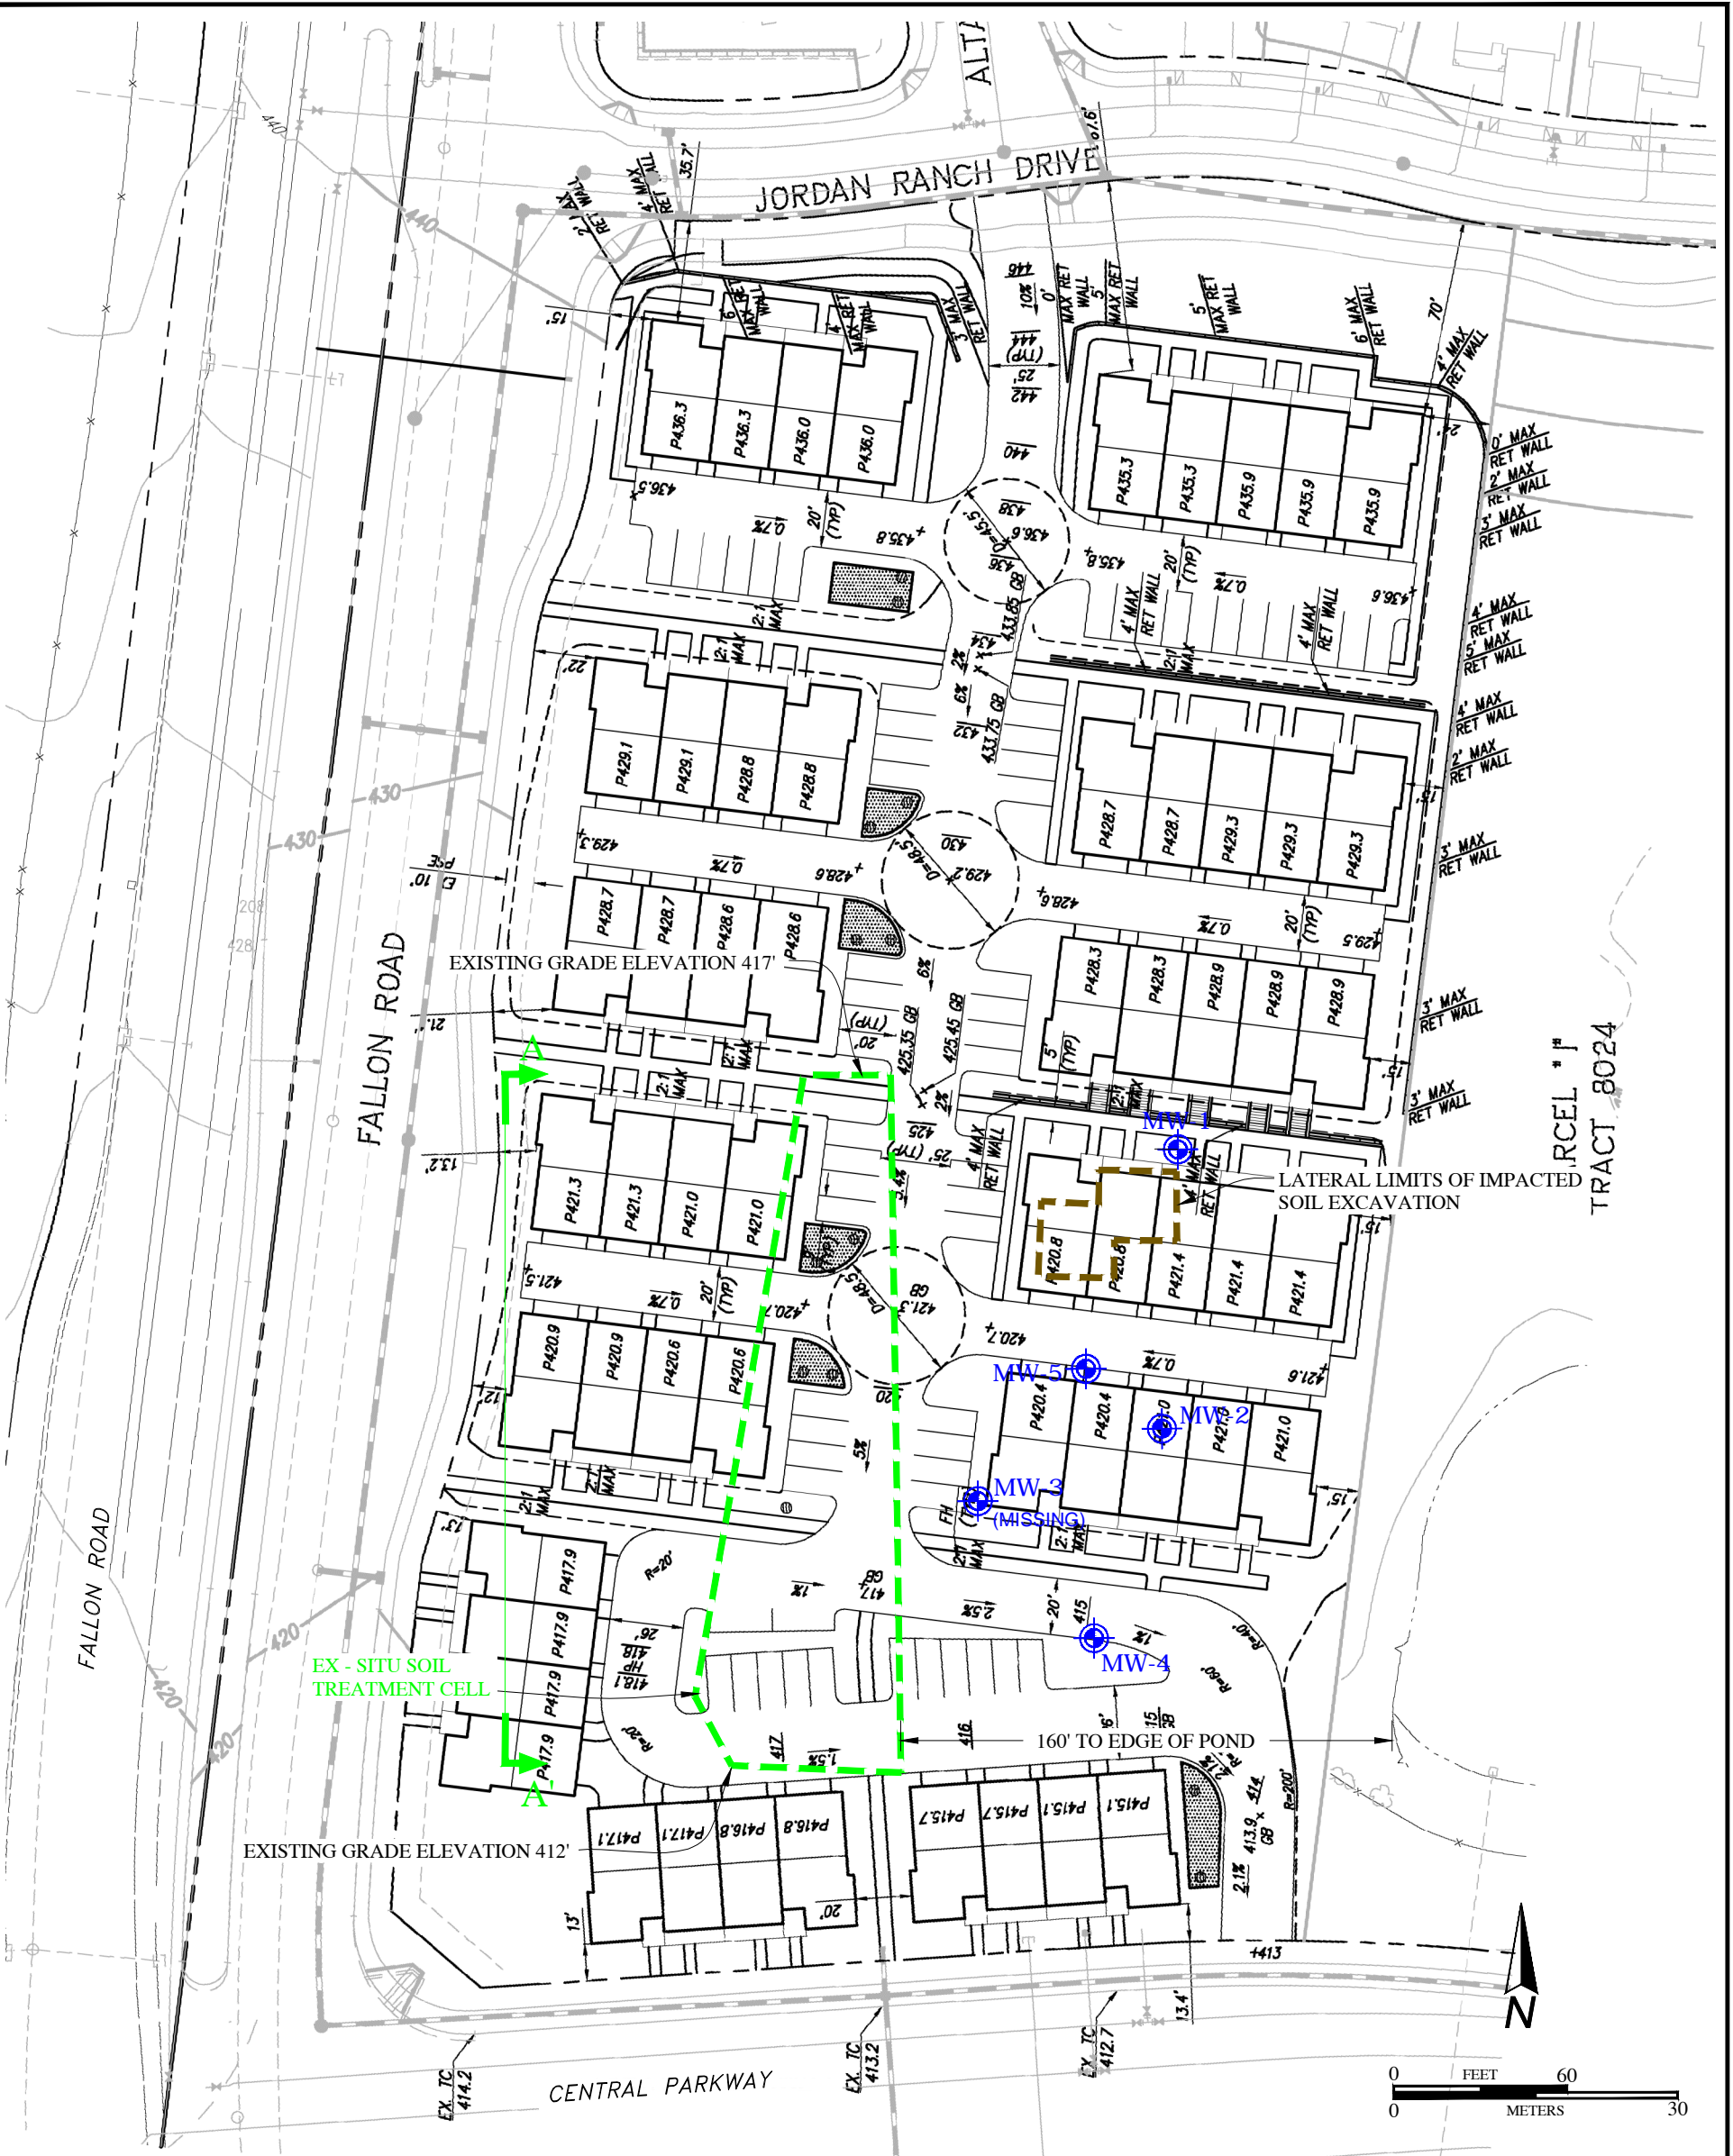
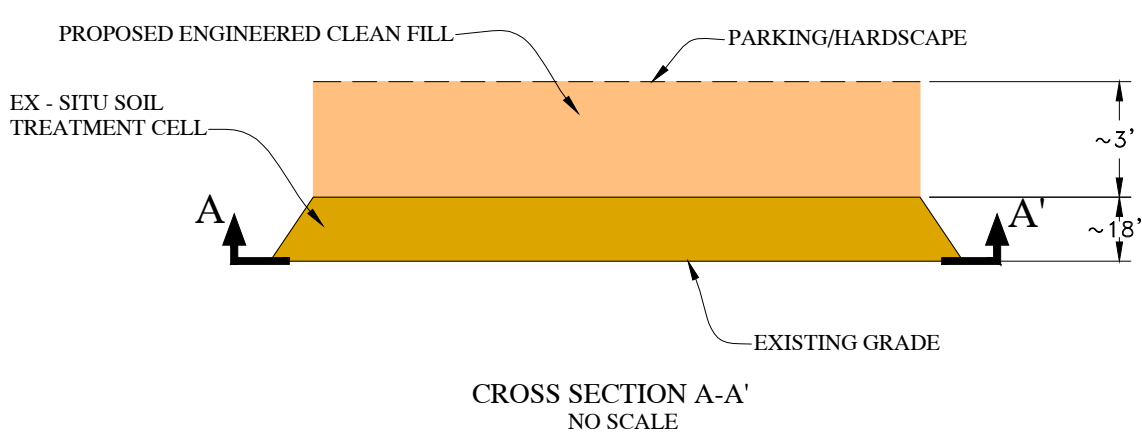
FIGURE NO.  
**2**

Comment 2: The attached Figure 2 – Proposed Soil Reuse Plan Profile depicts the current development plan and final location of the treated stockpile in plan view and cross section view. As shown on Figure 2, the stockpile is located greater than 100 west of the pond. The proposed final grade elevations shown on the development plan confirm approximately 3-5 feet of clean fill capped with parking space/hardscape is to be placed above the existing stockpile elevation. The proposed residential development will not have pools or substantial side yards. The shallowest groundwater encountered during drilling at the site was at 10 feet below existing grade, therefore the stockpile location meets the 5 foot separation from groundwater criteria. The stockpile is currently protected by stormwater BMPs as part of the active SWPPP program at Jordan Ranch.

**PROPOSED SOIL RE-USE PLAN PROFILE**  
JORDAN RANCH PARCEL A  
DUBLIN, CALIFORNIA
