**PHASE I ENVIRONMENTAL
ASSESSMENT
Markus Supply Ace Hardware
Assessor's Parcel Number 001-0125-001
Oakland, California**

March 3, 2006

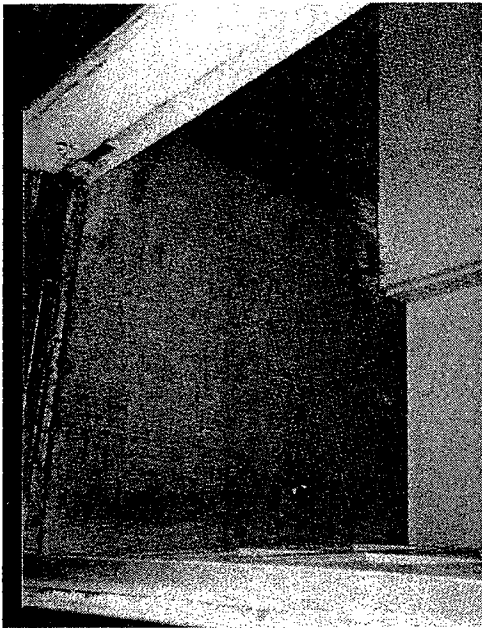
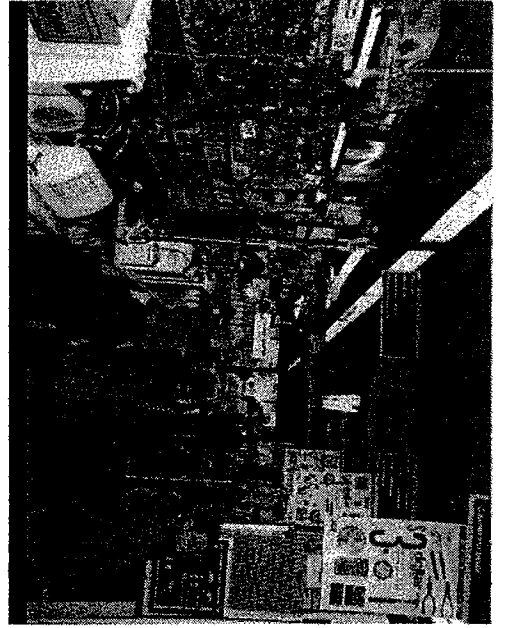
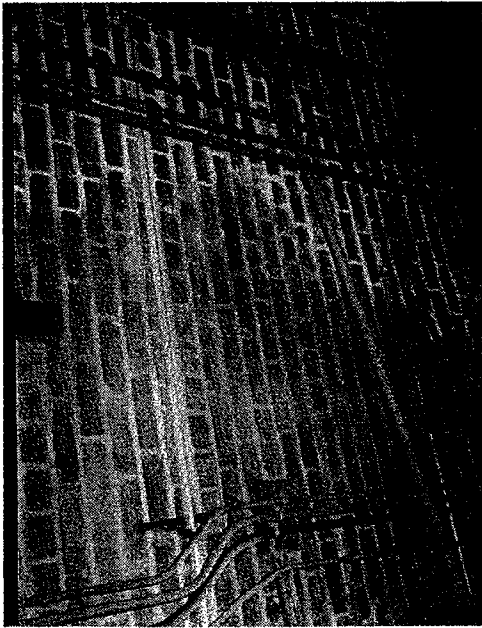
3 – Brick building exterior on 2 nd Street. Note red colored UST vent pipe (Tank #1) in center of photo, extending the top of the building. Also the seismic upgrades are visible in the photo.	6 – Shark Bite Recording Studio at 634 2 nd Street completely renovated all surfaces, including re-poured cement floor.	9 – Serendipity Candy Store and chocolate factory at 638 2 nd Street has a sealed concrete floor with newly painted walls and 2' X 4' drop ceiling. Bathrooms were new.
2 – View of brick building exterior on 2 nd Street. Note silver colored UST vent (Tank #2) pipe in center of photo, extending above the top of the building.	5 – View nearby Subject Property, toward Cost Plus building (right side of photo), looking east-southeast from southwest corner of the property.	8 – Utility closet with cinderblock interior wall.
1 – View of 2 nd Street brick building exterior. Note black-gray colored UST vent pipe (Tank #3) to the right of the door and left of the rain gutter.	4 – View of the adjacent property, PG&E yard (south-southwest)	7 – Currently a utility closet along 2 nd Street. Photo shows three cut pipes (one near pen). The pipes are approximately 1-inch in diameter and may be pipes from the former fuel pump island. The pump island and above grade piping may have been removed by a former tenant or owner.

Note: All three underground storage tank vent pipes are different, suggesting separate and distinct installation dates and vendors. Only three vent pipes were noted. Fuel tanks have vent pipes. Waste oil tanks typically do not have vent pipes.
