**Closure Plan for Area of Concern #8  
Former Hanson Aggregates Radium Facility  
3000 Busch Road, Pleasanton, California  
(ACEH Case RO0002952 and  
Geotracker ID SL0600101555)**

**July 10, 2009  
001-09567-08**

Prepared for:  
Lehigh Hanson West Region  
12667 Alcosta Boulevard, Suite 400  
San Ramon, California 94583

Prepared by:  
LFR Inc., an ARCADIS Company  
1900 Powell Street, 12th Floor  
Emeryville, California 94608

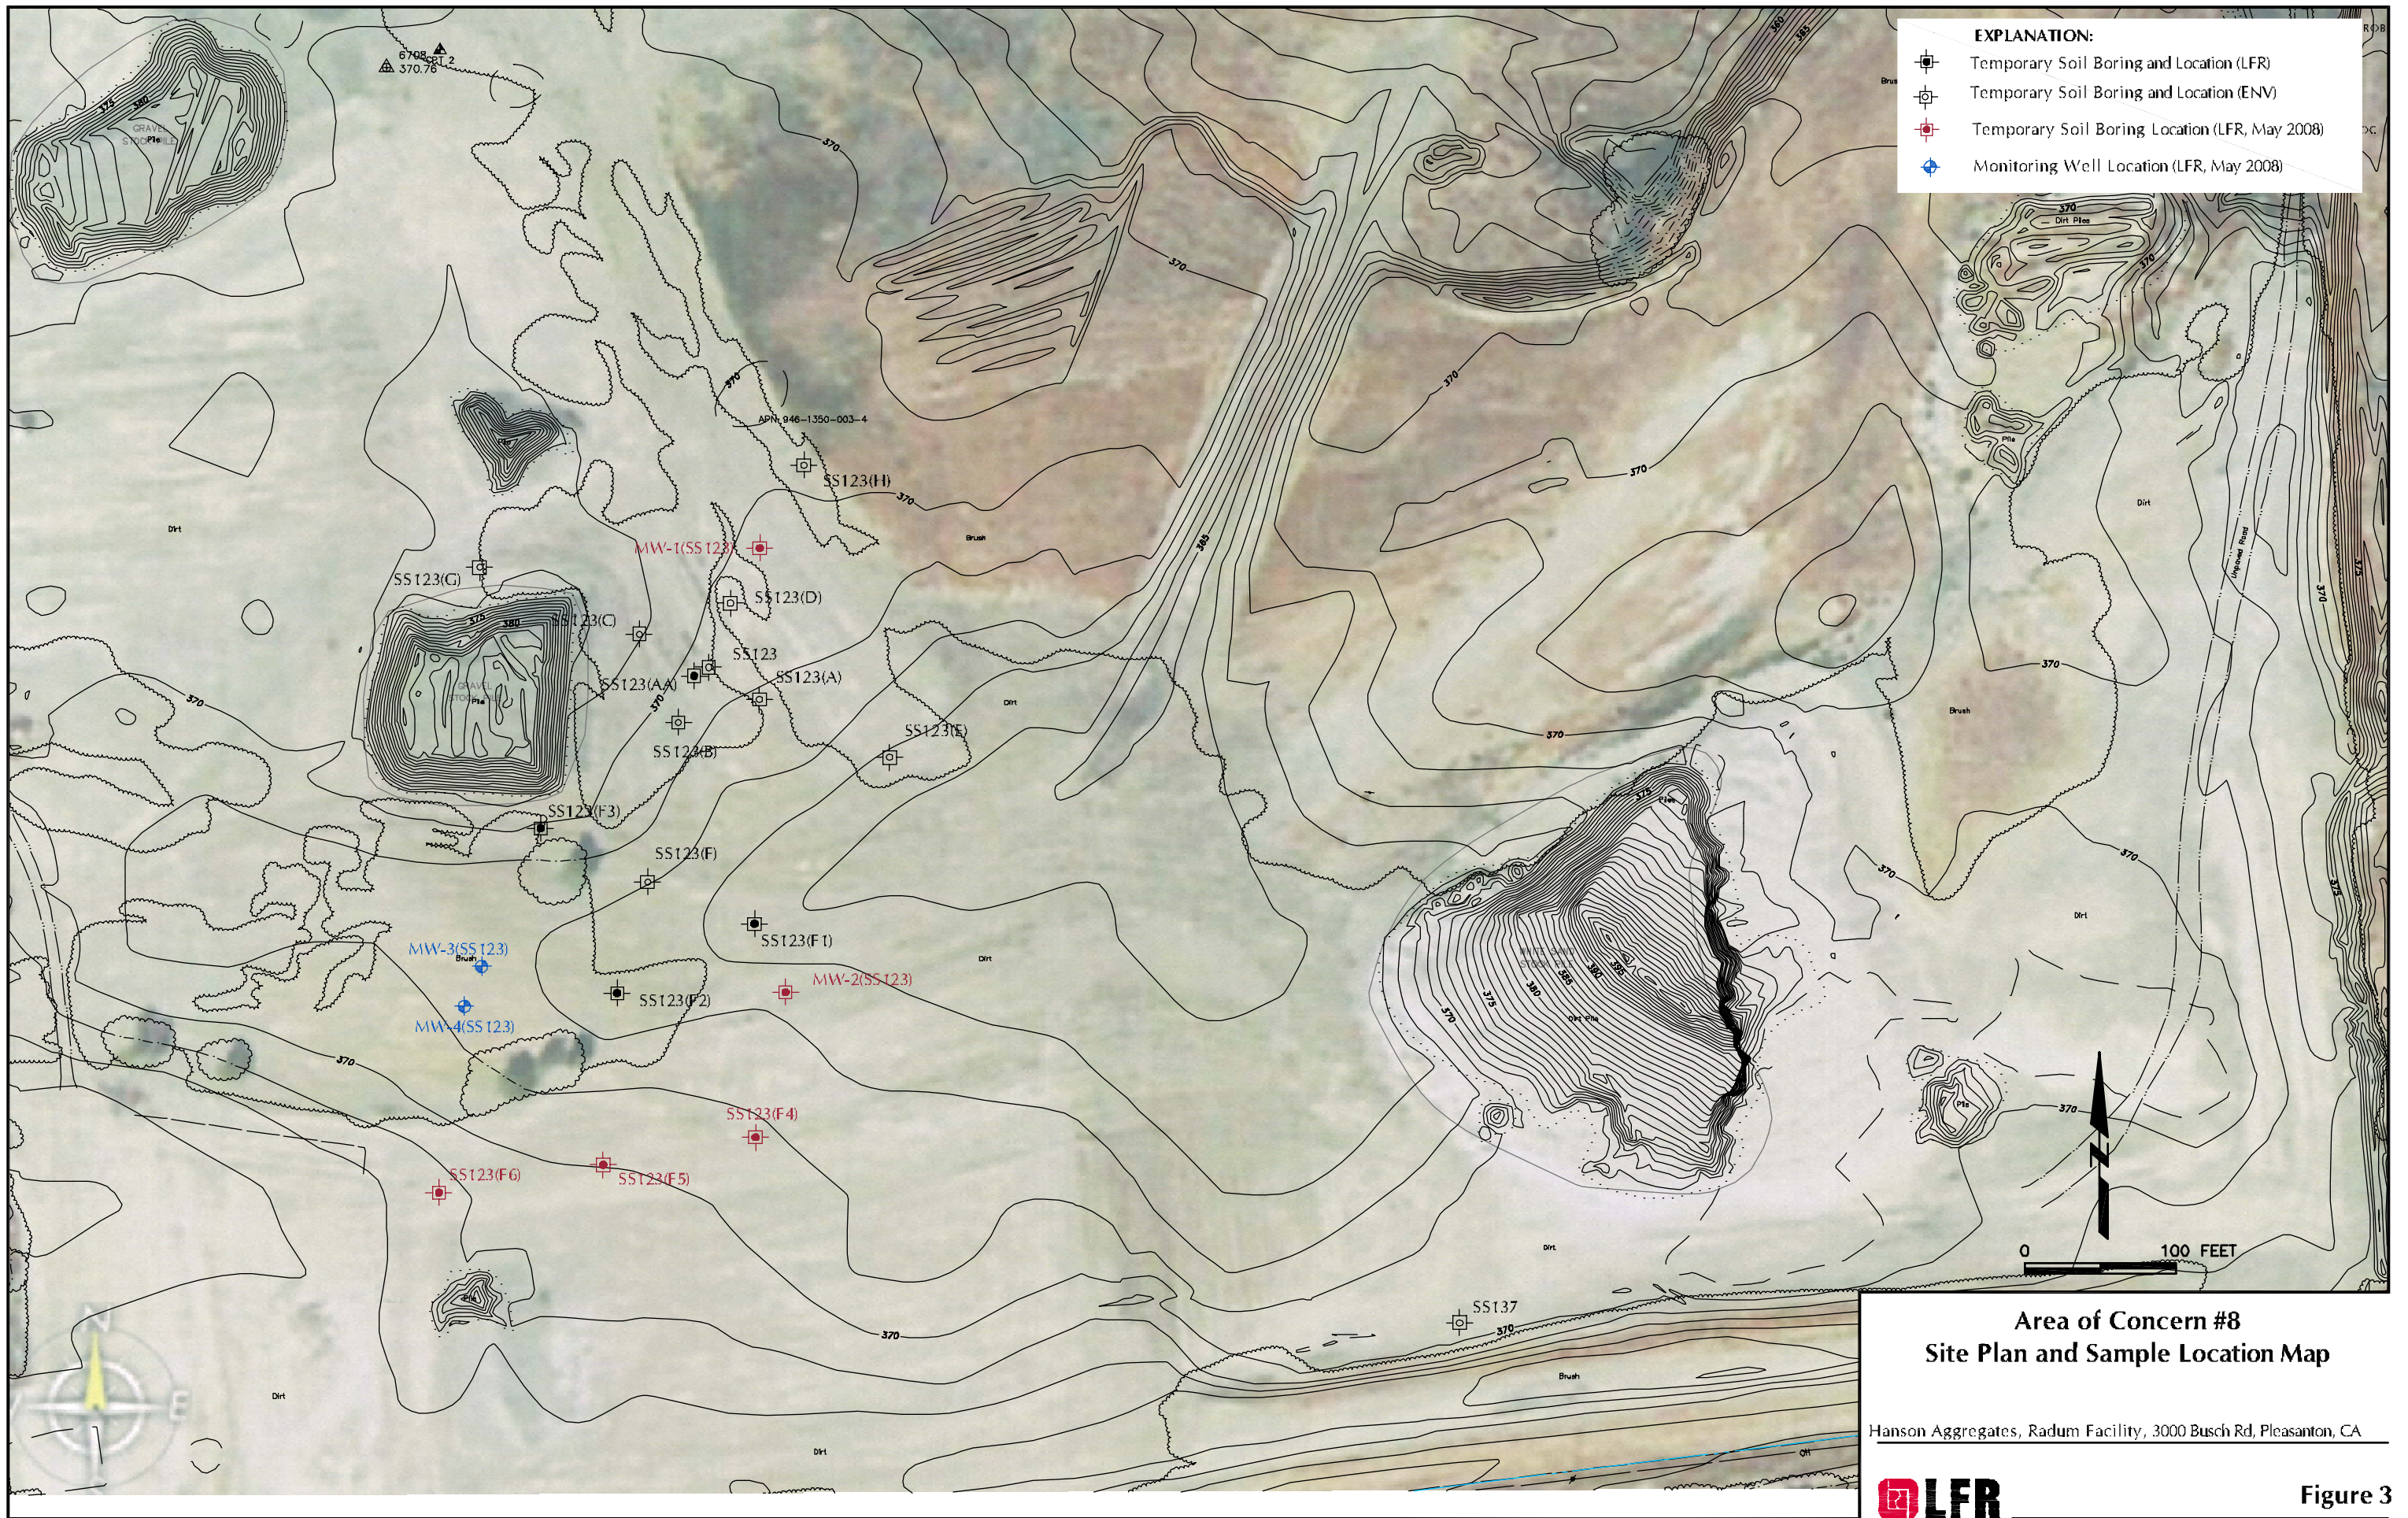
Figure 3

- 1 Site Location Map
- 2 Property Showing Areas of Concern
- 3 Area of Concern #8, Site Plan and Sample Location Map

Several subsurface investigations have been conducted to date throughout the Radum property and at the Site by various consultants (see references listed in Section 5.0). At the Site, subsurface investigations have been conducted by ENV on behalf of Legacy and by LFR on behalf of Hanson. The first subsurface investigation conducted at the Site consisted of a single temporary soil boring (soil boring SS-123) advanced in 2007 as part of due diligence activities that included soil borings located in a random grid pattern through the Radum property. No surface indications of potentially affected surface or subsurface soil were observed at the Site. However, analytical results for depth-discrete soil samples collected from soil boring SS-123 from approximately 2 to 40 feet below ground surface contained petroleum hydrocarbon concentrations that were greater than San Francisco Bay Regional Water Quality Control Board (RWQCB) Environmental Screening Levels.

Both ENV and LFR conducted additional phases of investigations with step-out soil boring locations to collect additional soil and grab groundwater samples to characterize the nature and extent of the potentially affected soil and groundwater. All investigations were conducted based on ACEH-approved scopes of work. Results from the various subsurface investigations indicated that the source of contamination likely was asphalt material placed in former mining pits, that the material was relatively immobile, and that the extent of affected soil was limited laterally and vertically. Because of the nature and extent of contamination, LFR concluded that the Site was sufficiently characterized and no remediation activities were necessary (LFR 2008d).

After the Site was sufficiently characterized, LFR installed two groundwater monitoring wells (one shallow and one deep) in May 2008 and initiated quarterly groundwater monitoring to evaluate groundwater quality beneath the Site. Attempts were made to install additional groundwater monitoring wells, but insufficient groundwater was encountered in other locations. As approved by ACEH, four quarterly groundwater monitoring events were completed (ACEH 2008f). Results from the groundwater monitoring indicated that groundwater beneath the Site has not been significantly affected and LFR recommended that groundwater monitoring cease and that the two groundwater monitoring wells be properly abandoned (LFR 2009d). A response from ACEH is pending.

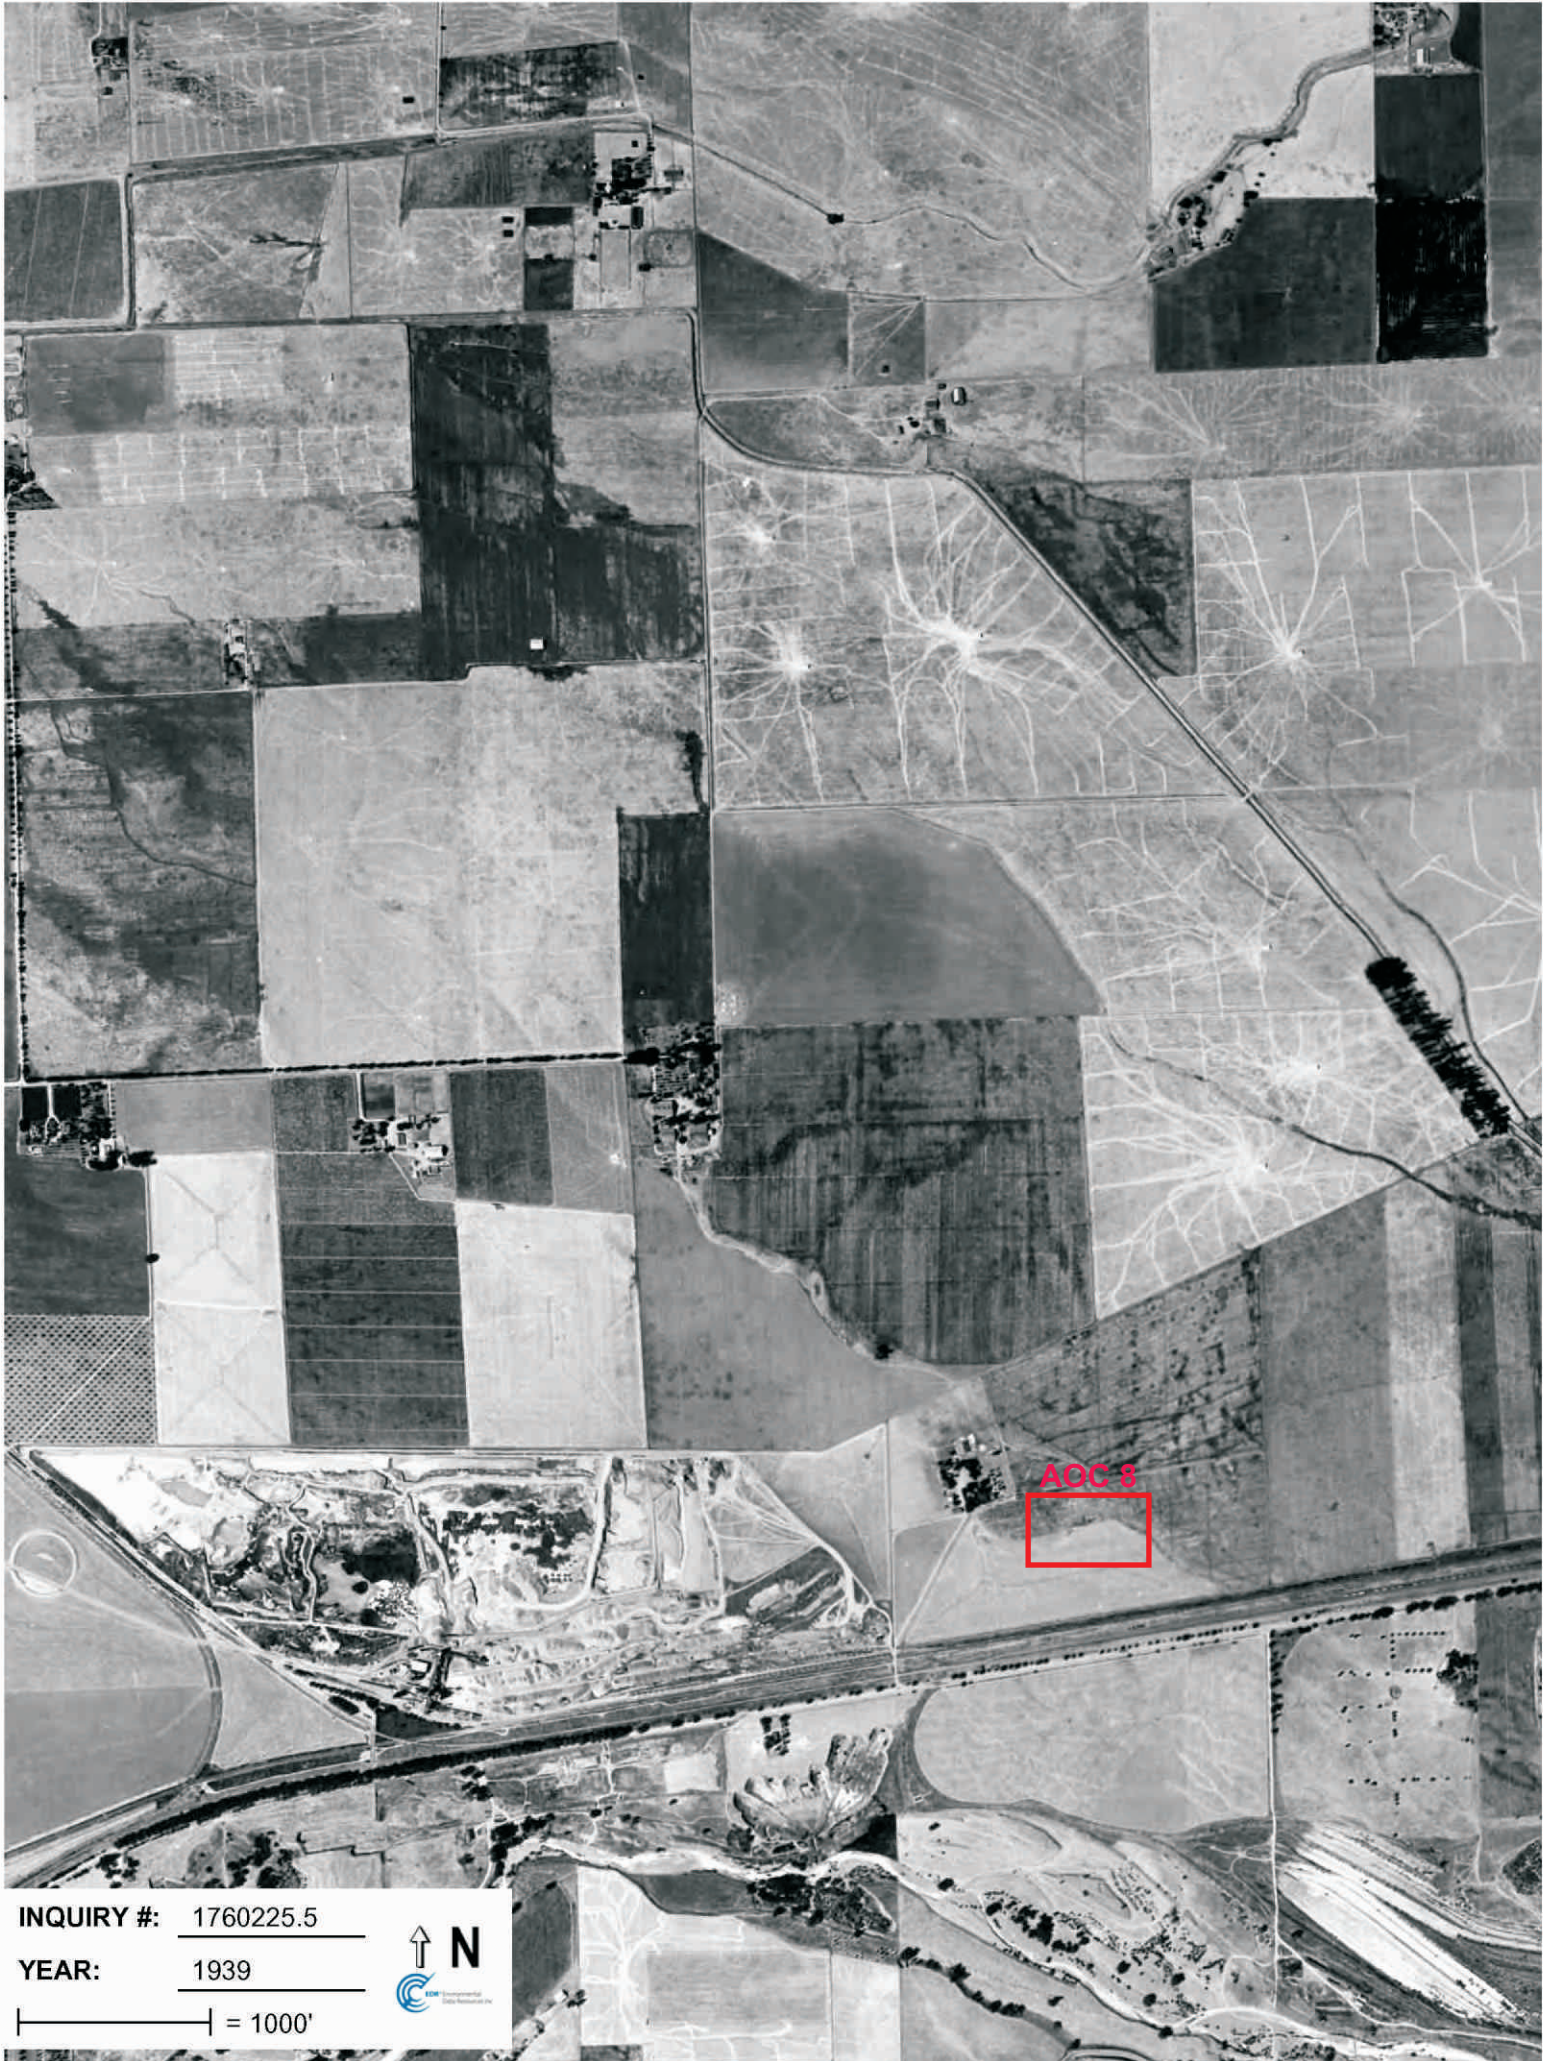
YEAR: 1939

- 1939: agriculture land
- 1950: aggregate mine pit filled with water and along the western edge the ground surface appears graded prior to mining
- 1958: aggregate mine pit filled with water
- 1965: aggregate mine pit filled with water
- 1974: aggregate mine pit filled with sediment
- 1982: aggregate mine pit filled with sediment; water and vegetation visible on the surface
- 1993: aggregate mine pit filled with sediment; evidence of vehicular tracks on the surface
- 1998: aggregate mine pit filled with sediment; evidence of vehicular tracks and vegetation on the surface
- Current conditions (no aerial photograph available): soil surface with vehicular tracks, mounds of soil, and vegetation on the surface
