Revised Closure Plan

Former Hanson Aggregates Radum Facility
3000 Busch Road, Pleasanton, California
(ACEH Case #RO0002941 and
Geotracker Global ID #SLT19719376)

December 12, 2011

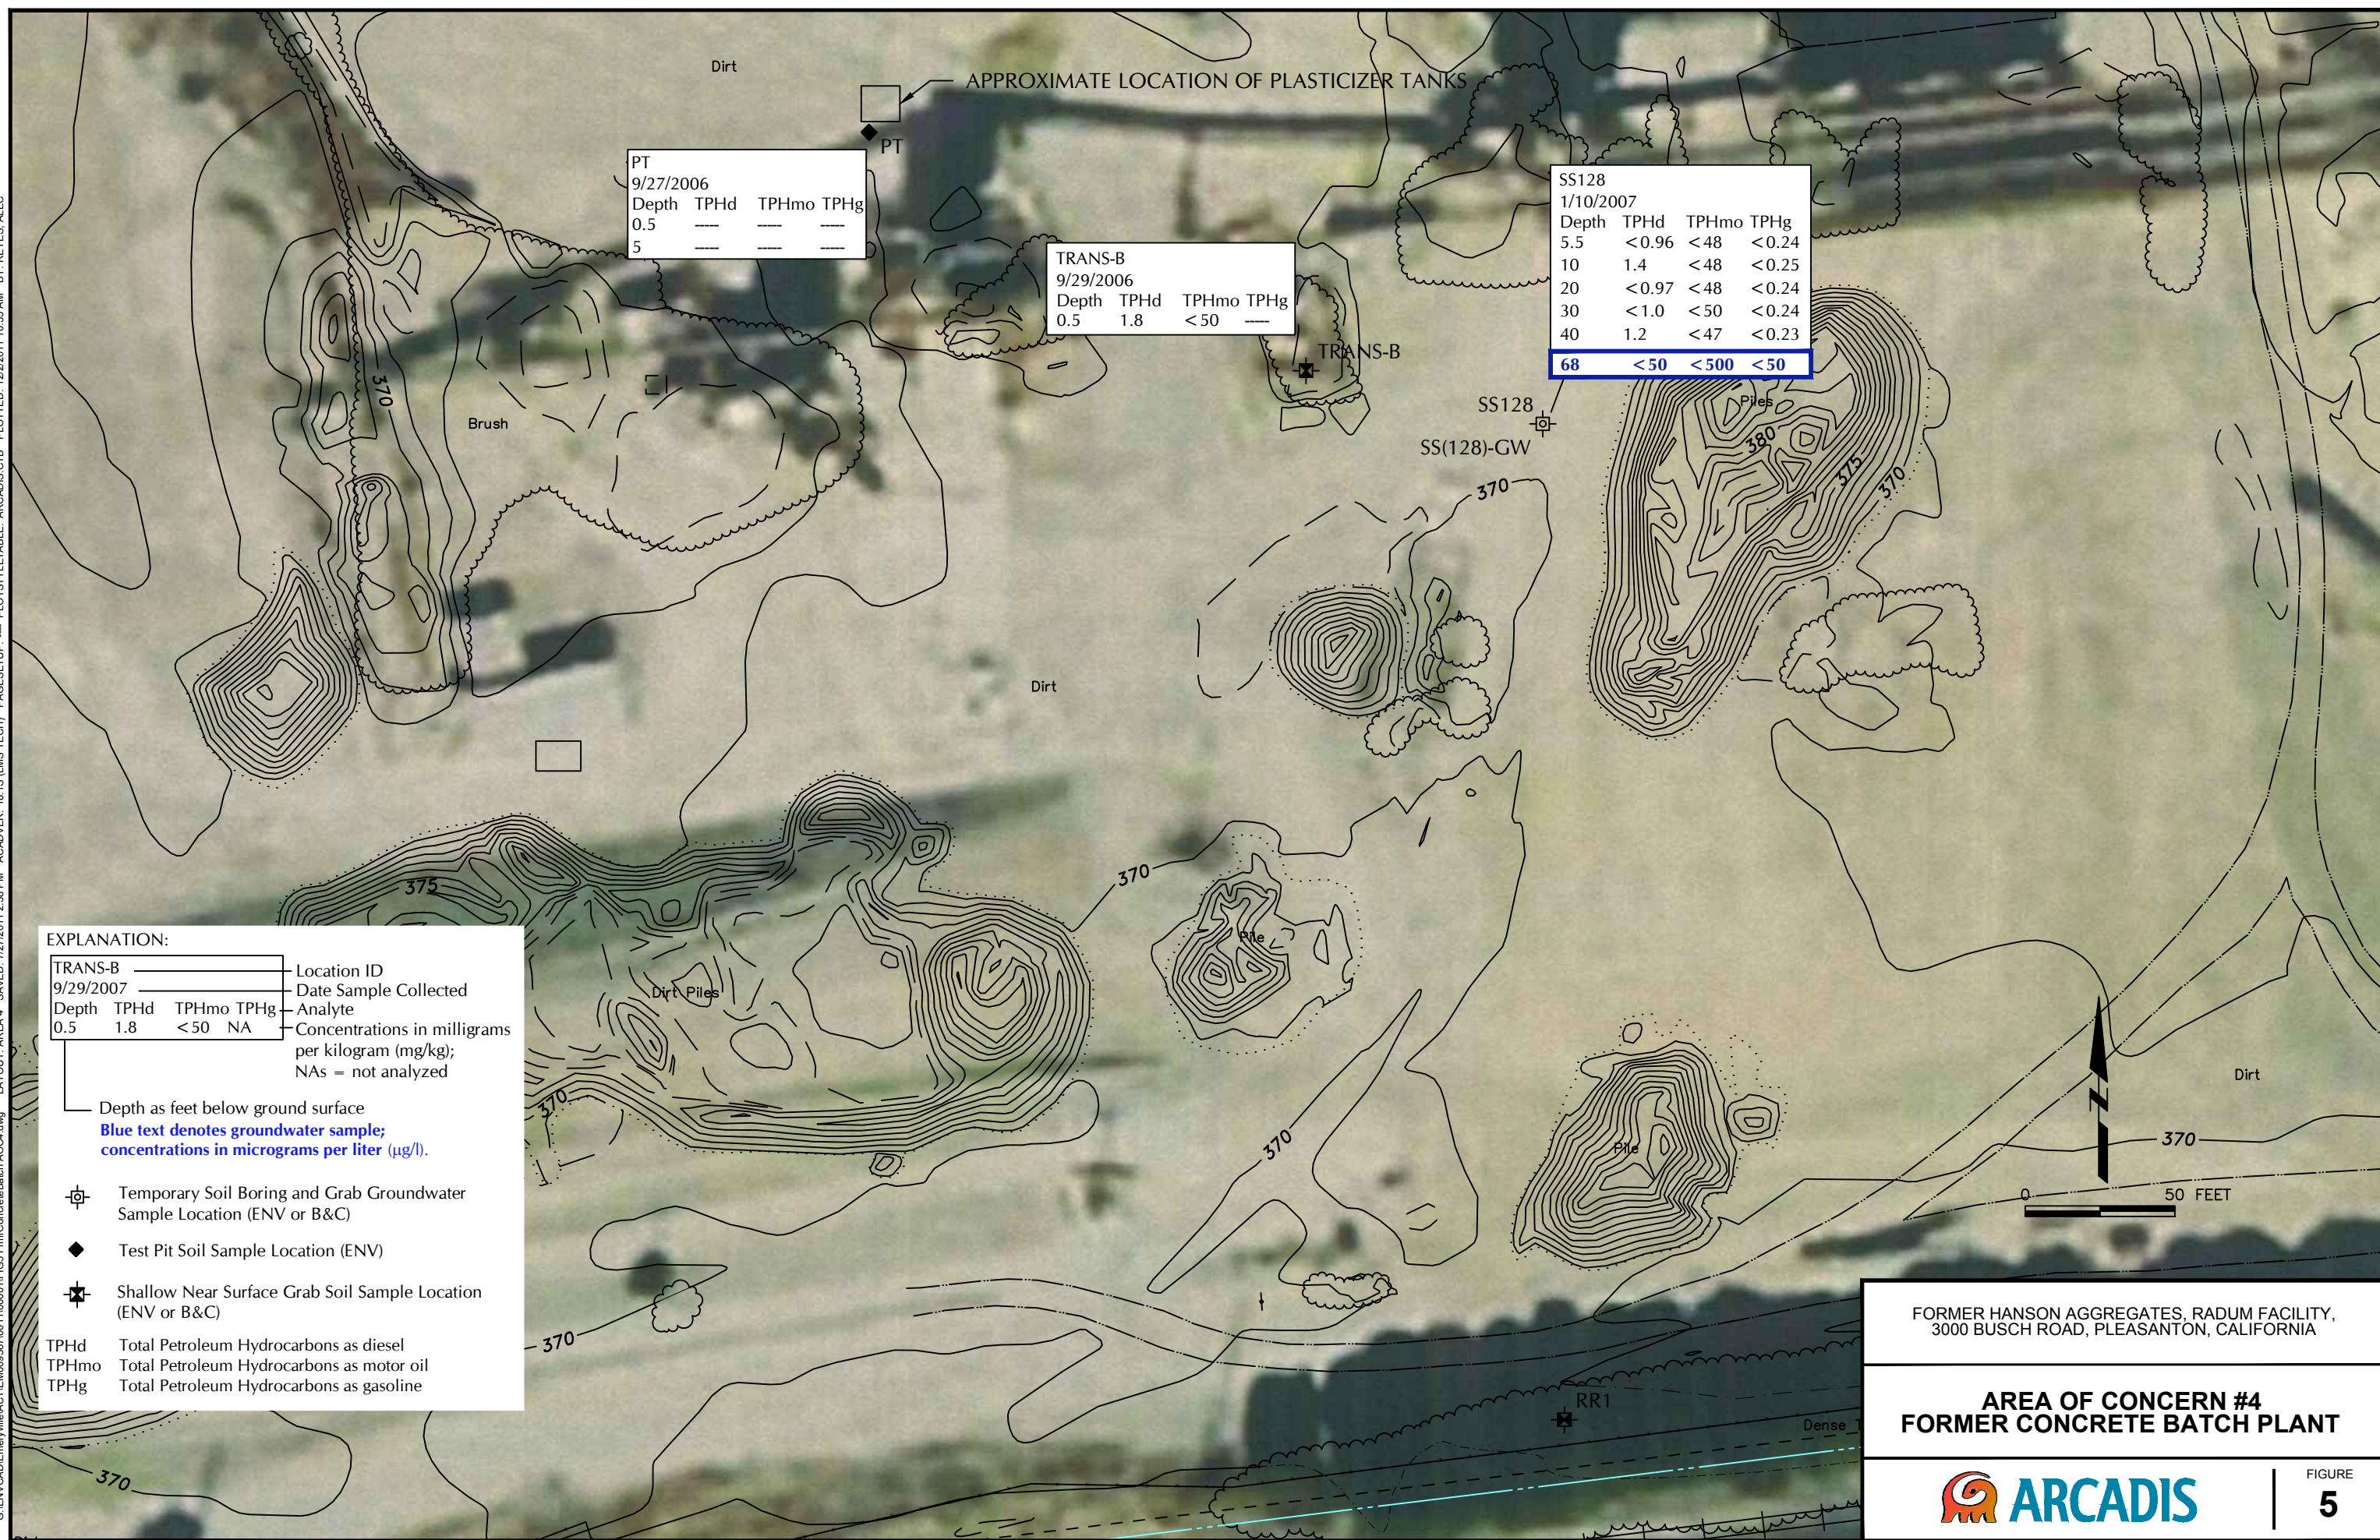
FIGURE 5

TRANS-B			
9/29/2006			
Depth	TPHd	TPHmo	TPHg
0.5	1.8	< 50	---

AREA OF CONCERN #4
FORMER CONCRETE BATCH PLANT

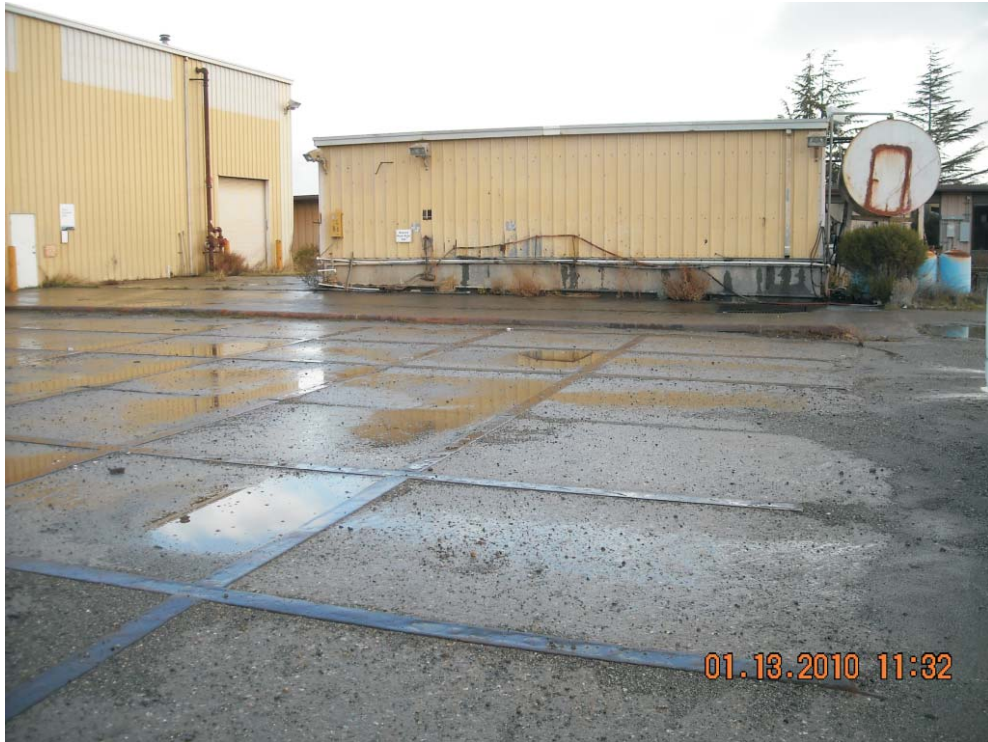
FORMER LUBE SHED LOOKING EAST

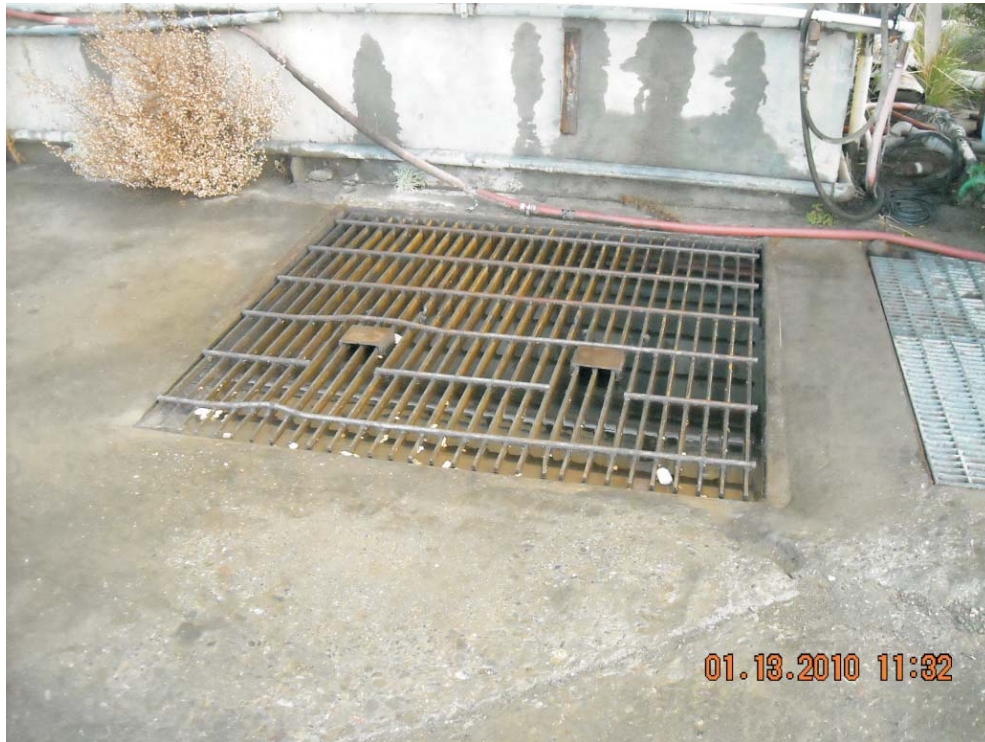
GREASE TRAP

- 4. Concrete Removal and Excavation in Wash Rack Area.** The Closure Plan currently proposes the removal of the grease trap and double weir in the southern portion of the wash rack. In order to assess whether soils beneath the wash rack area have been impacted, we request that the concrete be removed for inspection and sampling over an area extending five feet west, five feet north, and to the southern edge of the concrete south of the double weir. We also request that the concrete be removed for inspection and sampling from any areas where the concrete is cracked or shows signs of infiltration along expansion joints. The exposed areas are to be visually inspected and screened using a photoionization detector. Any areas with visible staining, odor, or elevated PID readings are to be overexcavated to remove the contaminated soil and perform confirmation soil sampling. Please include these plans in the Revised Closure Plan requested below.

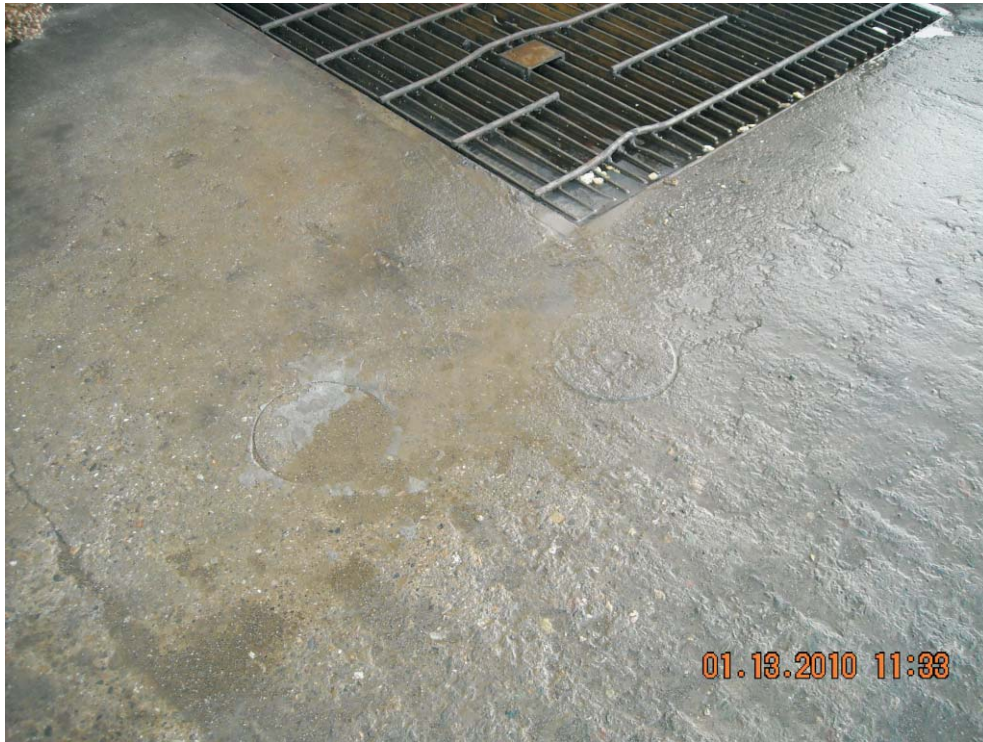
SOIL BORING EB-4 NEAR GREASE TRAP

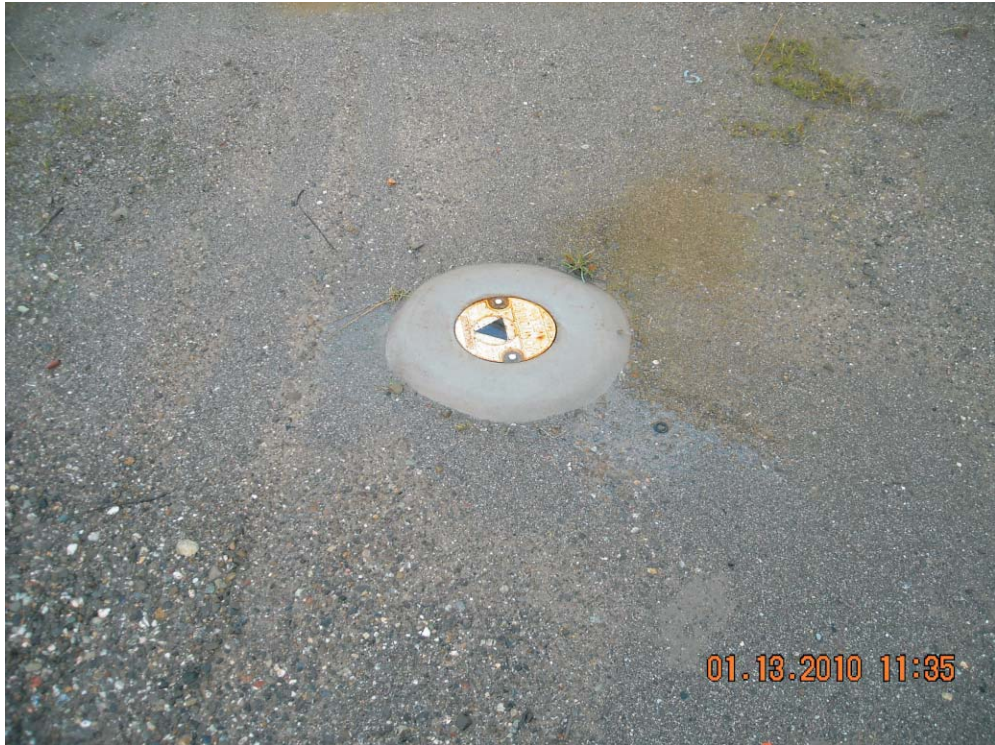
GROUNDWATER MONITORING WELL MW-1

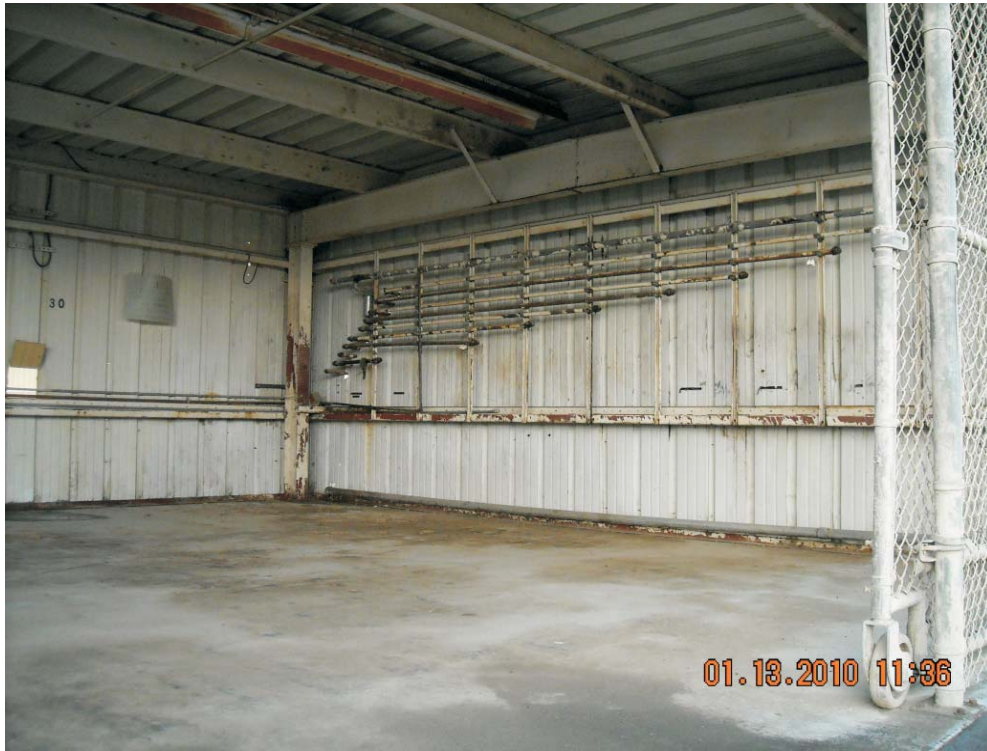
INSIDE THE FORMER LUBE SHED
