## REMOVAL ACTION OVERSIGHT AND DOCUMENTATION

Downtown Oakland CNG Station 205/209 Brush Street Oakland, CA 94607

Port of Oakland
Environmental Programs & Safety Department
530 Water Street
Oakland, CA 94607

October 16, 2007

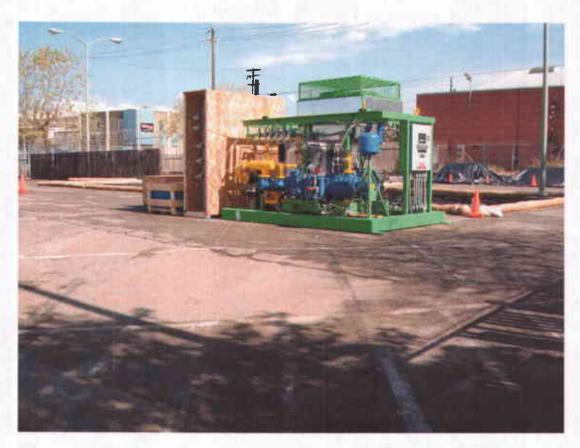
Photo #1 – One of the two CNG compressor units for the fueling station (Facing north; 4/20/2007)

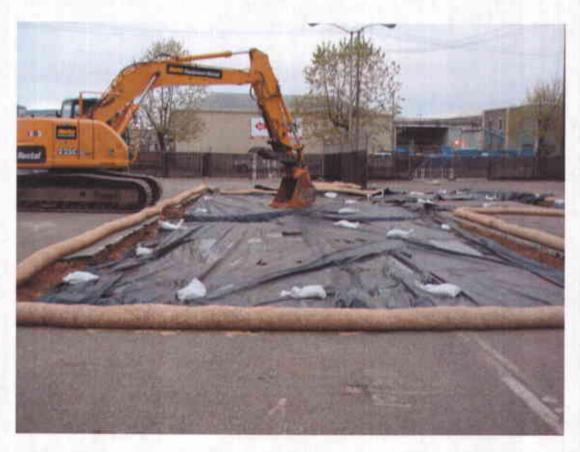
Photo #3 – Pre-excavation view of excavation upon arrival at the site on the morning of April 25, 2007 (Looking west toward Market Street)

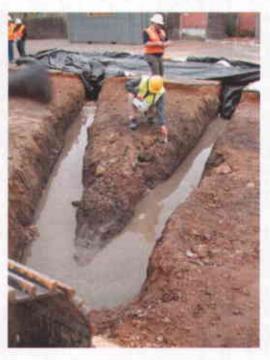
Accumulated rainwater drained into trenches; LEL monitoring near exposed soil surface (Facing north)

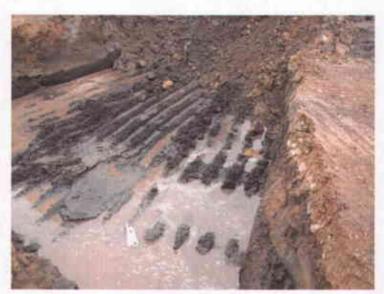
Photo #4 - Handling the accumulated rainwater (4/25/2007)

Rainwater drained into the excavation

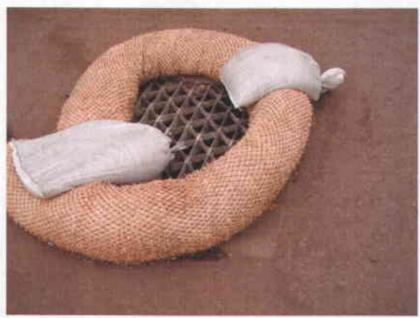
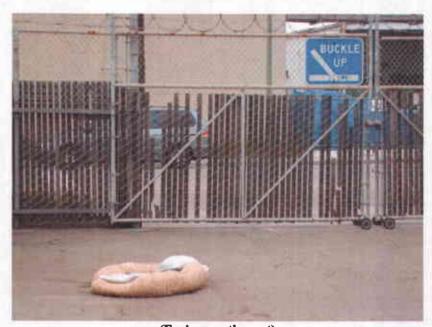
(Up-close view of storm drain)

(Facing north-west)

Photo #5 - Storm drain, located in the northern corner of the site, bordered with straw wattles and weighed down with sandbags

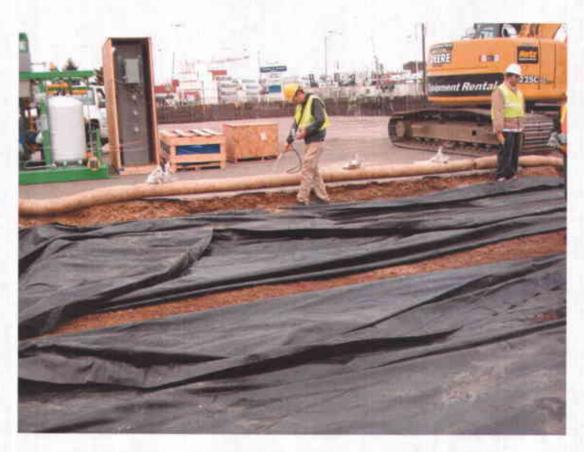
Photo #7 - PID and LEL/O $_2$ /H $_2$ S/CO monitoring upon exposure of surface soil (Facing south; 4/25/2007)

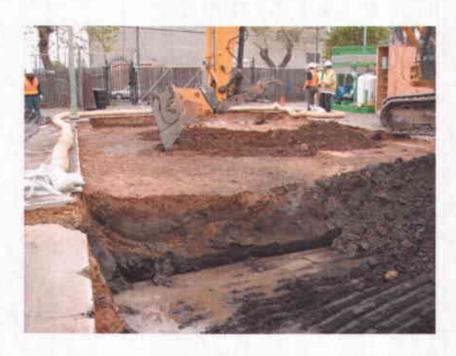
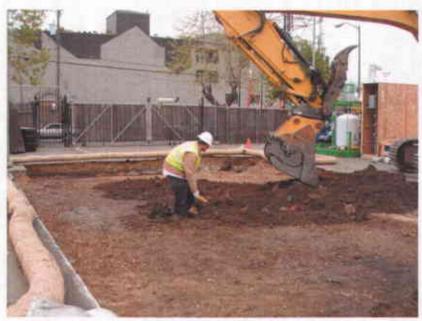
Photo #8 - Potholing a location further east within the pad footprint; since soil at this location appeared to be uncontaminated this location was defined as the "benchmark" and the eastern limit of soil excavation

(Facing east; 4/25/2007)

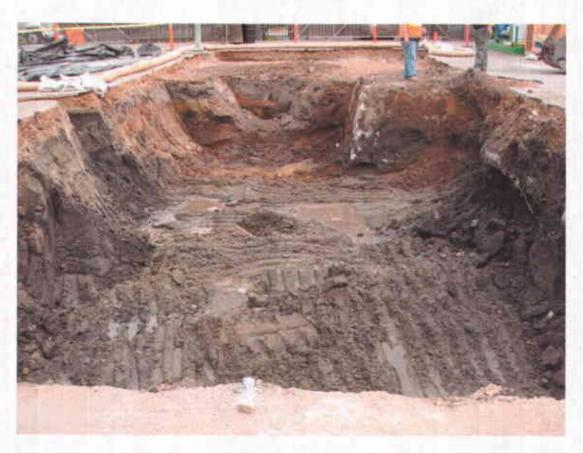
Photo #9 - View of final excavation (~ 7 ft deep) after confirmation sampling – note the old concrete foundation under man's feet
(Looking east toward Brush Street; 4/25/2007)

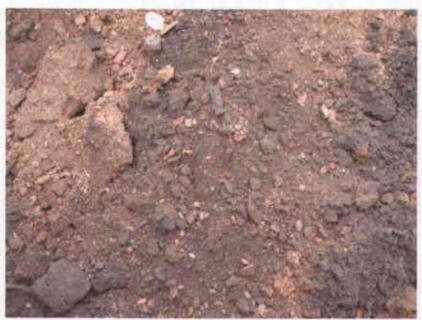
Photo #10 – Condition of excavation on morning of 4/26/2007, groundwater came to the surface during the night

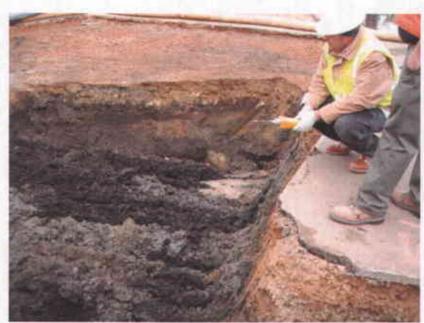
Photo #11 - (4/25/2007)

PID monitoring near the excavation surface; note the black color of the odor-causing soil (Facing east)

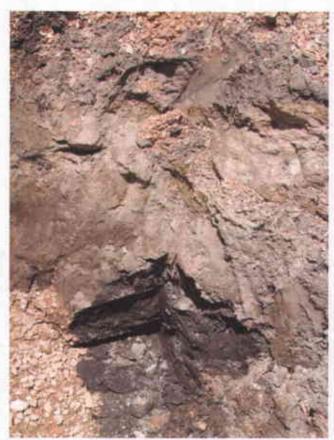
Black material on the north corner of the excavation wall; material had a faint odor (4/25/2007)

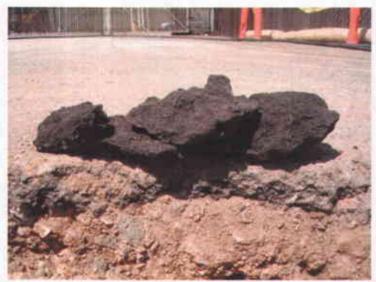
Photo #12

Close-up of black soils that appear to have heavy hydrocarbon staining; material had a faint odor (4/25/2007)

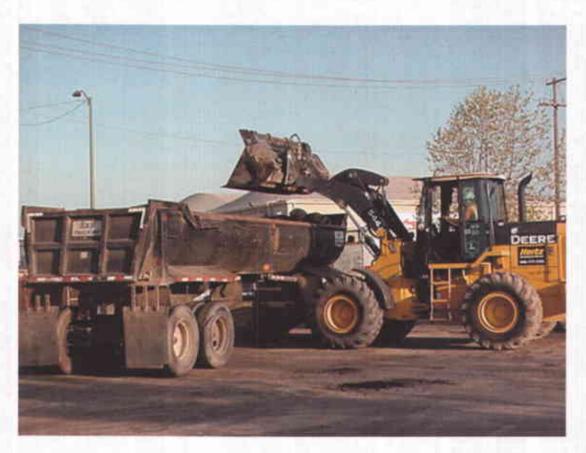
Photo~#15-Off-haul~truck~being~loaded~with~load~#4~from~stockpiled~soil~(4/27/2007)

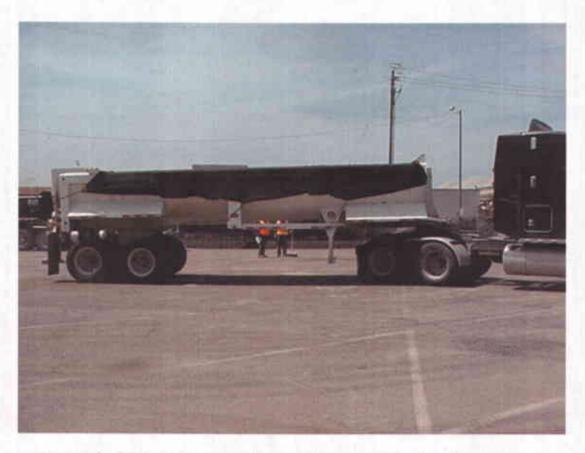
Photo #16 – Off-haul truck loaded with load #13, covered with a tarp, leaving for the Altamont Landfill
(Facing southwest corner of site; 4/27/2007)

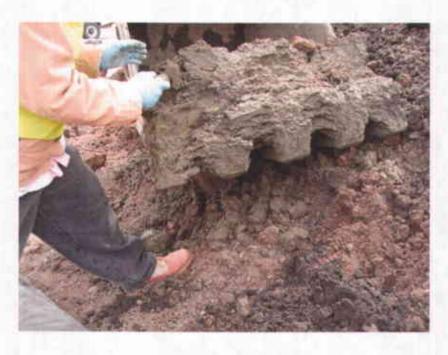
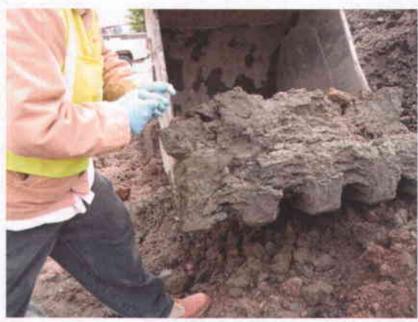
Photo #17 - Collection of confirmation soil samples in 6" X 1.5" stainless steel tubes from the materials brought to the surface in the excavator bucket (4/25/2007)

samples and sampling locations. A total of 11 soil samples were collected<sup>8</sup>: 8 from the excavation walls (~3 ft bgs) and 3 were the floor of the excavation (7 ft bgs) – See Figure 7. Samples were collected from the excavator bucket<sup>9</sup> using 1.5" X 6" stainless steel tubes pushed by hand into the soil (Photo #17). The tube containing the sample was then capped with Teflon squares and plastic end caps and labeled with sample location designation, date and time of sample collection, and placed in a cooler on ice. The cooler containing the samples was delivered to Curtis & Tompkins, Ltd. (Berkeley, CA), a state-certified analytical laboratory, under chain-of-custody documentation. Field observations relating to the collected samples were documented in Excavation Sampling Logs that are presented in Appendix C.

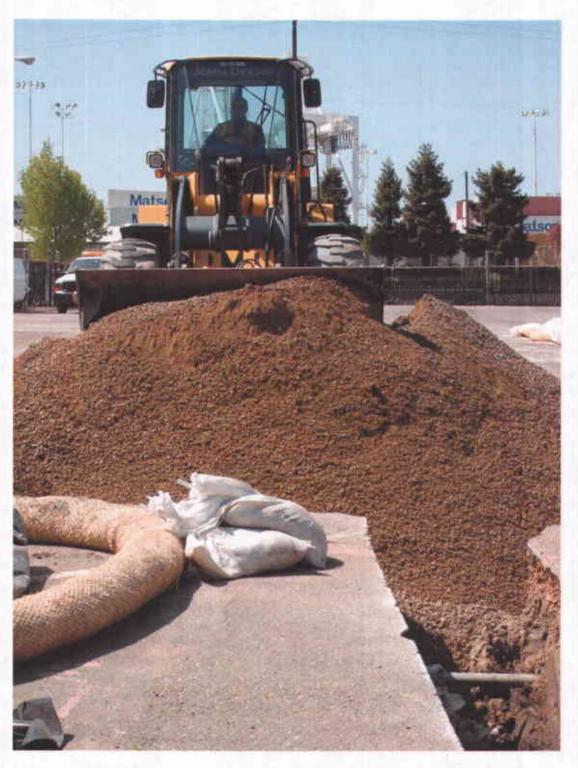
Photo #18 – Backfilling operations: the second load of backfill material being emptied into the excavation at the location of concrete foundation (Note the water being sprayed to impart moisture for compaction; 4/26/2007)

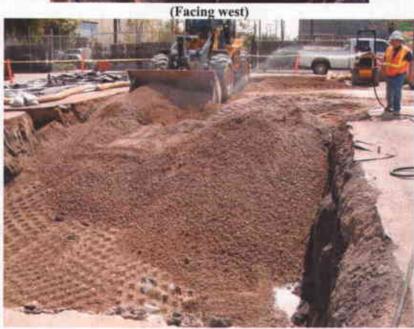
Photo #19 – Backfilling operations: John Deere 544 loader pushing backfill material into the excavation (4/26/2007)

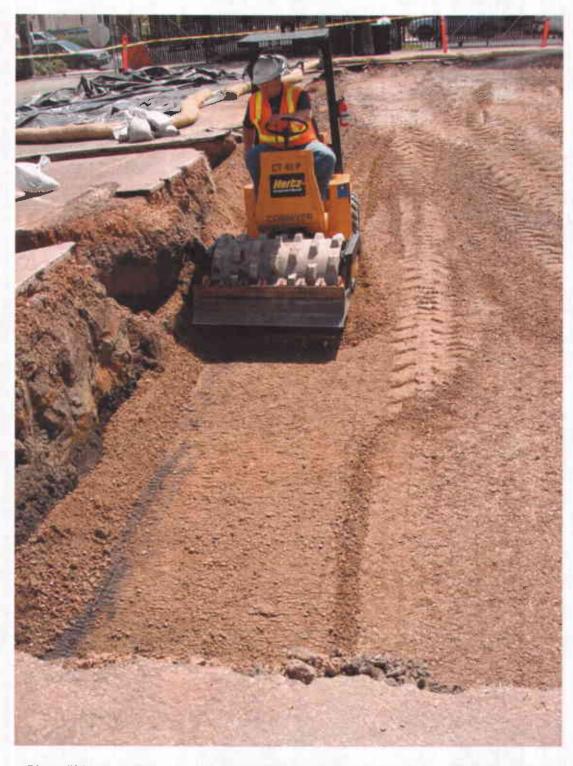
Photo #20 – Backfilling operations: adding water to the soil to insure proper moisture content for compaction (4/26/2007)

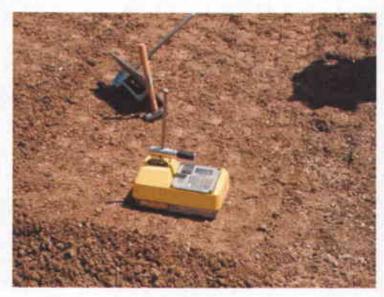
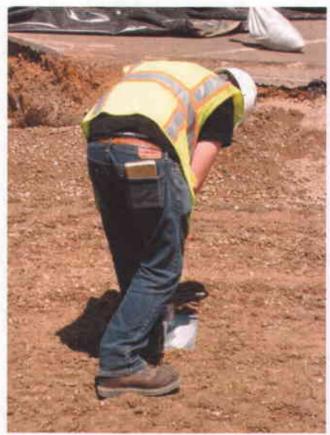
Photo #22 – Backfilling operations: Field compaction tests being conducted with a Troxler Nuclear Gauge (4/26/2007)

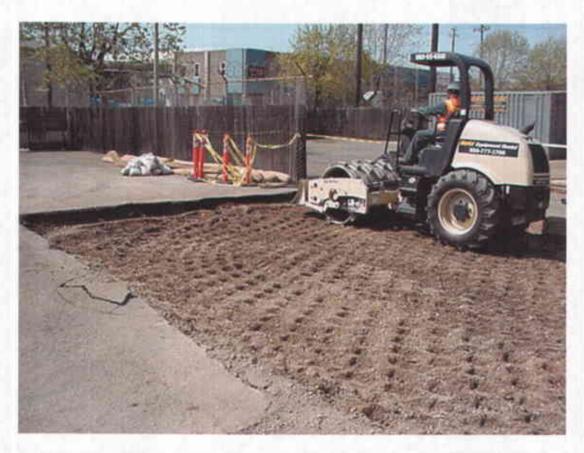
Photo #23 – Backfilling operations: utilizing a 5-ton Ingersoll-Rand SD-45 sheep foot compactor
(Facing north; 4/27/2007)

The backfilling of excavation and compaction of the emplaced backfill material began on Thursday (April 26) and was completed on Monday (April 30). NRC secured the backfill material (Class 2 Aggregate Base – see Appendix E for product specifications) from Dutra Materials (San Rafael, CA), which delivered approximately 200 yd<sup>3</sup> (fifteen truck loads) of the material to the site on April 26, 2007 (Photo #18). A John Deere 544 loader was used to move the backfill material into and around the excavation (Photo #19). Water was sprayed onto the backfill material as it was placed into the excavation (Photo #20). Initially NRC used a one-ton self-propelled John Deere CP-40 sheep-foot compacter to compact the emplaced material (Photo #21). However, field compaction tests (Photo #22) performed on April 26 indicated that this compactor did not produce a compaction density of close to the desired 95% level. On April 27, NRC replaced the compactor with a 5-ton self-propelled Ingersoll-Rand SD-45 sheep-foot unit (Photo #23).

compaction had been performed using the heavier, 5-ton Ingersoll-Rand SD-45 sheep foot compactor, indicated achievement of a compaction density of 93%. Photo #24 shows the site appearance on April 30, 2007, when it was handed over to the contractor to resume its CNG Fueling Station construction.

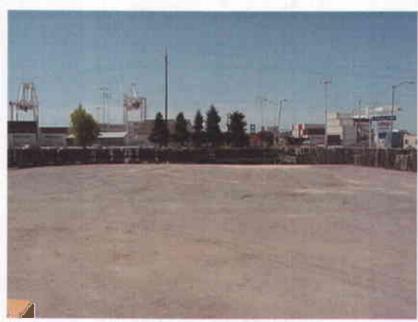
Southern section of the site

Photo #24 - Completion of removal action: final condition of the site as it was turned over to Clean Energy at 11:19 a.m. on 4/30/2007

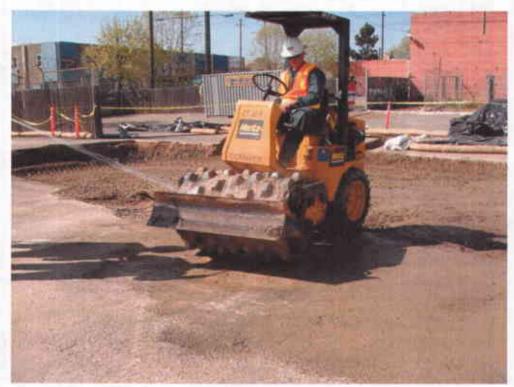
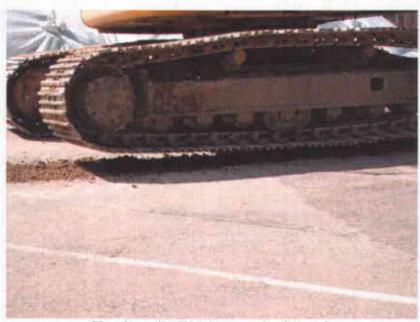
Cleaning equipment before return to rental agency

Cleaning soil off of the excavator's treads

Photo #27: Cleaning of the equipment before removing them from the work area (4/26/07)

Care was exercised by the field crew to keep the work area clean and prevent material from the work area being dragged by the construction equipment (Photos #27 and #28). Areas where excavated soil or fresh backfill materials had been stockpiled were swept and the sweepings placed into the final truck load that was taken offsite.

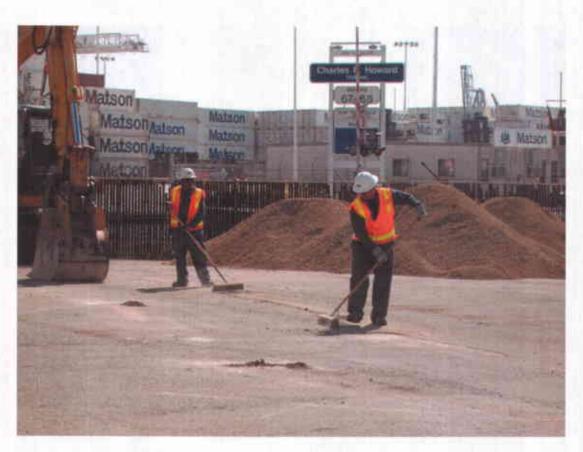
Photo #28 – Cleaning prior to leaving the site for the day (4/26/2007)

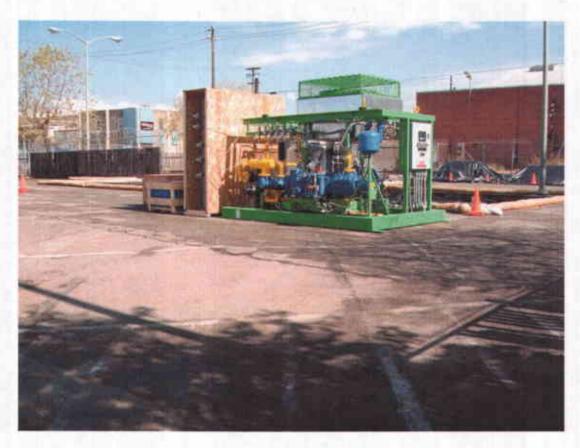
Photo #1 (4/20/2007)— One of the two CNG Compressor Units for the Fueling Station. Equipment pad is located immediately behind the compressor unit. View towards the northwest.

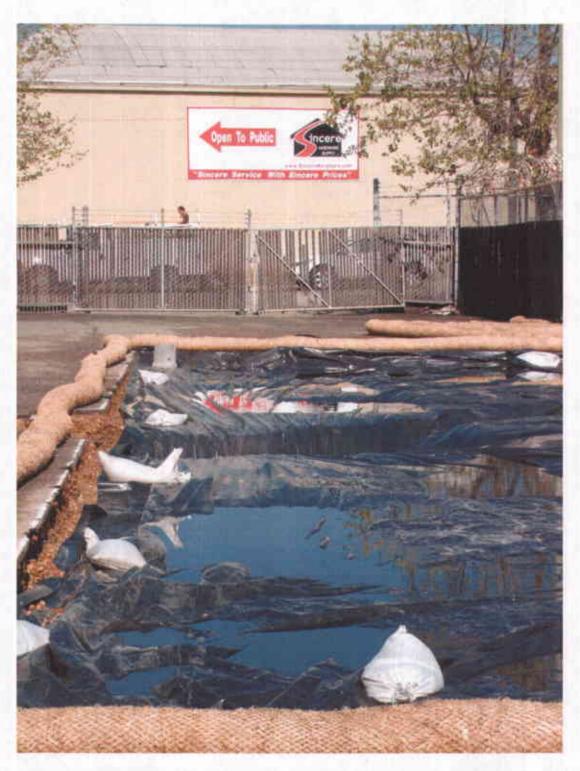
Photo #2 (4/20/2007)— A view of the area being excavated for building pad construction, note the accumulated rainwater on the plastic sheeting covering the equipment pad excavation.

(Looking west from the adjacent sidewalk on Brush Street)

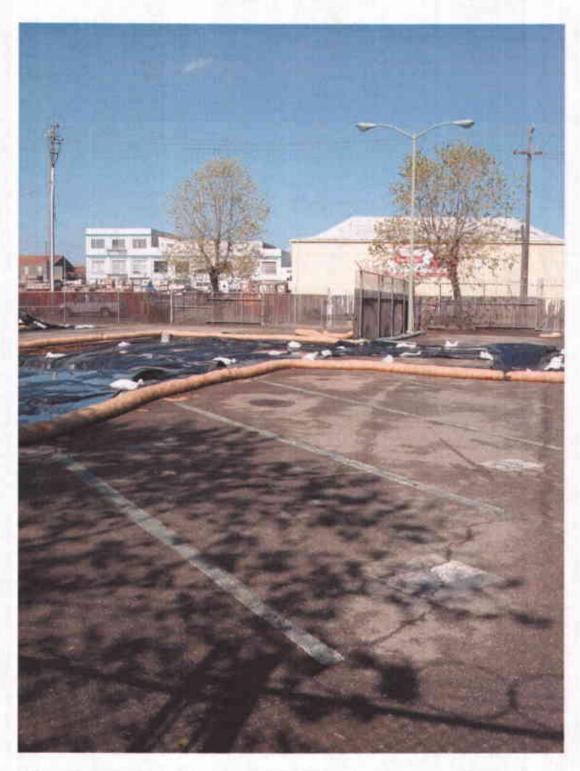
Photo #3 (4/20/2007) – Another view of the building pad excavation area. Equipment pad excavation is on the left side and the dispenser excavation is on the far right side of the photograph.

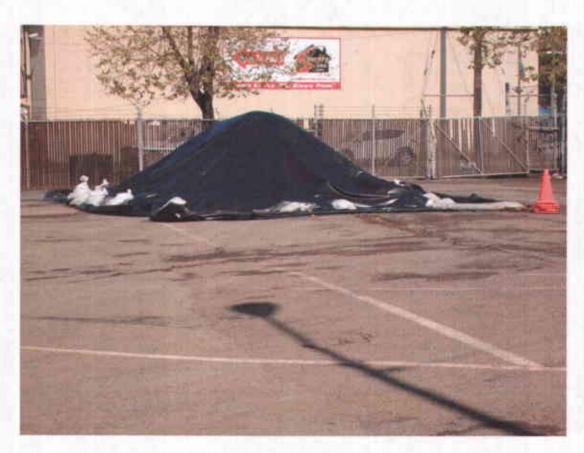
Photo #4 (4/20/2007) - Pile of excavated soil on and under protective plastic cover

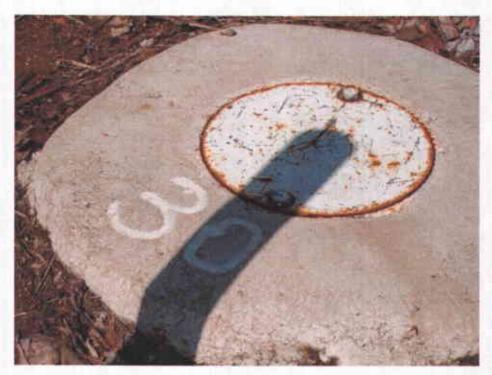
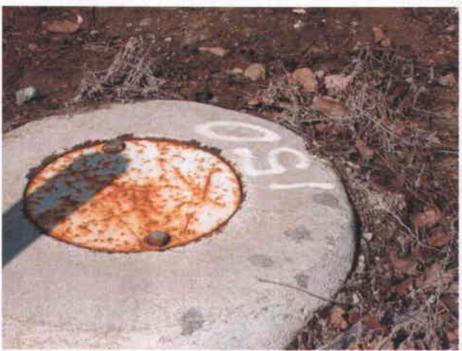
Photo #5 (4/20/2007) - Two of the three saltwater intrusion monitoring wells located outside but adjacent to the site at the terminus of Brush Street

(Note: The numbers indicated the depth of each well; the third well, not shown here, is 100 ft deep)
