Re: Ambassador Laundry, 3623 Adeline Street, Emeryville, California,
Fuel Leak Case No. RO0002973, Geotracker Global ID T0619717287
Soil and Groundwater Management Plan

February 26, 2010
Project No. 790.026

Subject: Results of Surficial Soil Sampling, Ambassador Housing, 1168 36th Street,
Emeryville, California

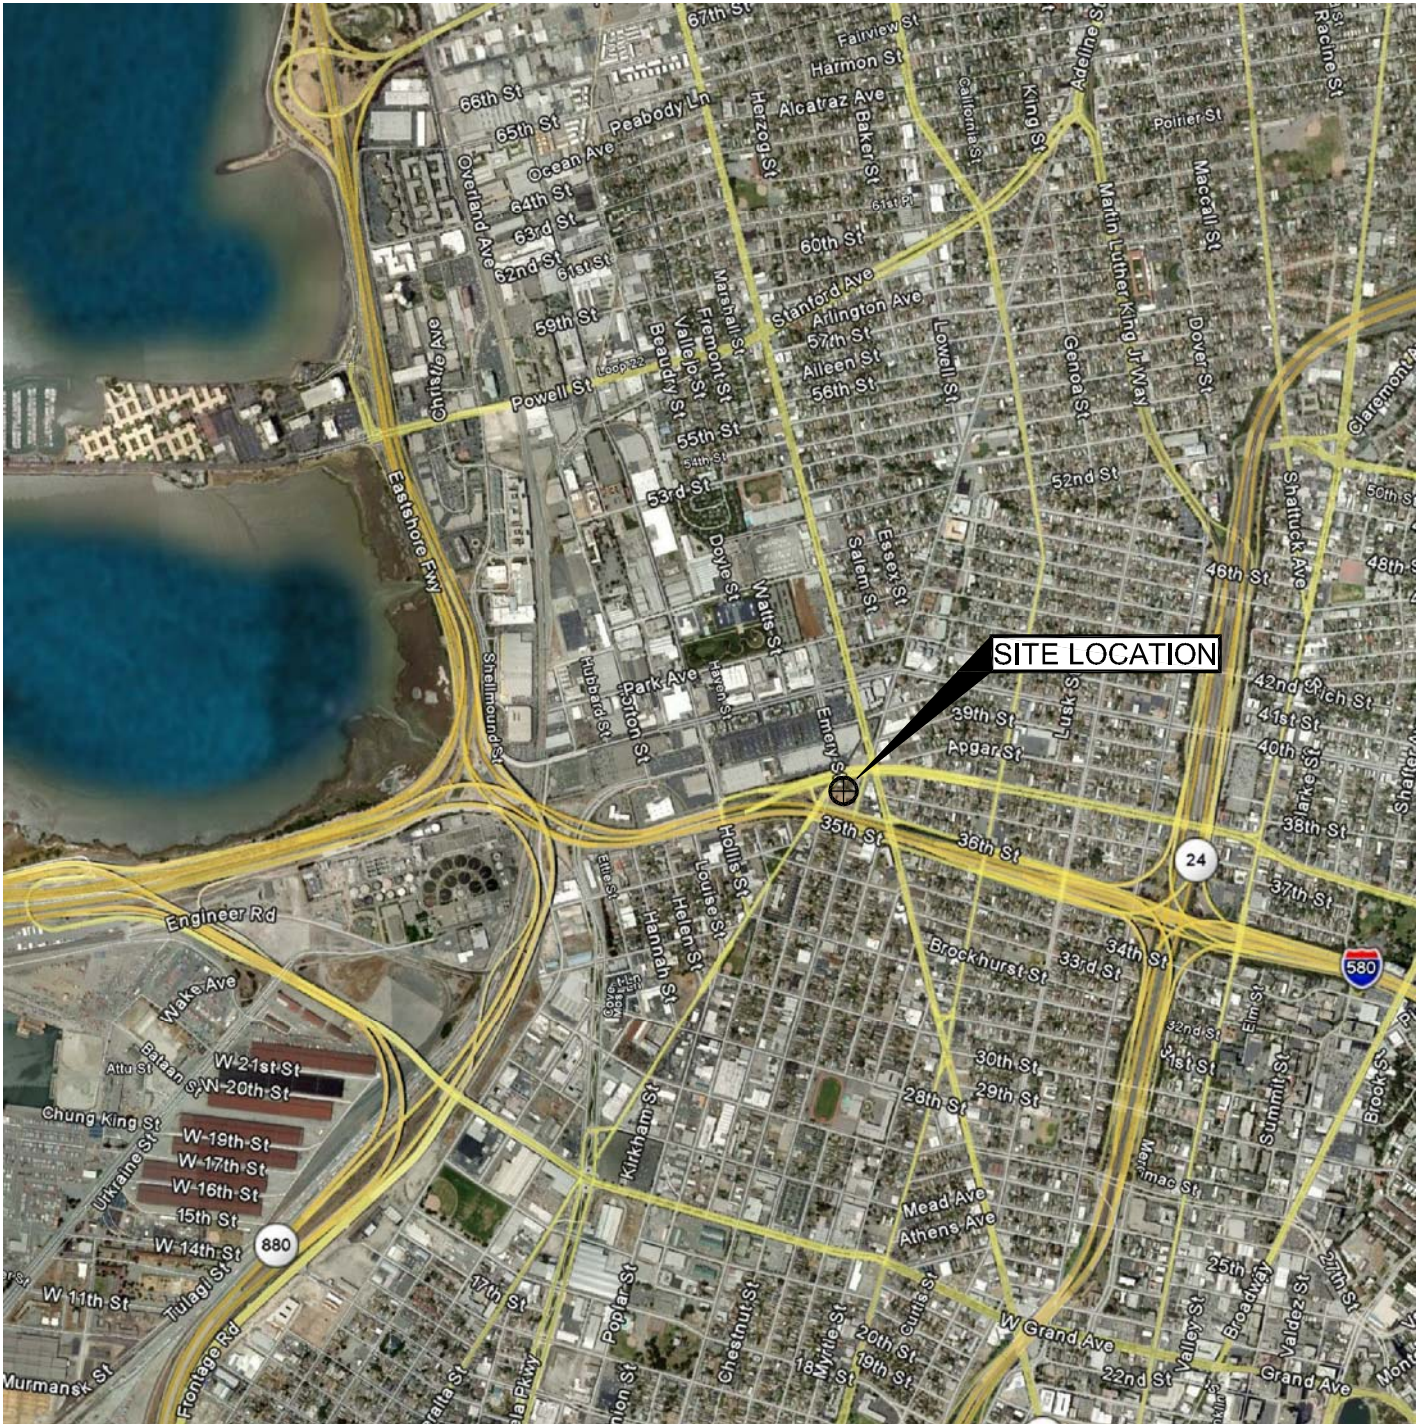
VICINITY MAP
Ambassador Housing 1168 36th Street
Emeryville, California

SOURCE: This aerial photo was obtained from Google Earth Pro dated July 2009.
