AEI Project No. 10693

**PHASE I  
ENVIRONMENTAL SITE ASSESSMENT**

6235 College Avenue  
Oakland, California 94618

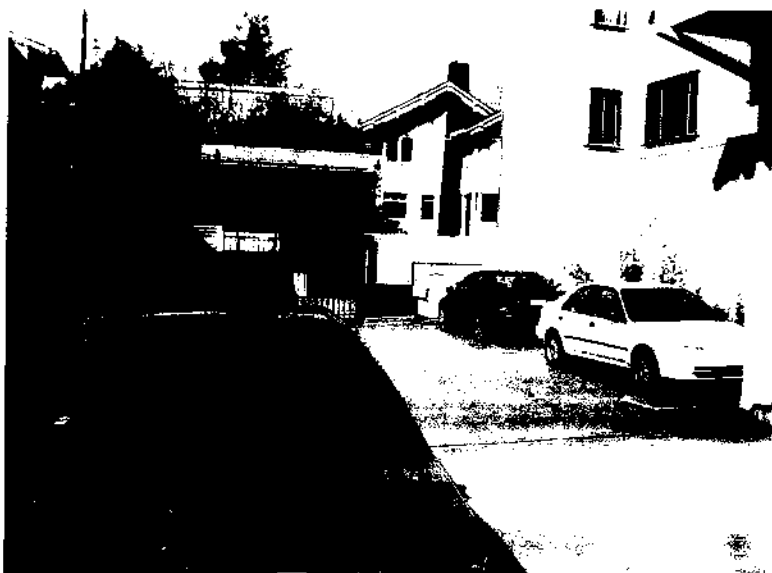
AEI reviewed a building plan which indicated that that an underground storage tank (UST) used for storing gasoline may have been located on the northwest portion of the subject property as late as 1986. The location of the UST was noted as "undetermined", however, a fill pipe was noted on the plans in this location. Building permits dated 1941 listed the occupant of the property as Berkeley Fuel and Supply; however, it is unknown whether the former UST was associated with this business. The subject property was not listed on the regulatory database as a current or former UST site; however, based on the building plan, it is apparent that a UST was formerly located onsite. The location of the former UST is unknown. Based on the unknown management and/or removal practices utilized in connection with the UST, the potential exists that a release of petroleum hydrocarbons from the UST has impacted the subsurface of the subject property via groundwater.

3. Northwestern portion of subject property.

AEI's investigation revealed recognized environmental conditions associated with the subject property/nearby properties that require further investigation. AEI recommends that a subsurface investigation and a geophysical survey be conducted at the subject property in connection with the former on-site UST and the long-term dry cleaning operations.

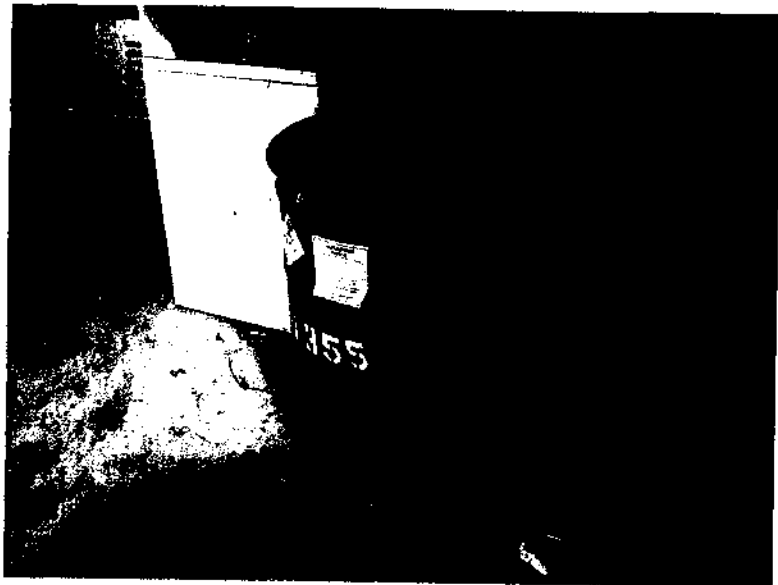
AEI observed hazardous materials and wastes on the subject property associated with on-site dry cleaning activities. Hazardous waste was observed to be stored in two 55-gallon drums located behind and outside the subject property building. Although the drums were located outside, they were situated beneath the second story overhang of the building allowing for a moderate level of protection from the elements. The drums were stored directly on concrete. No secondary containment was present. No floor or storm drains were observed near the drums, and no obvious evidence of leakage from the drums was observed during the site reconnaissance. Waste is removed on a periodic basis by a licensed hazardous waste collection service.

4. Hazardous waste drum storage area.

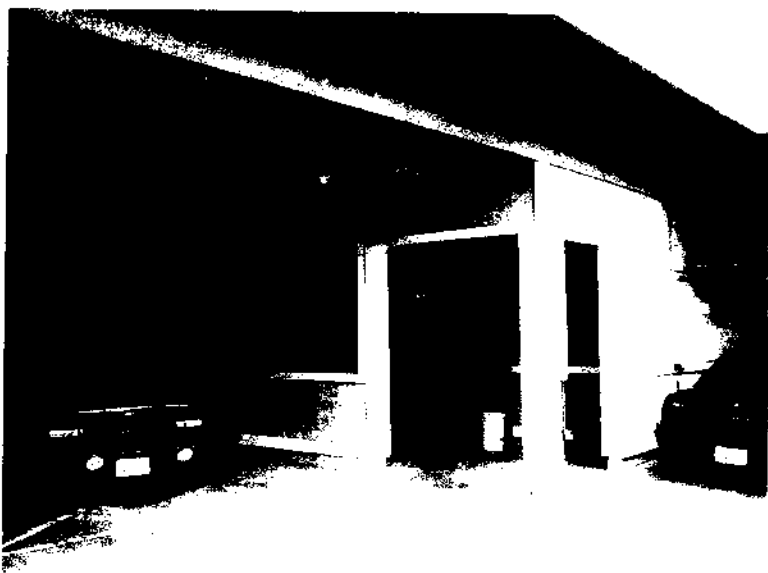
6. Rear access to dry-cleaning facility.
