Pulte Home Corporation
6210 Stoneridge Mall Road, Fifth Floor
Pleasanton, CA 94588

**PHASE I ENVIRONMENTAL SITE ASSESSMENT
THE PAPERMILL PROPERTIES
EMERYVILLE, CALIFORNIA**

APRIL 17, 2006

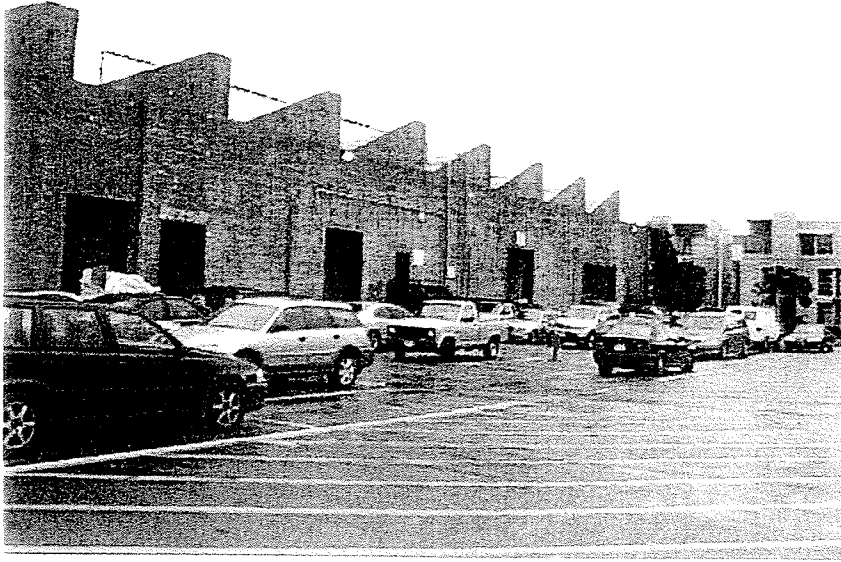
Photo 1.
View of east side of Hollis Street building, looking north.

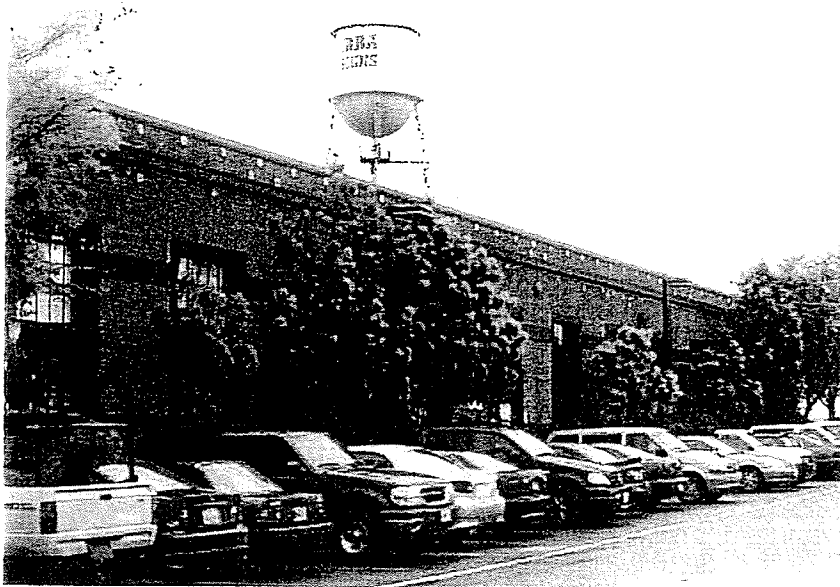
Photo 2.
View of south side of Powell Street building, looking east.

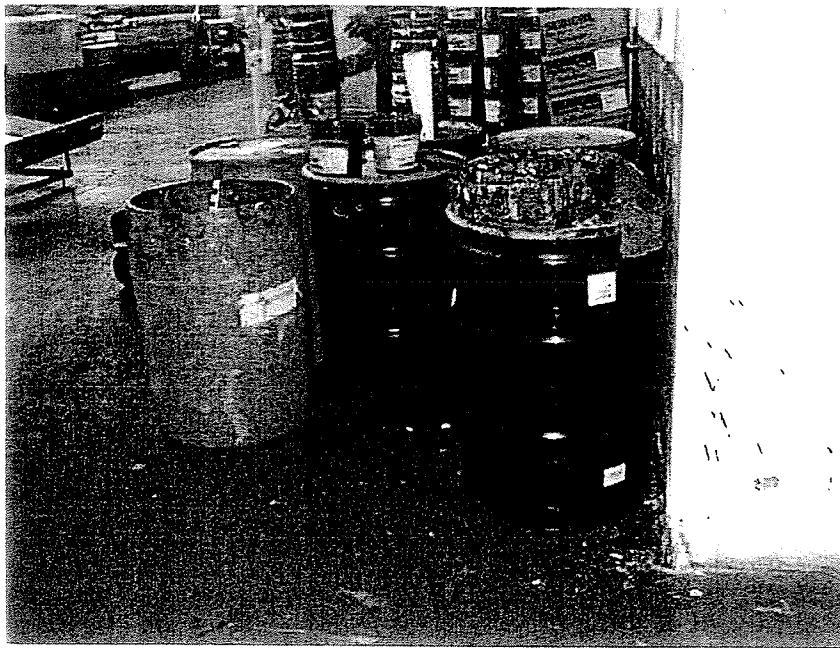
Photo 1.
Waste paint and solvent storage at Bel Aire Displays.

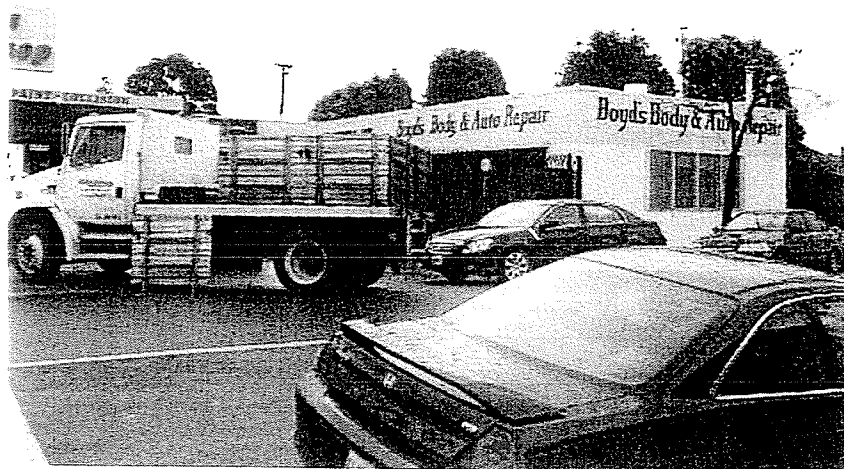
Boyd's Body Shop, 1245 Powell Street, is located immediately east of the subject property across Beaudry Street. The site is listed on the RCRA-SQG and HAZNET databases. There are no RCRA violations listed for the facility. The HAZNET database lists offsite disposal of wastes typically associated with an auto body shop. ACDEH records noted waste paint and waste solvent at the site during their 1994 inspection. No violations were noted. ACDEH records do not indicate the presence of any USTs at the site. However, historical aerial photographs (Section 2.6.1) and Sanborn Fire Insurance Maps (Section 2.6.2) suggest the possible historical presence of a gas station at the facility in the late 1950s and 1960s. The potential exists that USTs remain at the facility, or were historically removed from the facility. Because the facility is immediately upgradient of the subject property, any groundwater contamination present at the facility has the potential to affect the subject property.

Photo 1.
Boyd's Body and Auto Repair east of subject property.
