28 November 2006  
Project 4017.02

Subject: Updated Phase I Environmental Site Assessment  
11759 Dublin Boulevard  
Dublin, California

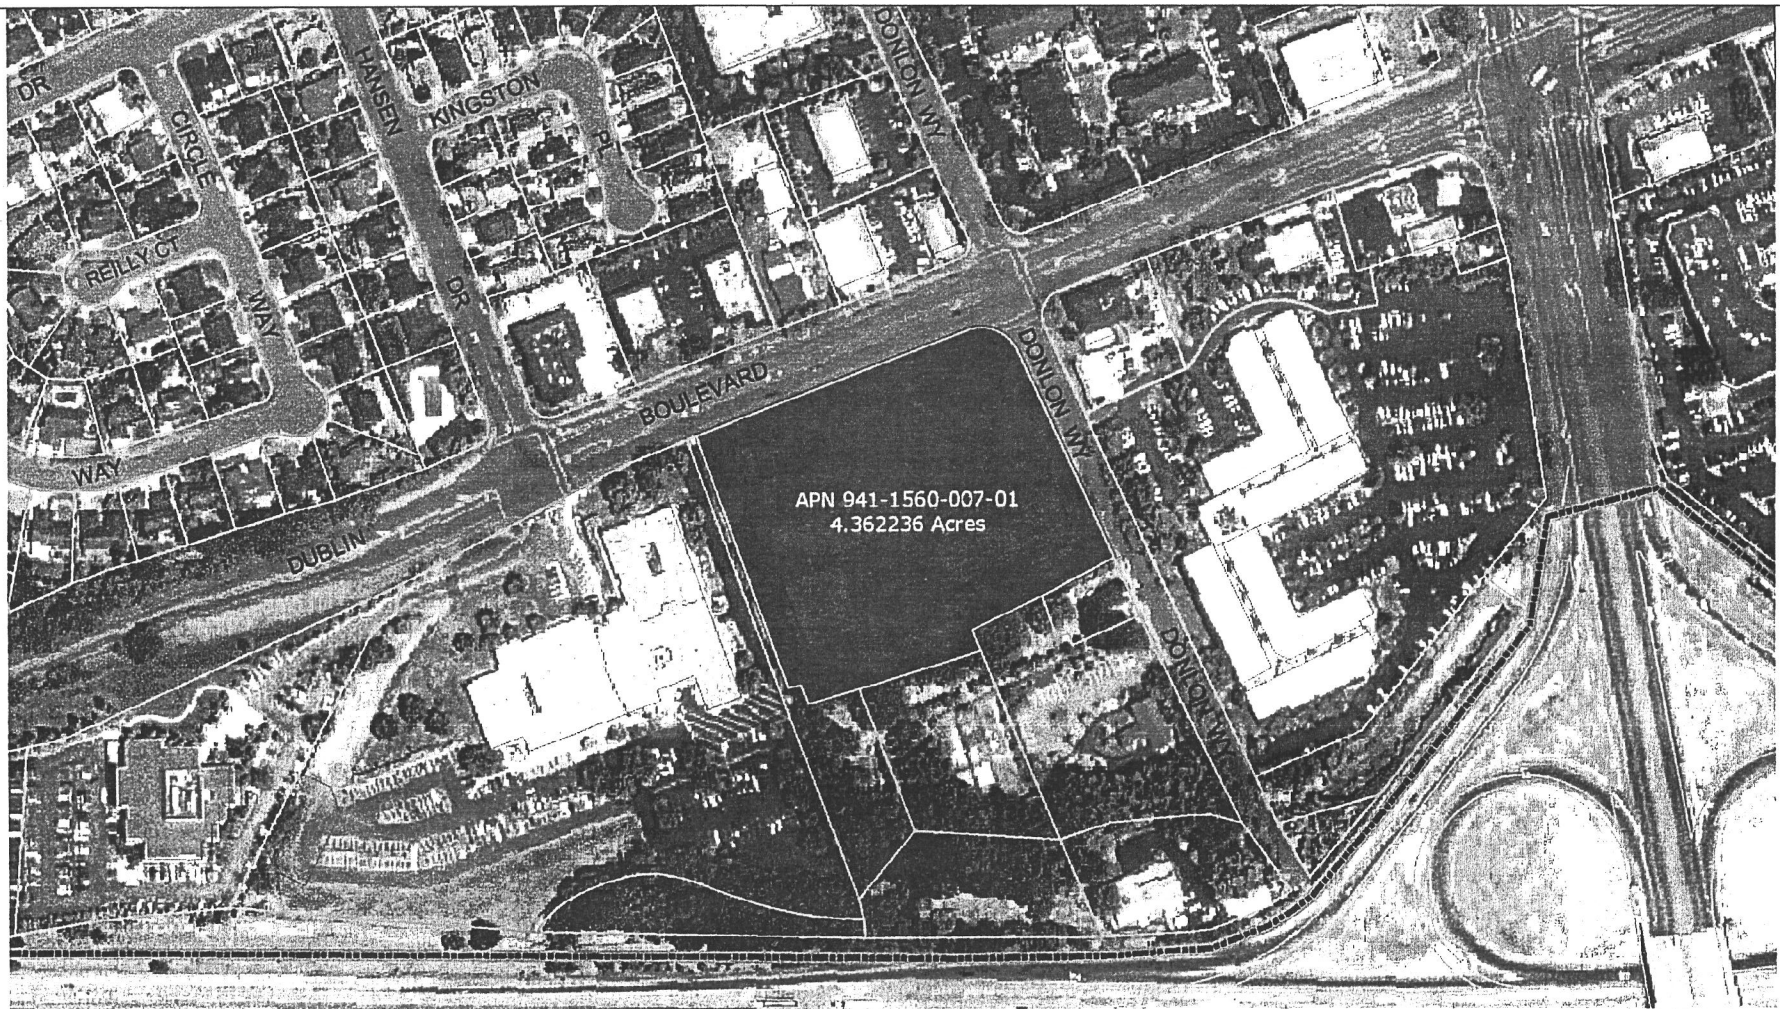
Date 12/10/04	Project No. 4017.01	Figure 2
---------------	---------------------	----------

The 11759 Dublin Boulevard property is about 4.36 acres in area and is occupied by two buildings and a parking area and called Dublin Square Center (Figure 2). The Site is located in a mixed commercial and residential area of Dublin, California. It is bounded by Dublin Boulevard to the north, Donlon Way to the east, commercial properties to the west, and residential properties and a cemetery to the south. The Site is at an elevation ranging from about 400 feet above mean sea level (msl) and slopes downward in a northeasterly direction.

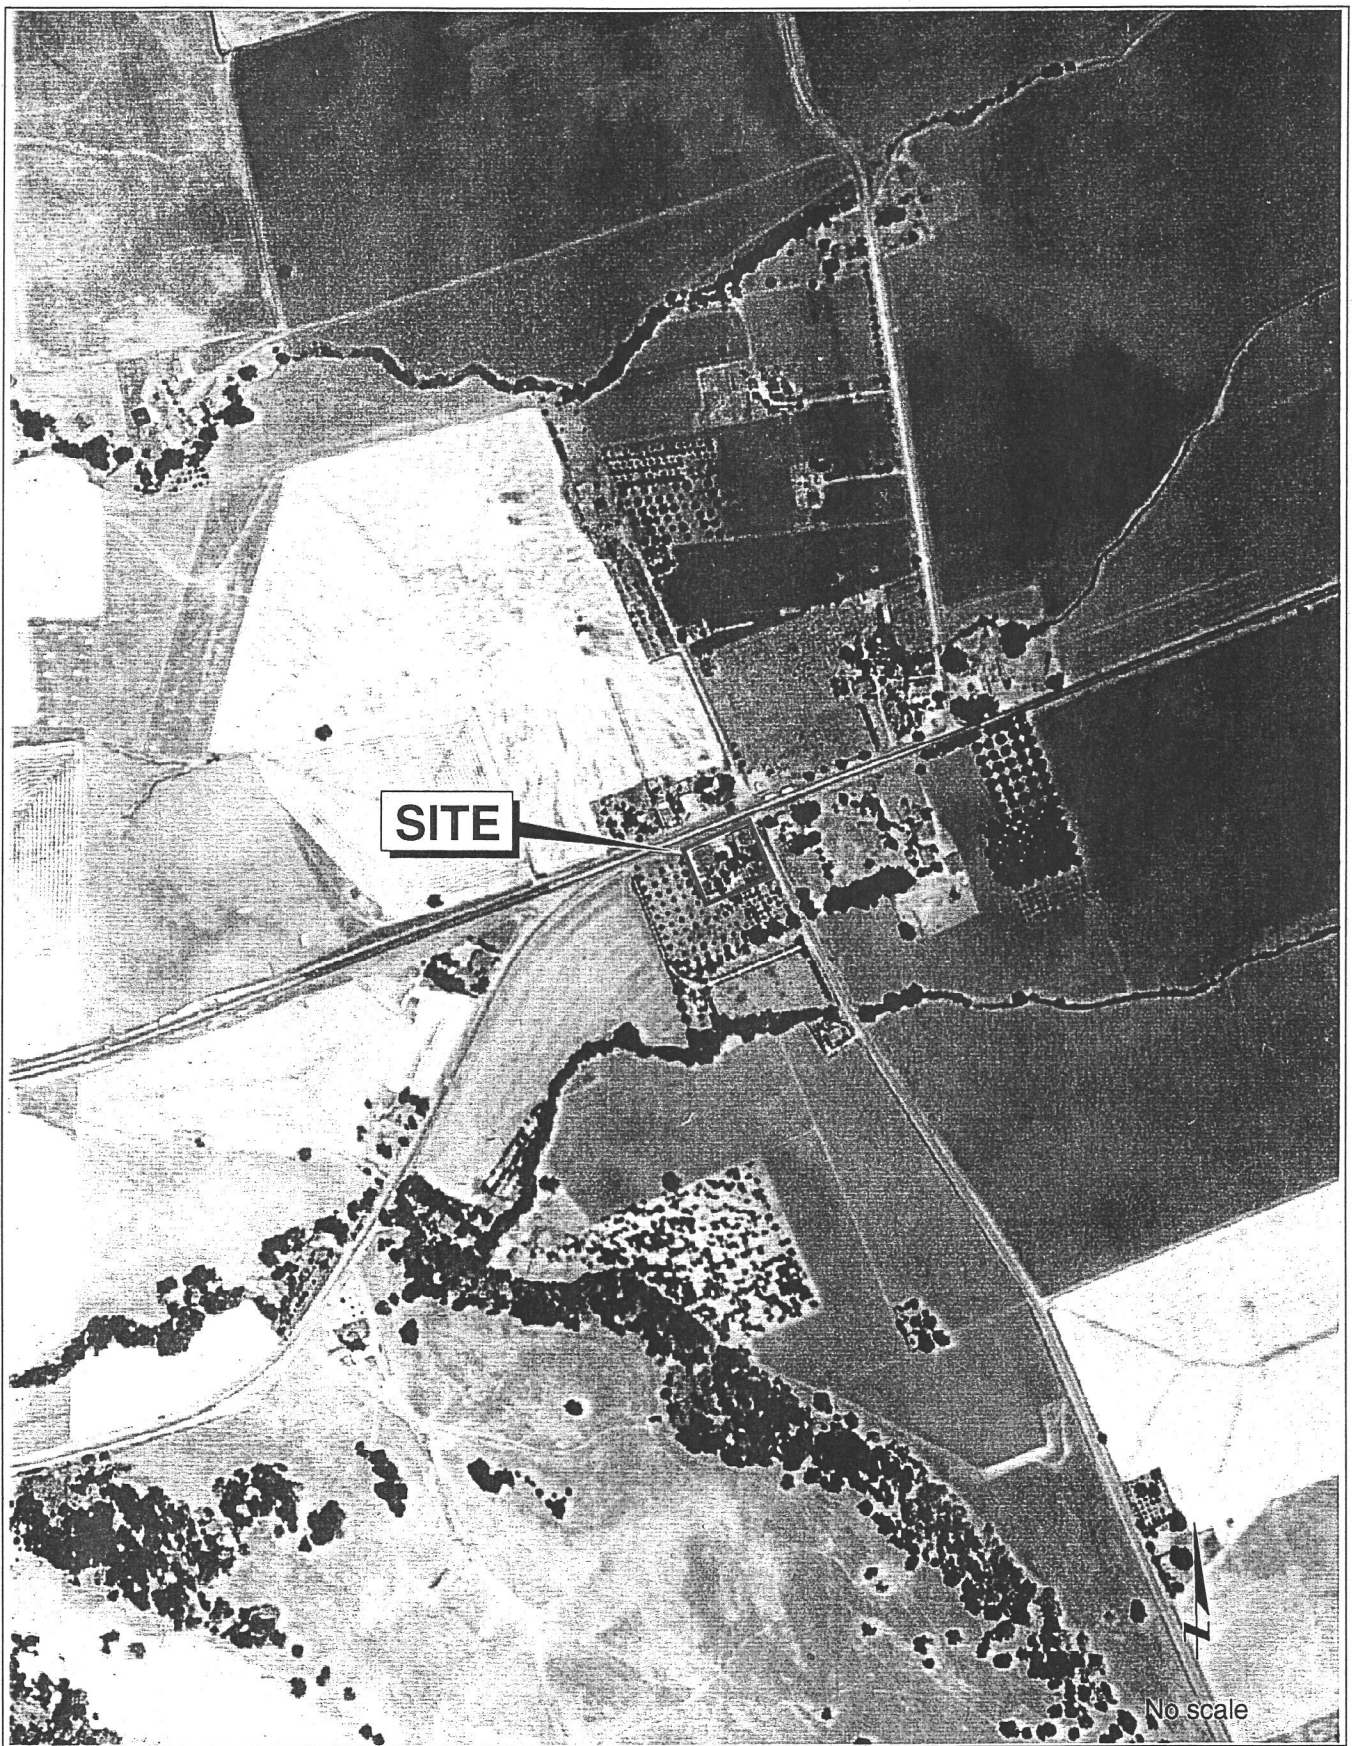
Figure B-1

1939 AERIAL PHOTOGRAPH

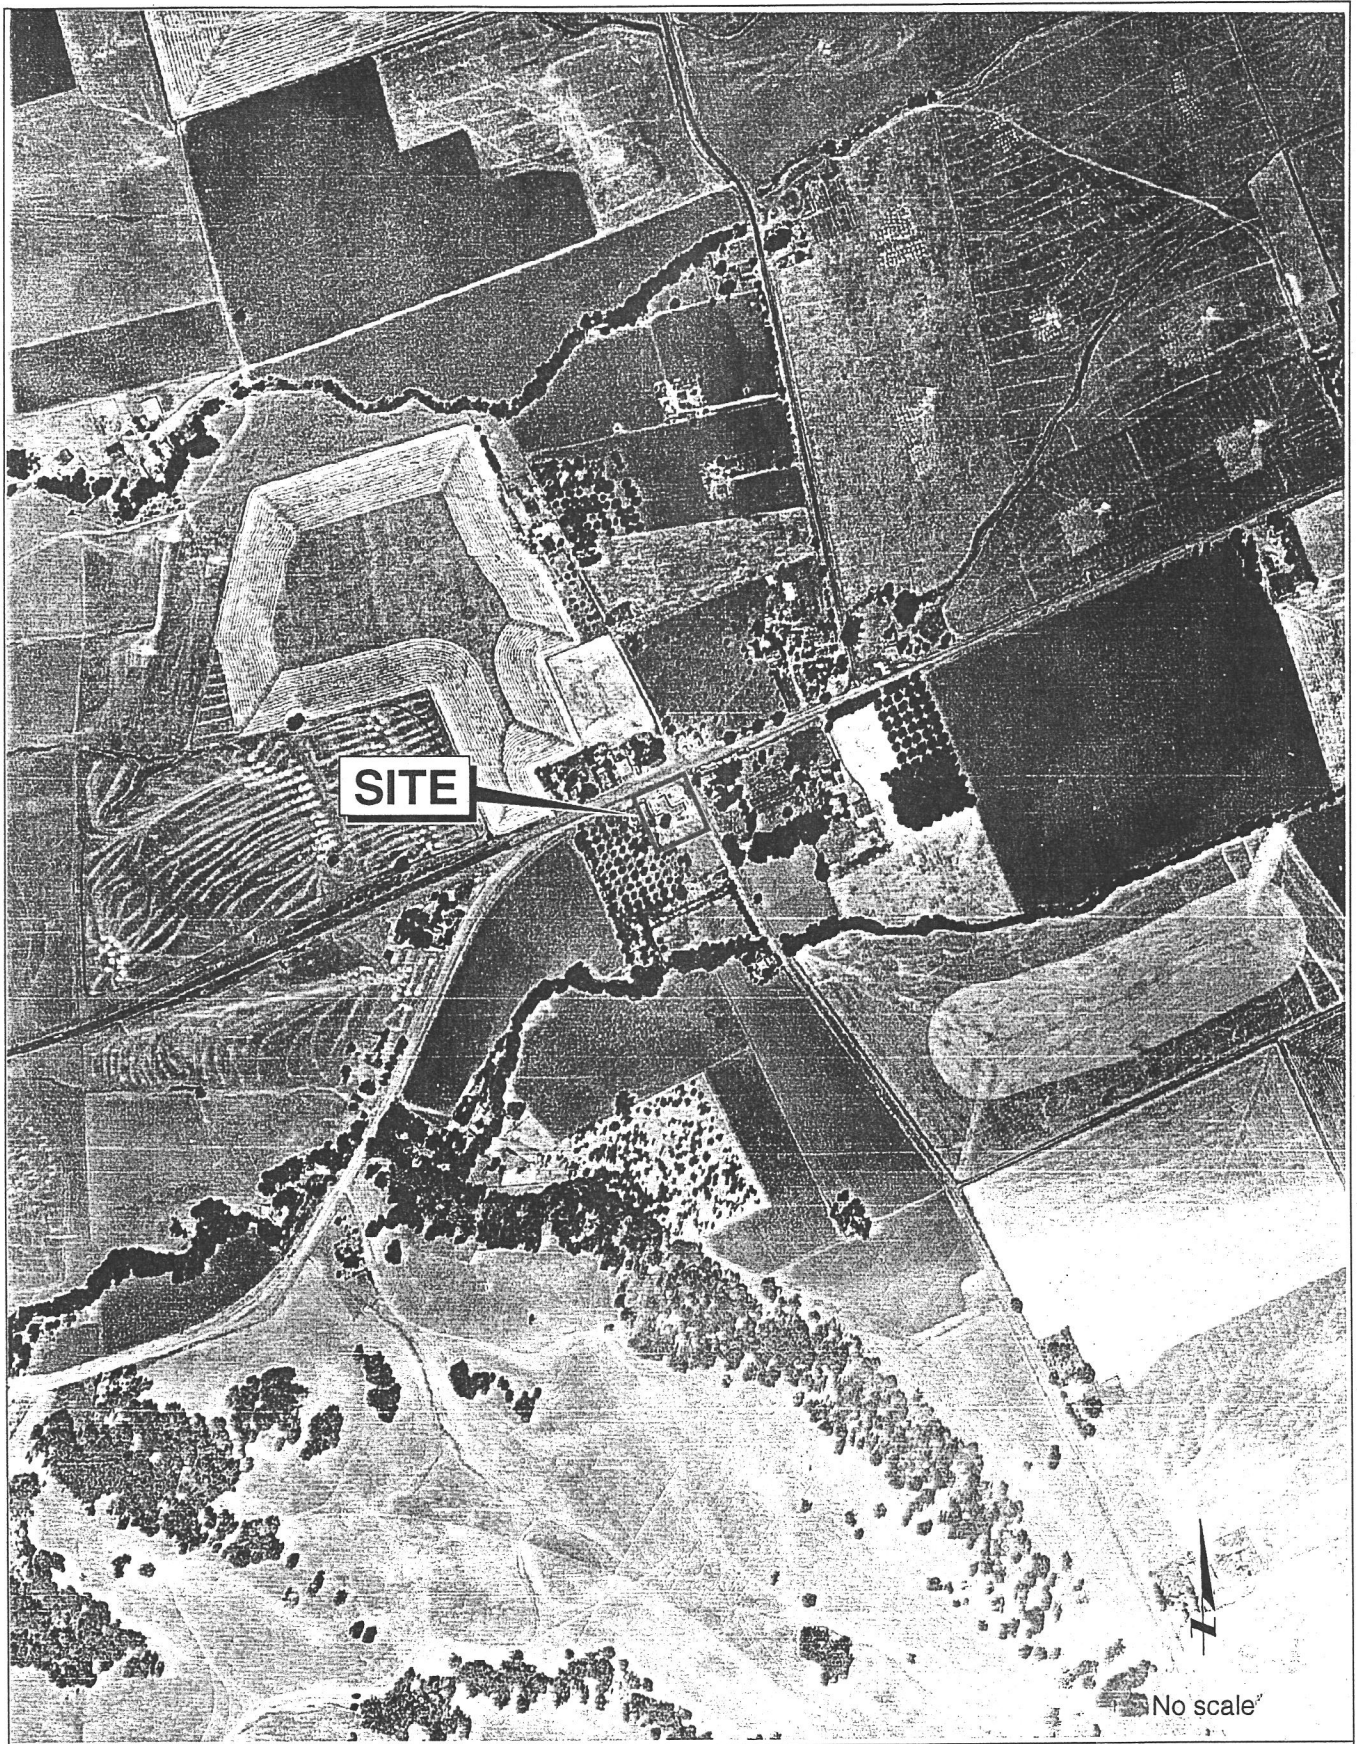
Figure B-2

The 1946 and 1958 aerial photograph show the Site and surrounding areas as unchanged from the 1939 aerial photograph. The freeway off-ramps are present to the southeast of the Site in the 1958 aerial photograph. The 1961 historical topographic map shows the Site and surrounding areas as developed. The 1965 aerial photograph shows the Site as unoccupied with an industrial building to the west of the Site. Residential properties are present to the northwest and agricultural land is present to the north, south, and east of the Site.

1946 AERIAL PHOTOGRAPH

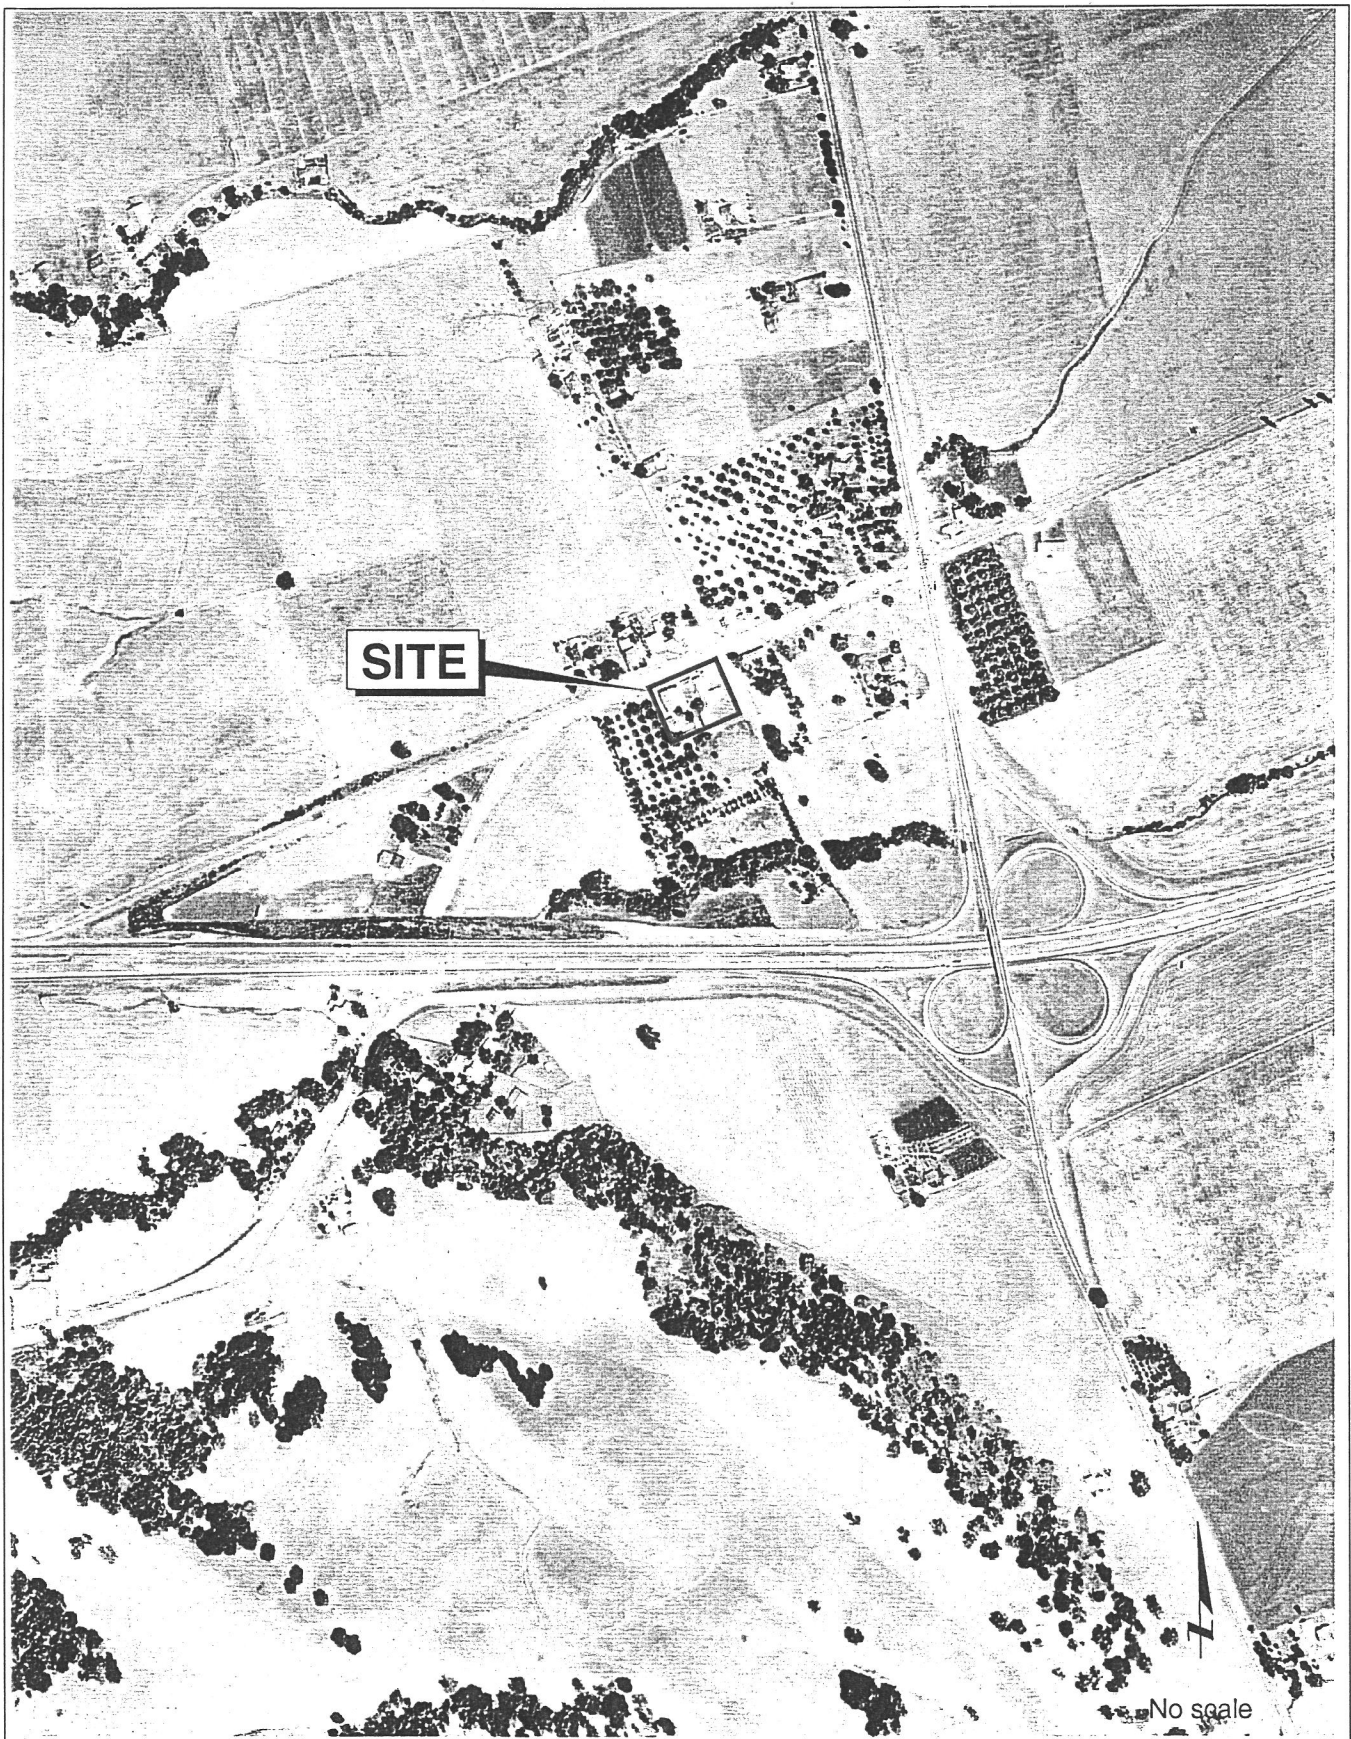
Figure B-3

1958 AERIAL PHOTOGRAPH

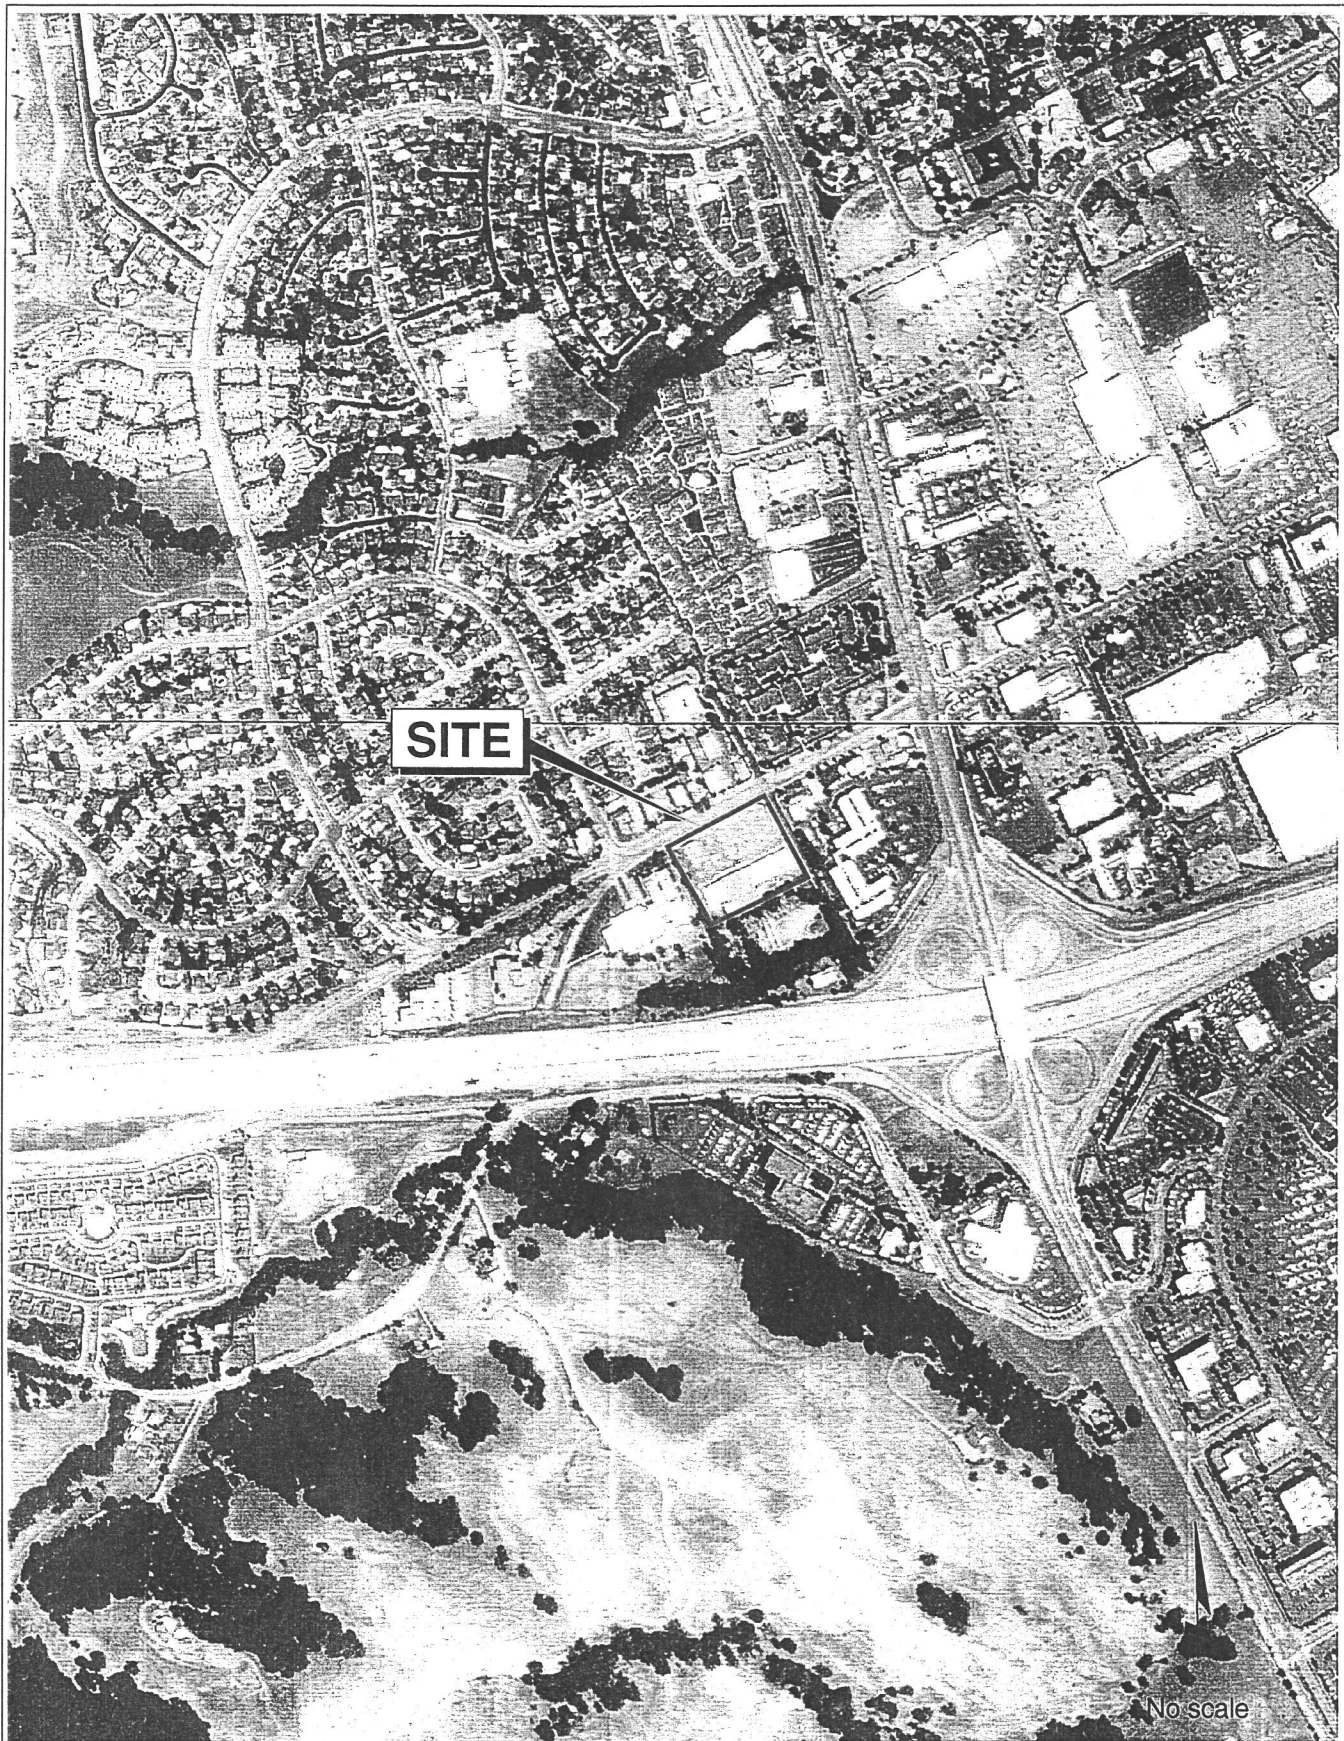
The 1982 aerial photograph shows the Site occupied by two buildings and a parking area, as it appears today. Residential buildings are present to the north, east, west, and south of the Site. The surrounding properties are shown densely populated in comparison to the 1965 aerial photograph. No significant changes to the Site and surrounding properties are shown on the 1993 aerial photograph.

1993 AERIAL PHOTOGRAPH
