Transmittal
Data Gaps Investigation Summary Report
Apex Refrigeration, Inc., Fuel Leak Case No. RO0003069, Emeryville, California

Data Gaps Investigation Summary Report
Apex Refrigeration, Inc.
1550 Park Avenue
Emeryville, California

ERRG Project No. 2013-094

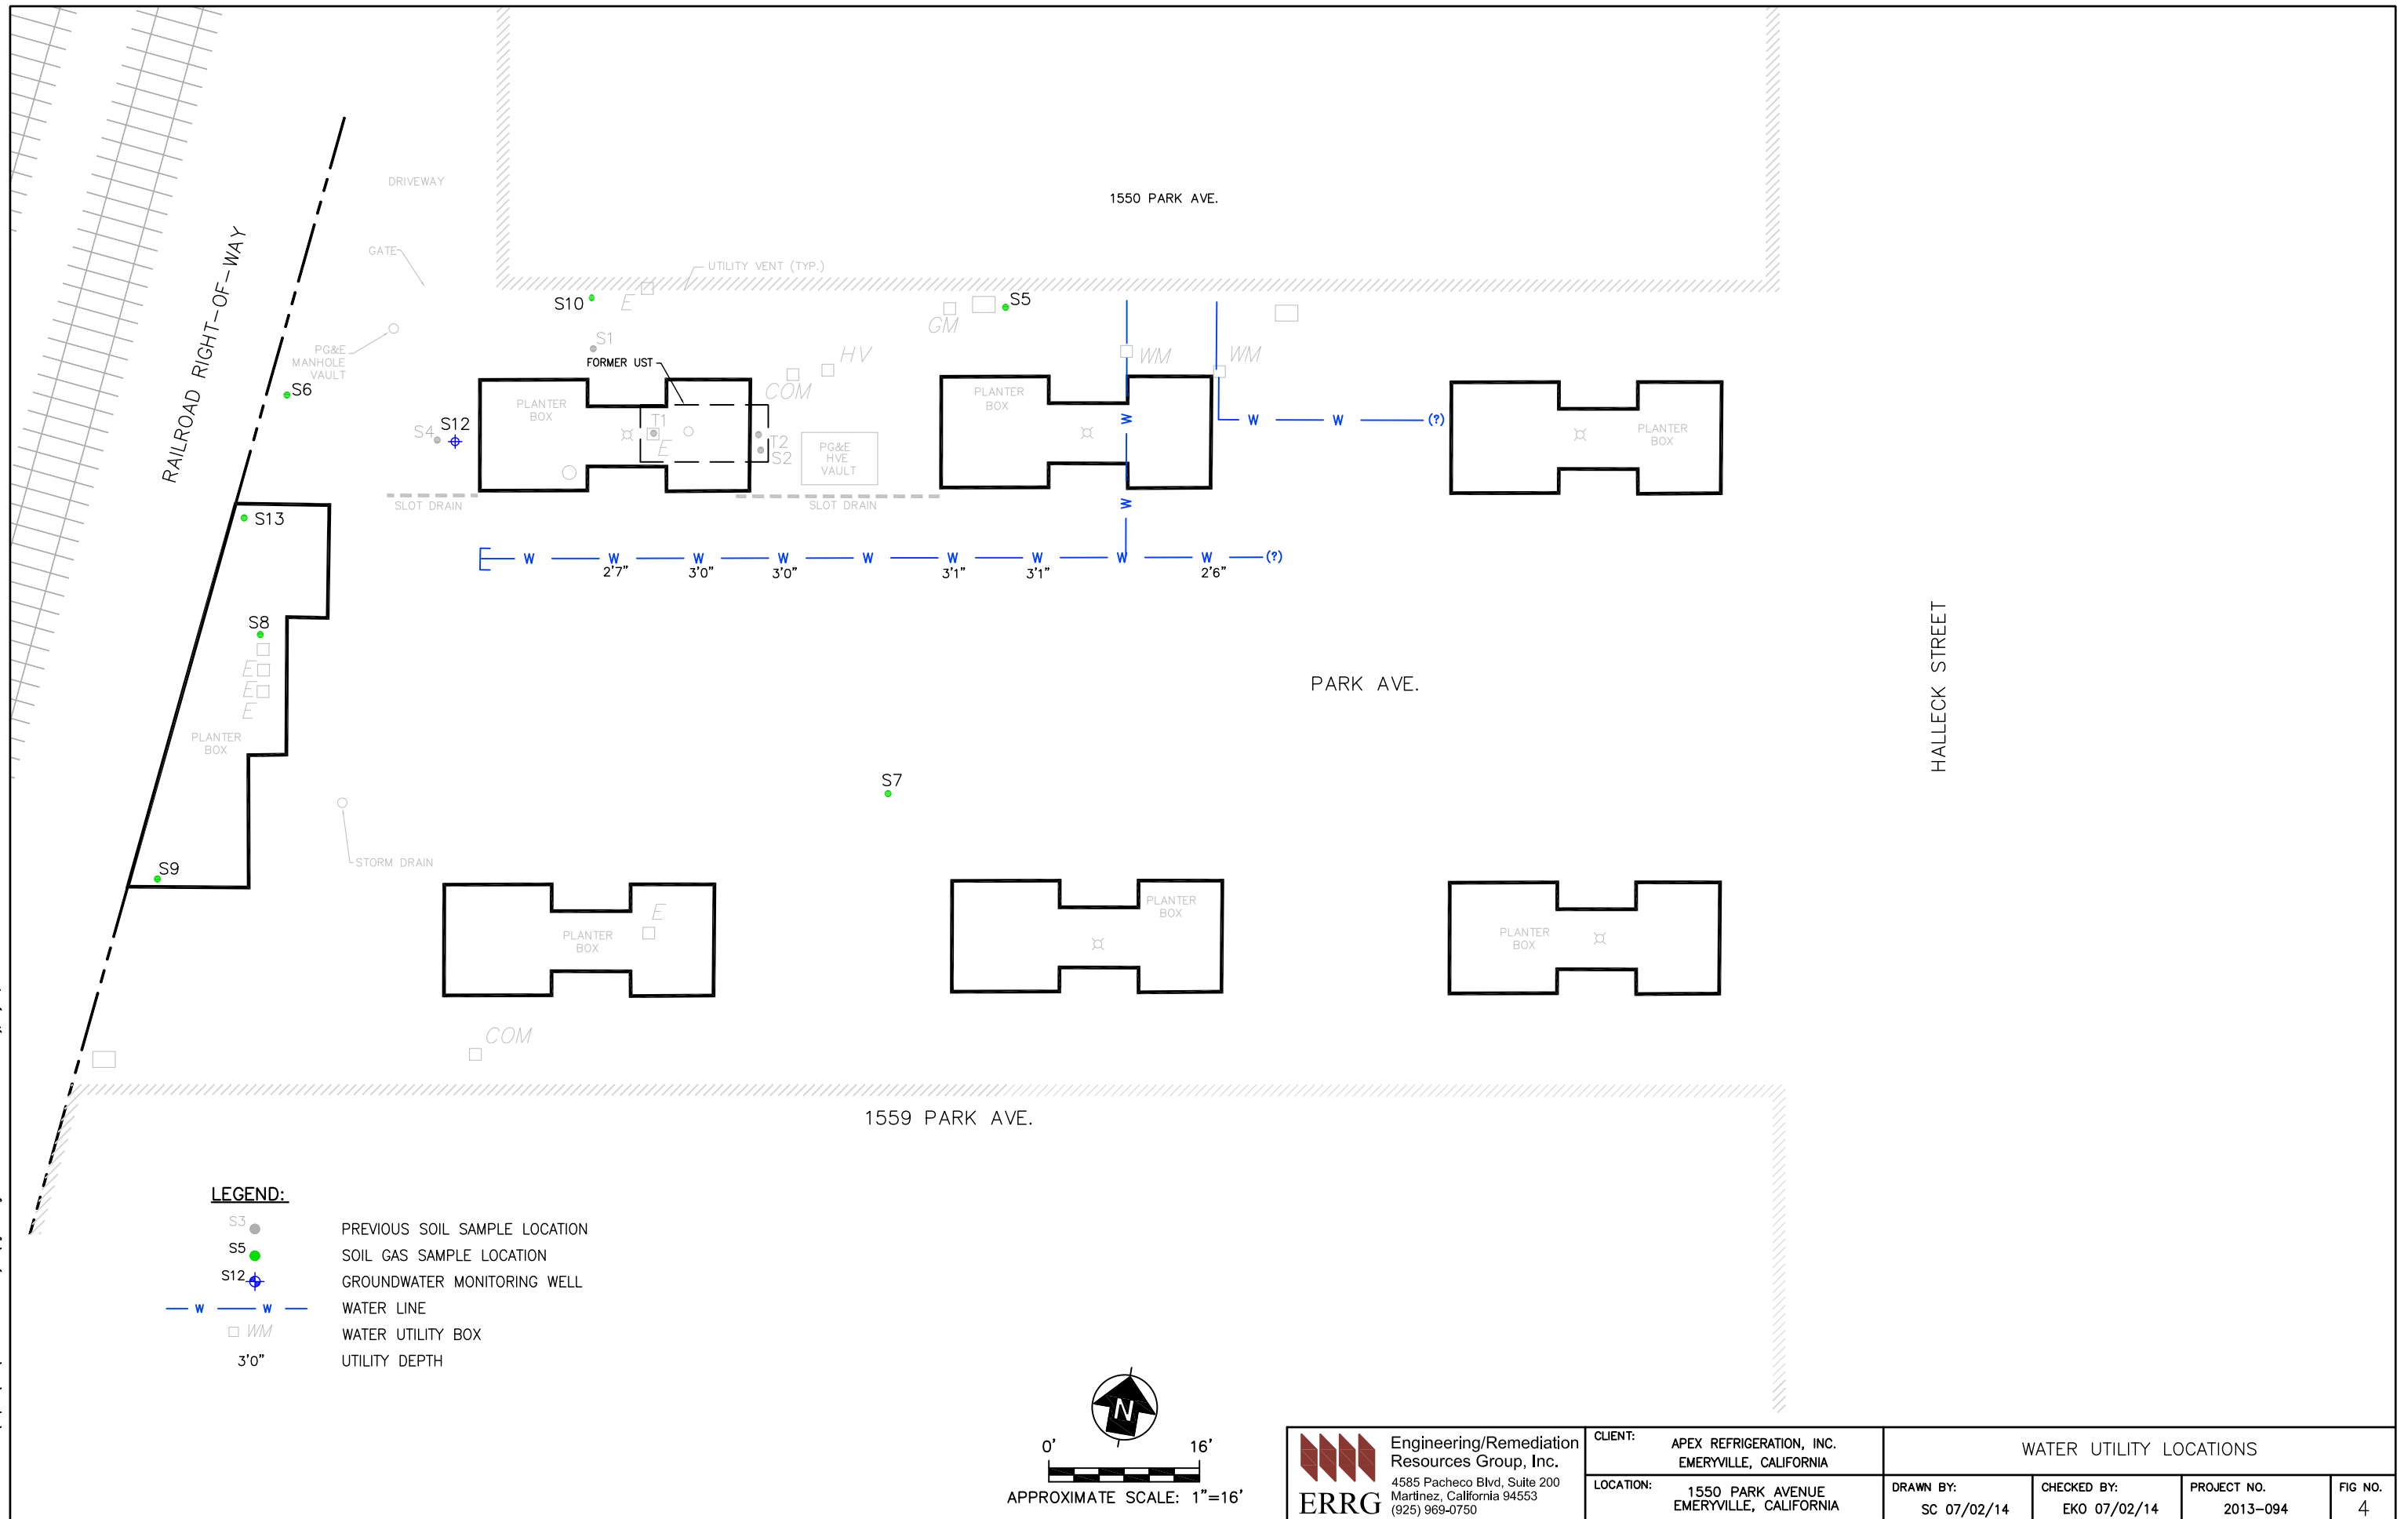
- S3 ● PREVIOUS SOIL SAMPLE LOCATION
- S5 ● SOIL GAS SAMPLE LOCATION
- S12 ⊕ GROUNDWATER MONITORING WELL
- W — W — WATER LINE
- WM WATER UTILITY BOX
- 3'0" UTILITY DEPTH

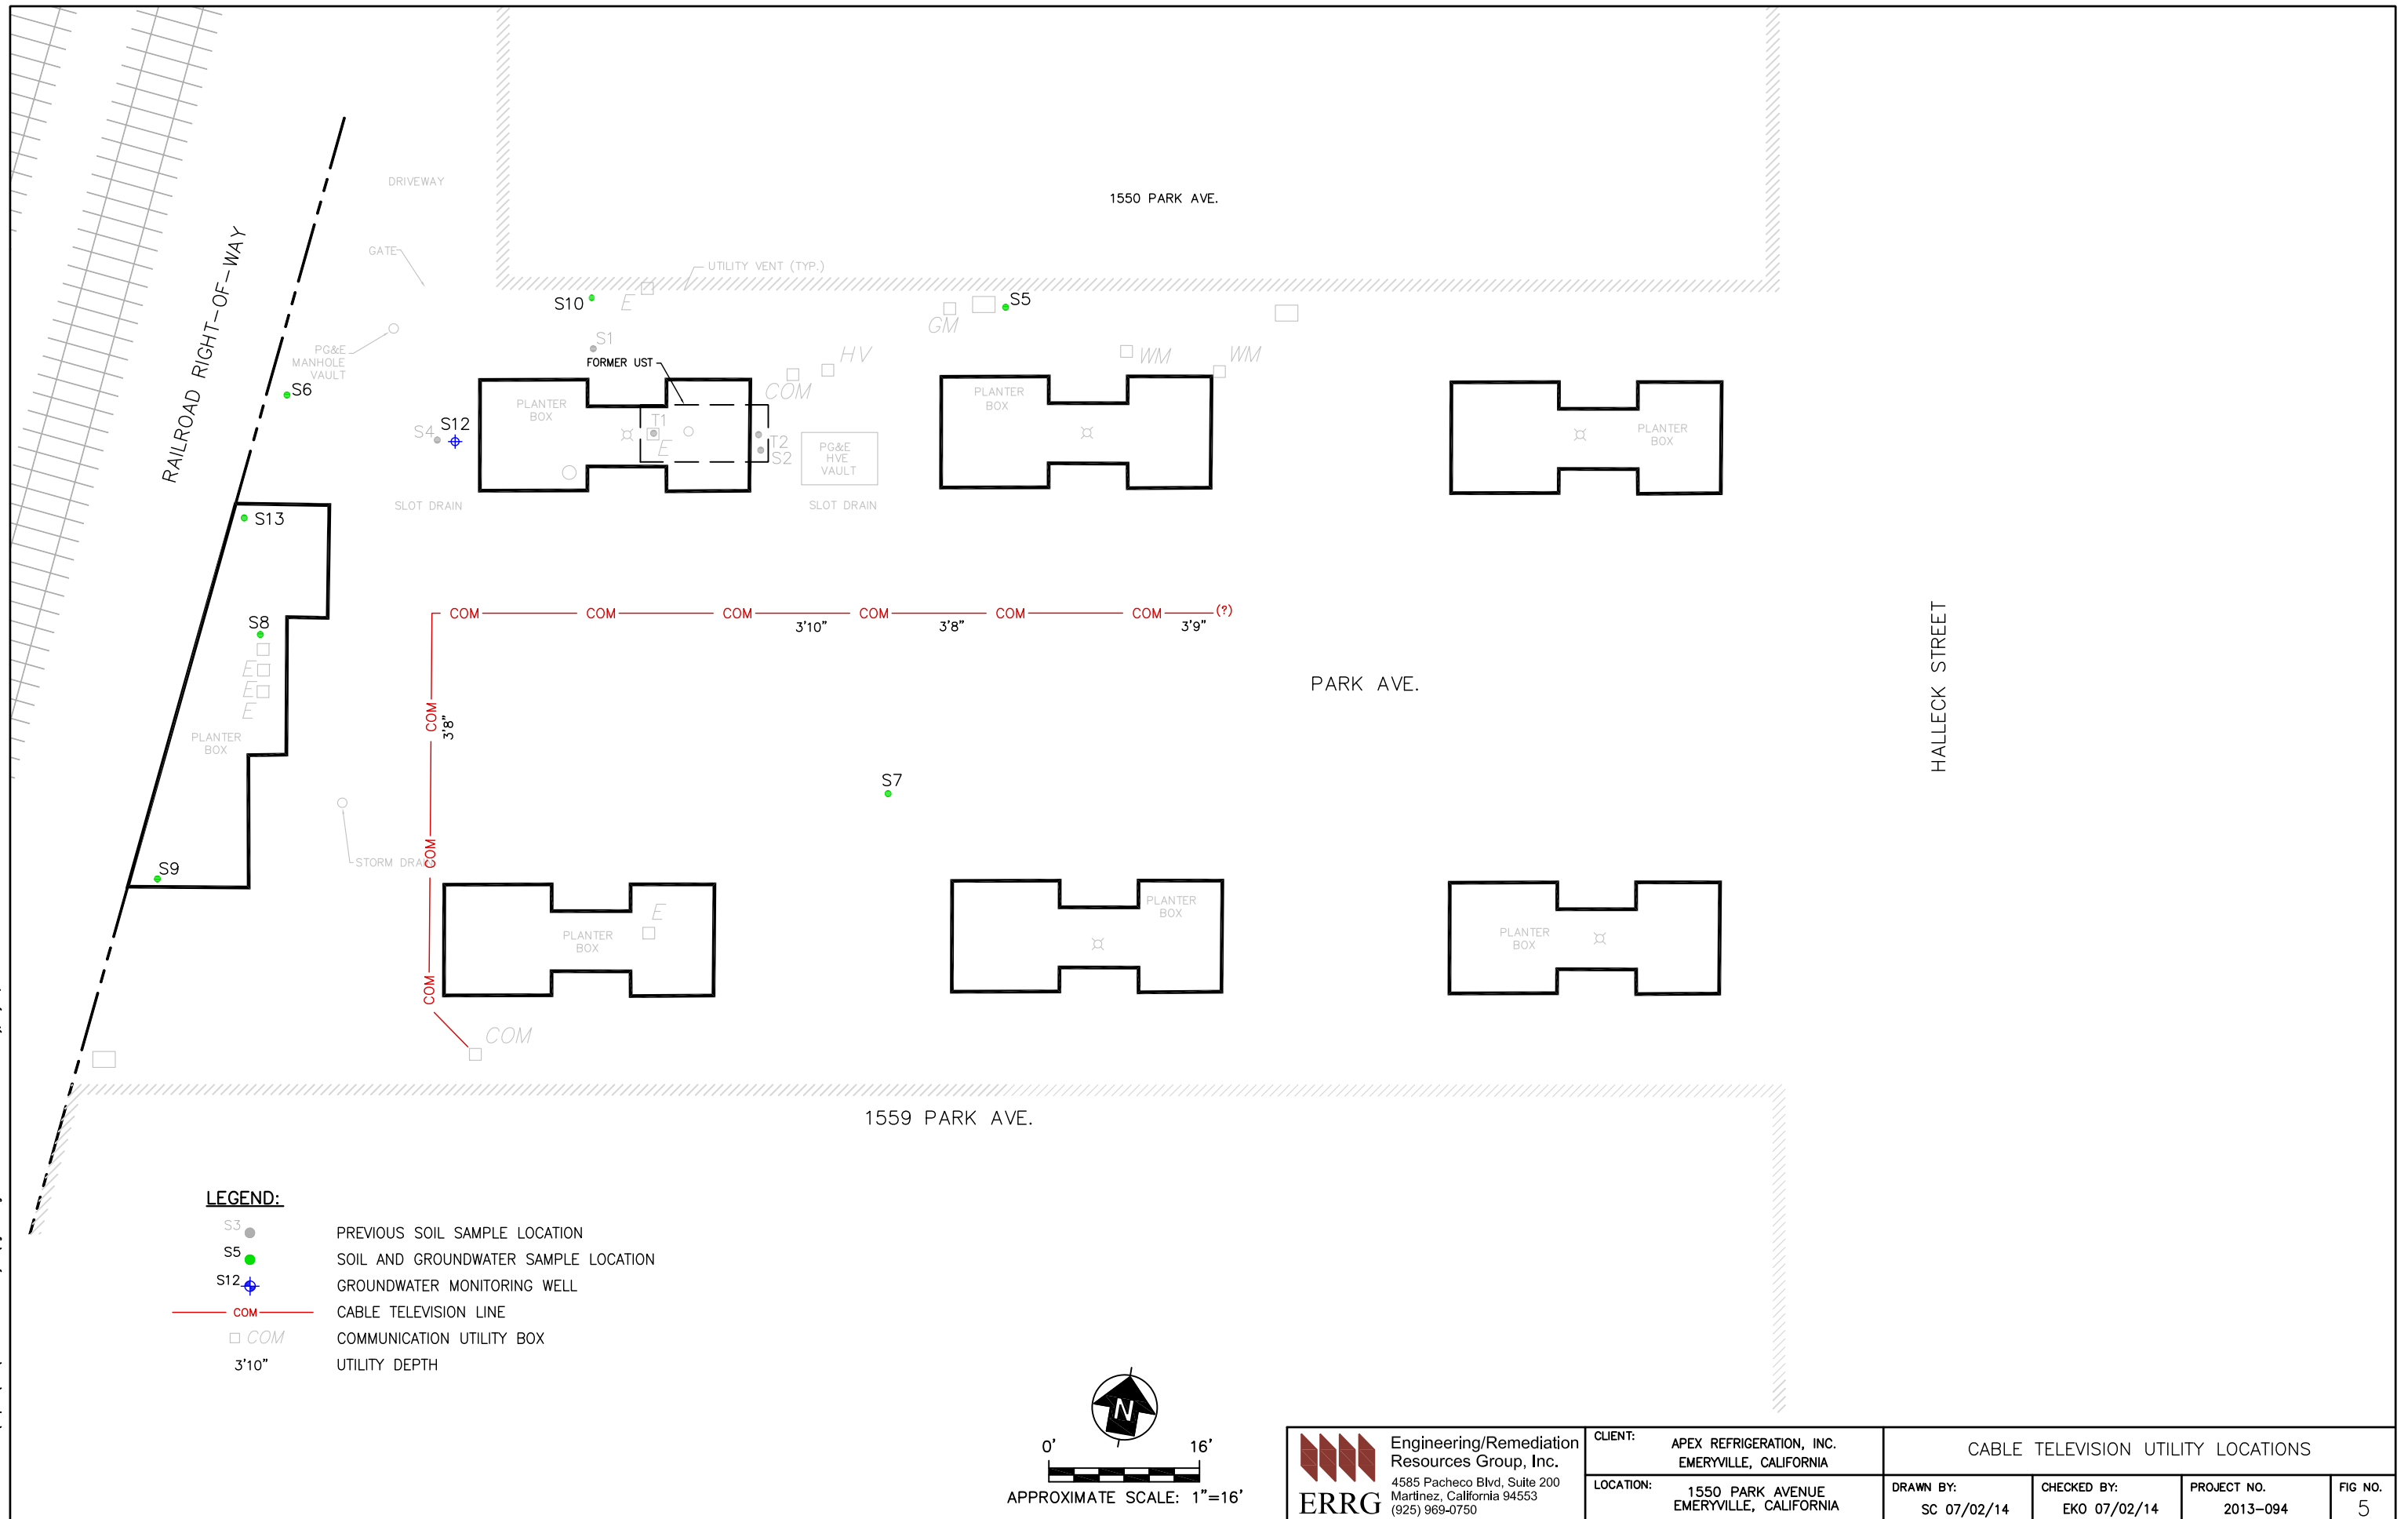
- S3 ● PREVIOUS SOIL SAMPLE LOCATION
- S5 ● SOIL AND GROUNDWATER SAMPLE LOCATION
- S12 ⊕ GROUNDWATER MONITORING WELL
- COM — CABLE TELEVISION LINE
- COM COMMUNICATION UTILITY BOX
- 3'10" UTILITY DEPTH

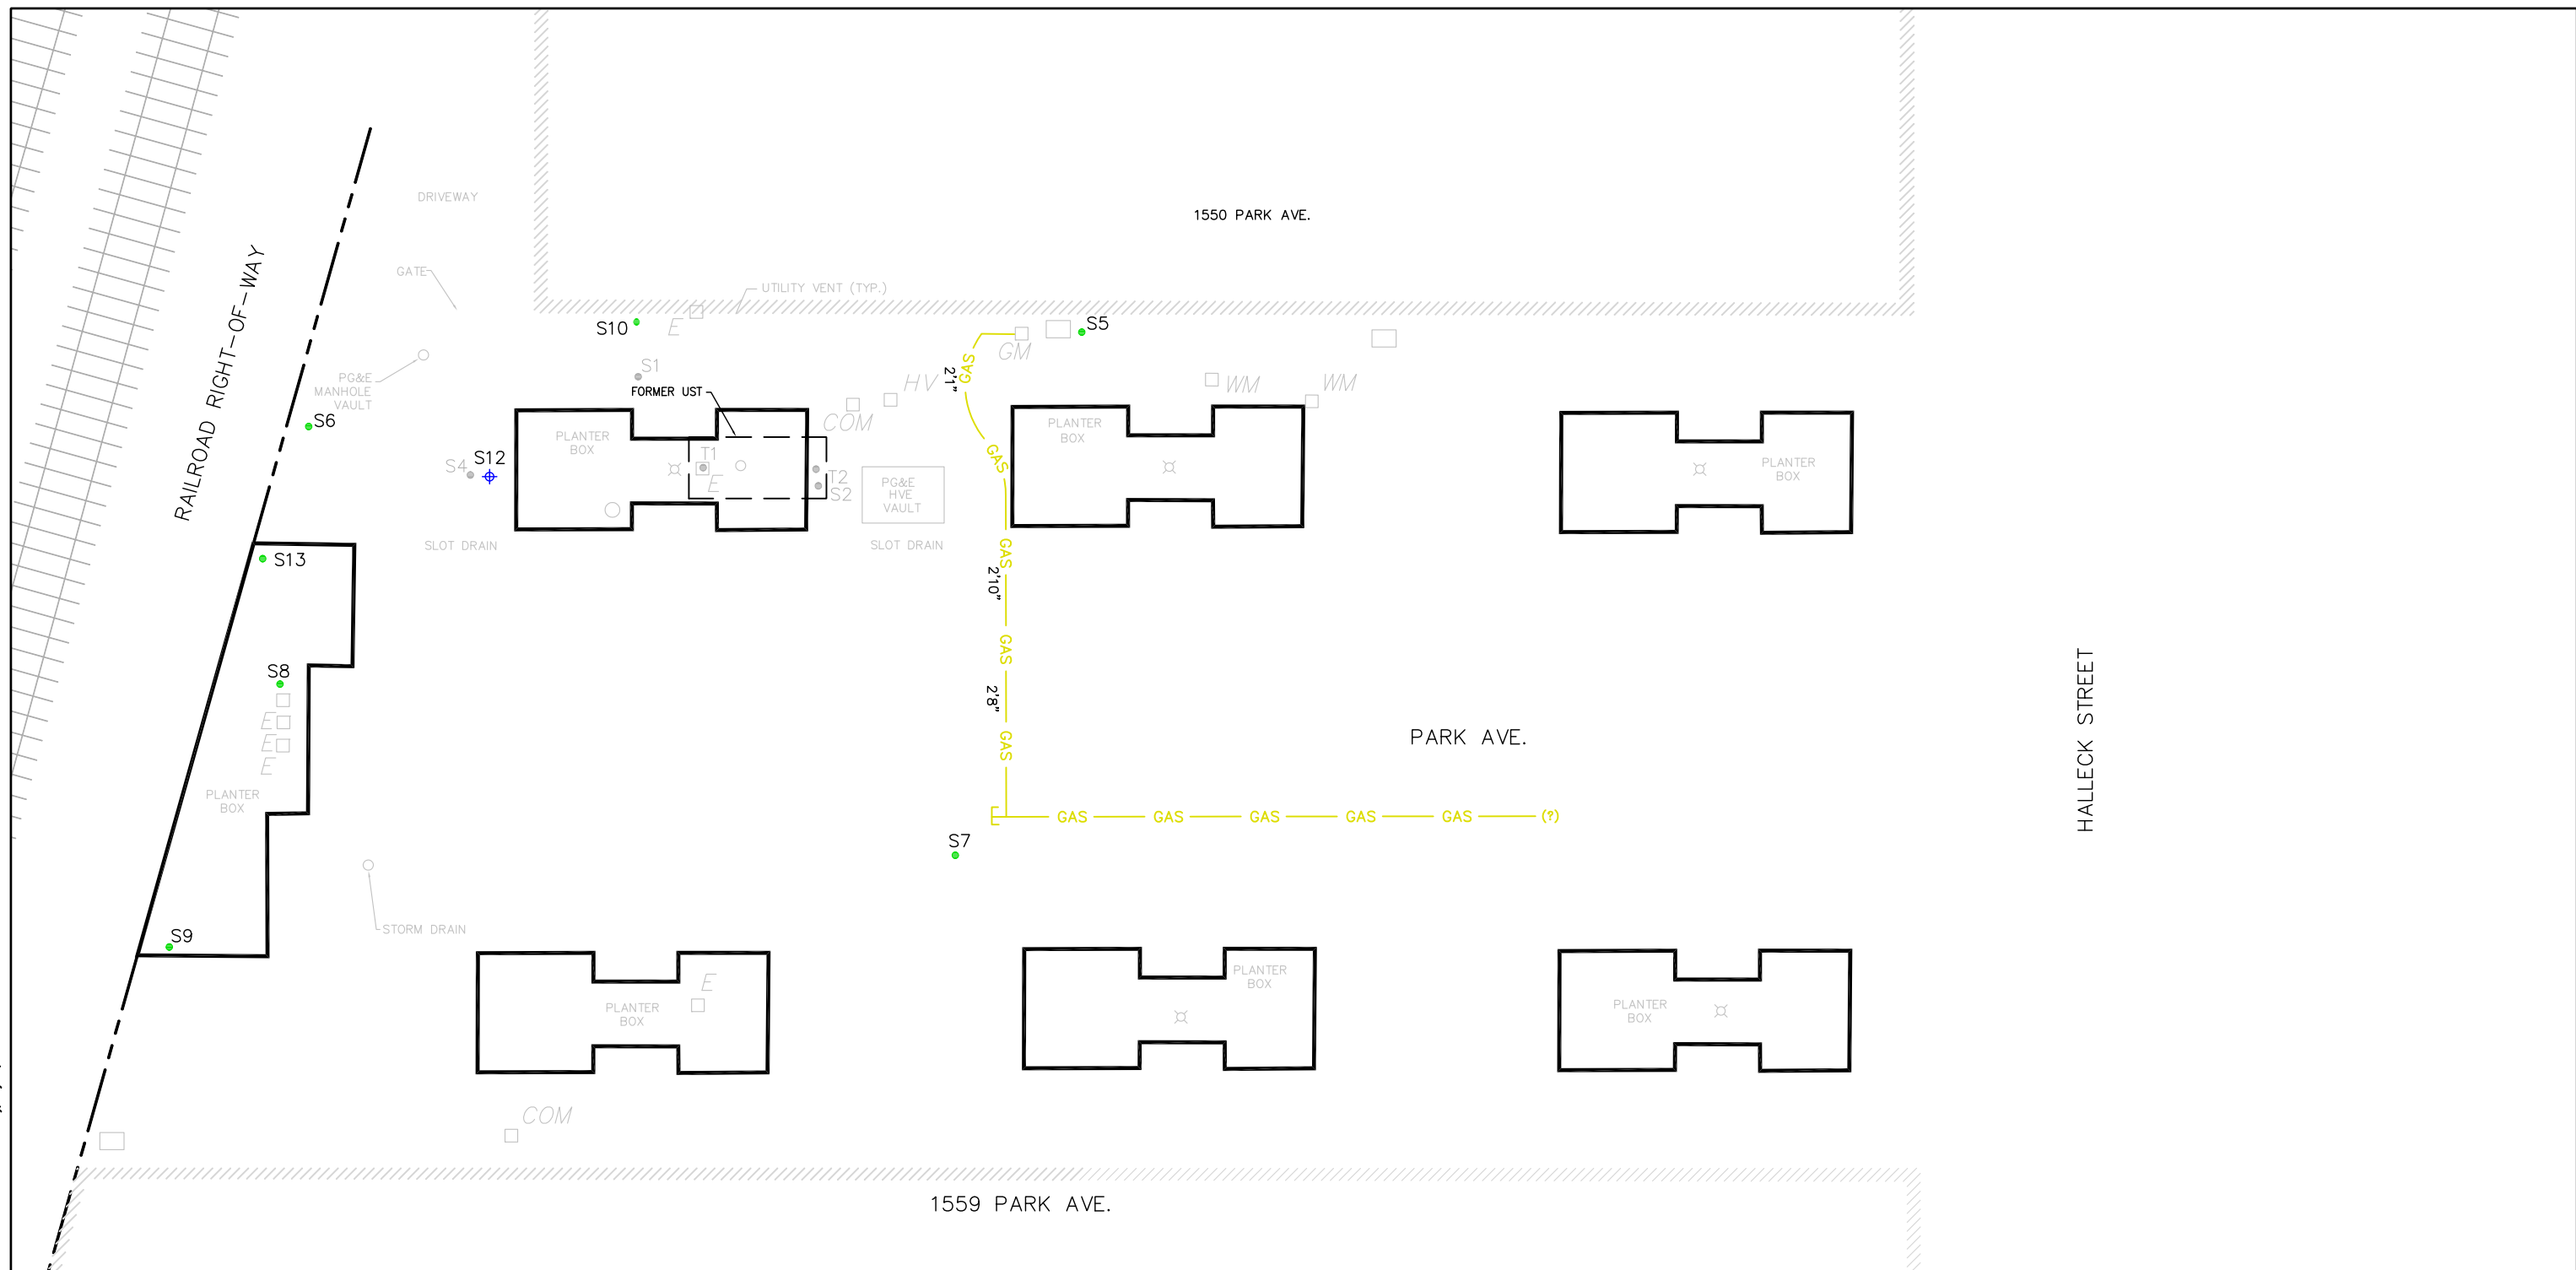
- S3 ● PREVIOUS SOIL SAMPLE LOCATION
- S5 ● SOIL AND GROUNDWATER SAMPLE LOCATION
- S12 ⊕ GROUNDWATER MONITORING WELL
- GAS — GAS LINE
- GM □ GAS METER UTILITY BOX
- 2'1" UTILITY DEPTH

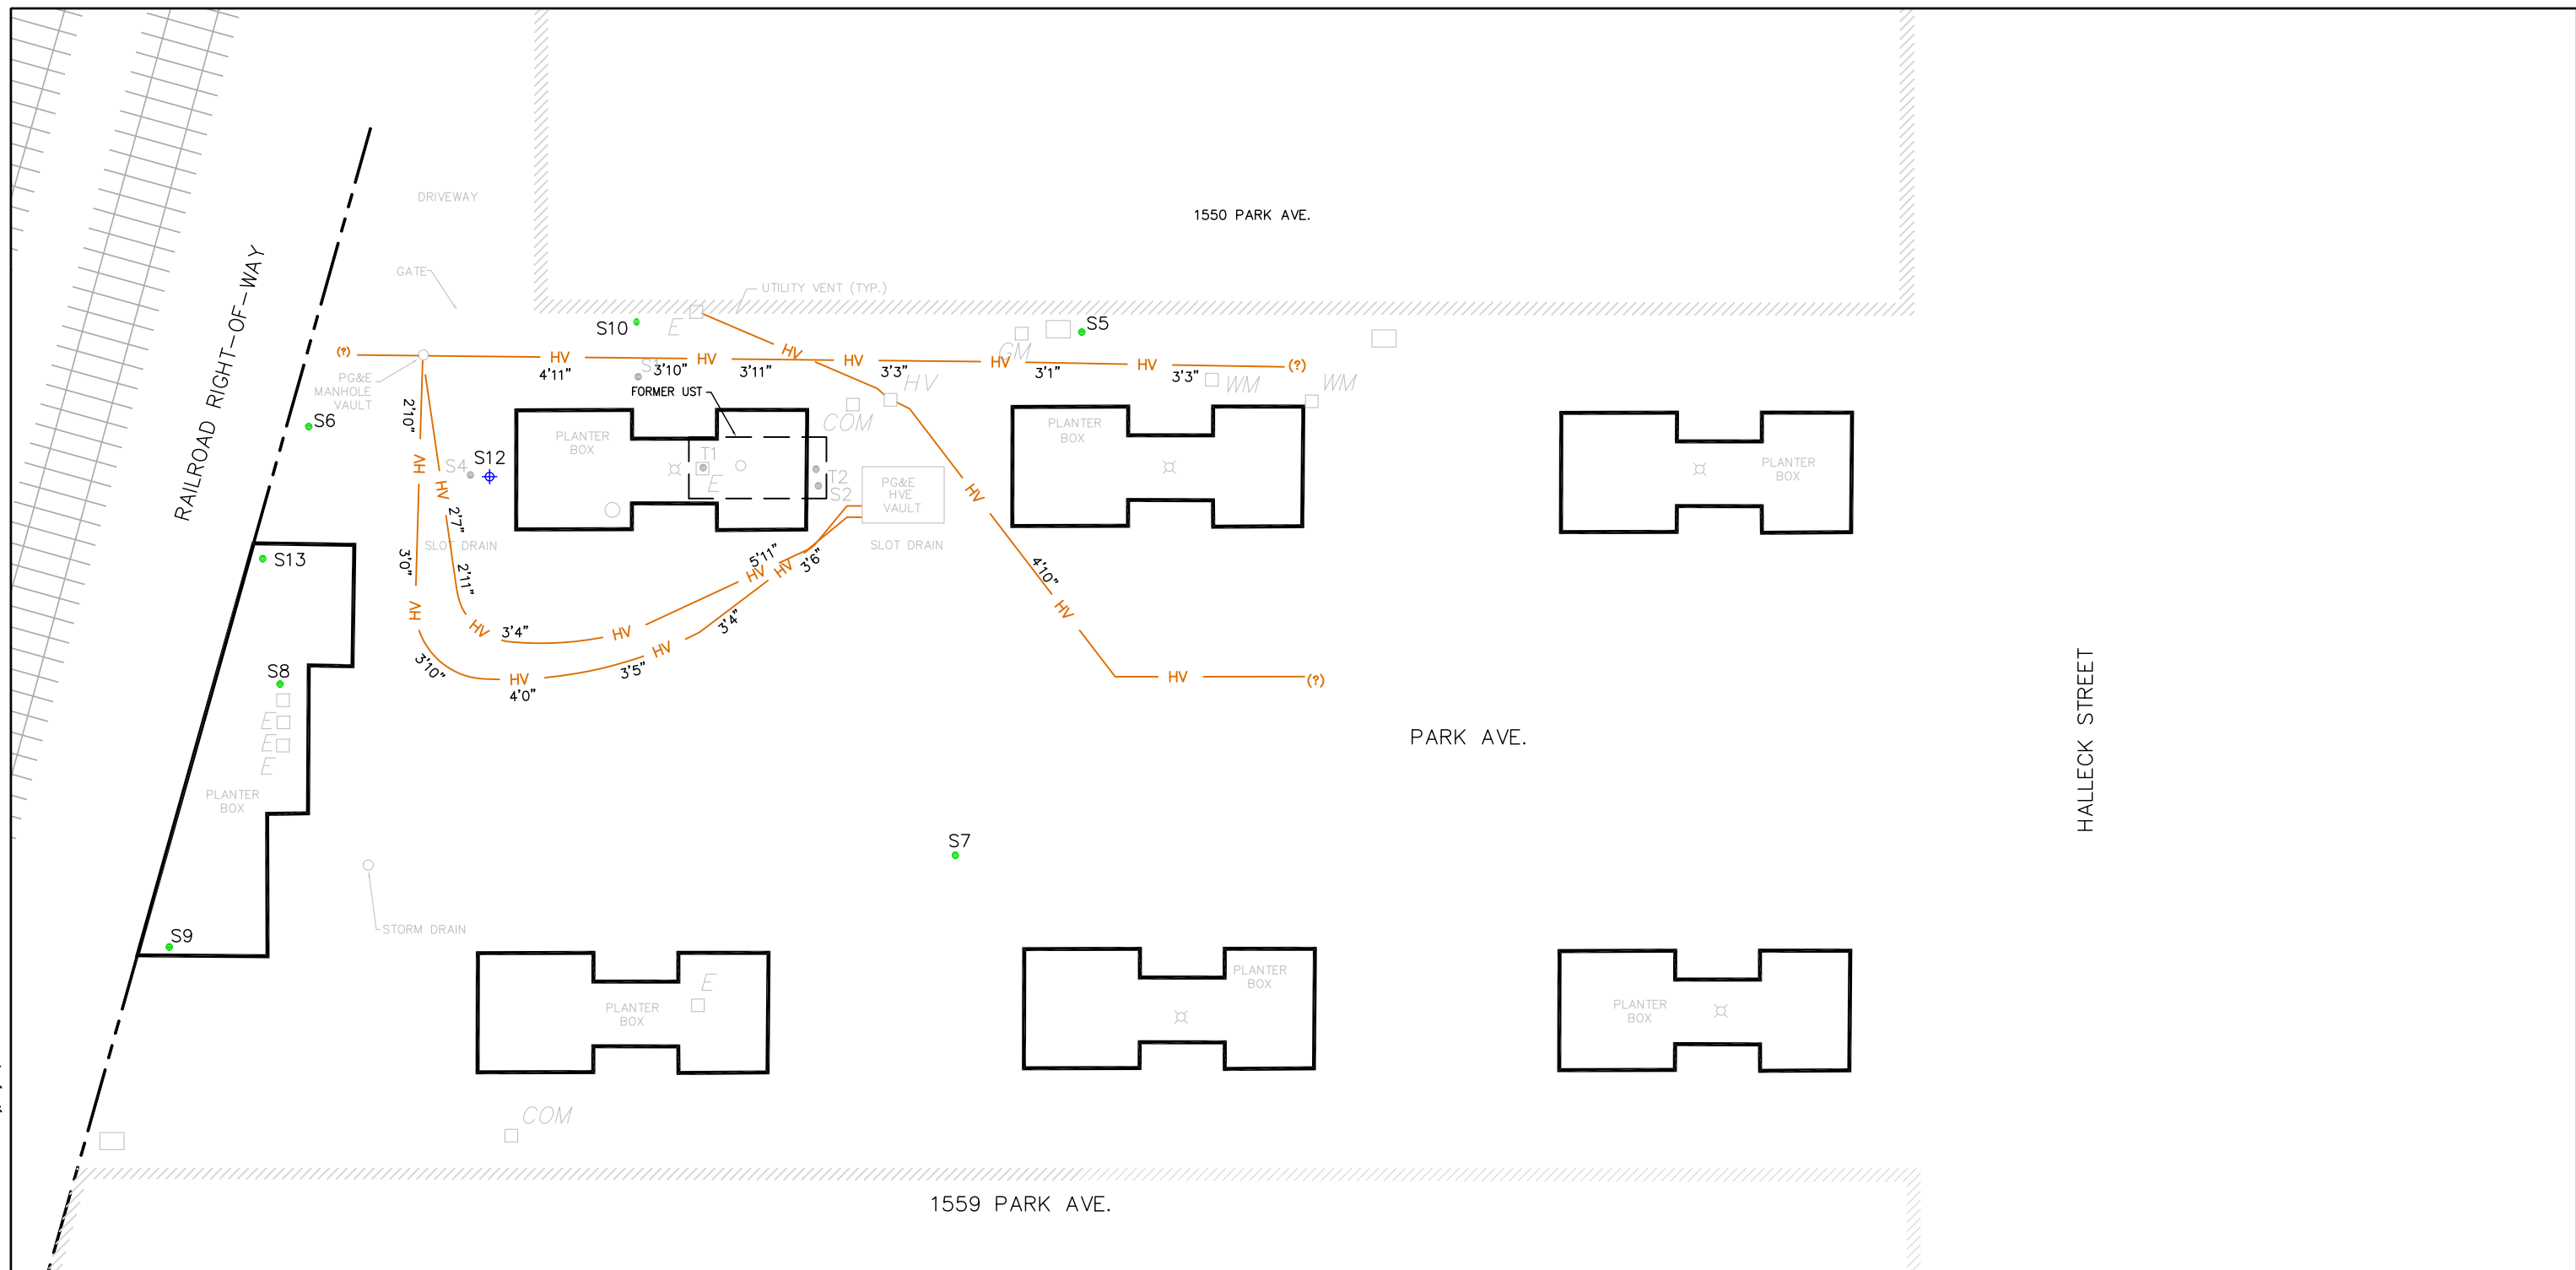
- S3 ● PREVIOUS SOIL SAMPLE LOCATION
- S5 ● SOIL AND GROUNDWATER SAMPLE LOCATION
- S12 ⊕ GROUNDWATER MONITORING WELL
- HV — HIGH VOLTAGE ELECTRICAL LINE
- E □ ELECTRICAL UTILITY BOX
- 3'0" — UTILITY DEPTH

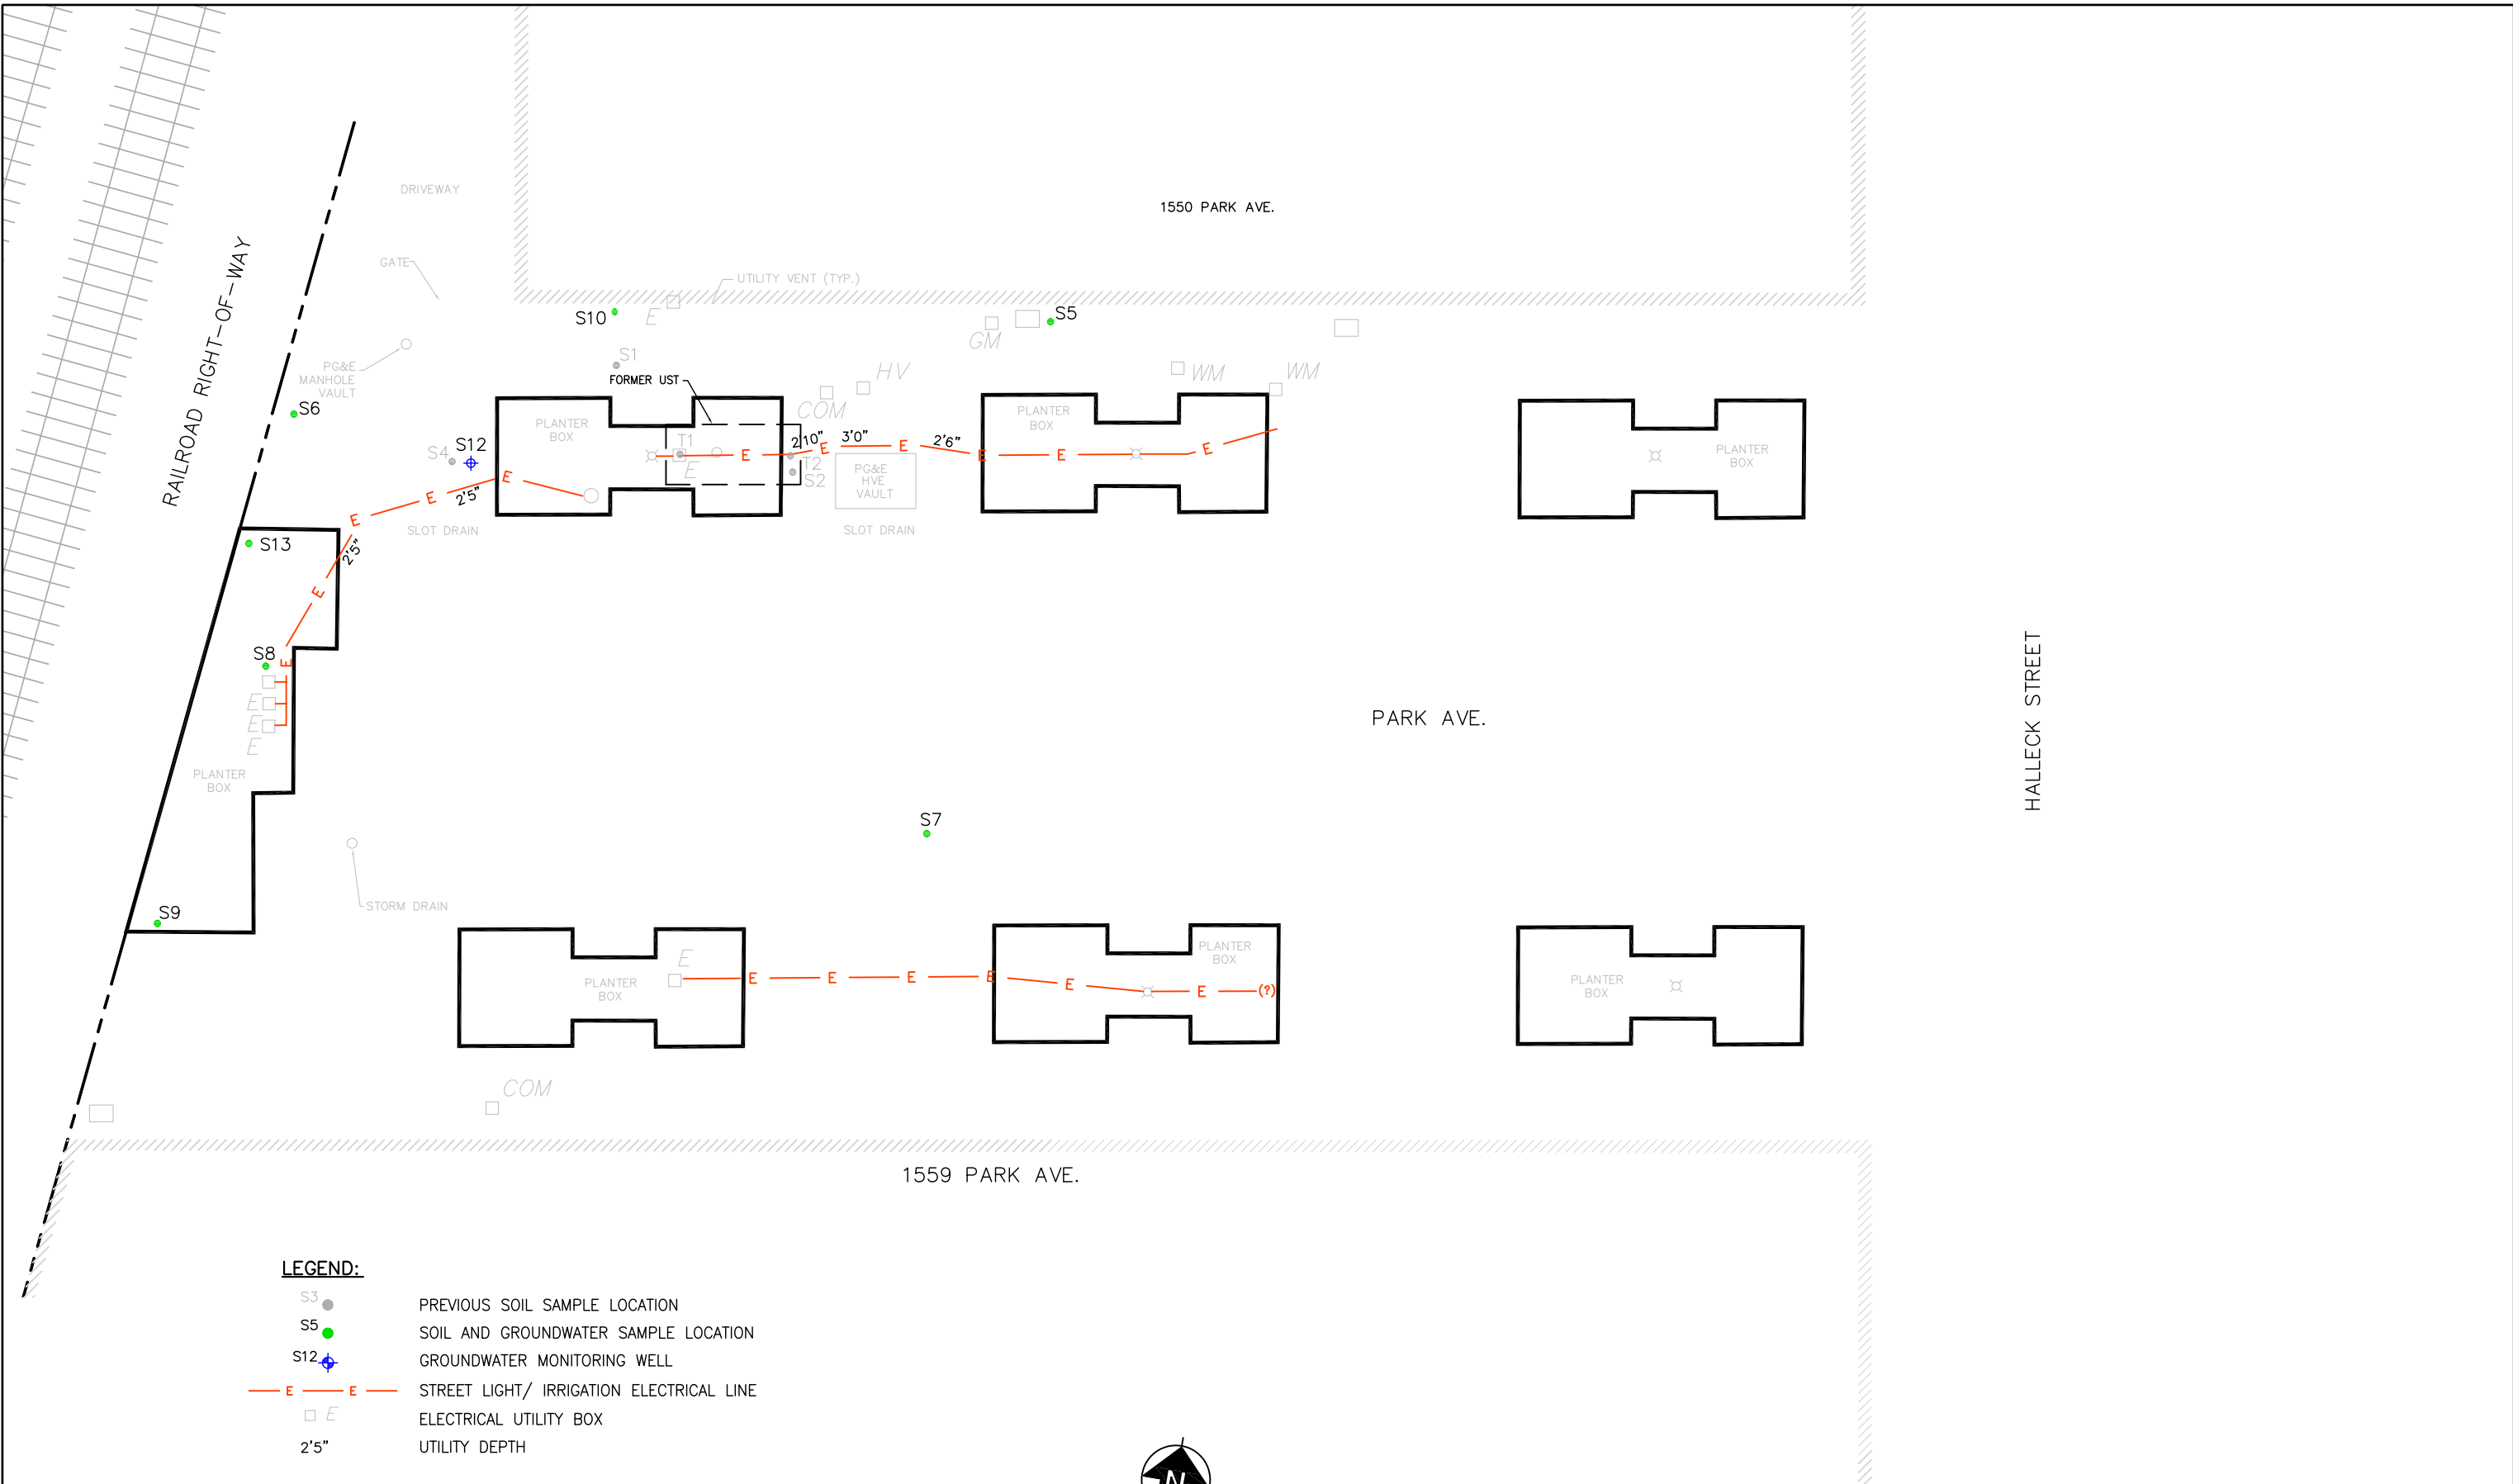
- S3 ● PREVIOUS SOIL SAMPLE LOCATION
- S5 ● SOIL AND GROUNDWATER SAMPLE LOCATION
- S12 ⊕ GROUNDWATER MONITORING WELL
- E — E — STREET LIGHT/ IRRIGATION ELECTRICAL LINE
- E ELECTRICAL UTILITY BOX
- 2'5" UTILITY DEPTH
