**P&D ENVIRONMENTAL, INC.**  
**55 Santa Clara Avenue, Suite 240**  
**Oakland, CA 94610**  
**(510) 658-6916**

March 12, 2010  
Report 0494.R1

**SUBJECT: UNDERGROUND STORAGE TANK REMOVAL REPORT**  
1550 Park Avenue  
Emeryville, CA

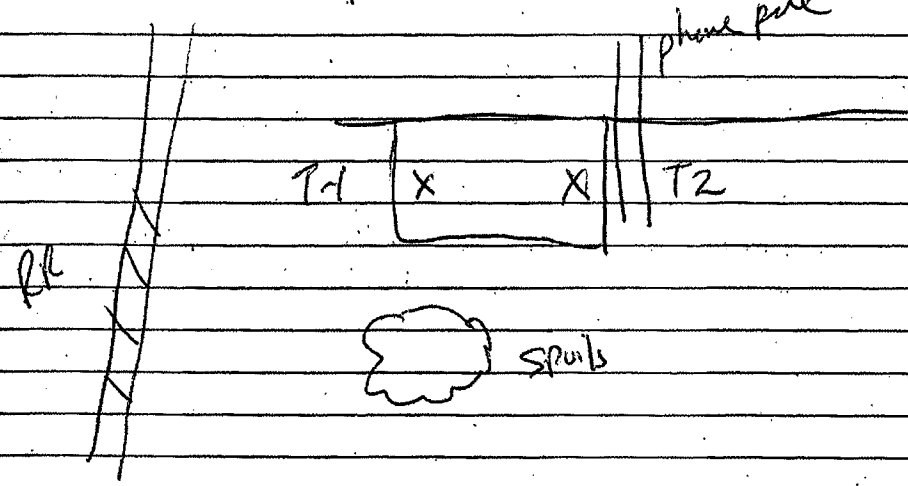
Spills to be transported to City yard for ~~the~~ storage prior to disposal  
T-1 ~ 7' bgs West end moist silty clay, no odors observed  
T-2 ~ 6' bgs East end " " " " " "  
4 discrete samples of the stockpile taken to be composited + run at the lab

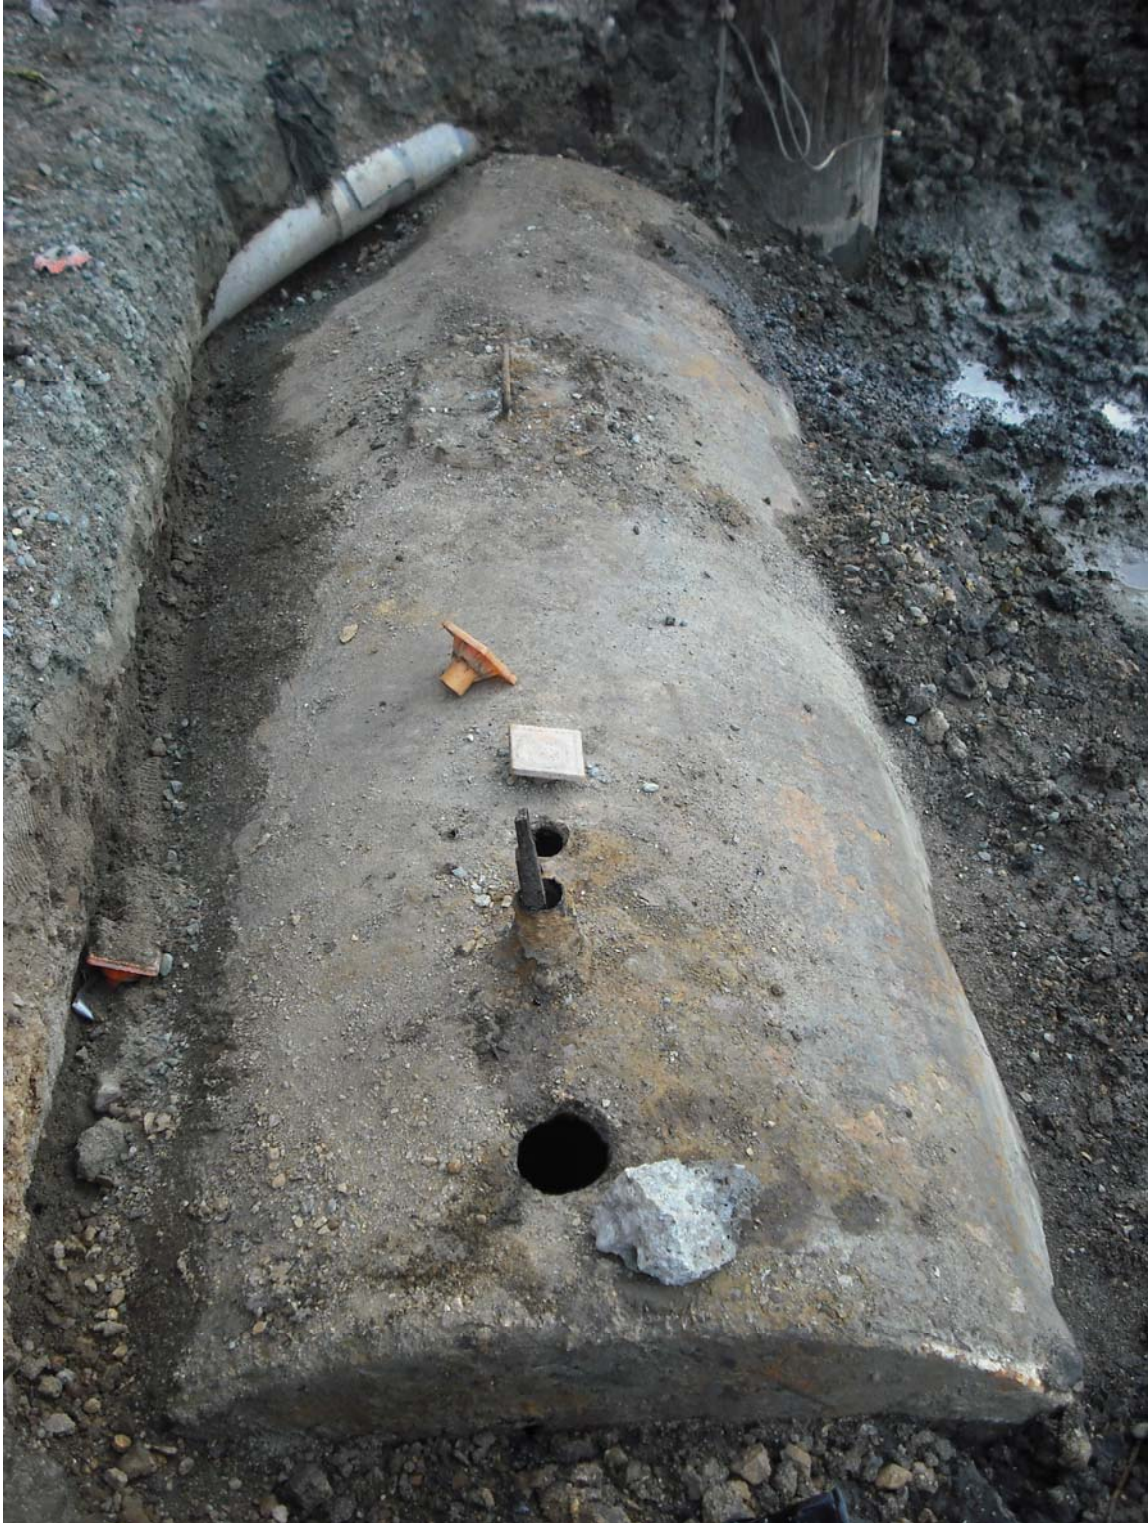
UST prior to removal

At the time of UST removal, a high voltage electrical conduit associated with the utility pole located immediately at the east end of the UST was observed to be located on top of the northeast corner of the UST. It appeared that the top of the UST had been depressed to provide space for the placement of the conduit at the time that the conduit was installed.

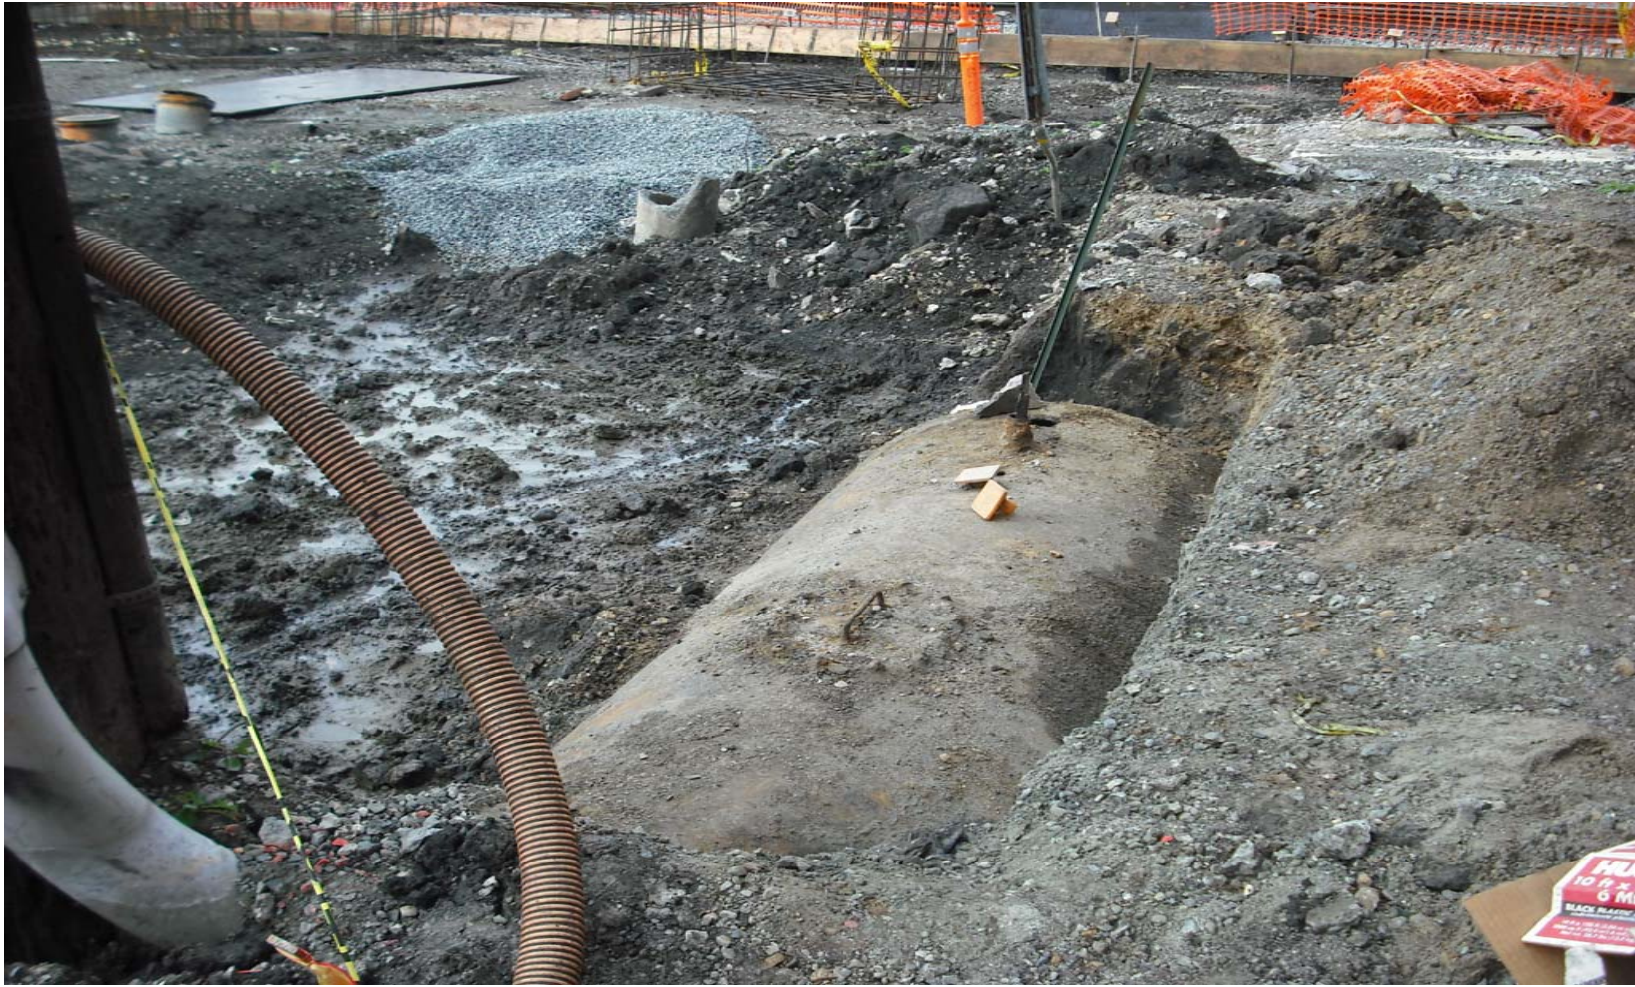
Construction excavation located to the south of UST

Following soil sample collection from the UST pit, the bottom one half foot of the construction excavation located to the south of the UST pit was excavated and stockpiled. The area of excavation is shown in Figure 3. All excavated soil from the UST pit and from the adjacent construction excavation was transported to a nearby City yard where it was stockpiled on a sheet of visqueen. A total of 4 stainless steel tubes were filled with soil from different locations in the stockpile by manually pushing the tubes into the soil for disposal characterization purposes. The samples were to be composited at the laboratory and were designated as SP1. The tubes were sealed, labeled and stored as described above. Following sample collection the stockpile was covered with plastic and secured, pending removal from the site.

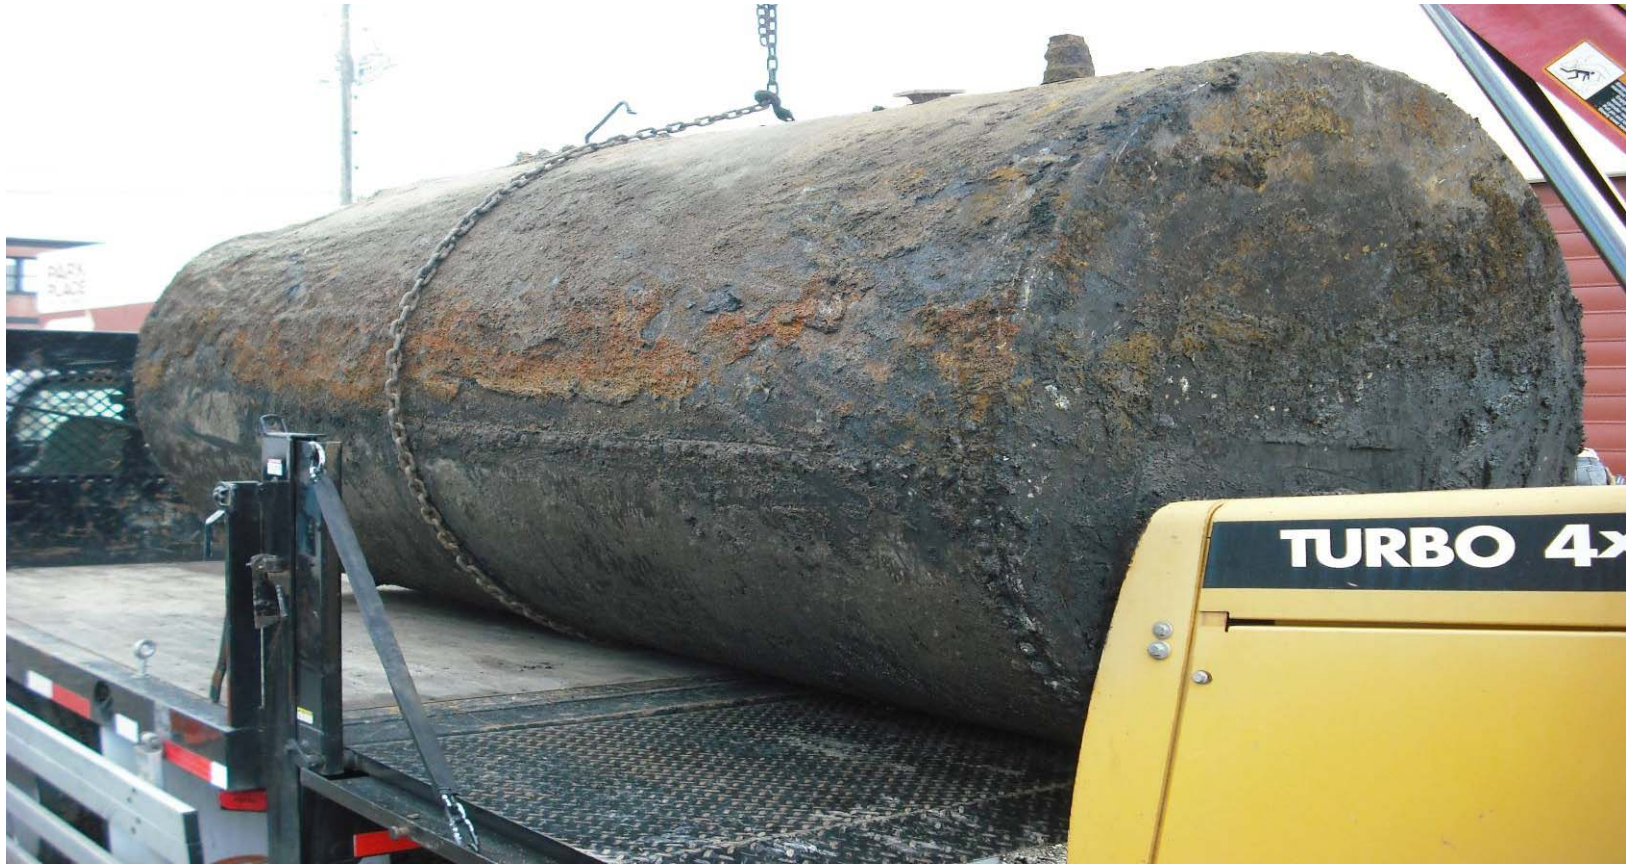
UST following removal

Following removal of the UST from the pit, the UST was visually inspected. The UST was measured to be 5 feet in diameter and 10 feet in length with a calculated volume of approximately 1500 gallons. The UST was constructed of single wall bare steel with riveted seams. The exterior of the UST appeared to be in good condition, with rust scaling observed primarily around the entire UST exterior at an elevation midway between the top and the bottom of the UST. No evidence of holes, cracks, or pitting from substantial corrosion was observed. However, a hole was observed at the west end of the UST at the southwest corner where a rivet was observed to be missing at an elevation approximately midway between the top and the bottom of the UST. It was unclear if the rivet was dislodged during the UST removal activities. Mr. Barney Chan of the ACDEH was present at the site to observe the UST removal and the UST condition following removal.

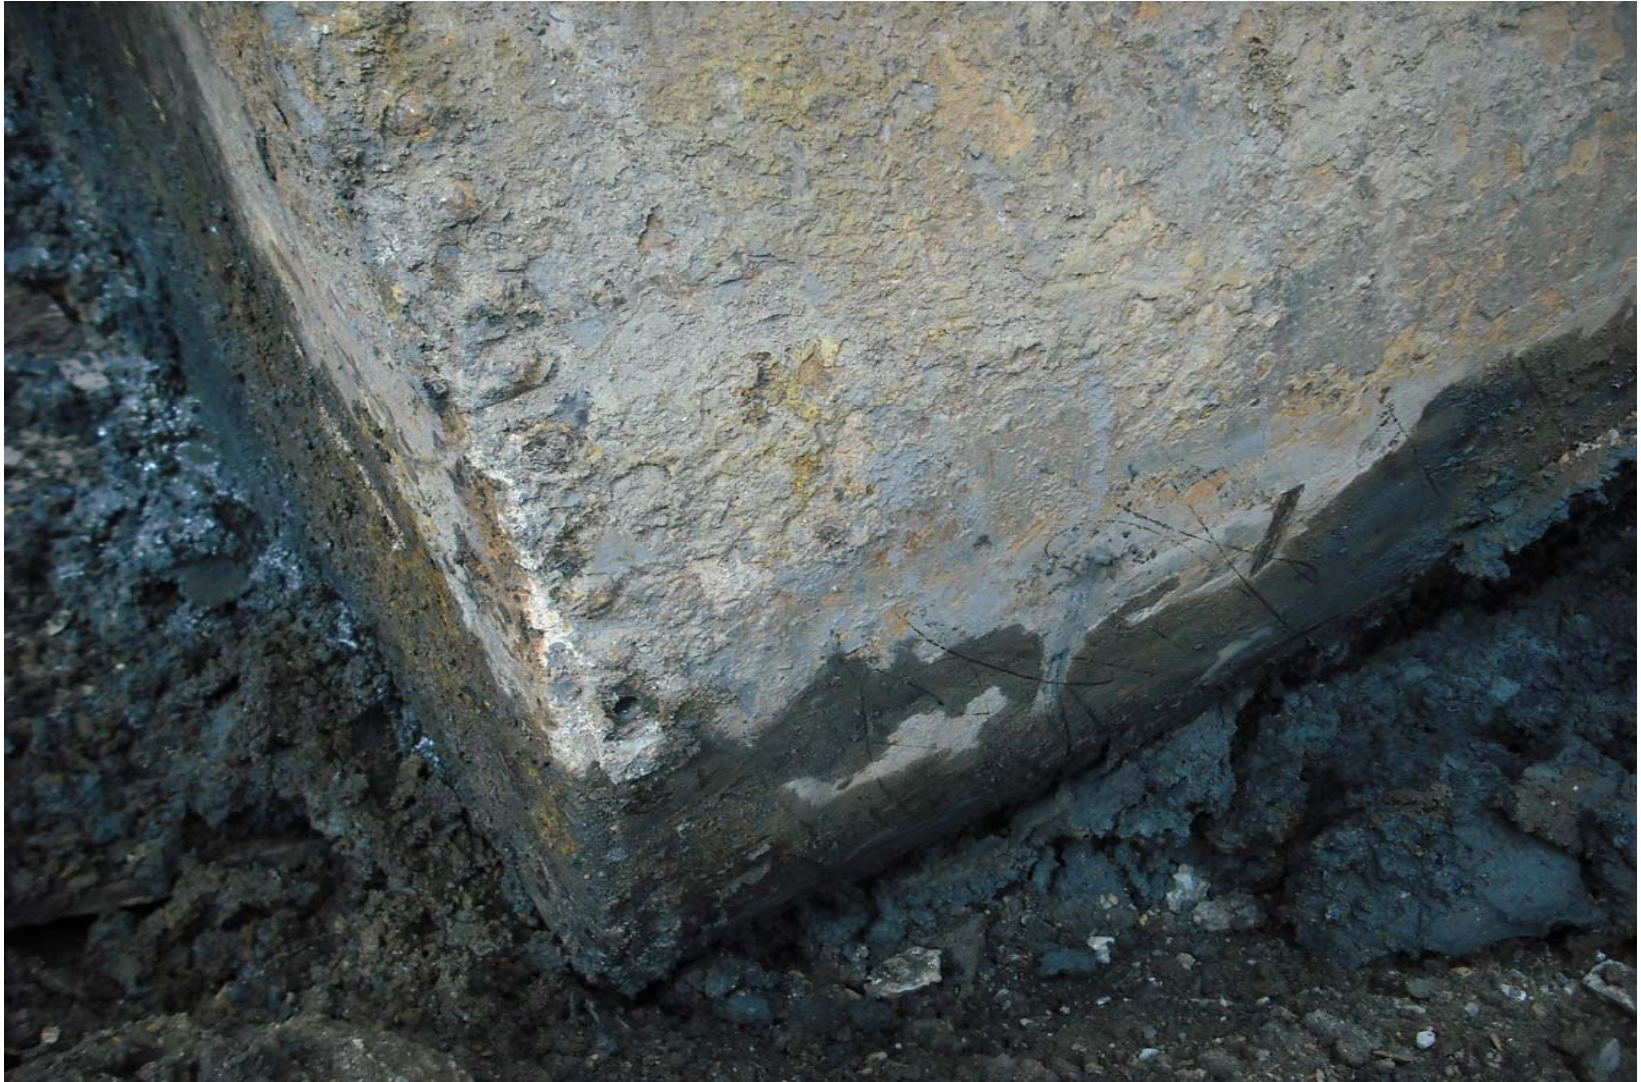
Missing rivet from UST

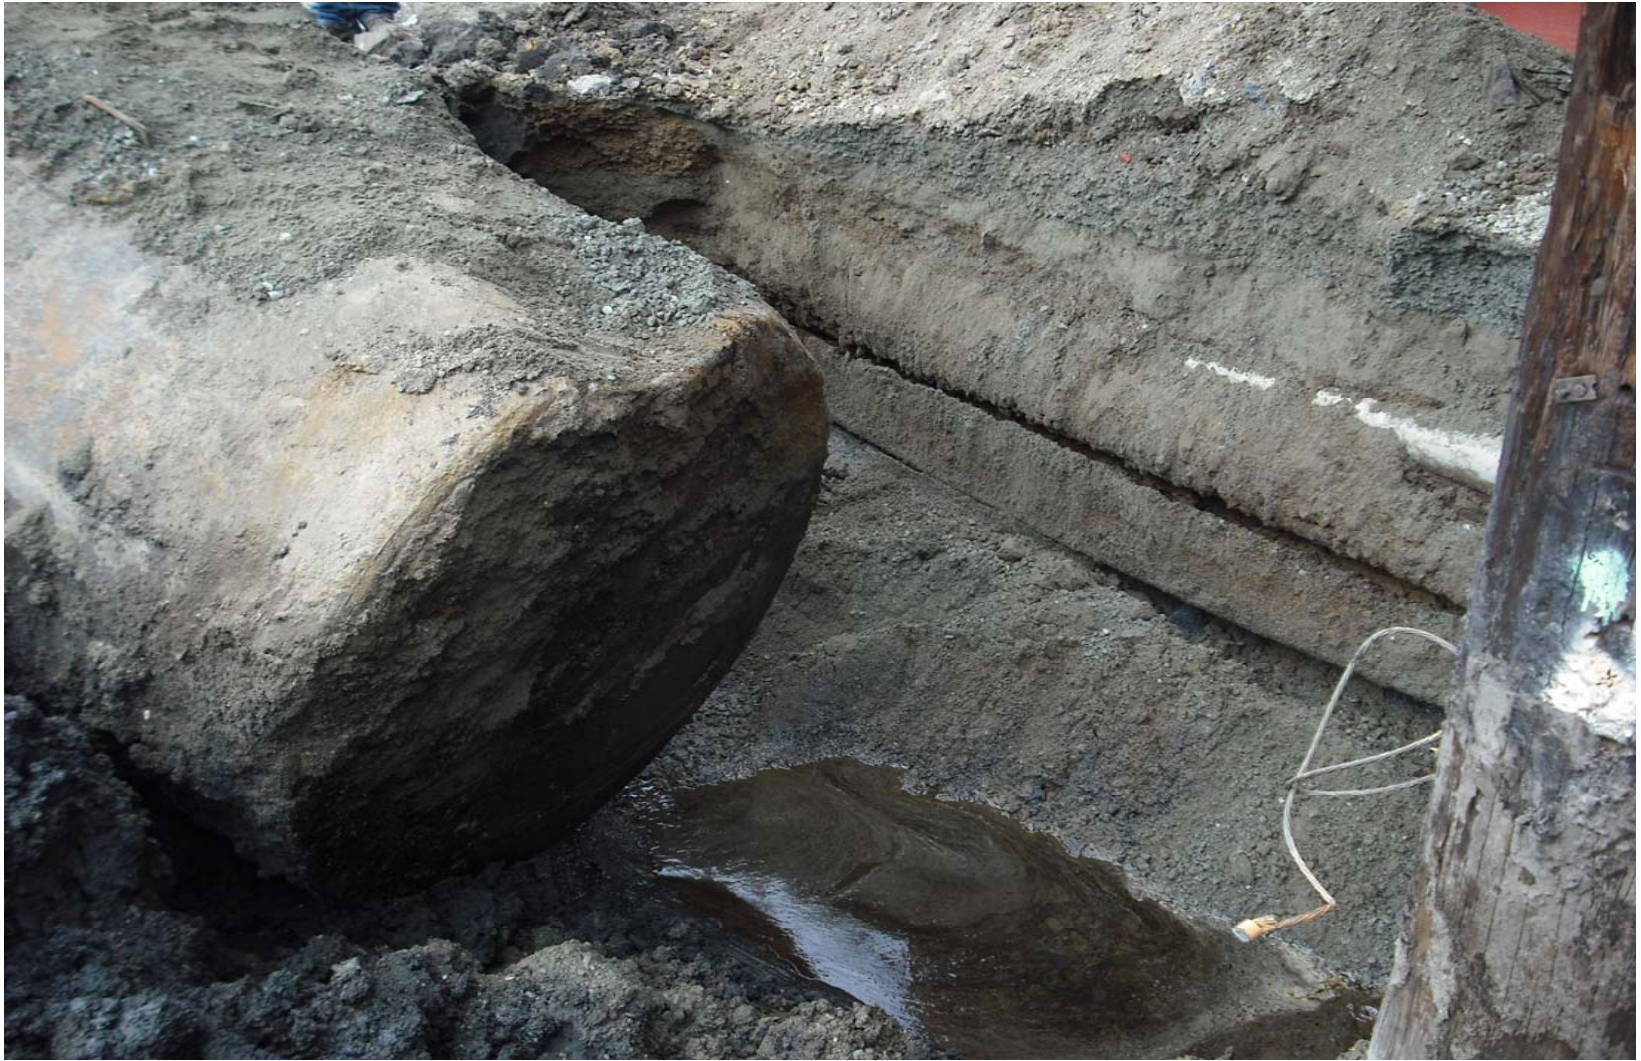
Oily water in UST pit

Following removal of the UST from the pit, water with a discontinuous layer of black oil floating on the water was observed to be present in the UST pit at a depth of approximately 6 feet below the ground surface. Mr. Chan of the ACDEH determined that an inadequate amount of water was present in the bottom of the UST pit for water sample collection. As described above, the water was removed from the UST pit by Clearwater.

Visual observation of the groundwater in the UST pit and the results of the soil samples collected from beneath the UST show that soil and groundwater beneath the UST has been impacted by petroleum hydrocarbons. Based on the UST ownership being identified as the adjacent property owner at 1550 Park Avenue, P&D recommends that no further action be taken by the City of Emeryville.

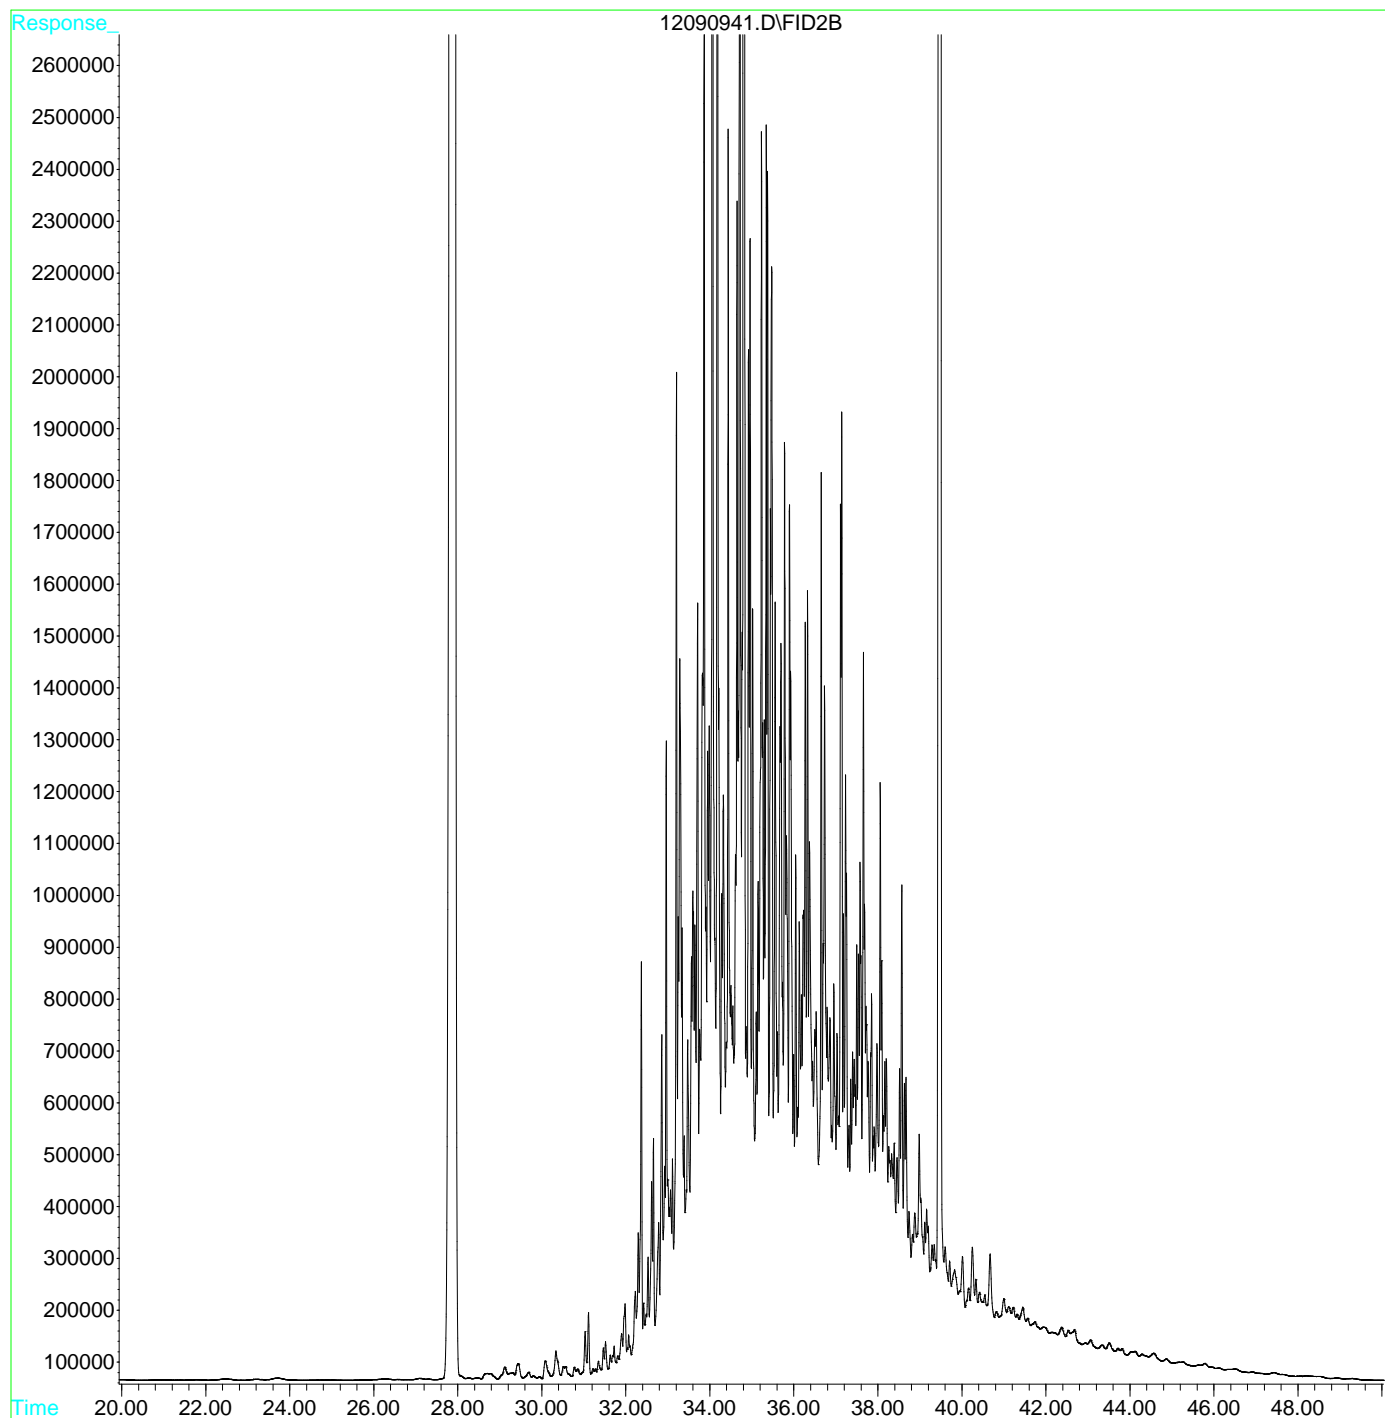
Lab ID	Client ID	Matrix	Fuel Fingerprint
0912246-001A	UST OIL	O	This sample shows a significant hydrocarbon pattern that resembles fuel oil, possibly bunker oil. Chromatograms enclosed.

File : D:\HPCHEM\GC11\DATAB\12090941.D  
Operator : Thu  
Acquired : 10 Dec 2009 9:59 am using AcqMethod GC11AW.M  
Instrument : GC-11  
Sample Name: 0912246-001A OIL RE  
Misc Info : TPH(FF)\_O  
Vial Number: 71

The sample was analyzed for fuel fingerprint analysis using EPA Methods 3550C/8015B. The laboratory results identified the sample as consisting of fuel oil and possibly bunker oil, and the laboratory report included a chromatogram of the sample analysis. A copy of the laboratory report and chain of custody documentation is attached with this report.
