# MONITORING WELL ABANDONMENT REPORT

1550 PARK AVENUE  
EMERYVILLE, CALIFORNIA

November 1, 2017  
Project: A1293-4

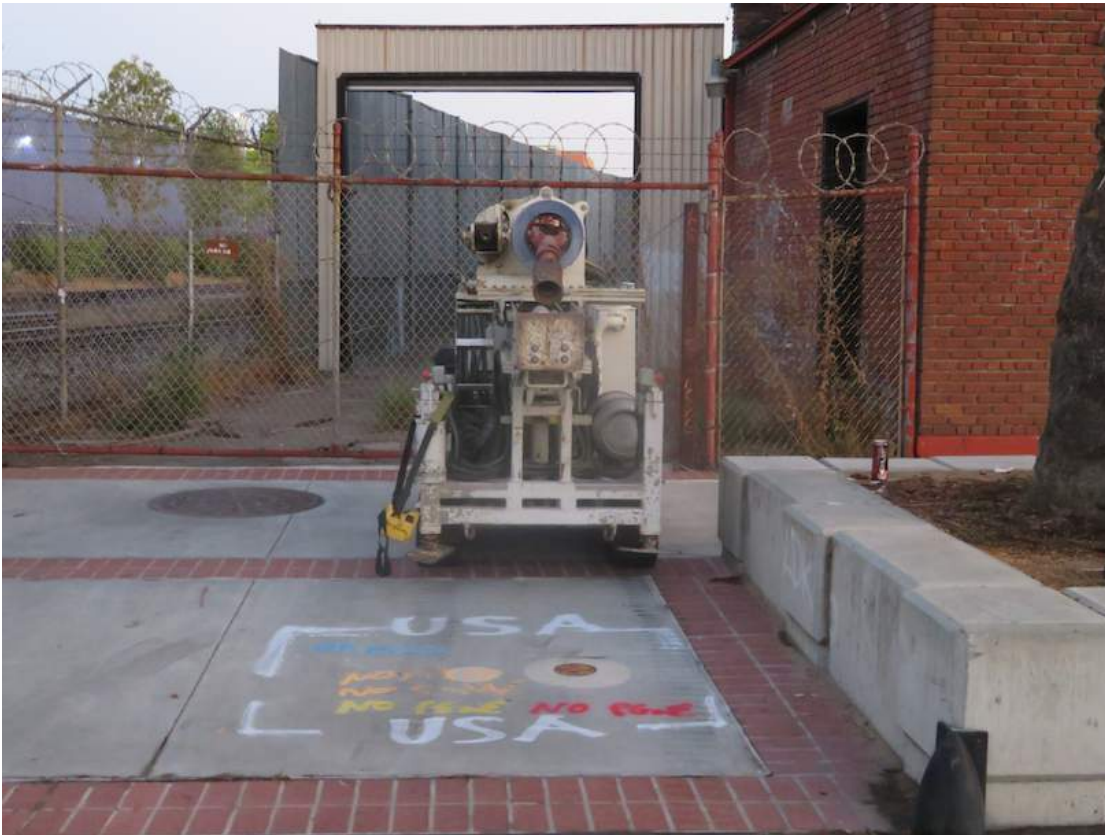
Photograph 1 – Limited access rig in position to begin well abandonment.

MW-1 was located near the northwest corner of the Property in a sidewalk area close to a raised planter bed. Adanta arrived onsite at 6:15 am to cordon off the work area and to deter others from blocking the work zone. Gregg Drilling arrived onsite at 7:00 am with a limited access hollow stem auger drill rig.

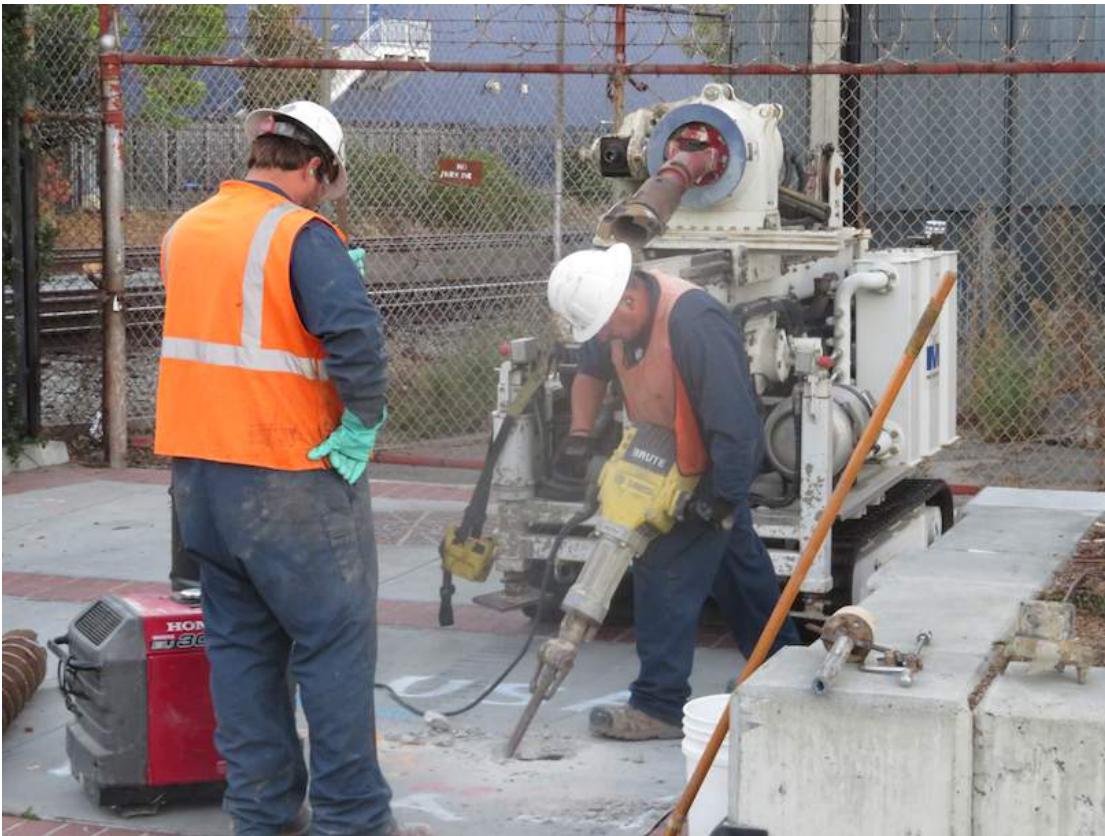
Photograph 2 – Using jack hammer to clear well head from surrounding concrete. Jack hammer is powered by generator in left bottom of photo.

Gregg Drilling used a jack hammer powered by a generator to remove the concrete around the well box, exposing the PVC well casing. The concrete and well box were placed in a 55-gallon DOT-approved steel drum. The upper two feet of well casing was removed by hand. Gregg Drilling then advanced an 8-inch diameter auger to a depth of about eight feet below surface. PVC well materials, packing materials, and excess soil were brought to the surface by the auger. These materials were placed in the 55-gallon DOT-approved steel drum for later disposal.

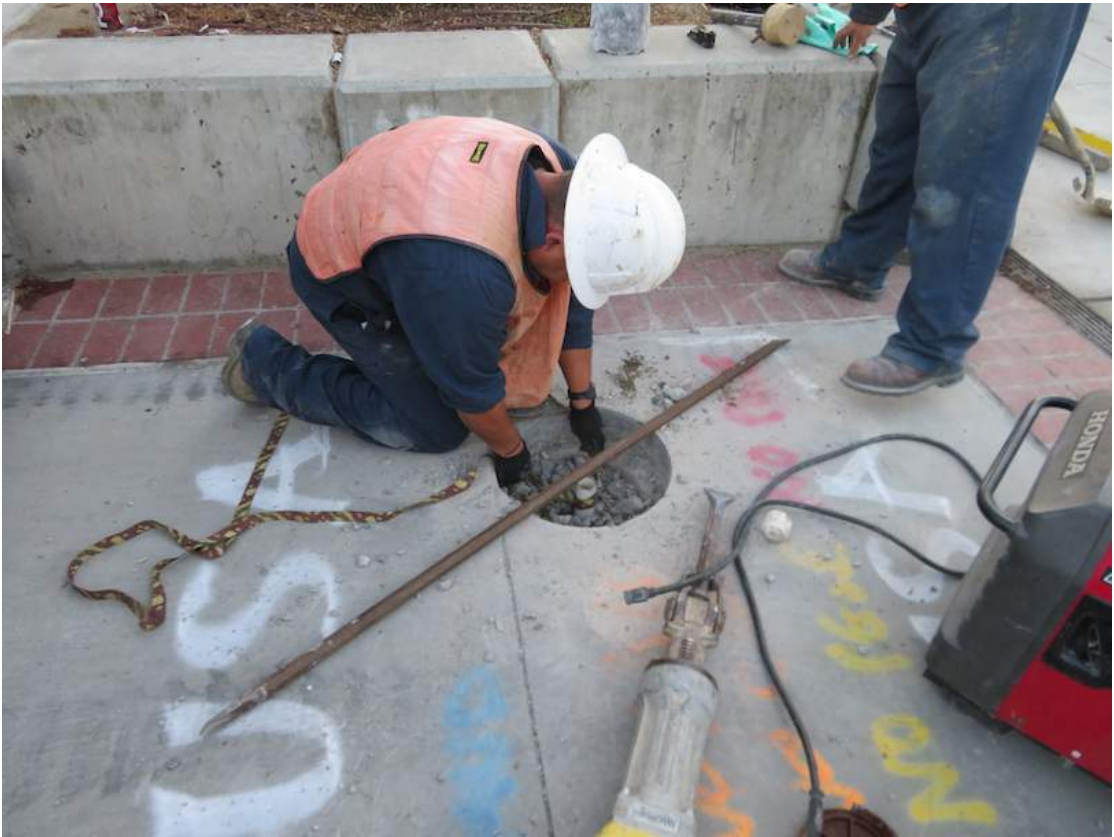
Photograph 3 – Clearing concrete from around well head.

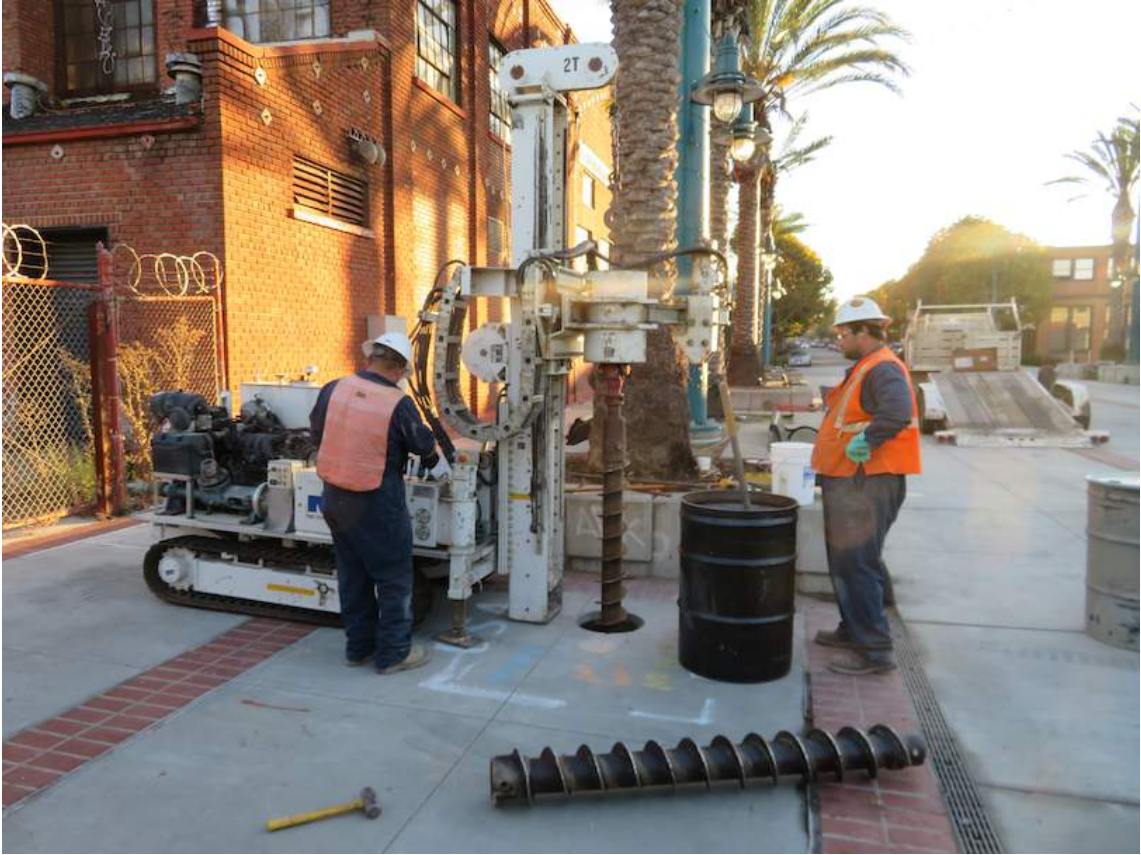
Photograph 4 – Using 8-inch diameter auger to drill out well material.

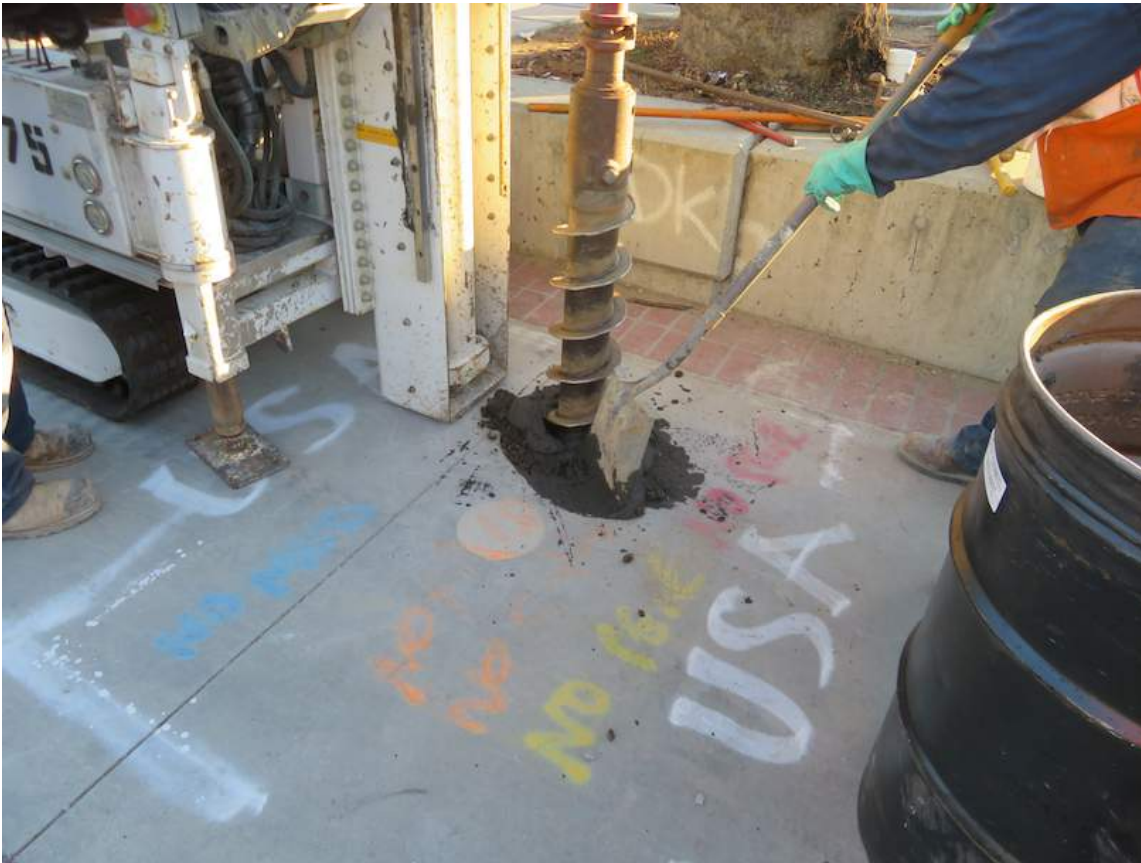
Photograph 5 – Close-up of drilling out well material.

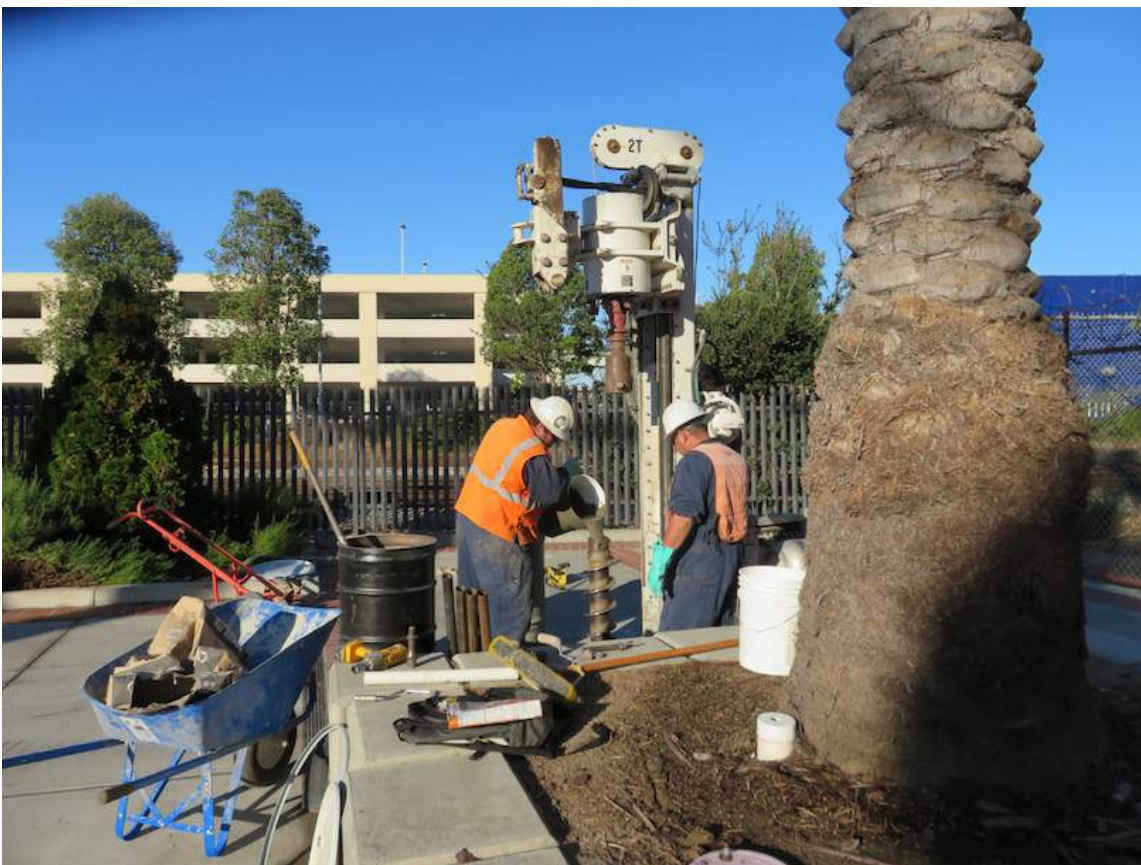
Photograph 6 - Pouring grout into auger to reach the bottom of the hole.

The Public Works Agency inspector, Eneyew Amberber arrived at the Property at approximately 9:15, and Gregg Drilling commenced grouting the well. Initially the plug was removed from the tip of the auger and a Portland cement mixture was inserted into the bottom of the hole using a 5-gallon bucket. The auger was removed from the hole, and the remainder of the grout was poured into the hole until it was approximately 18 inches from ground surface. Dry Portland cement was used to cover the grout, and the remaining space of the hole was filled with a sidewalk-grade concrete mixture. Mr. Amberber approved the grouting of the hole. The surrounding area was cleaned prior to leaving the Property.

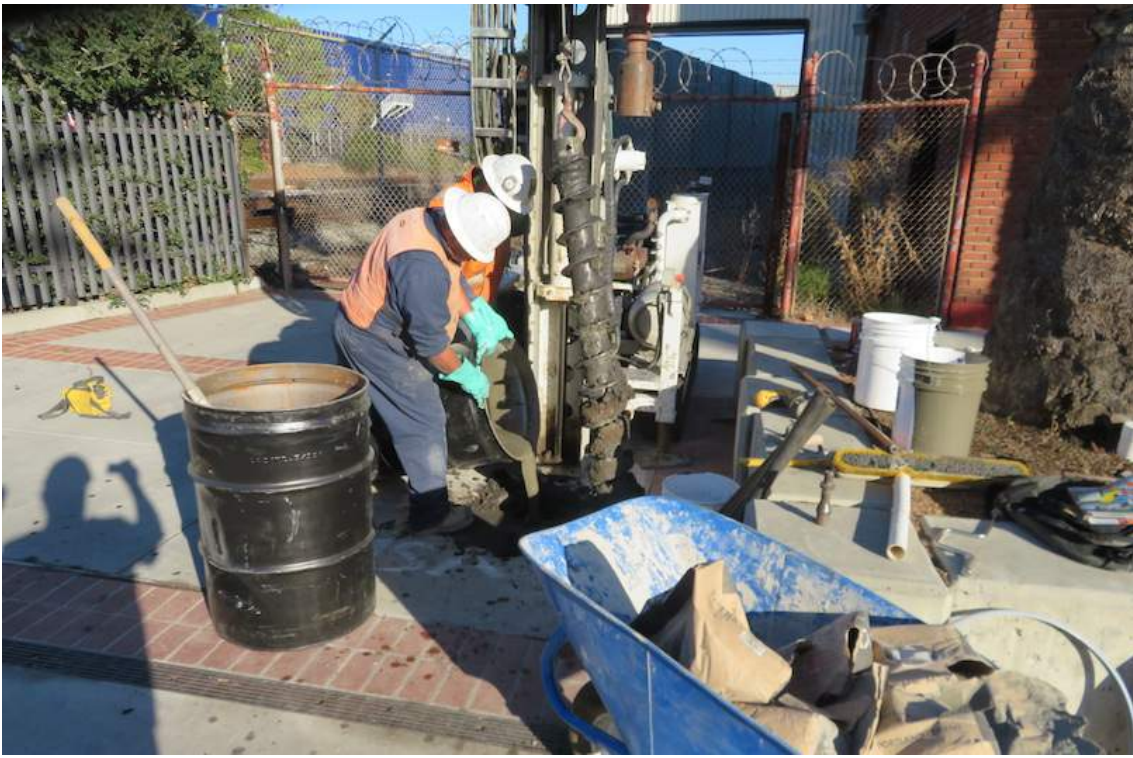
Photograph 7 – Filling in hole with grout.

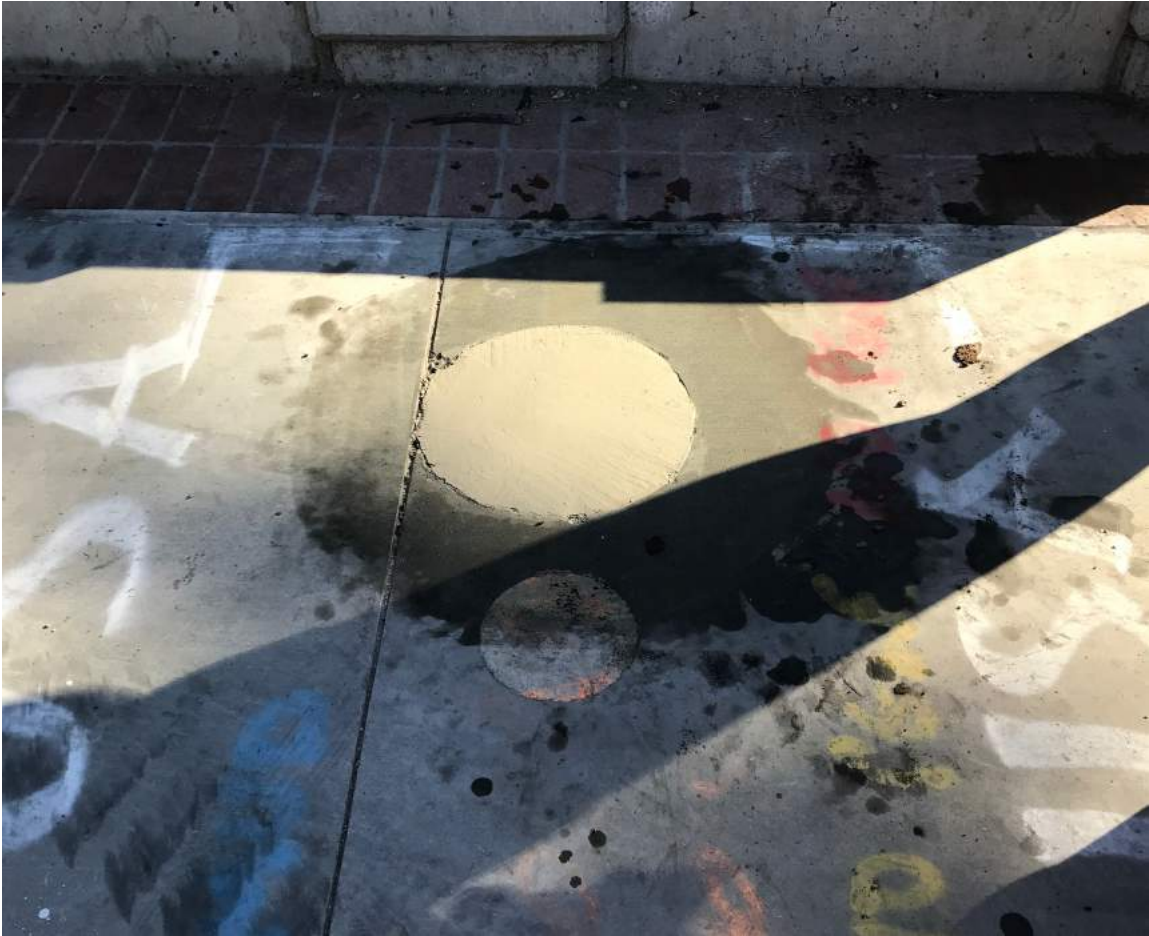
Photograph 8 – Completed concrete surface over former monitoring well location.

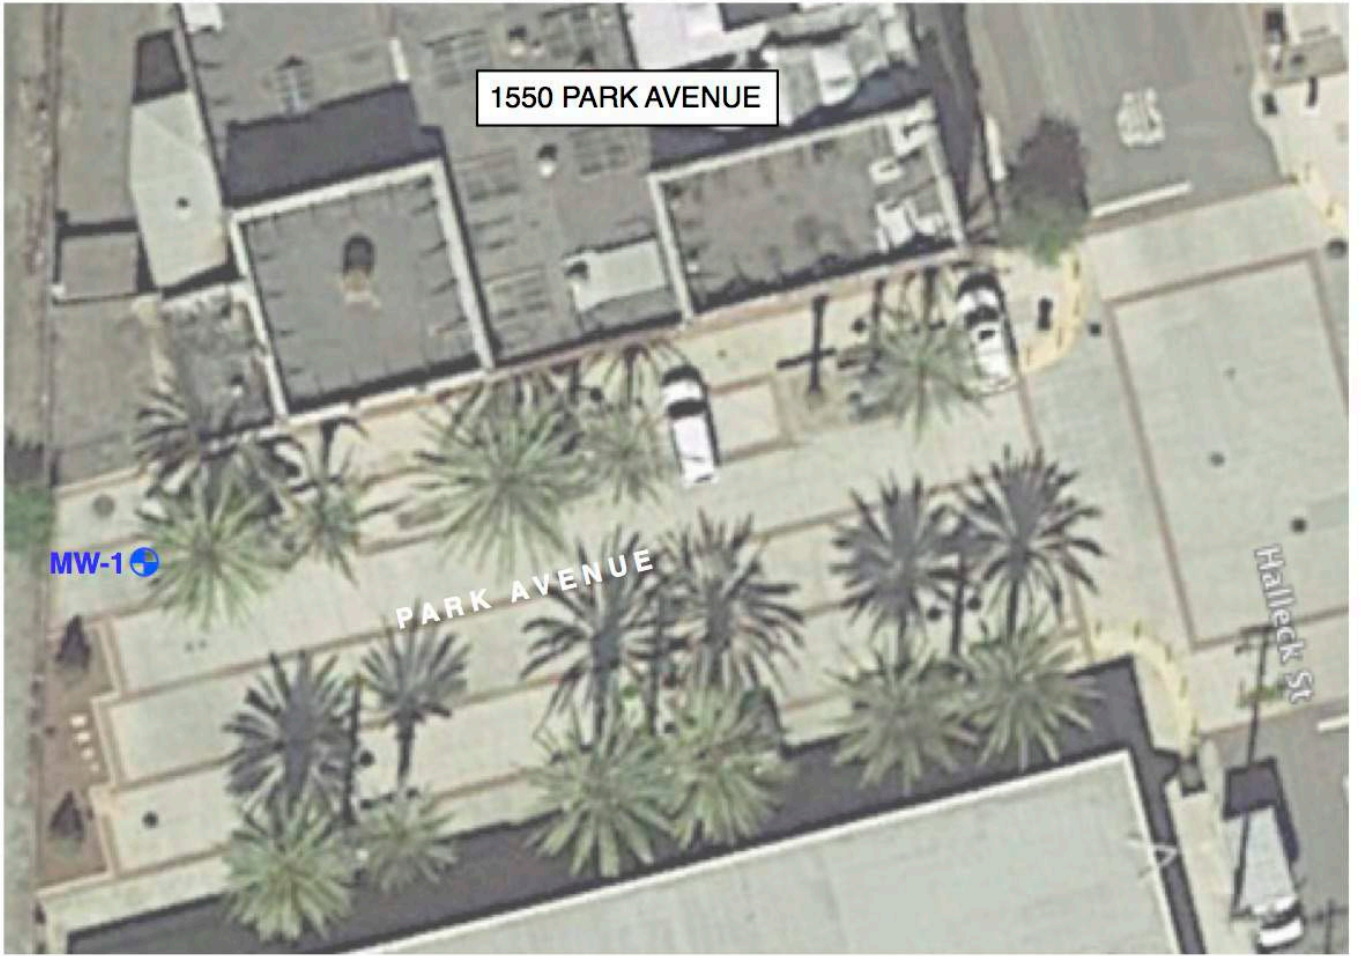
**FIGURE  
2**

MW-1 is located adjacent to a raised concrete landscaping bed slightly north of Park Avenue near the west boundary of the Property. The well was constructed using a 6-inch diameter hollow-stem auger that drilled a boring to 7.5 feet below surface. A pre-packed 1 ½-inch diameter PVC well was inserted into the bore hole. The bottom five feet of the PVC material was machine slotted.

**MONITORING WELL  
LOCATION MAP**
