Subject: Case Closure for Fuel Leak Case No. RO0003078 and GeoTracker Global ID T10000003245, Ashland Youth Center, 16335 East 14<sup>th</sup> Street, San Leandro, CA 94580

REMEDIAL ACTION COMPLETION CERTIFICATION

**CASE CLOSURE SUMMARY  
LEAKING UNDERGROUND FUEL STORAGE TANK - LOCAL OVERSIGHT PROGRAM**

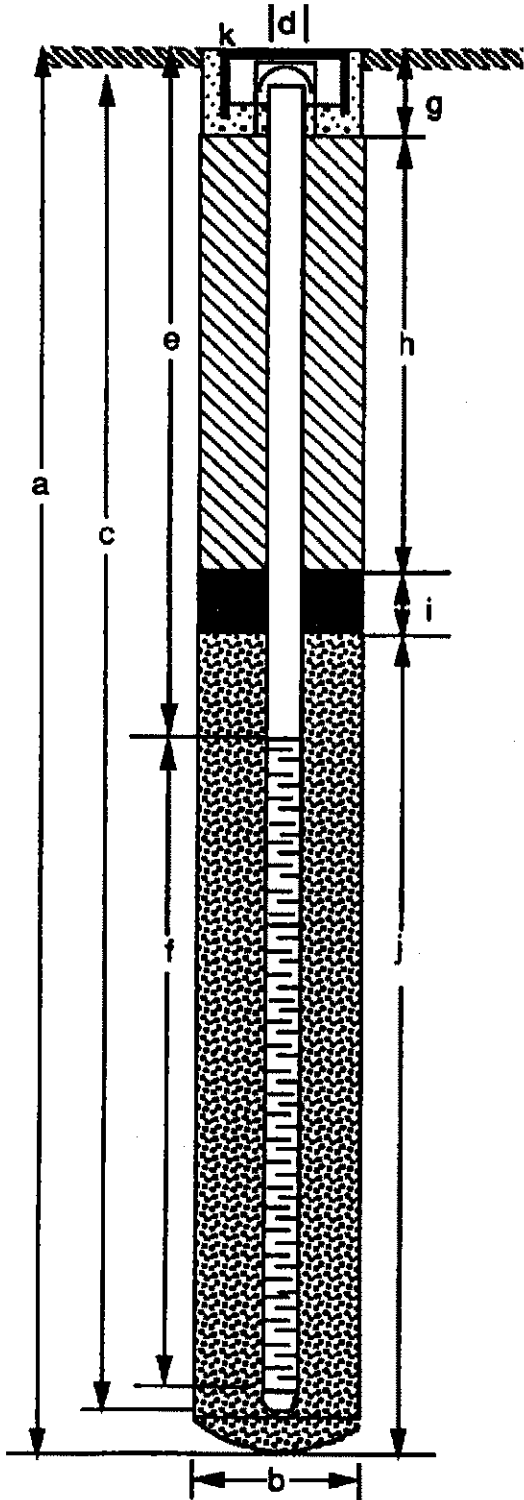
## EXPLORATORY BORING

- a. Total depth 22 ft.
- b. Diameter 8 in.
- Drilling method Hollow Stem Auger

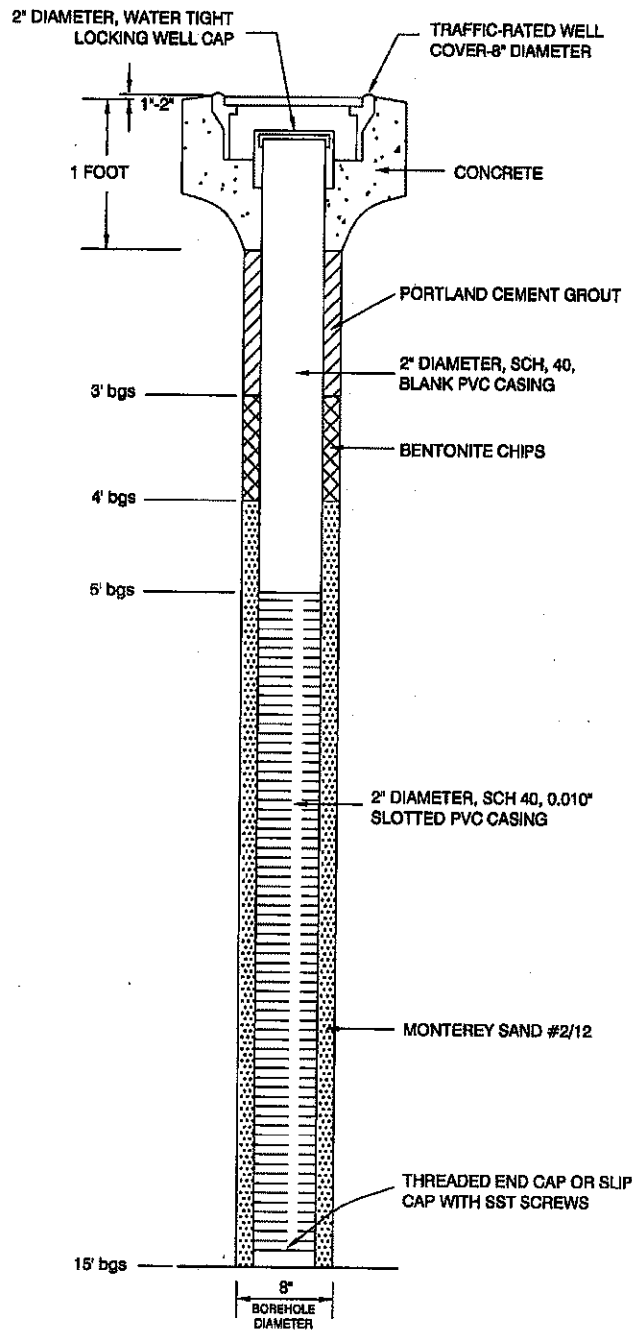
MONITORING WELL NO: MW - 9

15						0		SM	Brown, saturated, silty fine to medium SAND.	
						0		CL	Brown, moist, dense silty CLAY.	
20									Total depth = 15 feet bgs. Groundwater encountered at approximately 8.5 feet bgs during drilling activities. Groundwater monitoring well installed 10/1/08. See MW-9 well construction diagram. Static groundwater measured at 8.11 feet below top of casing on 10/14/08.

TOTAL DEPTH = 15'
