August 21, 2006

**PHASE I
ENVIRONMENTAL SITE ASSESSMENT**

7600 MacArthur Boulevard
Oakland, California 94605

AEI Project No. 118073

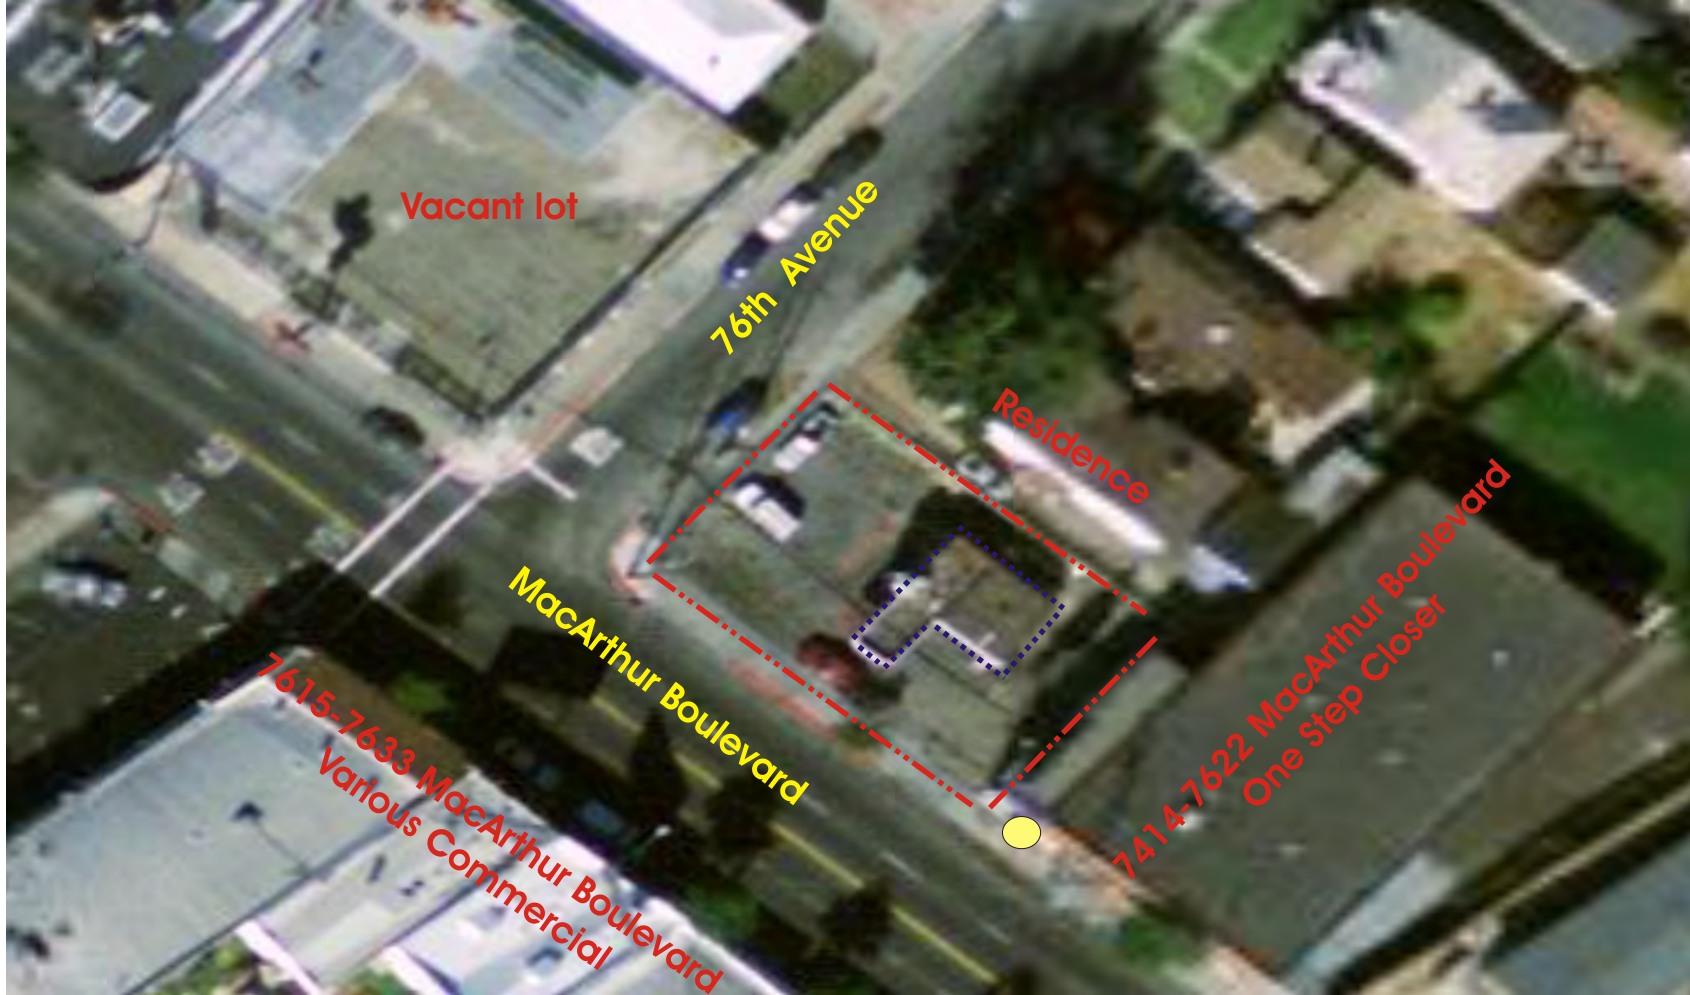
7600 MacArthur Boulevard Oakland, California	FIGURE 2A Job No: 118073
---	------------------------------------

SITE PLAN

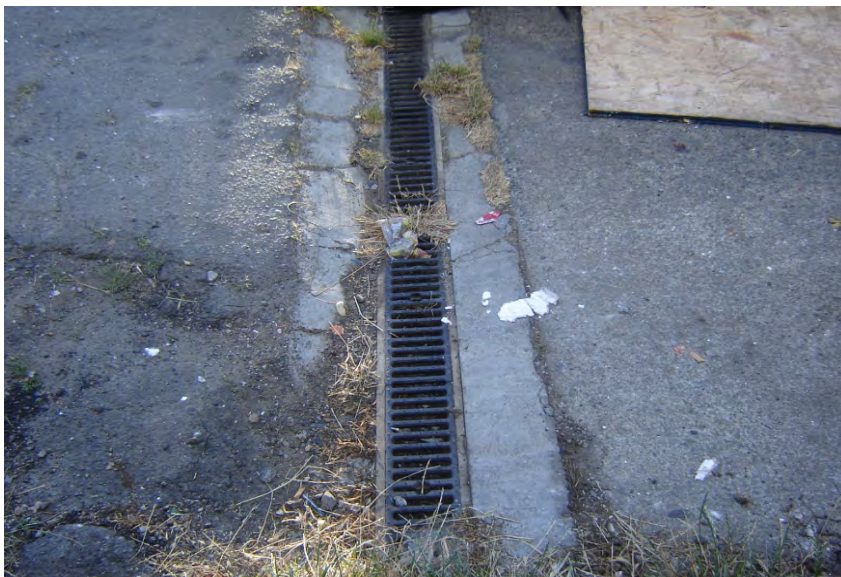
One trench drain was observed on the western portion of the subject property at the time of the site reconnaissance. The trench drain was about three inches deep, observed with soil, had vegetation growing in it and appeared to not have been in use of a period of time. No hazardous materials were observed in the vicinity. Based on the lack of hazardous materials observed, and observations indicating the lack of use, the trench drain is not expected to represent a significant environmental concern.

6. A picture of a trench drain located on the subject property.

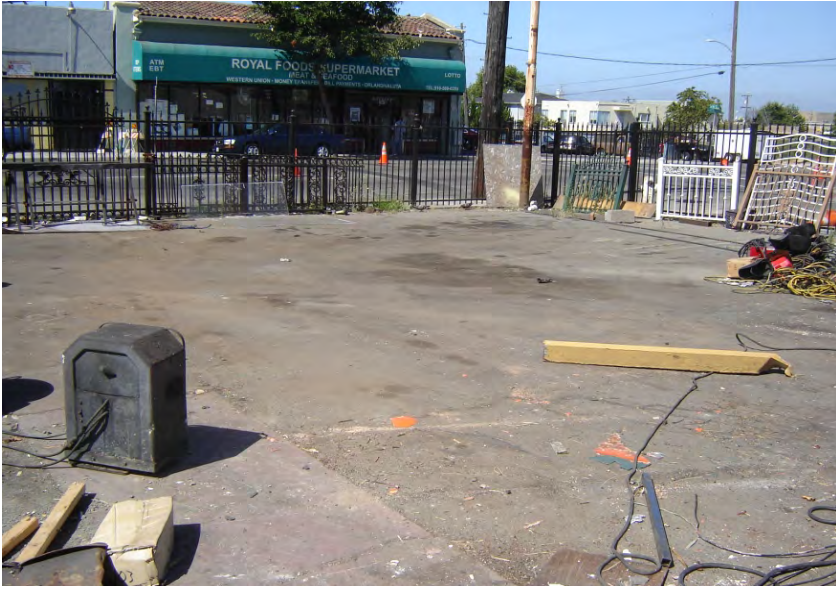
underground storage tanks (USTs). The subject property was not listed on the regulatory database as a current or former UST site and no records in regards to the USTs were on file at the regulatory agencies researched. Ms. Gardner had no knowledge if the USTs were still onsite or if they had been removed; however, during the site reconnaissance, AEI noted the presence of what resembled vent pipes and a pump island. Based on the historical use of the subject property as a gas station, and lack of documentation at local regulatory agencies indicating the removal of the USTs and/or sampling, the potential exists that the USTs remain in place and have impacted the subsurface of the subject property. Based on this information, the identification of USTs on the subject property is considered a recognized environmental concern.

7. A picture of a suspected UST location area on the subject property.

AEI's investigation revealed recognized environmental conditions associated with the subject property that requires further investigation. AEI recommends the performance of a geophysical survey to determine if USTs remain on-site. Additionally, subsurface sampling is recommended to investigate if the USTs, below grade hydraulic lift and historical operations have impacted the subject property.

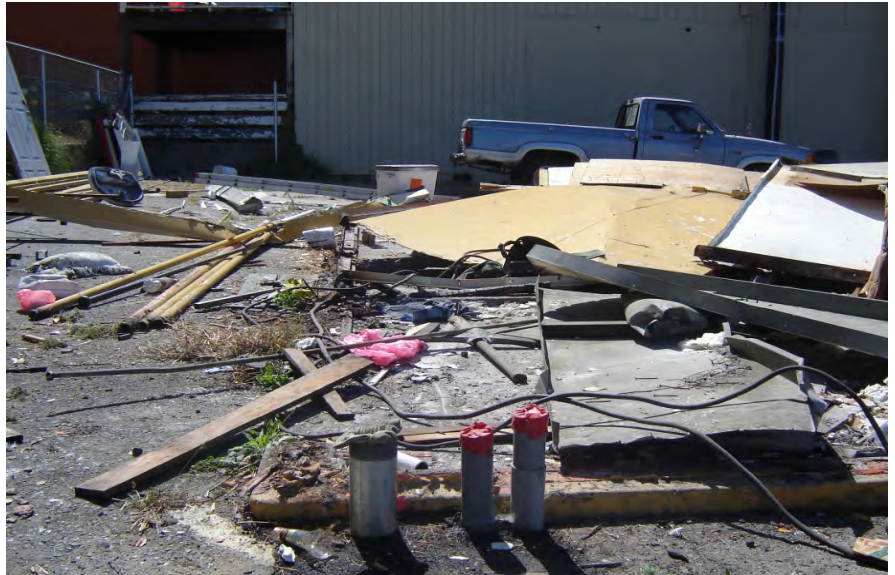
8. A picture of building debris located on the property.

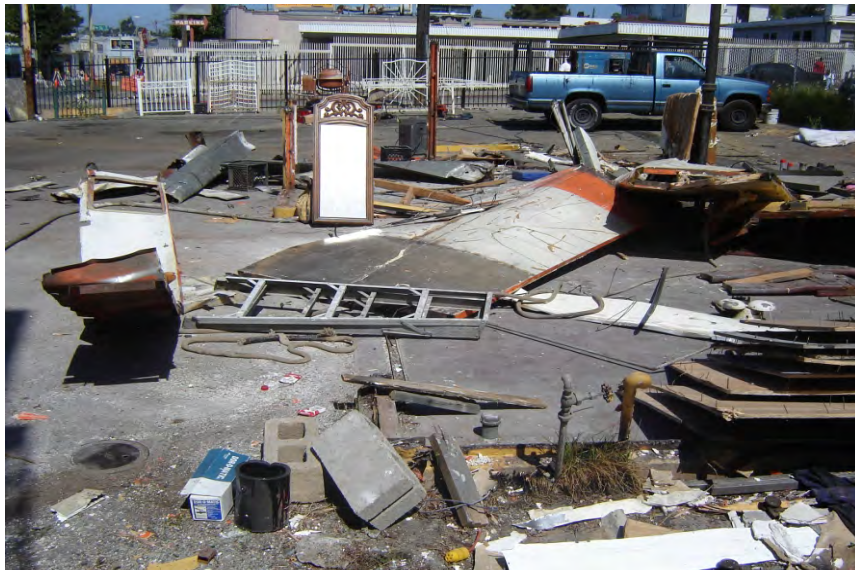
9. A second picture of building debris.

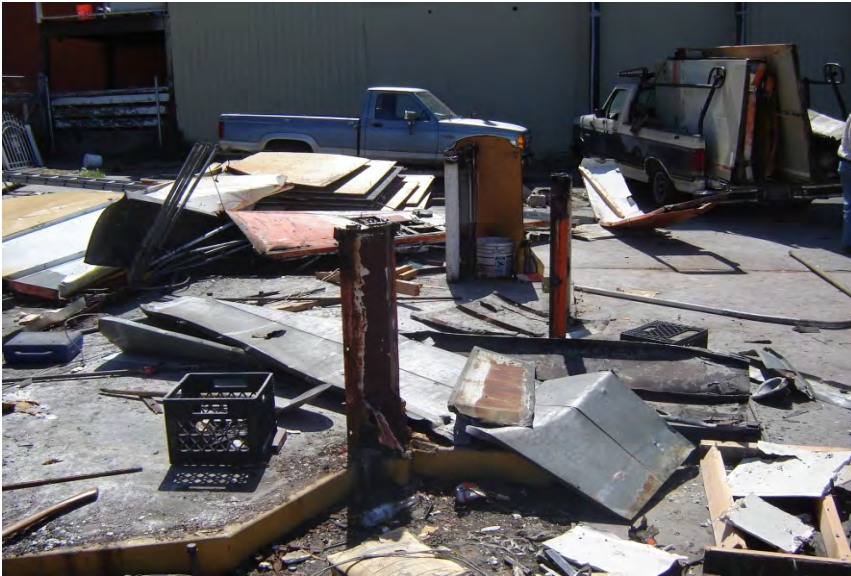
10. A picture of the former “island” area of the subject property.

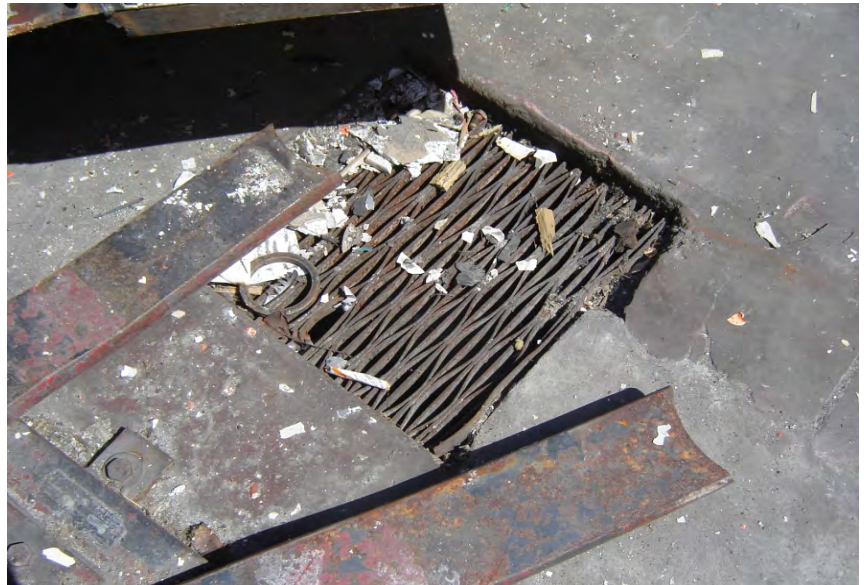
One rectangular floor drain was observed next to a hydraulic lift, which was in a similar location as the “waste oil drain” noted in a 1953 architectural plan reviewed at the OBD. Ms. Gardner had no knowledge of how long the drain had been located on site or its use. Drains have the

potential to act as conduits to the subsurface of properties. Due to the historic use of the subject property as a gasoline service station, hazardous substances and petroleum products were presumably utilized onsite. While there is no information indicating the length of time the drain has been located on-site, there is a potential that contaminants such as oils or solvents present in waste streams could impact the soil beneath the property if the drain system has become compromised. Based on this information and the proximity to the hydraulic lift the presence of the drain represents a recognized environmental condition.

11. A picture of the drain located on the subject property, next to the hydraulic lift.

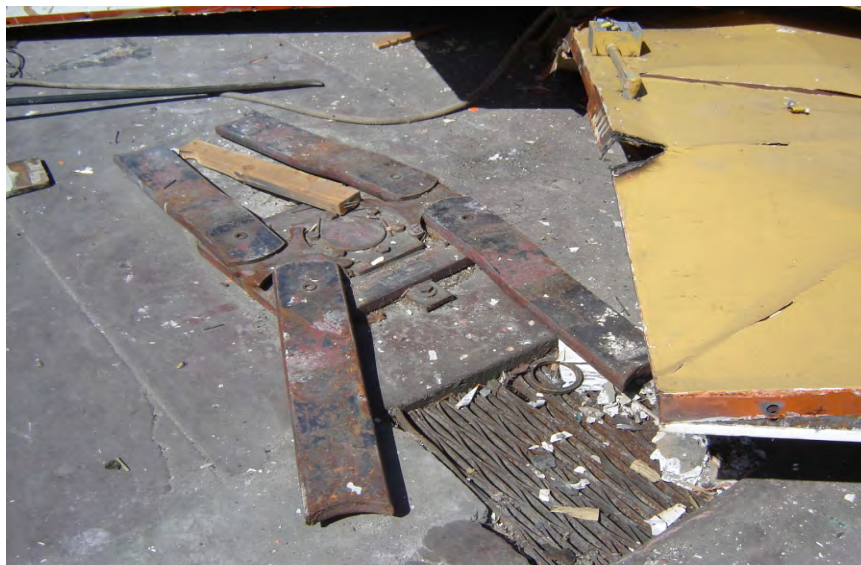
A below grade hydraulic lift was observed on the subject property next to the aforementioned floor drain. The hydraulic lift appeared aged and has presumably been out of service for a long period of time. The lift is presumed to be the same one noted in the 1953 architectural plan reviewed at the OBD. In addition to the lift, a “lift control tank” was noted in the 1953 architectural plan. However, the “lift control tank” was not observed at the time of the site reconnaissance. Below grade lifts have the potential to utilize hydraulic fluids that are PCB-containing, dielectric fluids. Based on the length of time the lift has been located on-site, the potential exists that the hydraulic fluids may have impacted the subsurface of the subject property and therefore represents a recognized environmental condition.

12. A picture of the hydraulic lift located on the subject property.

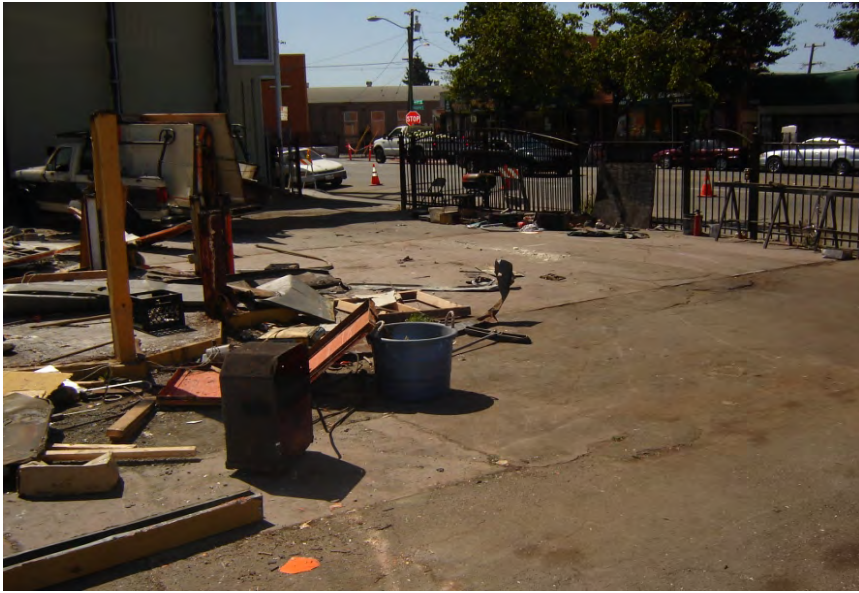
13. A picture of a second area where a fourth UST may be located.
