580 MARKETPLACE
ENVIRONMENTAL REPORT 10:

**PHASE I
ENVIRONMENTAL SITE ASSESSMENT
AND PHASE II SUBSURFACE INVESTIGATION
580 MARKETPLACE SHOPPING CENTER
3735-4065 EAST CASTRO VALLEY BOULEVARD
CASTRO VALLEY, CALIFORNIA**

DECEMBER 18, 1997

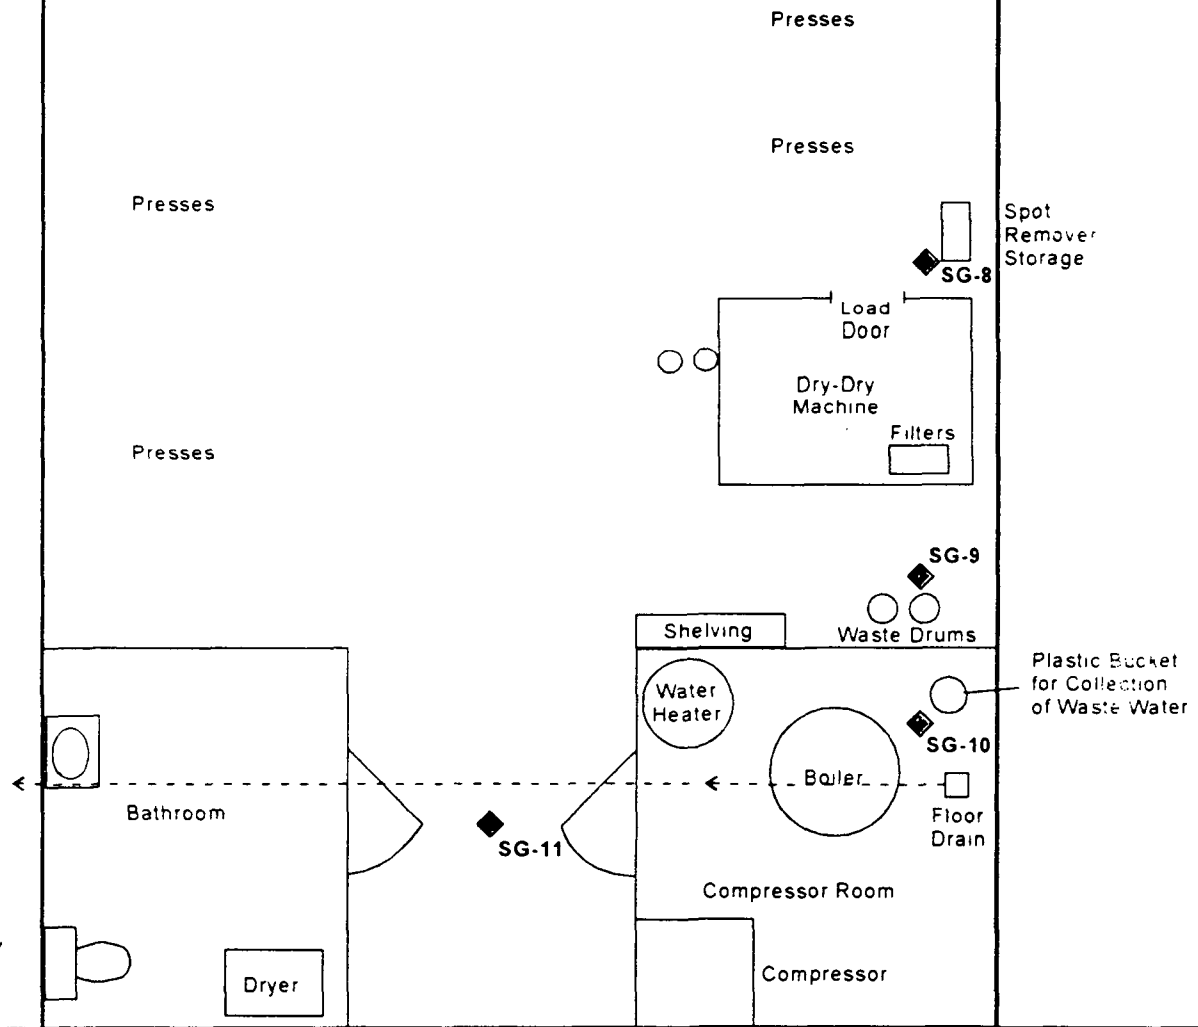
PLATE
4

- ◆ Soil Gas Sample Location
- - - Location of Sanitary Sewer

Dry Cleaner Sampling Locations
580 Marketplace Shopping Center
3735-4065 East Castro Valley Boulevard
Castro Valley, California
