**Subject: Phase I/Limited Phase II Environmental Site Assessment  
National Guard Armory  
16501 Ashland Avenue  
San Lorenzo, California 94580**

**PHASE I/LIMITED PHASE II ENVIRONMENTAL  
SITE ASSESSMENT  
NATIONAL GUARD ARMORY  
16501 ASHLAND AVENUE  
SAN LORENZO, CALIFORNIA 94580**

SITE VICINITY MAP	
SLUSD - NATIONAL GUARD ARMORY 16501 ASHLAND AVENUE SAN LORENZO, CALIFORNIA

SITE RECONNAISSANCE  
PHOTOGRAPHS  
JULY 21, 2009

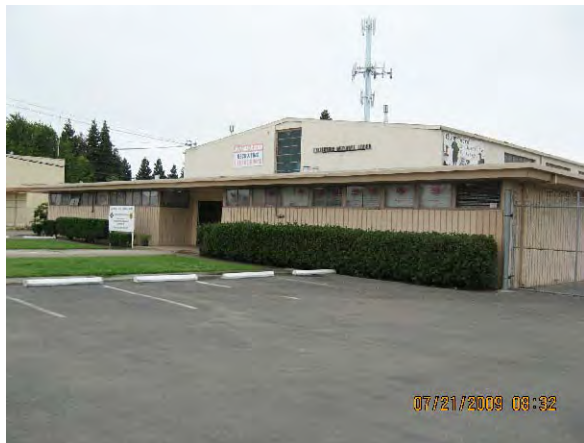
PHOTOGRAPH 1. Overview of site from northeastern boundary, shows armory building in foreground and adjacent cellular tower in background.

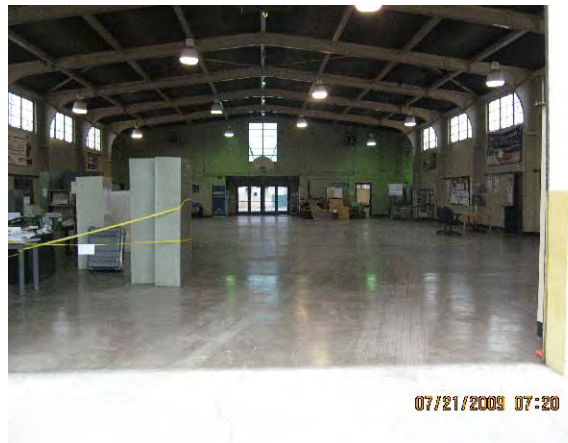
PHOTOGRAPH 2. Interior view of main room of armory building, with office doors visible along the edges. Stored furniture appeared to have been removed to allow asbestos abatement of select rooms.

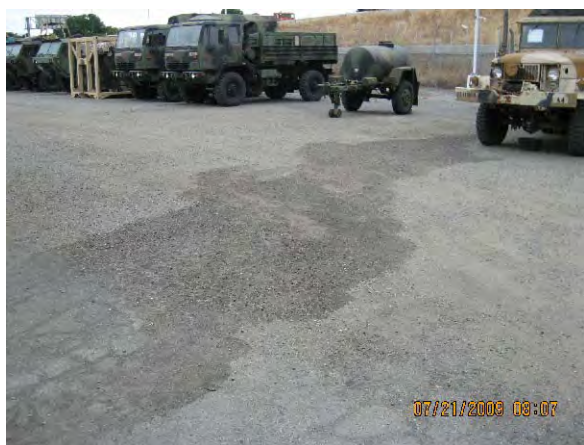
PHOTOGRAPH 3. Surface staining at northwest corner of armory building.

- A surface stain was observed northwest of the armory building, of sufficient size to be considered an REC;
- The site had a previous gasoline release. Although the case was granted regulatory closure, closure was obtained with a concentration of gasoline in groundwater of 600 micrograms per liter (ug/L) and was based on the use of the site at that time;
- Two open leaking underground storage tanks (LUST) cases are located in close proximity to the site.

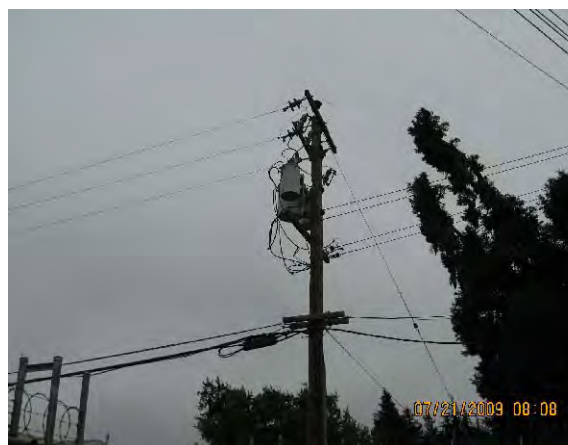
PHOTOGRAPH 4. Overhead transformers located along southern boundary of site.

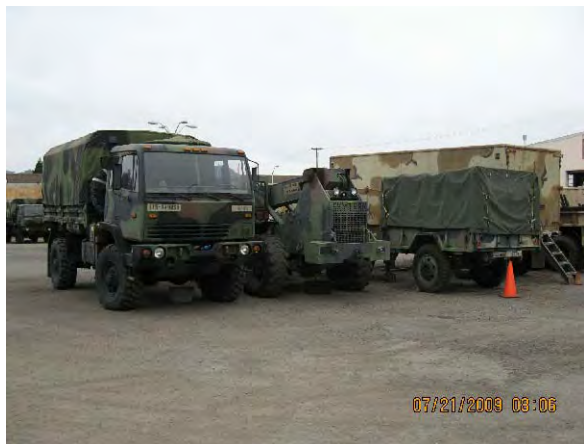
PHOTOGRAPH 5. Vehicle storage throughout site, primarily along northern border and between the maintenance and armory buildings. Vehicles appeared to be in good condition and stored with drip pans to contain possible oil leaks.

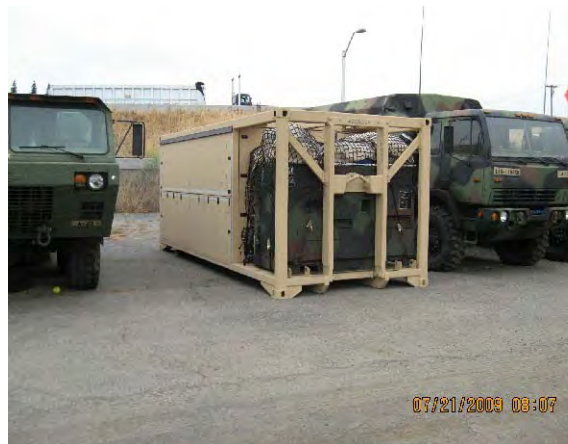
PHOTOGRAPH 6. Water purification with installed diesel generator. Generator was unused and had not previously been fueled.

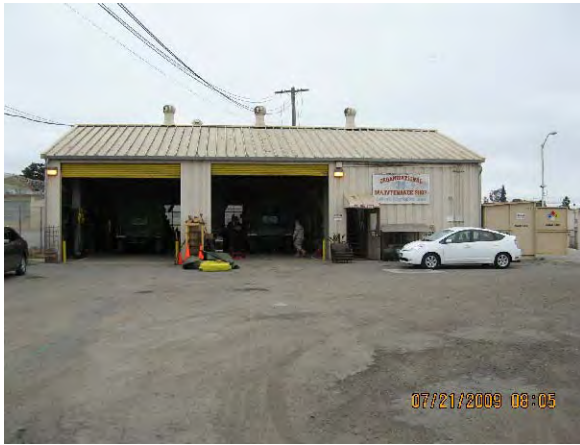
PHOTOGRAPH 7. Overview of maintenance building from the east. Building contains two maintenance bays and several offices.

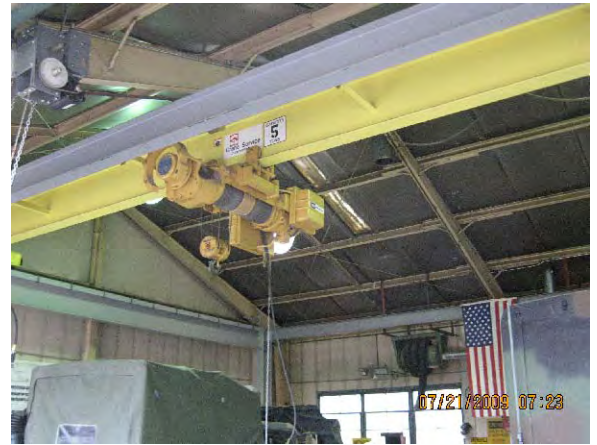
PHOTOGRAPH 8. Overhead crane used to lift vehicles for maintenance. Hydraulic lifts not installed.

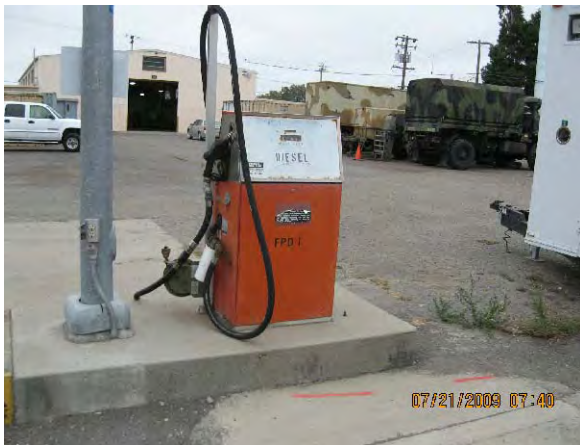
PHOTOGRAPH 9. Diesel fueling pump, located north of maintenance building.

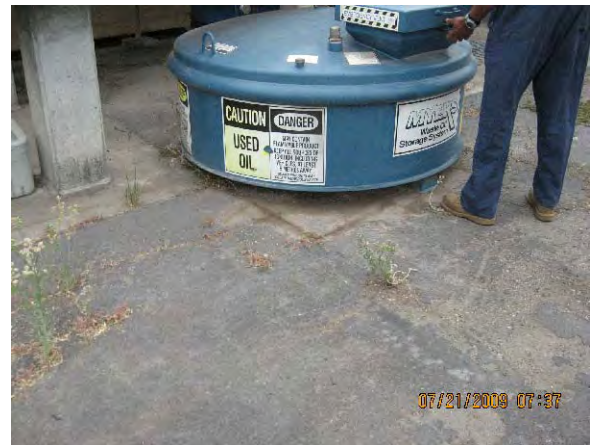
PHOTOGRAPH 10. Used motor oil AST. Area beneath AST contained absorbent material. Staining around AST minimal.

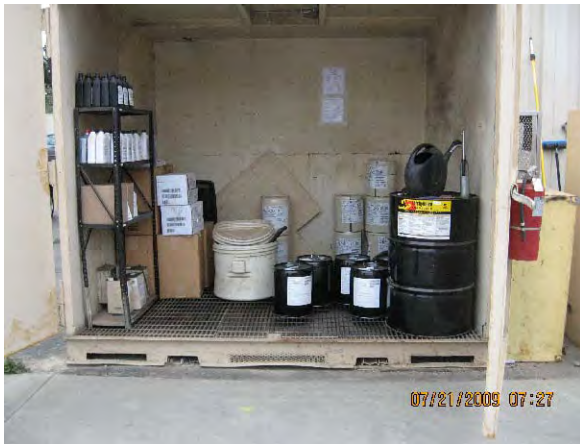
PHOTOGRAPH 11. New vehicle fluids storage, located adjacent to the north side of maintenance building

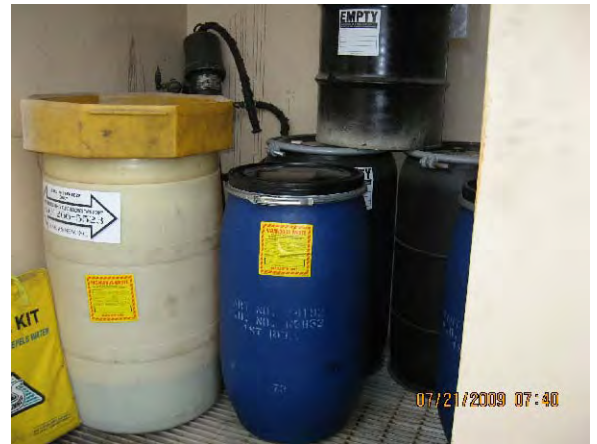
PHOTOGRAPH 12. Waste fluids storage, north of maintenance building.
