**Subject: 1395 MacArthur Boulevard, San Leandro, California
Remediation Status Report – Second Quarter 2017**

Remediation Status Report – Second Quarter 2017
SWISS VALLEY CLEANERS
1395 MacArthur Boulevard, San Leandro, California

27 July 2017
AGE-Project No. 12-2461

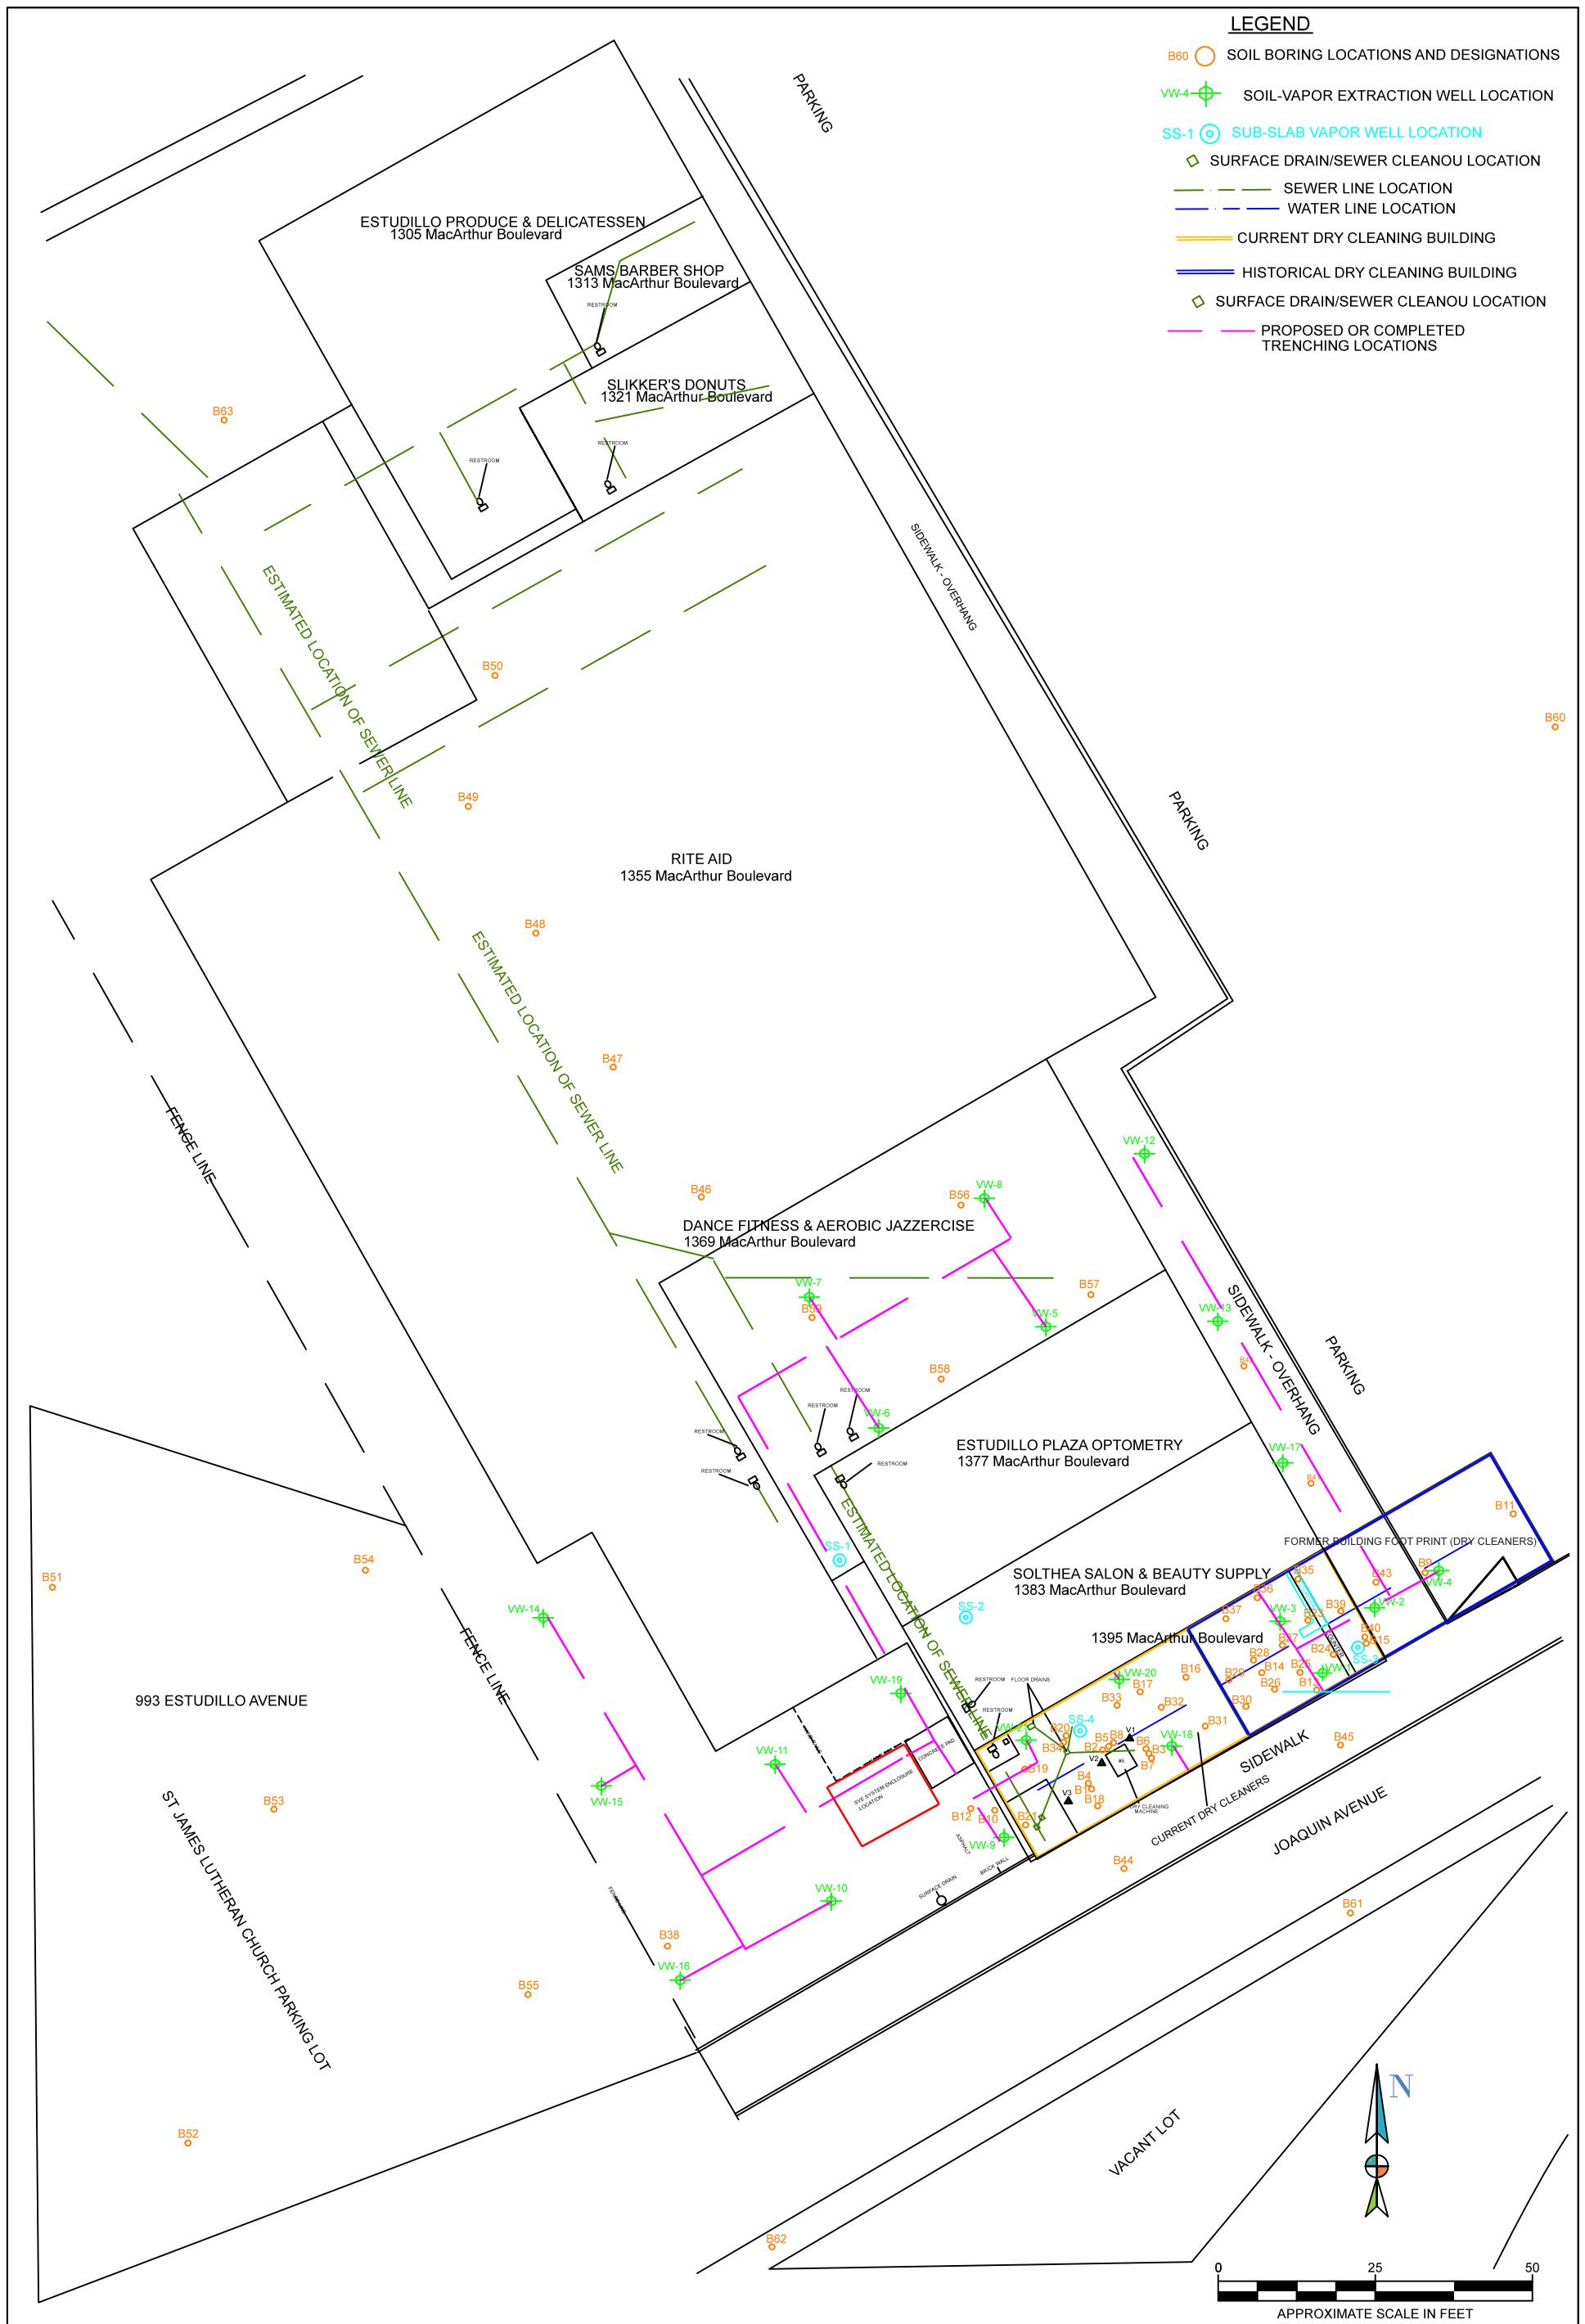
Figure 2 – *Soil-Vapor Well Locations & Trenching Locations*

At the request of Mr. William Mathews Brooks of Ardenbrook, Inc., Advanced GeoEnvironmental, Inc. (AGE) has prepared this, *Remediation Status Report – Second Quarter 2017*, for the Swiss Valley Cleaners site located at 1395 MacArthur Boulevard, San Leandro, California (site). This report documents remedial operation and maintenance of the soil-vapor extraction during the Second Quarter 2017. The location of the site is illustrated in Figure 1. A plot plan of the site, SVE wells and trenching locations are illustrated in Figure 2. Well construction details are included as Table 1.

Additionally, the SVE well network consists of twenty-one shallow screened SVE wells (VW-1 through VW-21) screened from 2 feet to 7 feet bsg. Each well is fitted with a ball valve to allow individual well adjustments. During this operational period all wells were utilized for SVE remediation (Table 2).

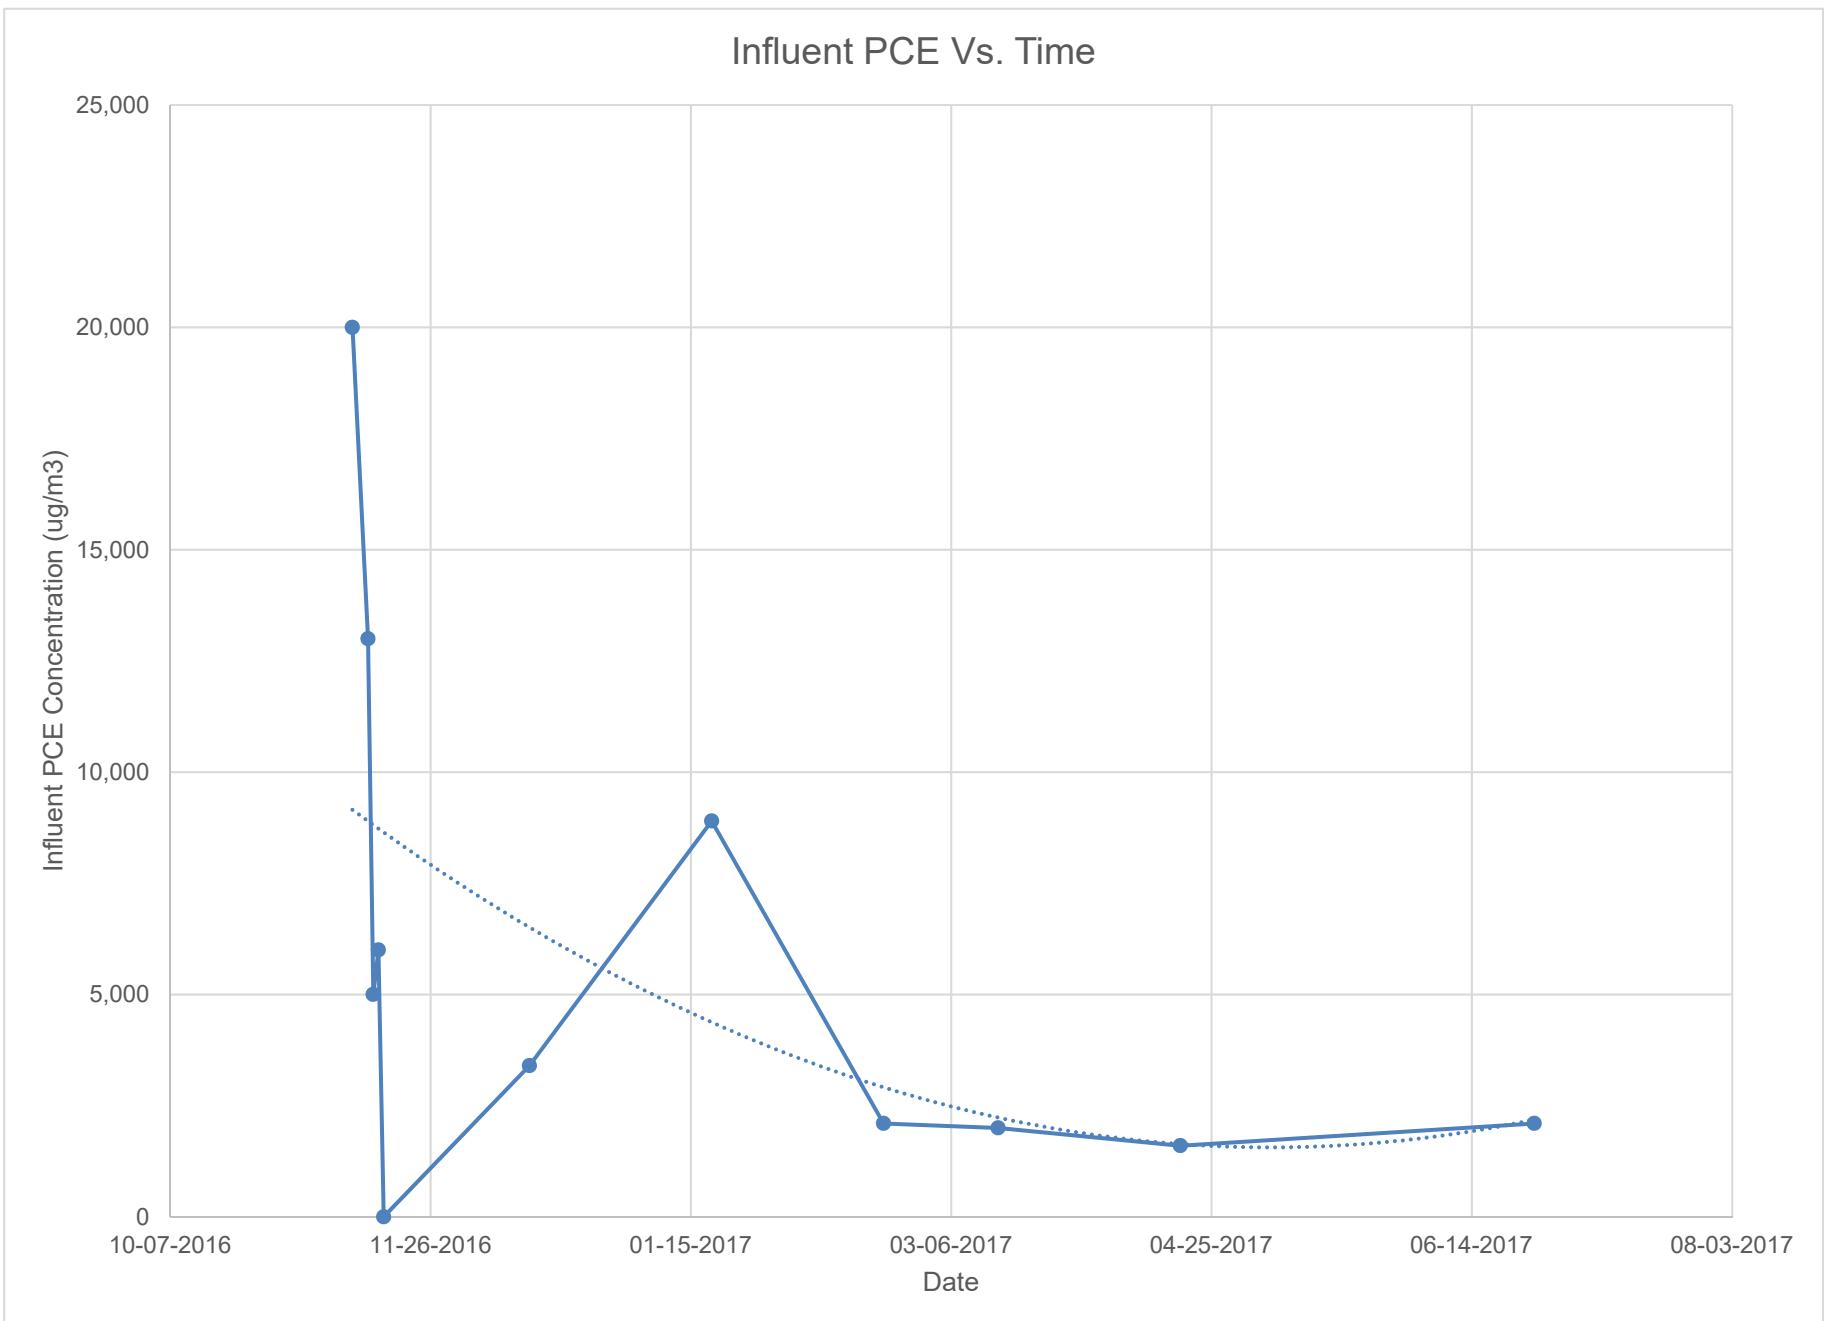
Appendix C – *Trend Graph*

- PCE was detected at low concentrations in both influent samples during the second quarter 2017 remediation period. Influent concentrations still appear to be reaching asymptotic levels (see trend graph in Appendix C). However, slight rebound was observed in recently performed indoor air and sub-slab samples and the system should continue to be run until constituents of concern are mitigated.
