SUBJECT: SUBSURFACE INVESTIGATION REPORT CERTIFICATION
Former Gasoline Station
4600 Grass Valley Road
Oakland, CA 94605

Report 0627.R1

SUBJECT: SUBSURFACE INVESTIGATION REPORT
Former Gasoline Station
4600 Grass Valley Road
Oakland, CA

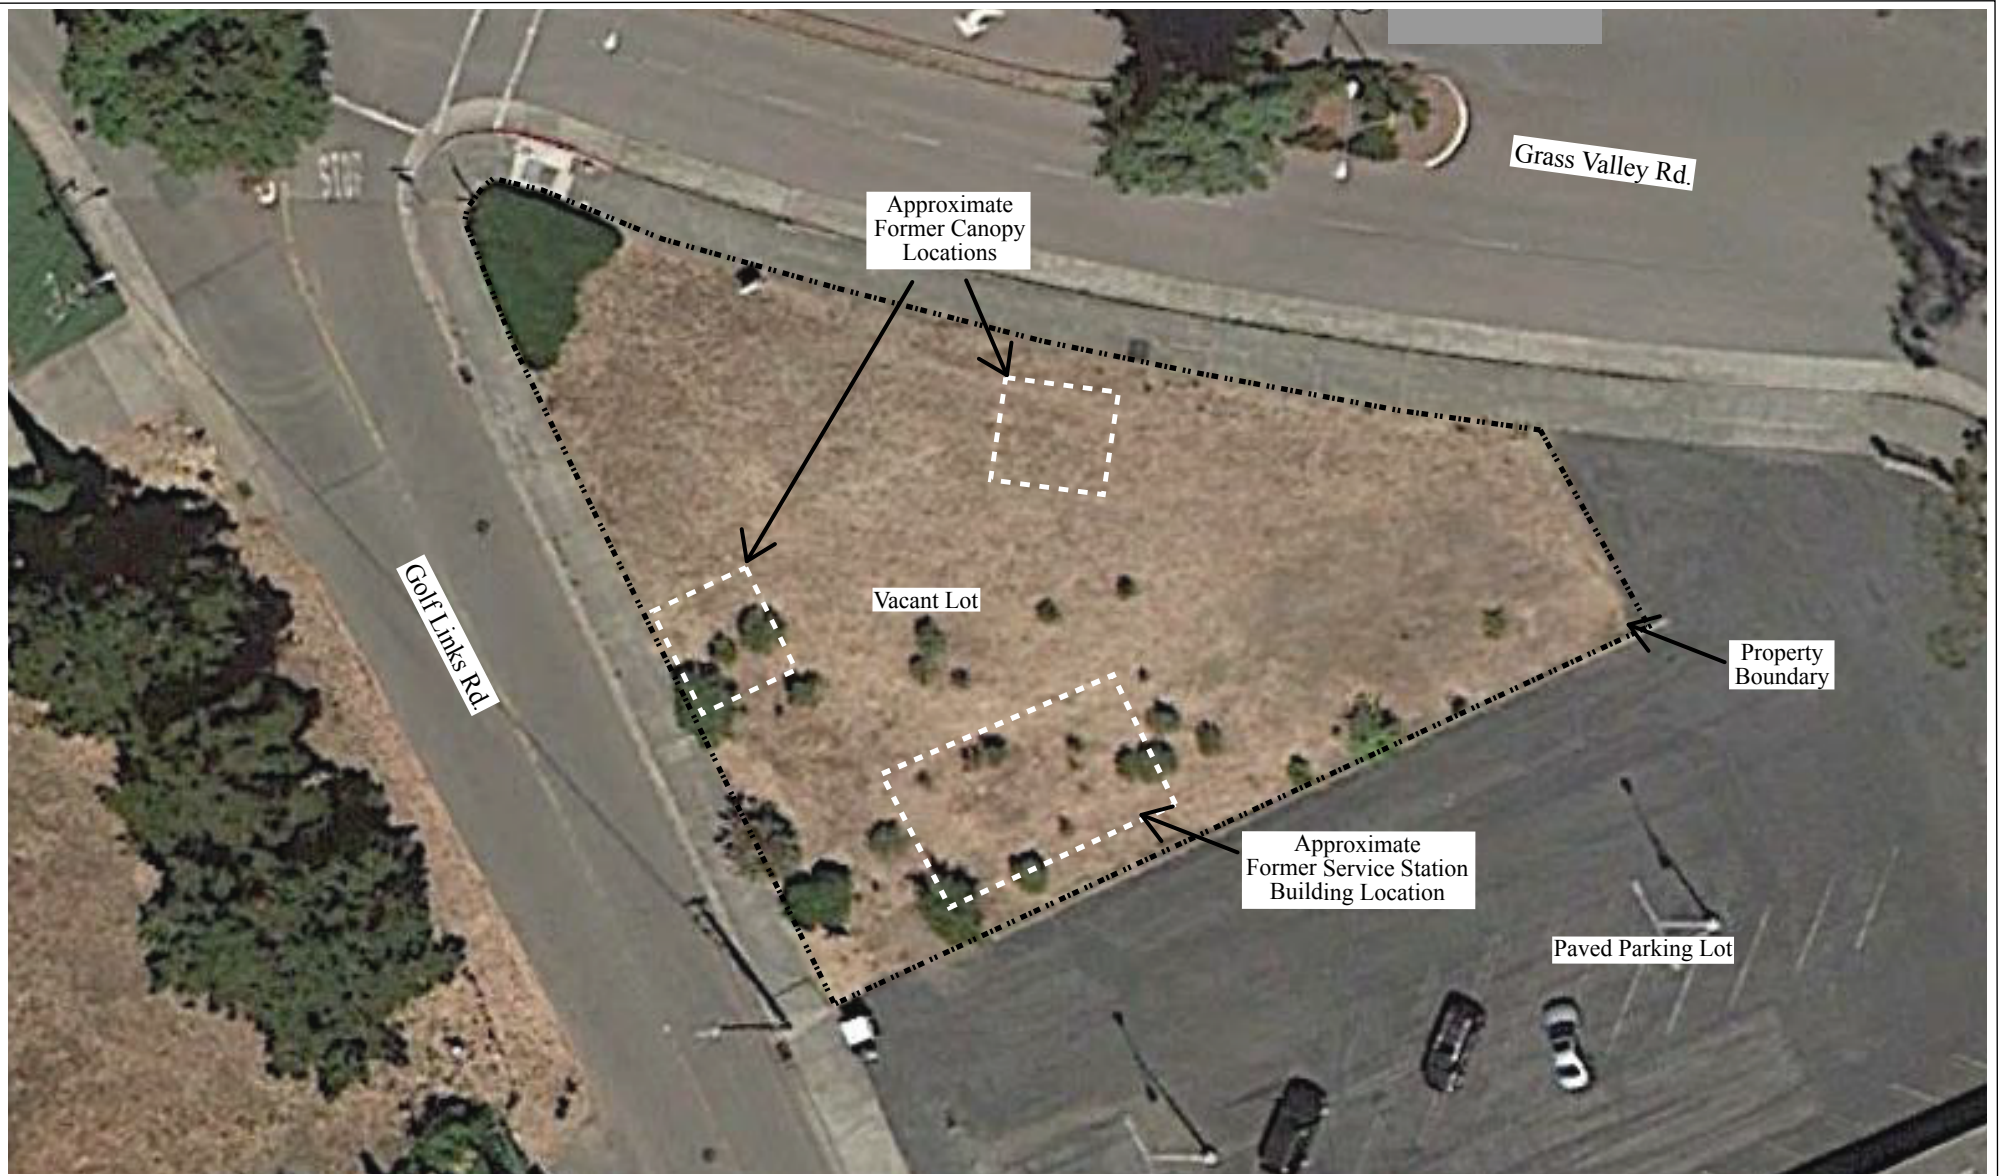
Figure 3
Site Aerial Photograph Showing Historical Gasoline Station Features
4600 Grass Valley Road
Oakland, California

information (i.e., former underground storage tank(s) size, type and locations, pump island locations, auto maintenance areas and use of hazardous materials etc.) was available within the local regulatory agency files reviewed. The former canopy locations identified on Figure 3 are interpreted to be the locations of the former fuel dispensers.
