**PHASE I ENVIRONMENTAL SITE ASSESSMENT
CALIFORNIA RURAL LEGAL ASSISTANCE, INC
1428-1432 FRANKLIN STREET
OAKLAND, CA 94612
RIMS#: 13-1544-1**

December 06, 2013

ENERCON Project No: UBOC407

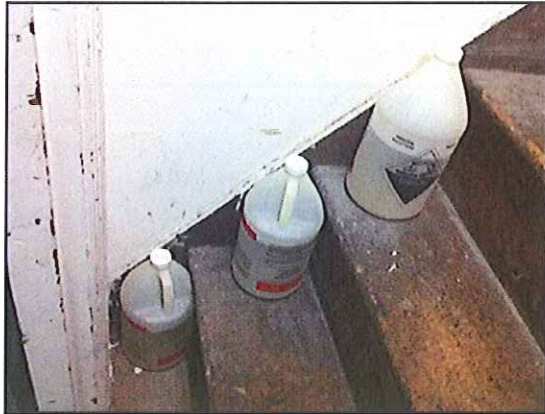
7 : Bottles of ammonia solution on roof access stairway in 1430 Franklin Street

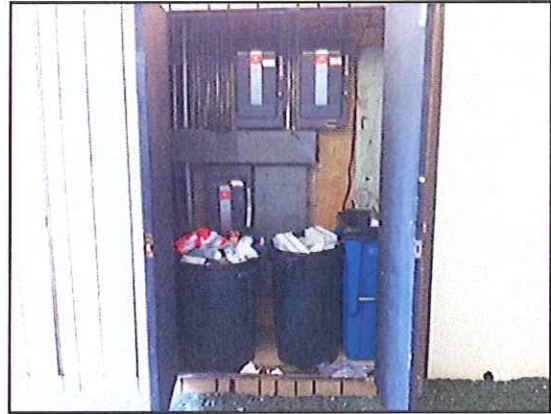
ENERCON observed ten gallons of paint in the electrical/storage closet in the entrance way of 1430 Franklin Street. Five gallons and one quart of paint were observed in the storage closet of 1430 Franklin Street Unit 100. Seven gallons and two quarts of paint were observed in the bathroom of 1432 Franklin Street. Three 110-ounce bottles of ammonia solution were observed behind the locked door to the roof access stairway. Small amounts of retail-sized household cleaners were observed under the sink in the employee lunch room.

General office type wastes were observed in garbage cans located in the electrical/storage closet in the entrance way of 1430 Franklin Street. The garbage cans are serviced by Waste Management on a weekly basis.

8 : Electrical/storage closet in entrance way of 1430 Franklin Street

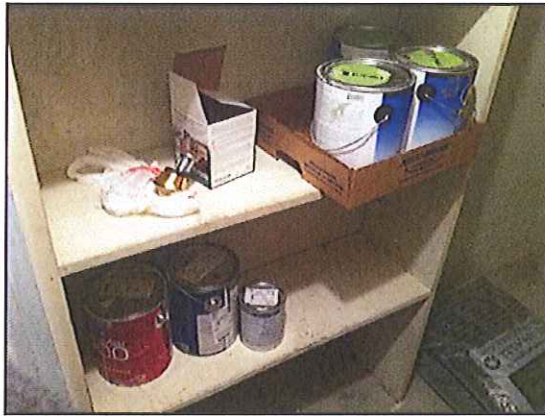
9 : Storage closet in 1430 Franklin Street Unit 100

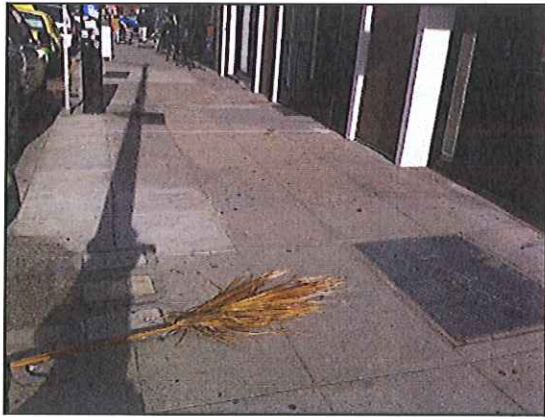
ENERCON contacted the Fire Prevention Division of the Oakland Fire Department (OFD), the Certified Unified Program Agency (CUPA) for the City of Oakland on November 15, 2013 for the purpose of conducting a records search of past or current environmental concerns associated with the subject property addresses. No records were found for the subject property addresses of 1428 or 1432 Franklin Avenue. The subject property address of 1430 Franklin Street does not appear in the EDR radius report, GeoTracker, or EnviroStor databases however, records reviewed at the OFD indicated that two 300-gallon heating fuel oil UST were listed as having been removed at 1430 Franklin Street in 2004. Based on a site sketch on the UST Closure/Removal Field Inspection Report, the USTs were located underneath the sidewalk between the on-site building and Franklin Street. Sample analysis found up to 3,800 milligrams per kilogram (mg/kg) total petroleum hydrocarbons as gasoline (TPHg) in soil underneath the UST. The RWQCB environmental screening level for middle distillate fuel oil is 500 mg/kg, which is lower than the concentrations found during tank removal. Groundwater was encountered during tank removal but was not sampled.

A "work plan for over-excavation of contaminated soils" was prepared by AEI Consultants and was submitted to the OFD in 2004, however, no records indicating that the over-excavation or further sampling could be found. No tank removal closure report could be found. According to the OFD Hazardous Materials Inspector, some cases of elevated contamination are referred to the ACEHD. ENERCON contacted the ACEHD for records regarding 1430 Franklin Street and no records were found.

13 : Potential former location of heating oil underground storage tank
