P&D ENVIRONMENTAL, INC.

April 3, 2014
Report 0675.R1

**SUBJECT: SUBSURFACE INVESTIGATION REPORT
(B1 THROUGH B4)
475 Lesser Street
Oakland, CA 94601**

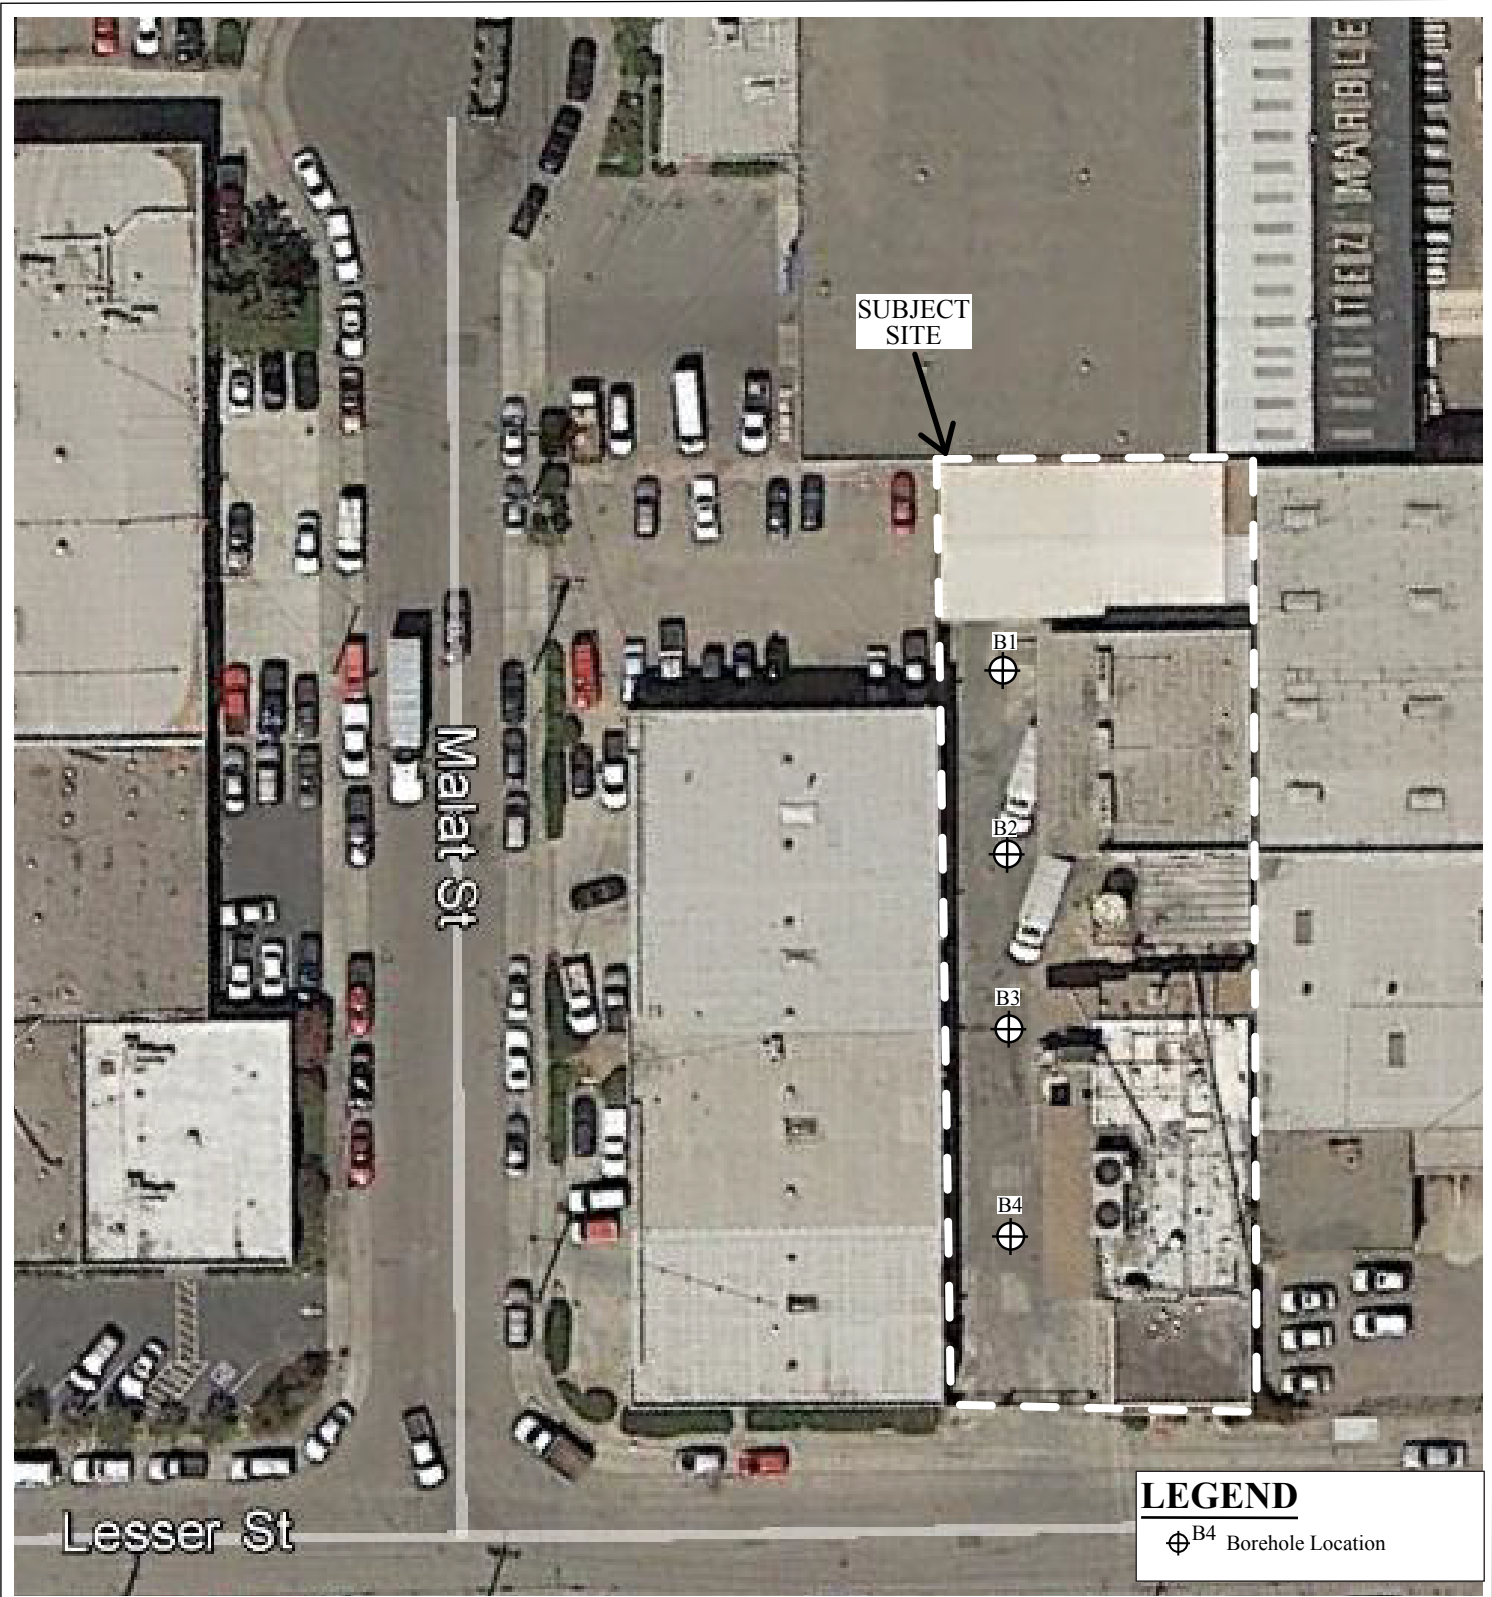
Figure 2
 Site Aerial Photograph Showing Borehole Locations
 475 Lesser Street
 Oakland, California

On March 26, 2014, P&D personnel oversaw drilling at locations B1 through B4 shown on Figure 2 for the collection of soil and groundwater samples at the subject site. All drilling was performed by Vironex, Inc. of Concord, California by continuously coring using Geoprobe direct push technology to drive a 2.0-inch outside diameter Geoprobe macrocore barrel sampler lined with transparent PVC sleeves. Boreholes B1 through B3 were continuously cored to a total depth of 8 feet below the ground surface (bgs), and borehole B4 was continuously cored to a total depth of 10 feet bgs.
