May 17, 2016

Subject: Data Gap Investigation to Evaluate Potential Indoor Air Vapor Intrusion by Soil-Gas related to a Former Residential Underground Heating Oil Tank located at 811 Paramount Road, Oakland, CA. (Alameda County Fuel Leak Case No. RO0003143 and CA GeoTracker Global ID T10000006106)

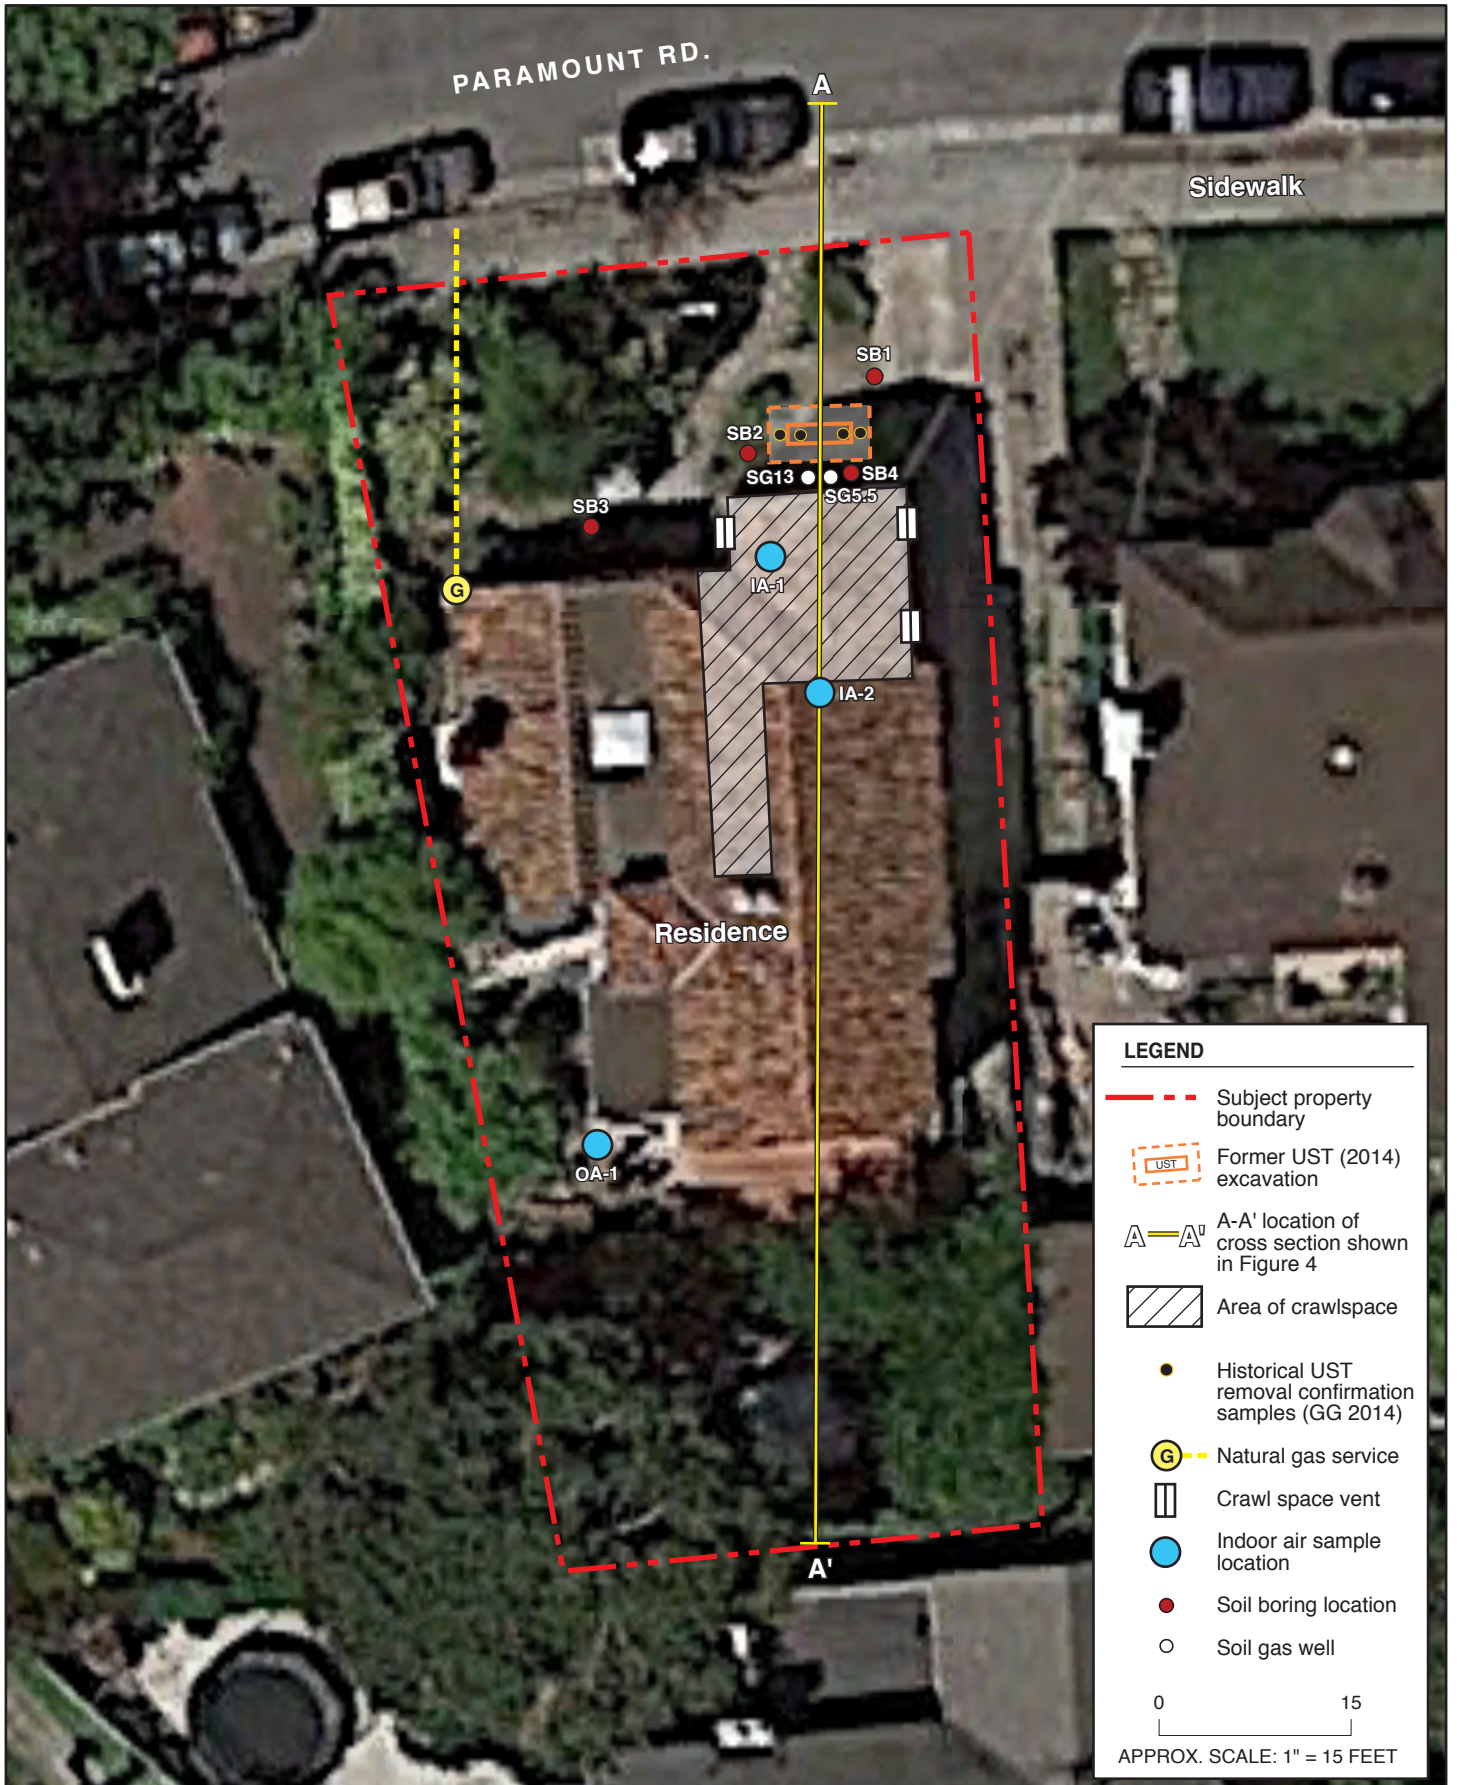
2015-16-14

- - - Subject property boundary
- UST Former UST (2014) excavation
- A—A' A-A' location of cross section shown in Figure 4
- Area of crawspace
- Historical UST removal confirmation samples (GG 2014)
- Ⓞ Natural gas service
- Crawl space vent
- Indoor air sample location
- Soil boring location
- Soil gas well

Attached Figure 1 shows the site location and Figure 2 is a site plan showing the locations of current and historical sampling of the former UST. Figures are included in Attachment A

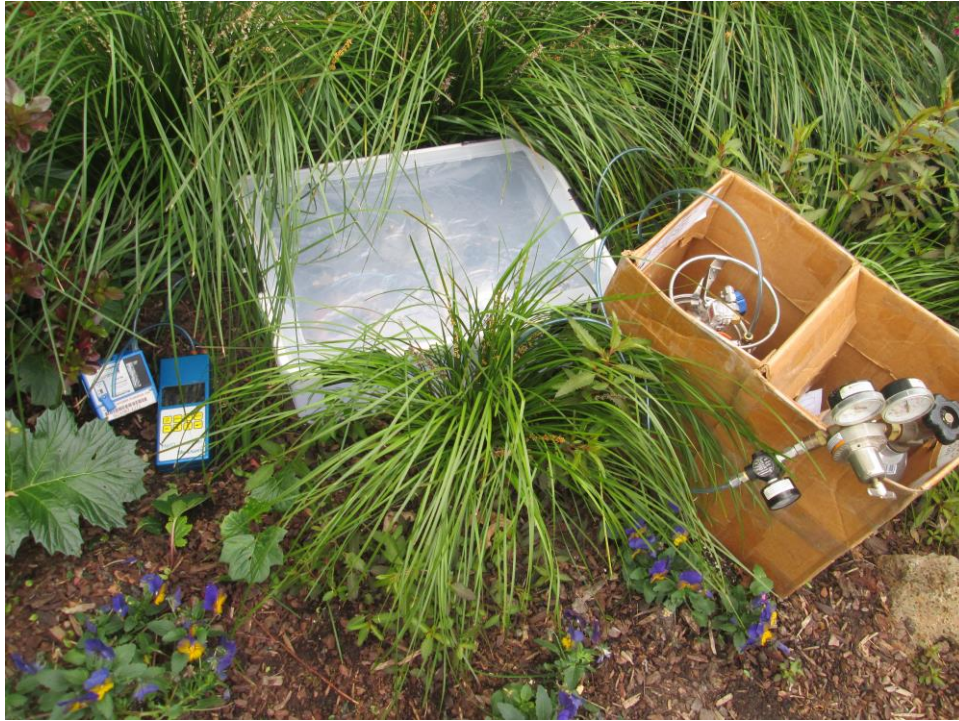
Photo No.: 01

Subject : Helium shroud soil-gas sampling apparatus over soil-gas well SG5.5

A Helium Shroud apparatus was used to test for ambient air leaks around the sampling train, and at the soil-gas tubing interface with the ground surface. The helium shroud apparatus was set

A helium shroud leak detection apparatus was used during the soil-gas collections. Helium was not detected during either the TO-15 indicating no leakage in the sampling train during collection. The TO-17 samples showed 0.13% helium in both the primary and duplicate sample analytical results. This small detection indicates a leak in the above ground manifold since the field leak check prior to sampling detected no helium.

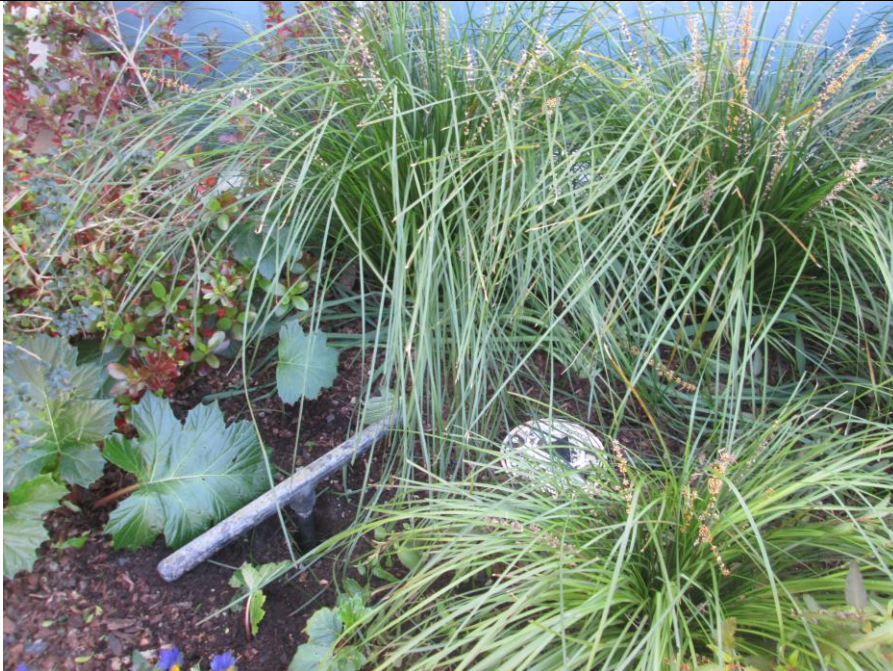
Photo No.: 02

Subject: Auger down to 5 feet below surface located about 1 foot northeast of soil-gas well SG5.5

One soil boring identified as SB4 was advanced utilizing a stainless steel hand auger in a location east and adjacent (within 2 feet) of soil-gas well SG5.5 to investigate the source of the contaminants TPHg, TPHd, benzene and 1,1,2-trichloroethane that were previously documented in soil-gas above their ESLs. Two soil samples from 3-3.5 and 5-5.5 feet bgs were collected by boring with the hand auger to the top of the target depth followed by retrieving the soil sample

with a hand-held drive hammer sampling tool. The boring lithology consisted of an upper 6 inches of garden soil overlying light brown silty clay. Light-green discoloration was noted in bore SB4 between 3-5 feet bgs and a light oil odor was noticeable in the 5 foot sample. The soil was collected in a stainless-steel sleeve held in the drive end of the sampler that is inserted into the borehole and driven from the top to the bottom of the target depth interval. The sampler retrieves a relatively undisturbed 1.5-inch-diameter, 6-inch-long soil sample from the desired depth. The samples contained in the steel sleeves were sealed with Teflon™ tape and non-reactive plastic caps, labeled, and placed in a chilled cooler. The drive hammer sampler was decontaminated with phosphate free soap and a triple rinsed between the two sampling locations.

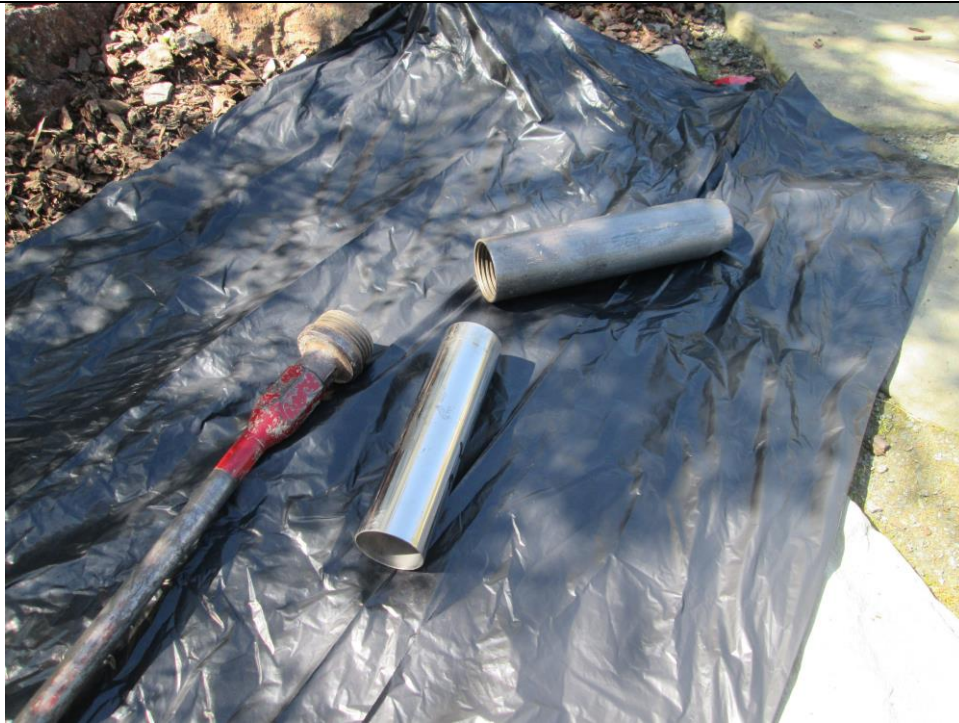
Photo No.: 03

Subject : Drive hammer sampling apparatus used for soil collection

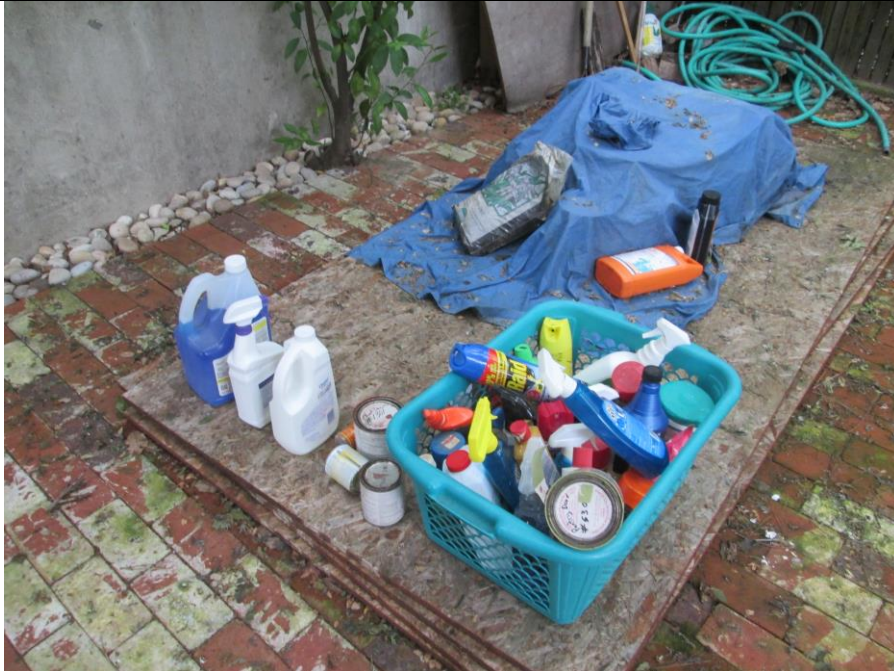
Photo No.: 04

Subject: Basement room household chemicals removed to outside garden before indoor air survey

To evaluate potential sources of contaminants in indoor air, a chemical inventory was conducted on March 31, 2016. It was noted during the inspection that all chemical products observed were commercially available products in their original packaging, with no signs of spillage. Several of the products contained various aerosol petroleum distillates, Stoddard Solvent, butane, propane, isobutene, but none of the contaminants of concern specifically targeted in this investigation. Professional dry cleaned clothes were not observed. The chemical inventory is contained in Attachment C.

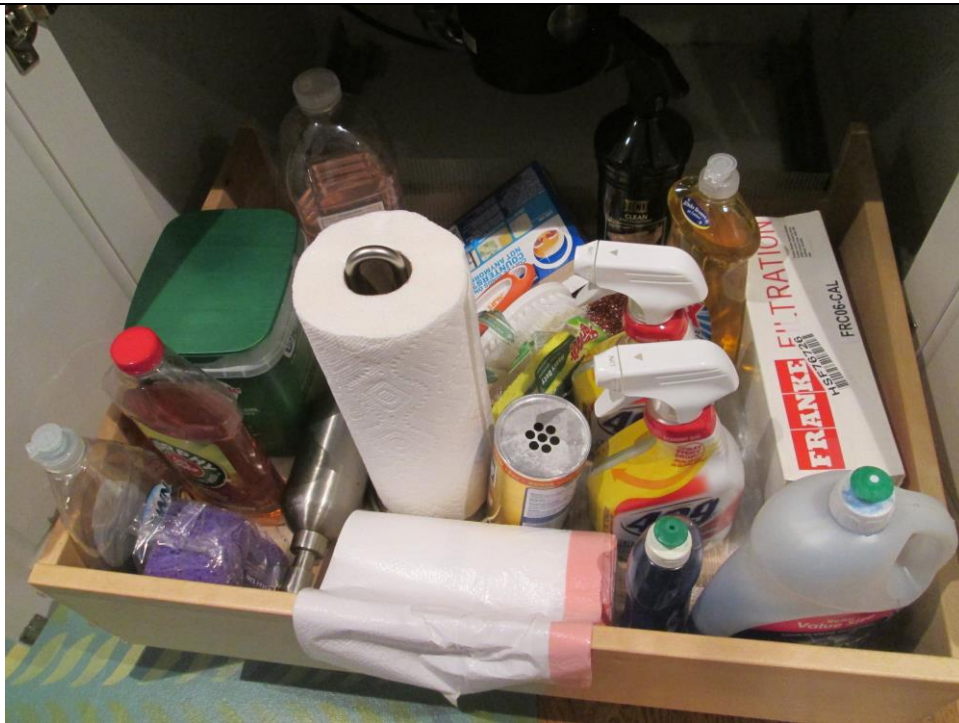
Photo No.: 05

Subject: Ground floor household chemicals stored under kitchen sink

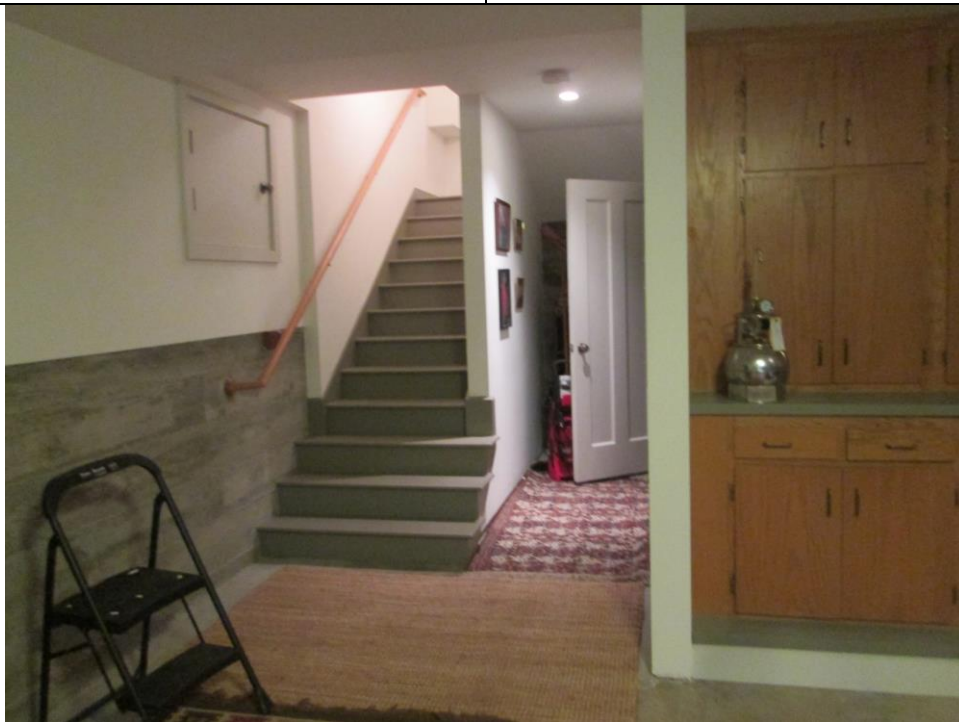
Subject: Indoor air basement room sampling location IA-2

The analytical results of the March 31 - April 1, 2016 indoor air survey indicated the residential indoor air to contain more contaminants than the ambient outdoor air which is the opposite situation of what was observed in the October 2015 survey. In general, the indoor air crawl space air showed 15 compounds detected, 4 of which exceeded their respective ESLs; the basement room air had 25 compound detections with 6 over their ESLs; and the outdoor air showed 12 compounds detected with 3 in excess of their ESLs.
