# UNDERGROUND STORAGE TANK CLOSURE REPORT

*1380 Mound St., Alameda, CA Project Site*

*September 30, 2014*

## 1380 MOUND STREET, ALAMEDA CA

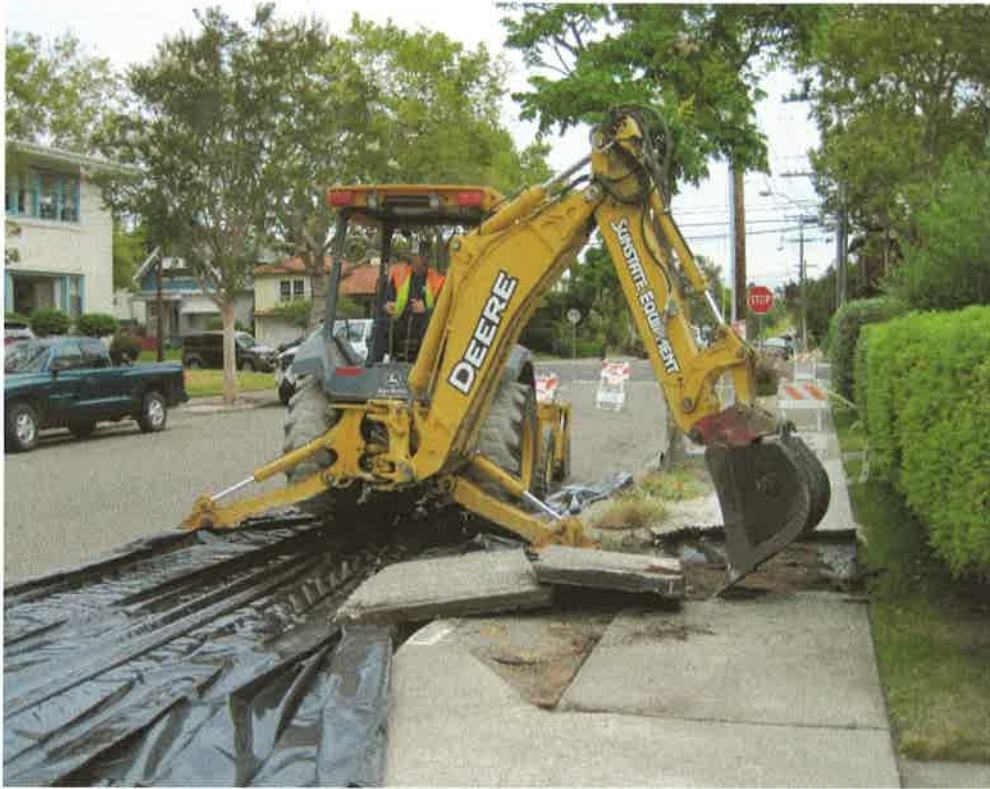
Photograph of sidewalk removal

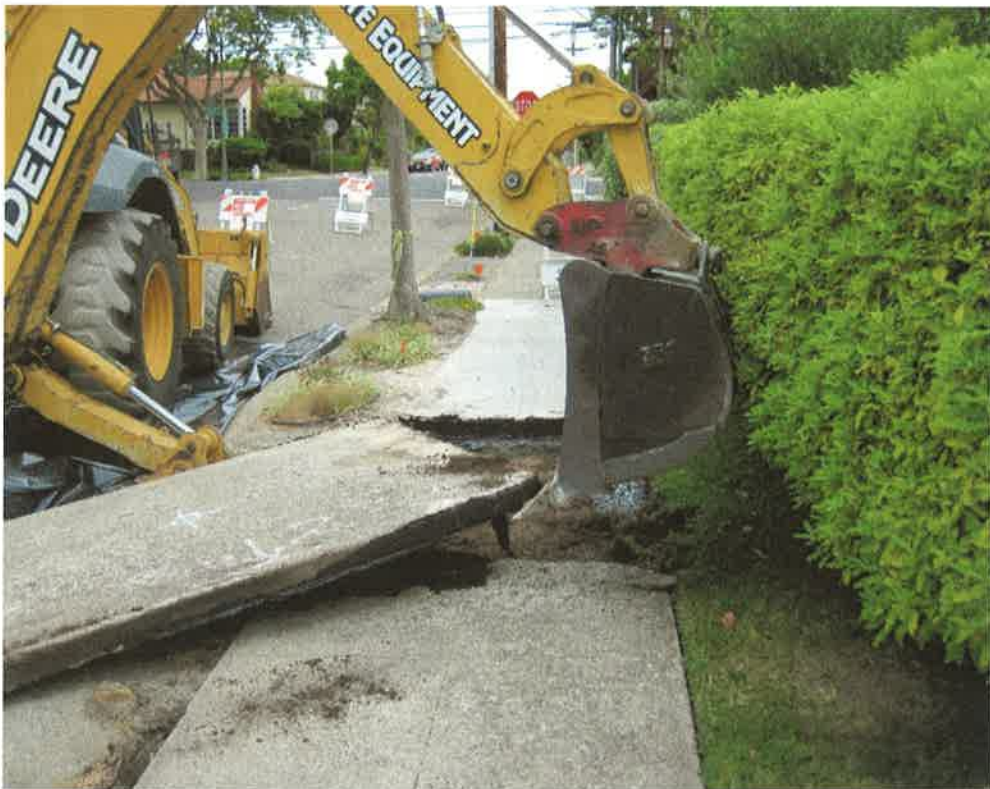
Additional photograph of sidewalk removal

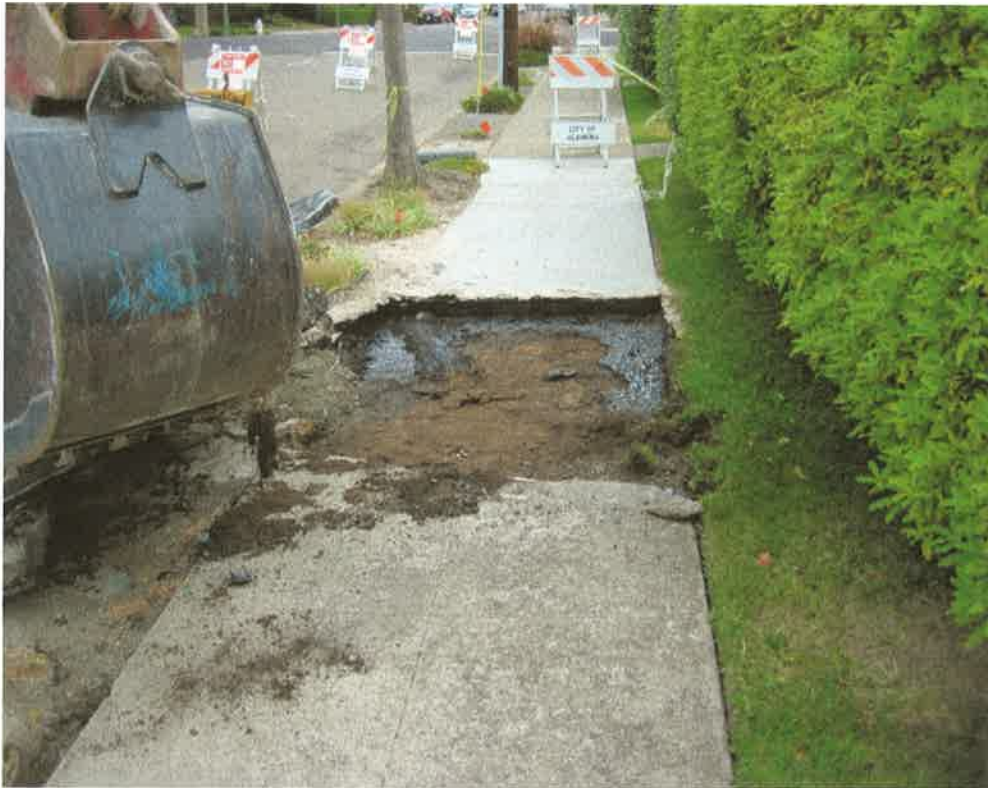
Photograph showing oil product seep beneath the sidewalk

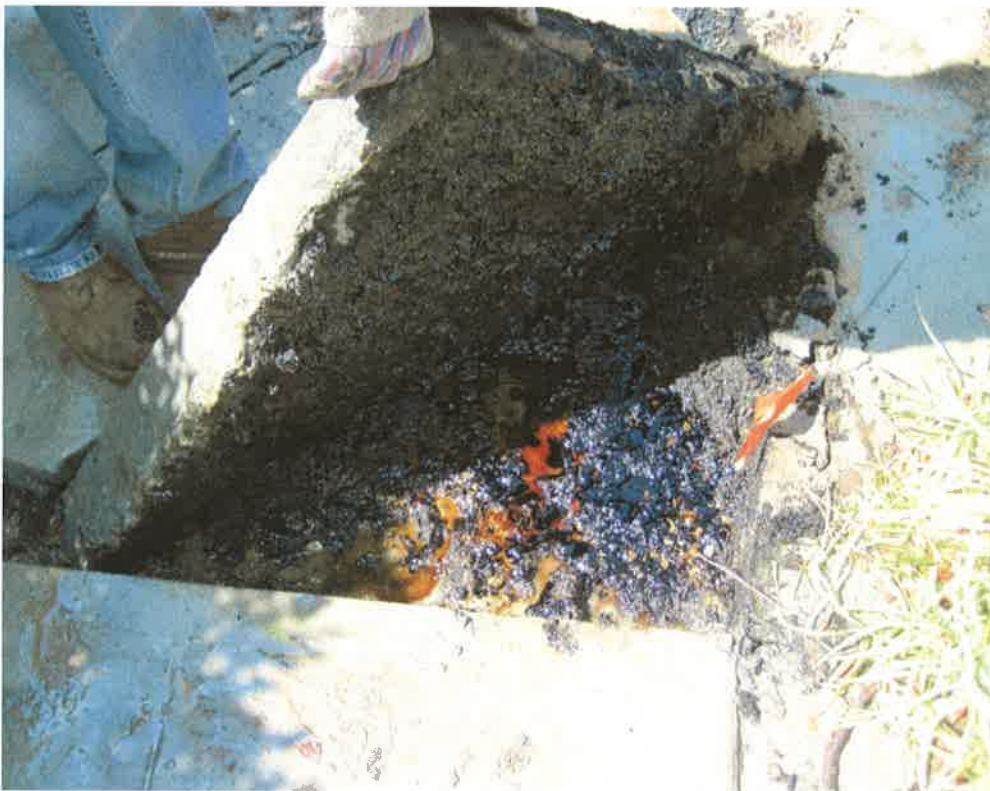
Additional photograph showing oil seep beneath sidewalk

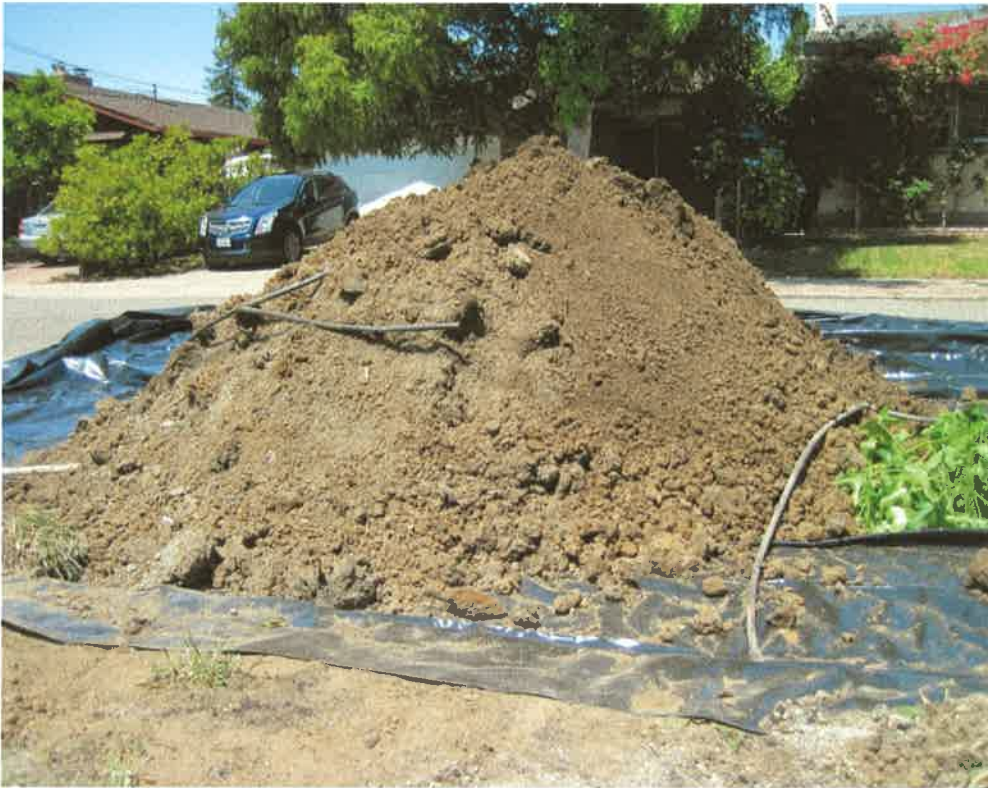
Photograph of soil over-burden stockpile that was placed in 20 CY bins

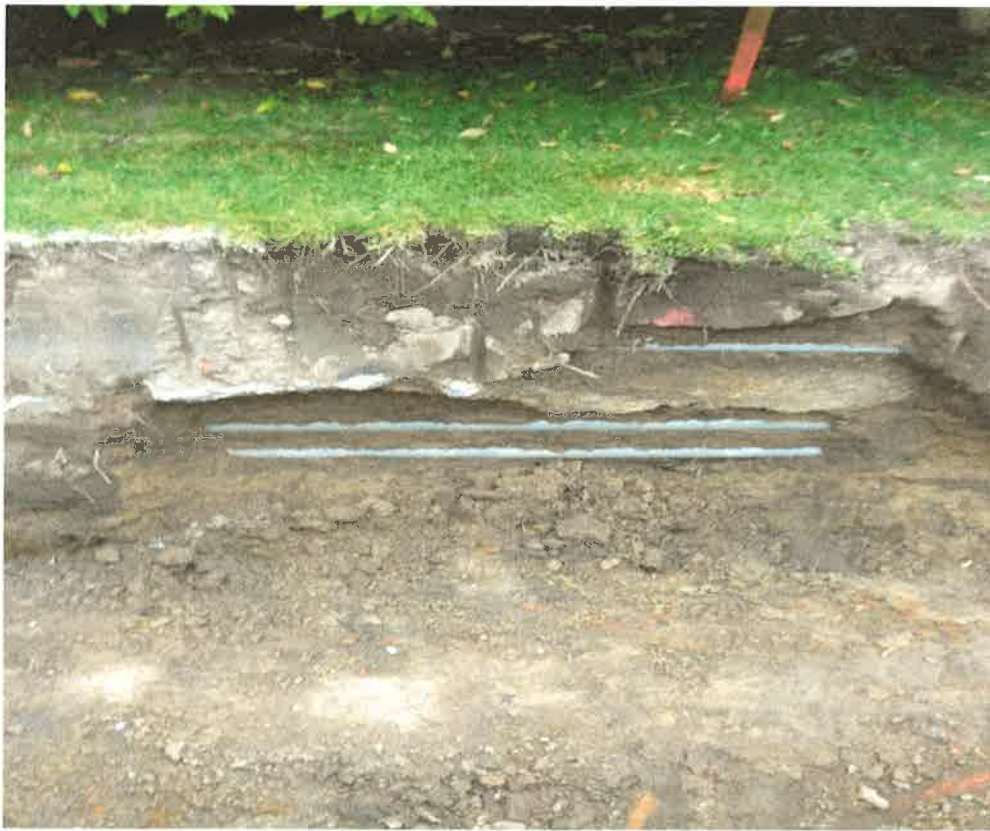
Photograph of joint trench located on south edge of tank excavation

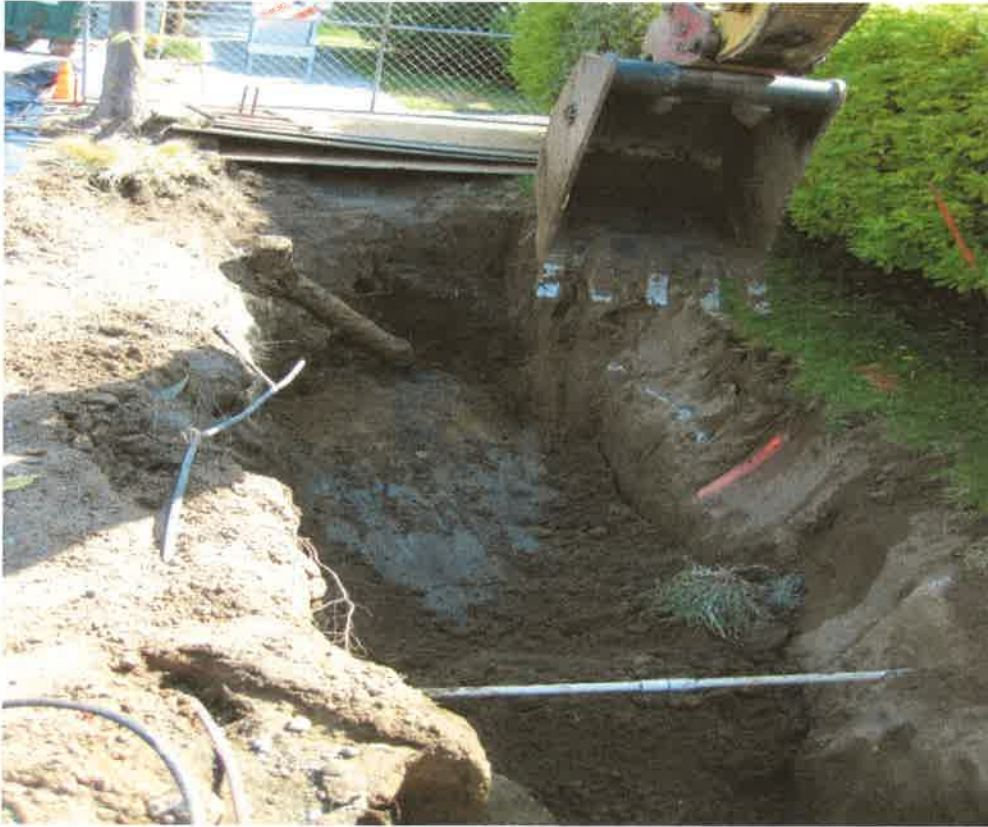
UST excavation facing east. The main fill pipe is visible in the background

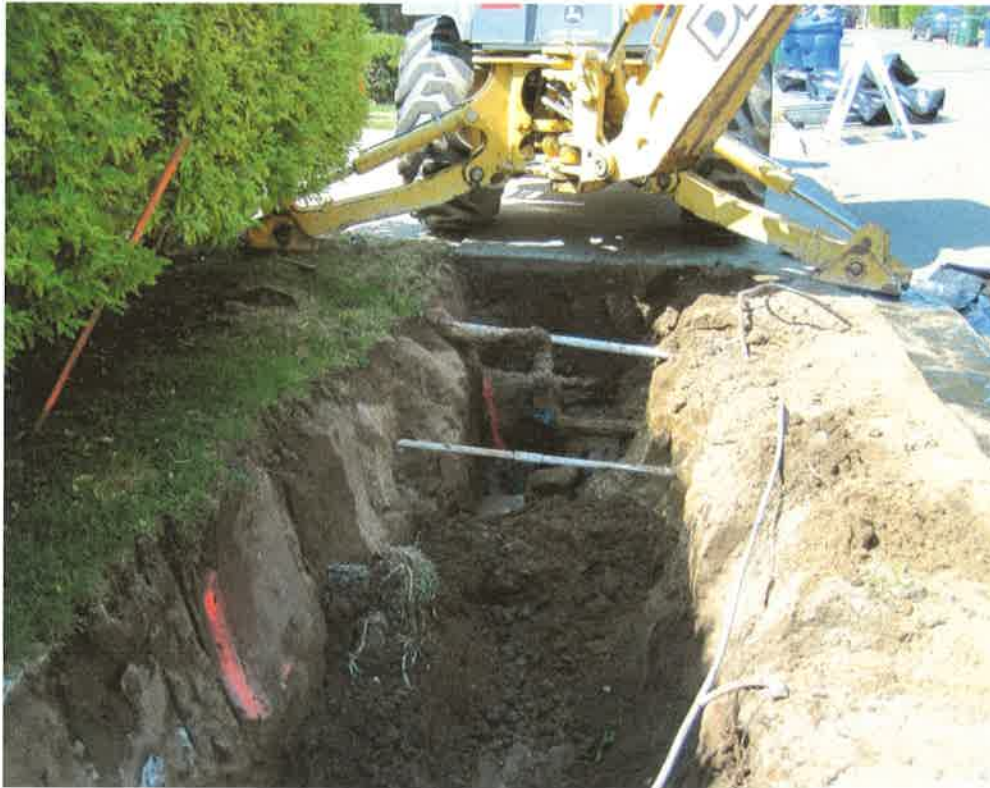
UST excavation facing west. The product delivery system manifold and piping is visible in the background

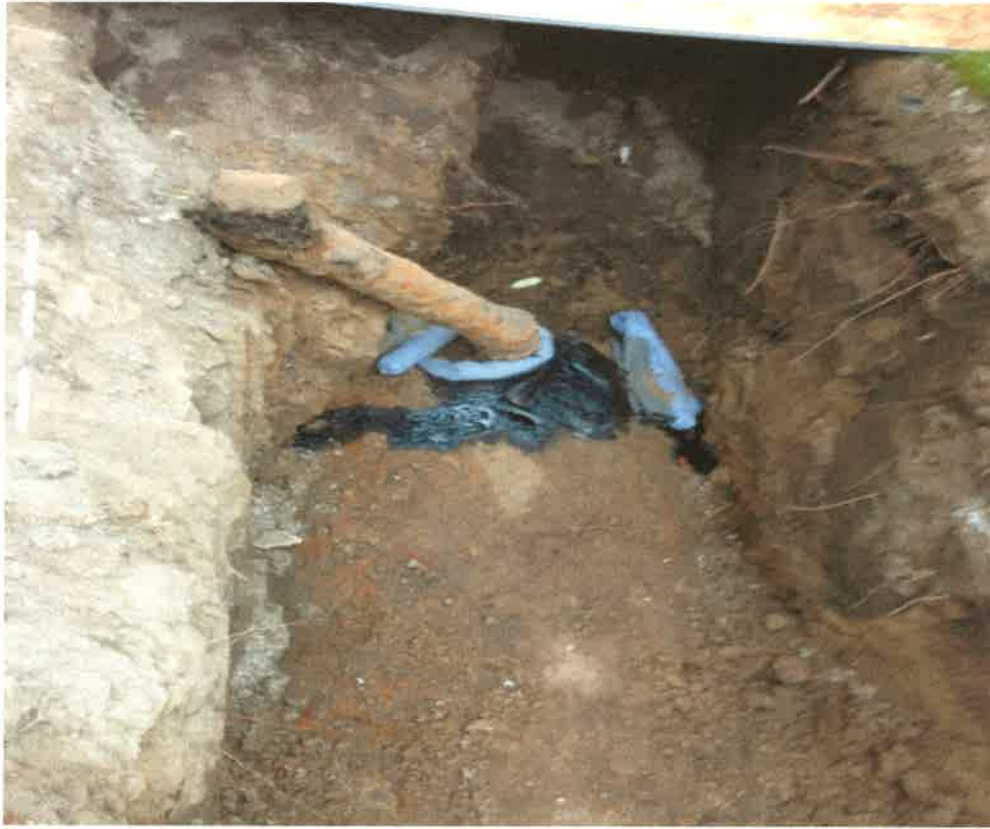
Main fill pipe. Product seepage is visible on surface of the tank

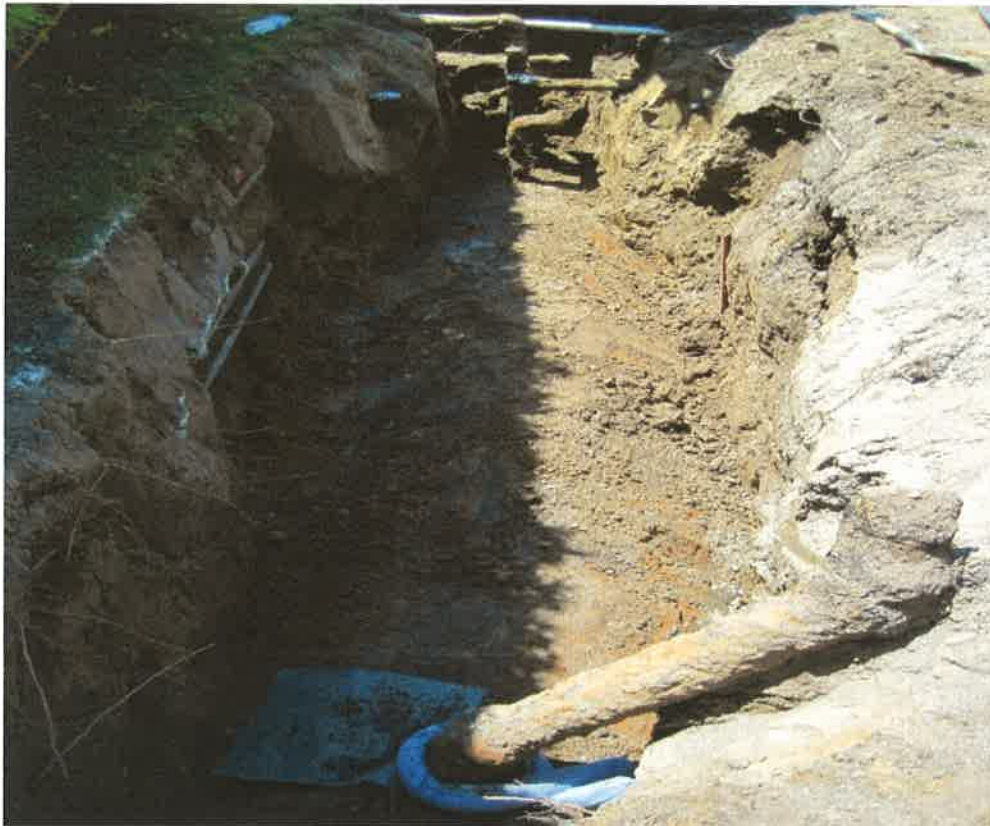
Surface of the tank showing both fill pipe and product delivery system manifold.  
The joint trench is visible to the left of the photograph

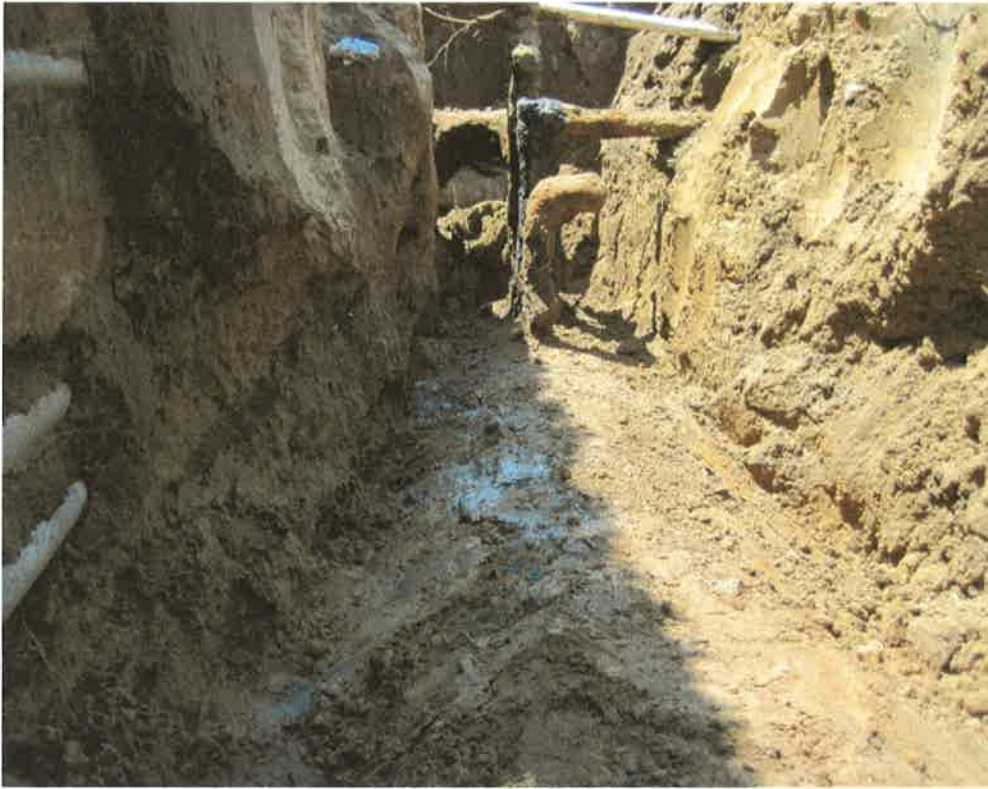
Close view of product delivery system manifold

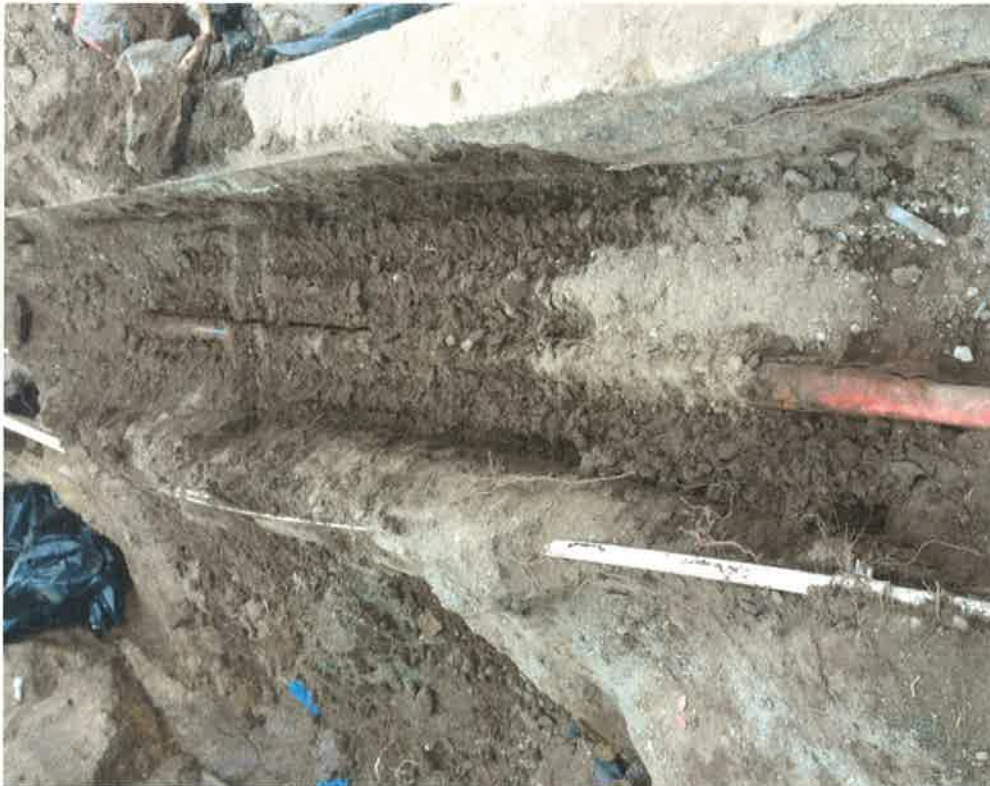
Photograph of return line found running parallel to North edge of tank

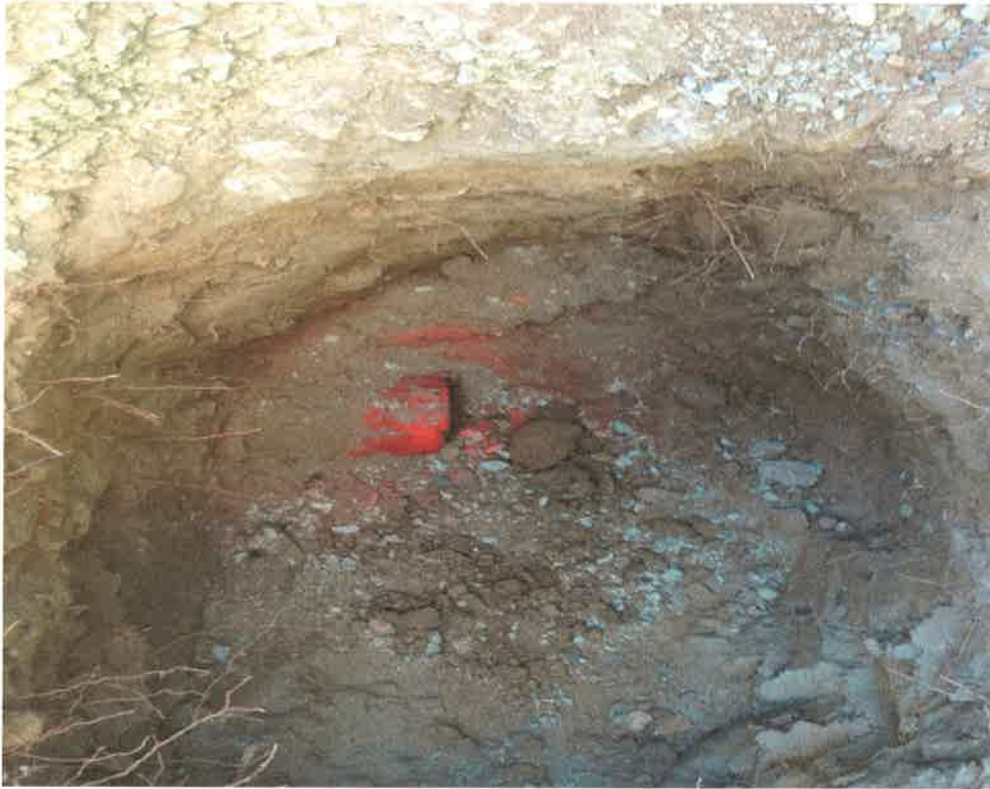
Termination point of return line found at utility pole

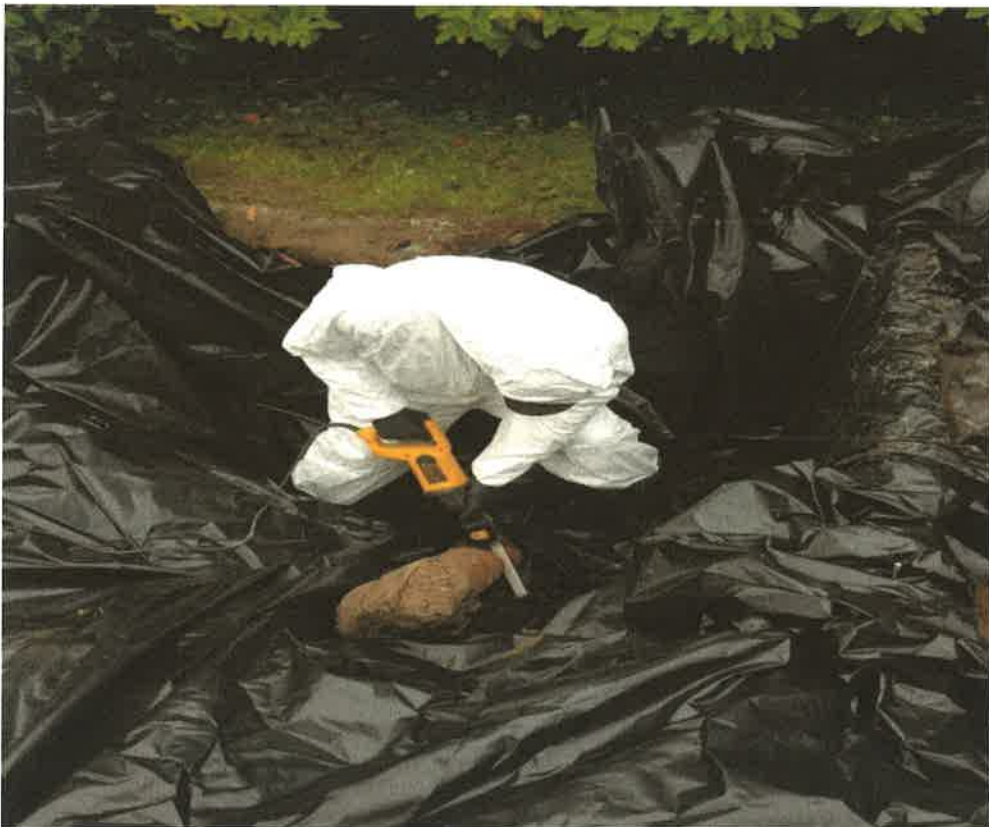
Photograph showing cutting of tank system piping

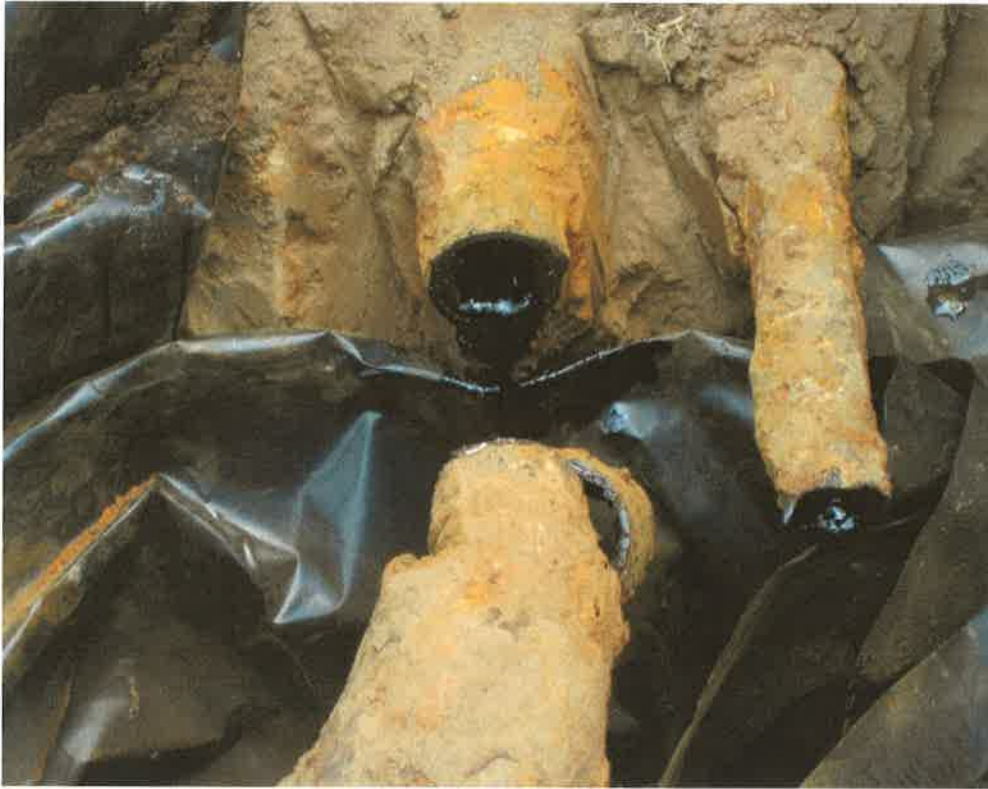
Photograph showing product seeping from pipes

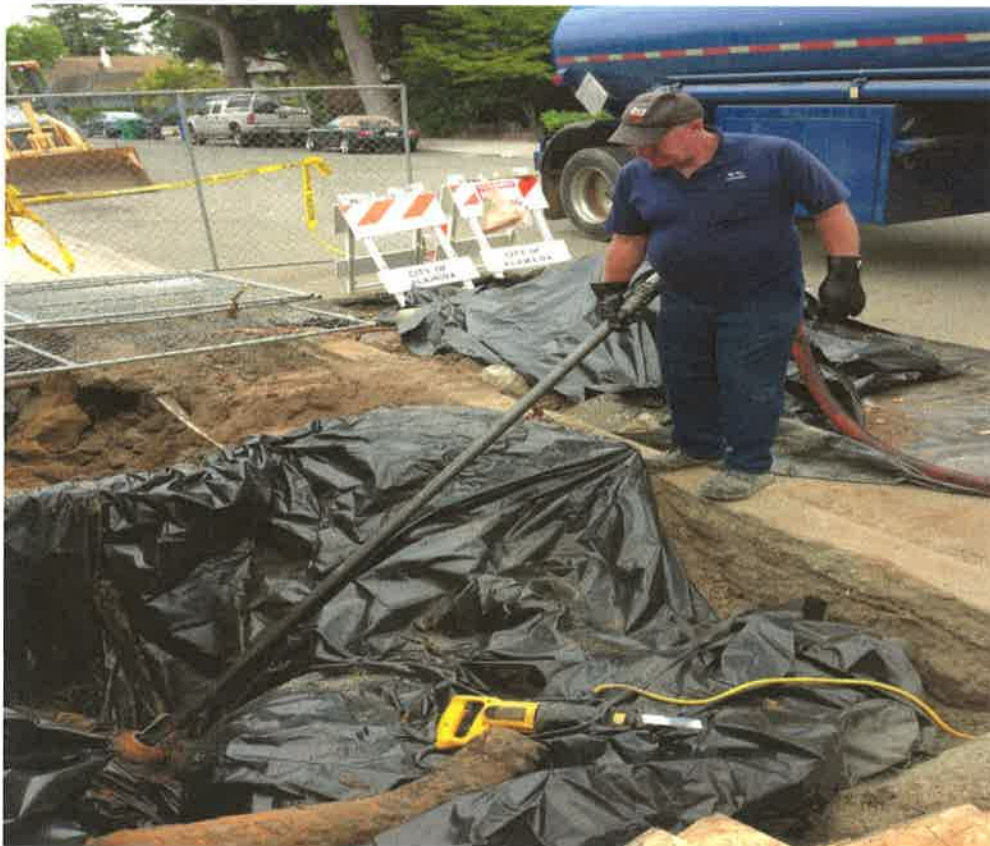
Product removal from tank

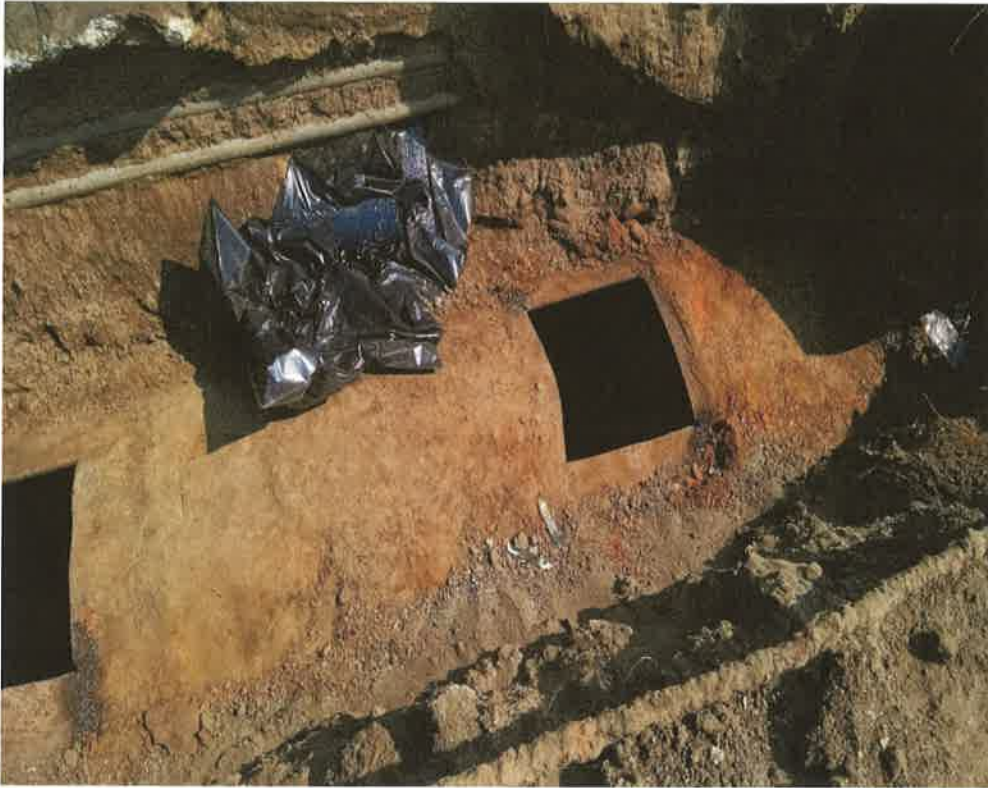
Photograph showing access holes cut into top of tank for cleaning

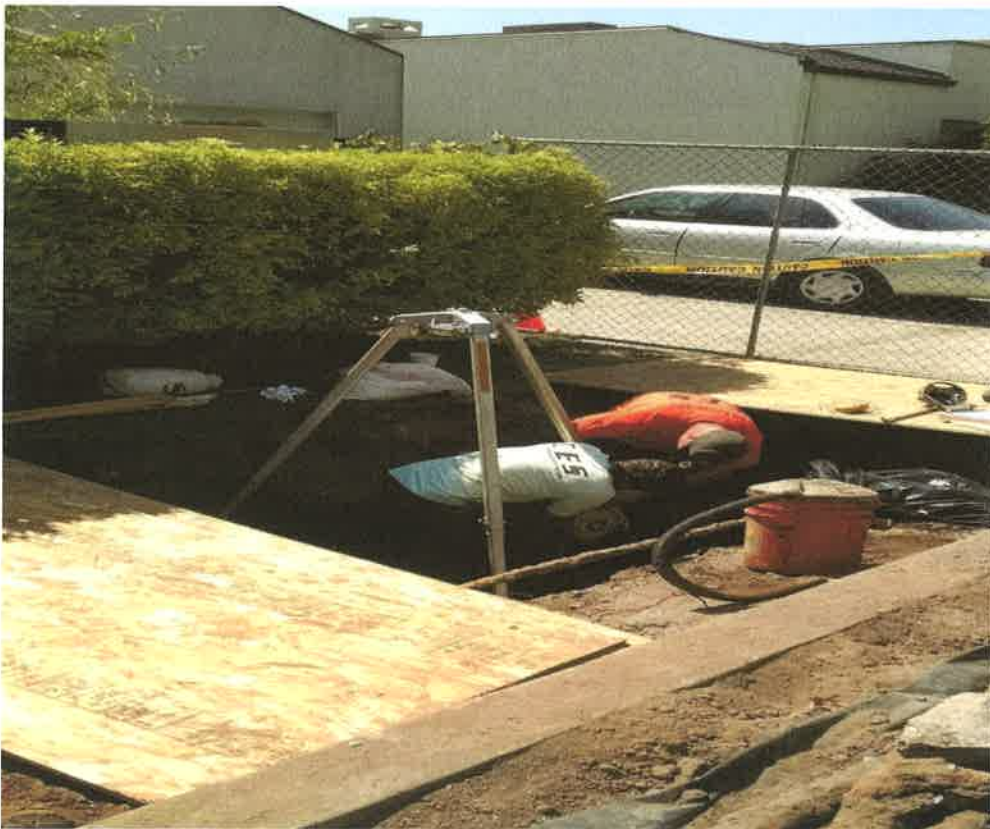
Tank cleaning operations

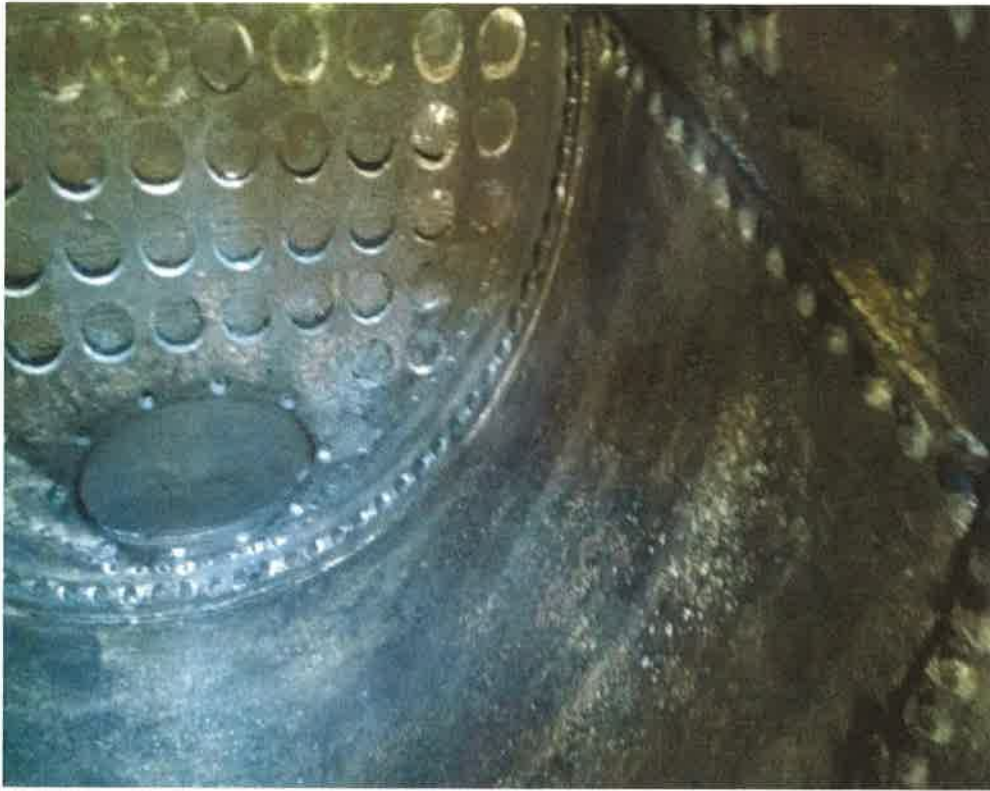
Inside surface of tank post cleaning

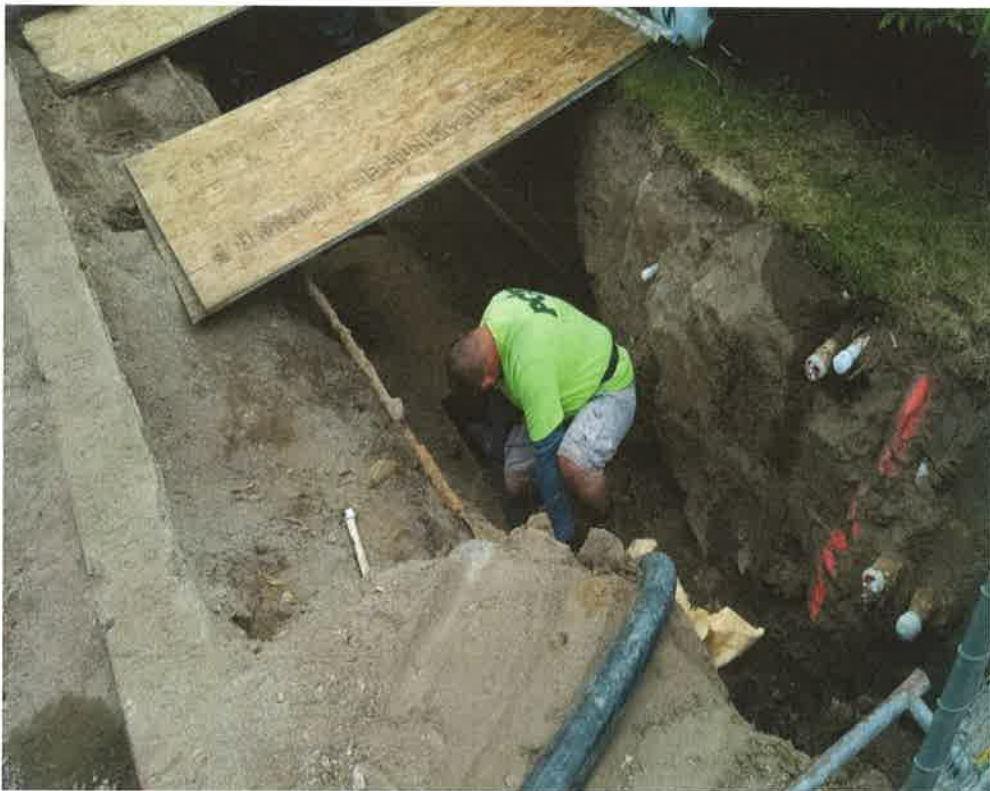
Pressure filling tank with CDF

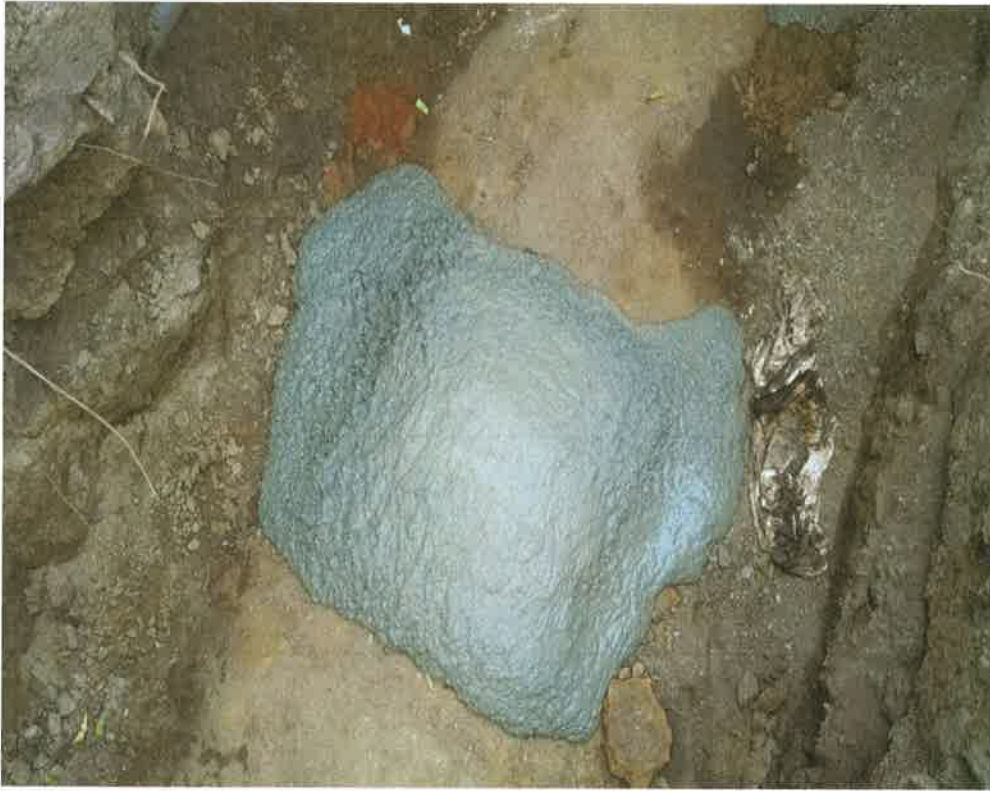
Overfill of CDF through access ports

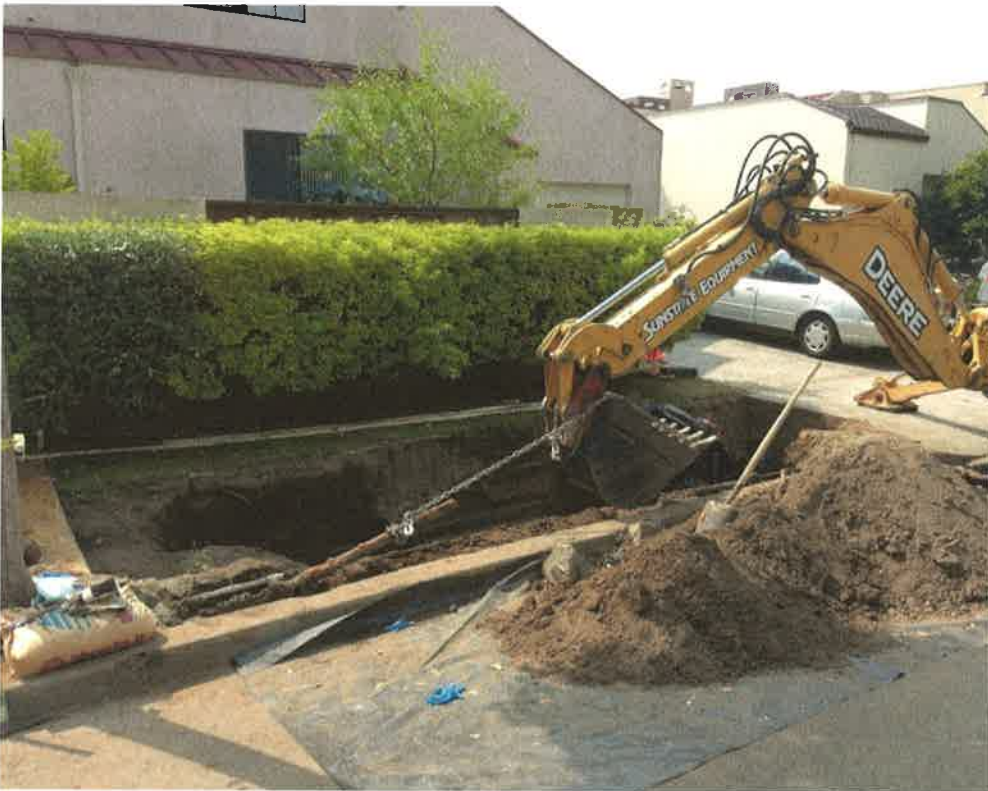
Removal of return line

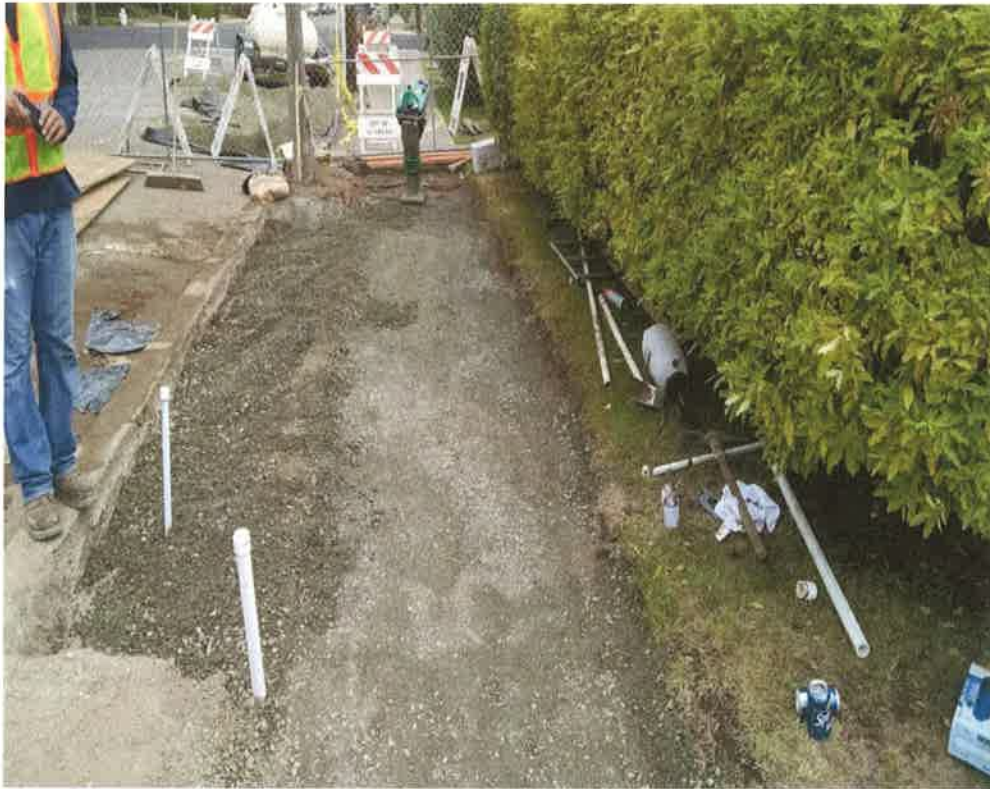
Backfill of excavation

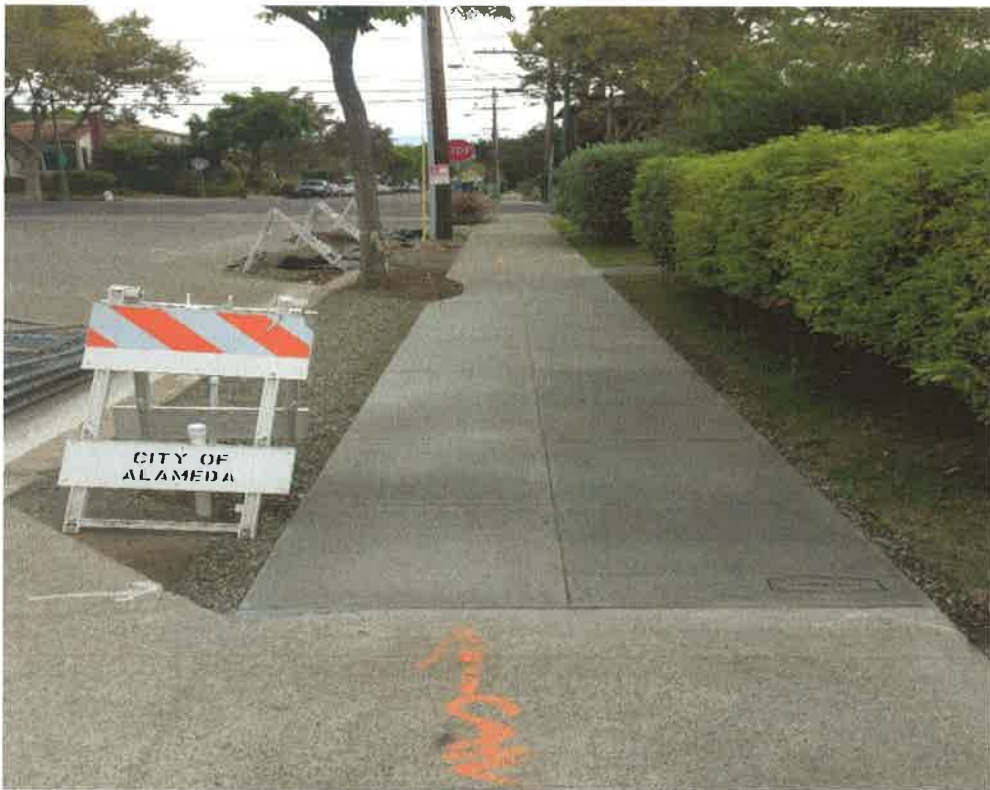
Restoration of sidewalk
