#### **Summary Report**

#### **Underground Storage Tank Removal**

2823 Adeline Street

Oakland, California

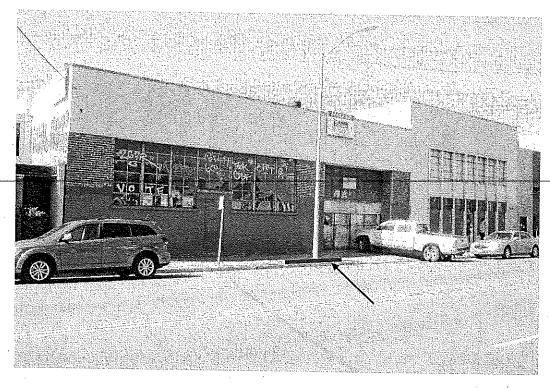
Photo # 1. View of Property frontage from Adeline Street. UST is located beneath street light as indicated.

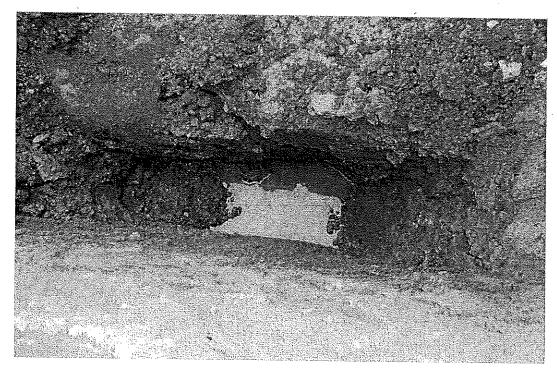
The initial groundwater grab sample collected from the tank excavation contained 2,000  $\mu$ g/l TVHg, 97  $\mu$ g/l benzene, 280  $\mu$ g/l toluene, 31  $\mu$ g/l ethylbenzene, 220  $\mu$ g/l xylenes and 50  $\mu$ g/l naphthalene. No MTBE or other fuel oxygenates were detected in the groundwater sample. The detection of 5.9  $\mu$ g/l 1,2-dichloroethane is likely not related to the gasoline UST.

Photo #4. Groundwater collecting in soil sampling location at a depth of about 8 feet below the ground surface.

- Based on laboratory analyses indicating hydrocarbon impacts to groundwater in the UST pit, additional grab groundwater samples should be collected downgradient from the UST location. One of the sample locations should be located next to the former dispenser pad in the warehouse in order to allow collection of a soil sample in that area in addition to the groundwater sample.
- UST rinsate and additional investigatory waste if generated, should be removed from the property under manifest after all additional site investigations are completed.
- 3) This summary report should be forwarded to the OFD as is required by that agency.
