Re: Environmental Site Summary Report Former Safeway Ice Cream Plant 2240 Filbert Street, Oakland, California Alameda County Site ID R00003157 Stantec PN: 185703027,200.0001

Environmental Site Summary

2240 Filbert Street Oakland, California Stantec PN: 185703027

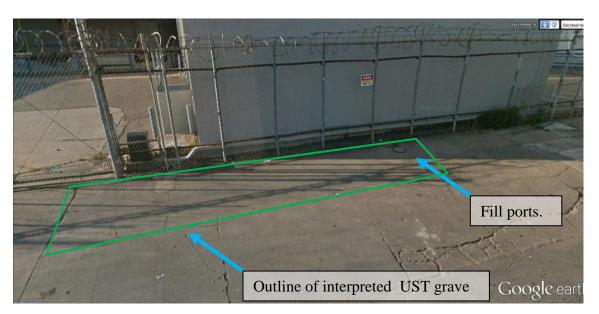
Myrtle Street Sidewalk:

In the figure below there are two UST type fill ports. The fill ports were filled with concrete and thus were not accessible to be traced out with a pipe locator. Long radargrams across the site show changes in the soil type where jagged cuts in the concrete were observed. From this information it is interpreted that a UST approximately 20 feet long and 4 feet wide was removed from this location.

Based on visual inspection and radar data, we interpret that two USTs and fuel lines were removed. The smaller UST maybe a 500 gallon. The larger tank is estimated to be a 1000 gallon UST, 15 feet long, 4 feet wide. The remote fill and the associated piping for the smaller UST was left in the ground. It appears that the company that removed the tanks on Myrtle street used a jack hammer to break up the concrete.

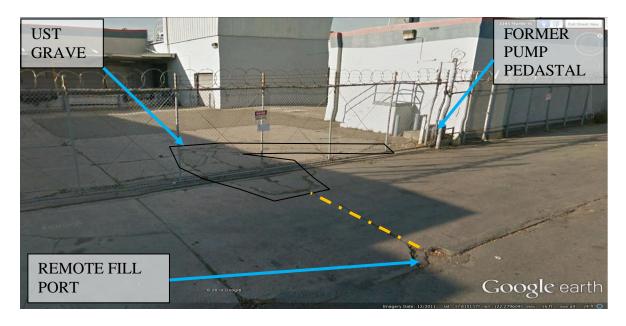
In the picture below is a jagged outline of an interpreted UST excavation which included fuel lines up to a fuel pump pedestal. A remote fill port in the street was energized and a traced to edge of the small UST excavation outline. Scan with radar did not show a

UST type anomaly. Metal detection could not be used in the area due to the reinforced concrete.

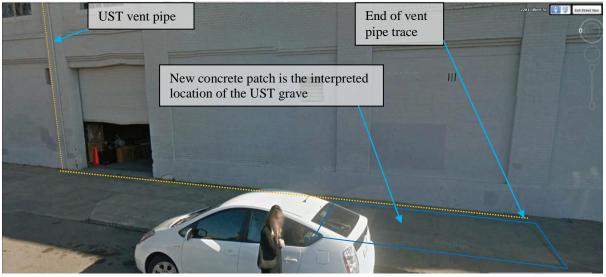
Filbert Street Sidewalk:

In the figure below, there was a UST vent pipe found adjacent to the roll up door. The vent pipe traced southward to the edge of a new concrete patch in the sidewalk. A circular concrete patch (seen in the photograph below) is interpreted to the location of the fill port. The concrete patch measures 8 feet wide by 14 feet long which would suggest that a 1000 gallon tank was buried at this location. No UST type anomalies were detected on the radargrams. No metal detectors could be used in this area due to the parked cars at the time of the survey.

Based on visual observations three vent pipes were observed on Filbert street. The northern most vent pipe traces to a new patch in the concrete and is interpreted to be cut and or removed. The second vent pipe connected to a UST that was removed from the southernmost concrete patch. Note: the concrete patches on Filbert street were cut with a concrete saw. The southernmost vent pipe appeared to connect to a possible

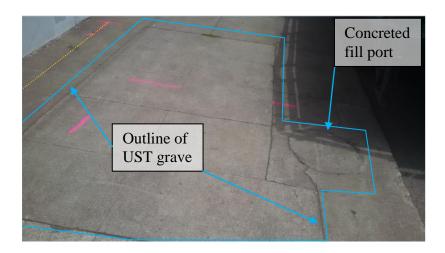
The figure below is a close up photograph of the above photograph.

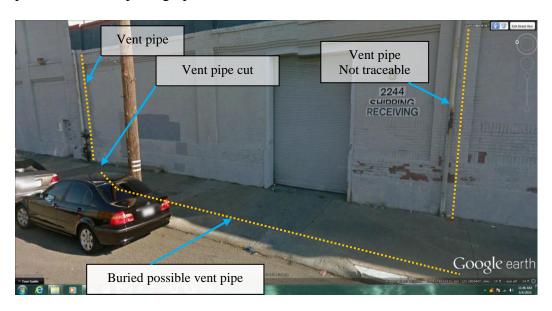
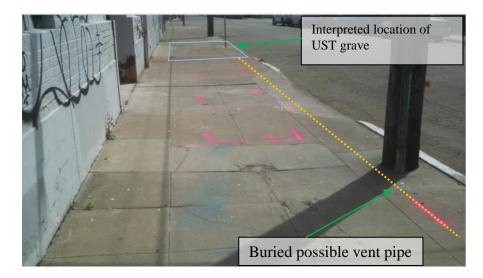
Two four inch diameter vent pipes were found further south along the sidewalk. Both of the pipes were energized but could not be traced. A pipe was found leading to the vent pipe pictured behind the black car. The pipe trace ends 3 feet before the vent suggesting that it may have been cut prior to a utility vault installation. The pipe trace continues southward to a new concrete patch seen in the photograph below.

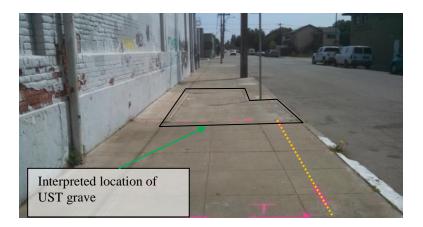
The photograph below is a close up image of the new asphalt patch. The concrete patch measures 8 feet wide by 14 feet long which would suggest that a 1000 gallon tank was buried at this location.

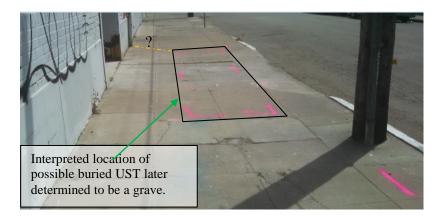
Three vent pipes were found on Filbert street, suggesting that a third UST needs to found. From radar scans across the length of the sidewalk a UST type anomaly was seen on the radargrams. From the scans we interpret that a UST maybe buried at the location shown in the photograph below (see radargrams following this photograph and the geophysical site map showing the results for the whole site).

UST that was investigated further with a follow up visit on 6/9/2014. Two holes were drilled above the location of the anomaly viewed on the radargram. A steel probe was pushed into clean sand a distance of five feet in each of the holes. This indicates the tank was removed and the grave backfilled with sand. The anomalies viewed may have caused by cut conduit or pipe left in the grave.

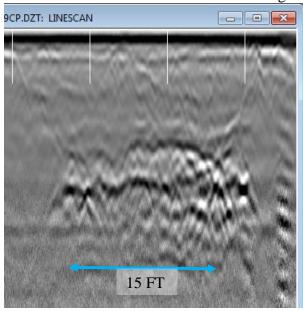
Below is a radarscan collected over the length of the potential UST.

This radargram was scanned across the width of the potential UST.

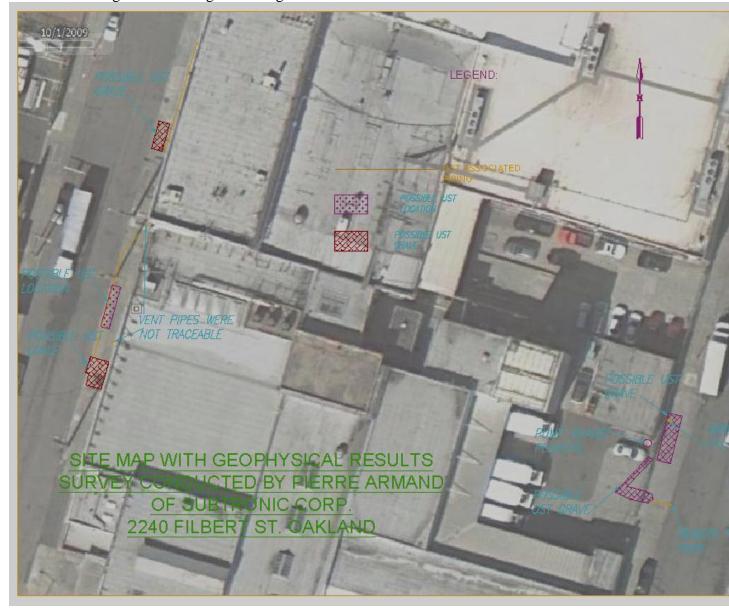
Below is an image summarising the UST grave locations.

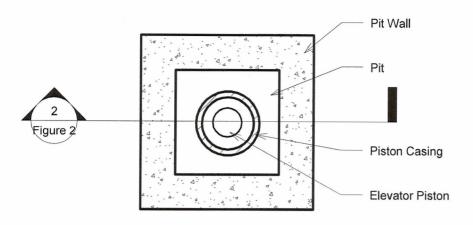
Elevator Pit Floor Plan

3/8" = 1'-0"
