Subject: Walgreens Diesel Spill Site Investigation Report
9494 Koopman Road
Sunol, Alameda County, California
Site Cleanup Case No. RO0003158
GeoTracker Global ID T10000006478

Walgreens Diesel Spill Site Investigation Report

Truck Crash Site
9494 Koopman Road
Sunol, California

February 15, 2017
33115-015204.00

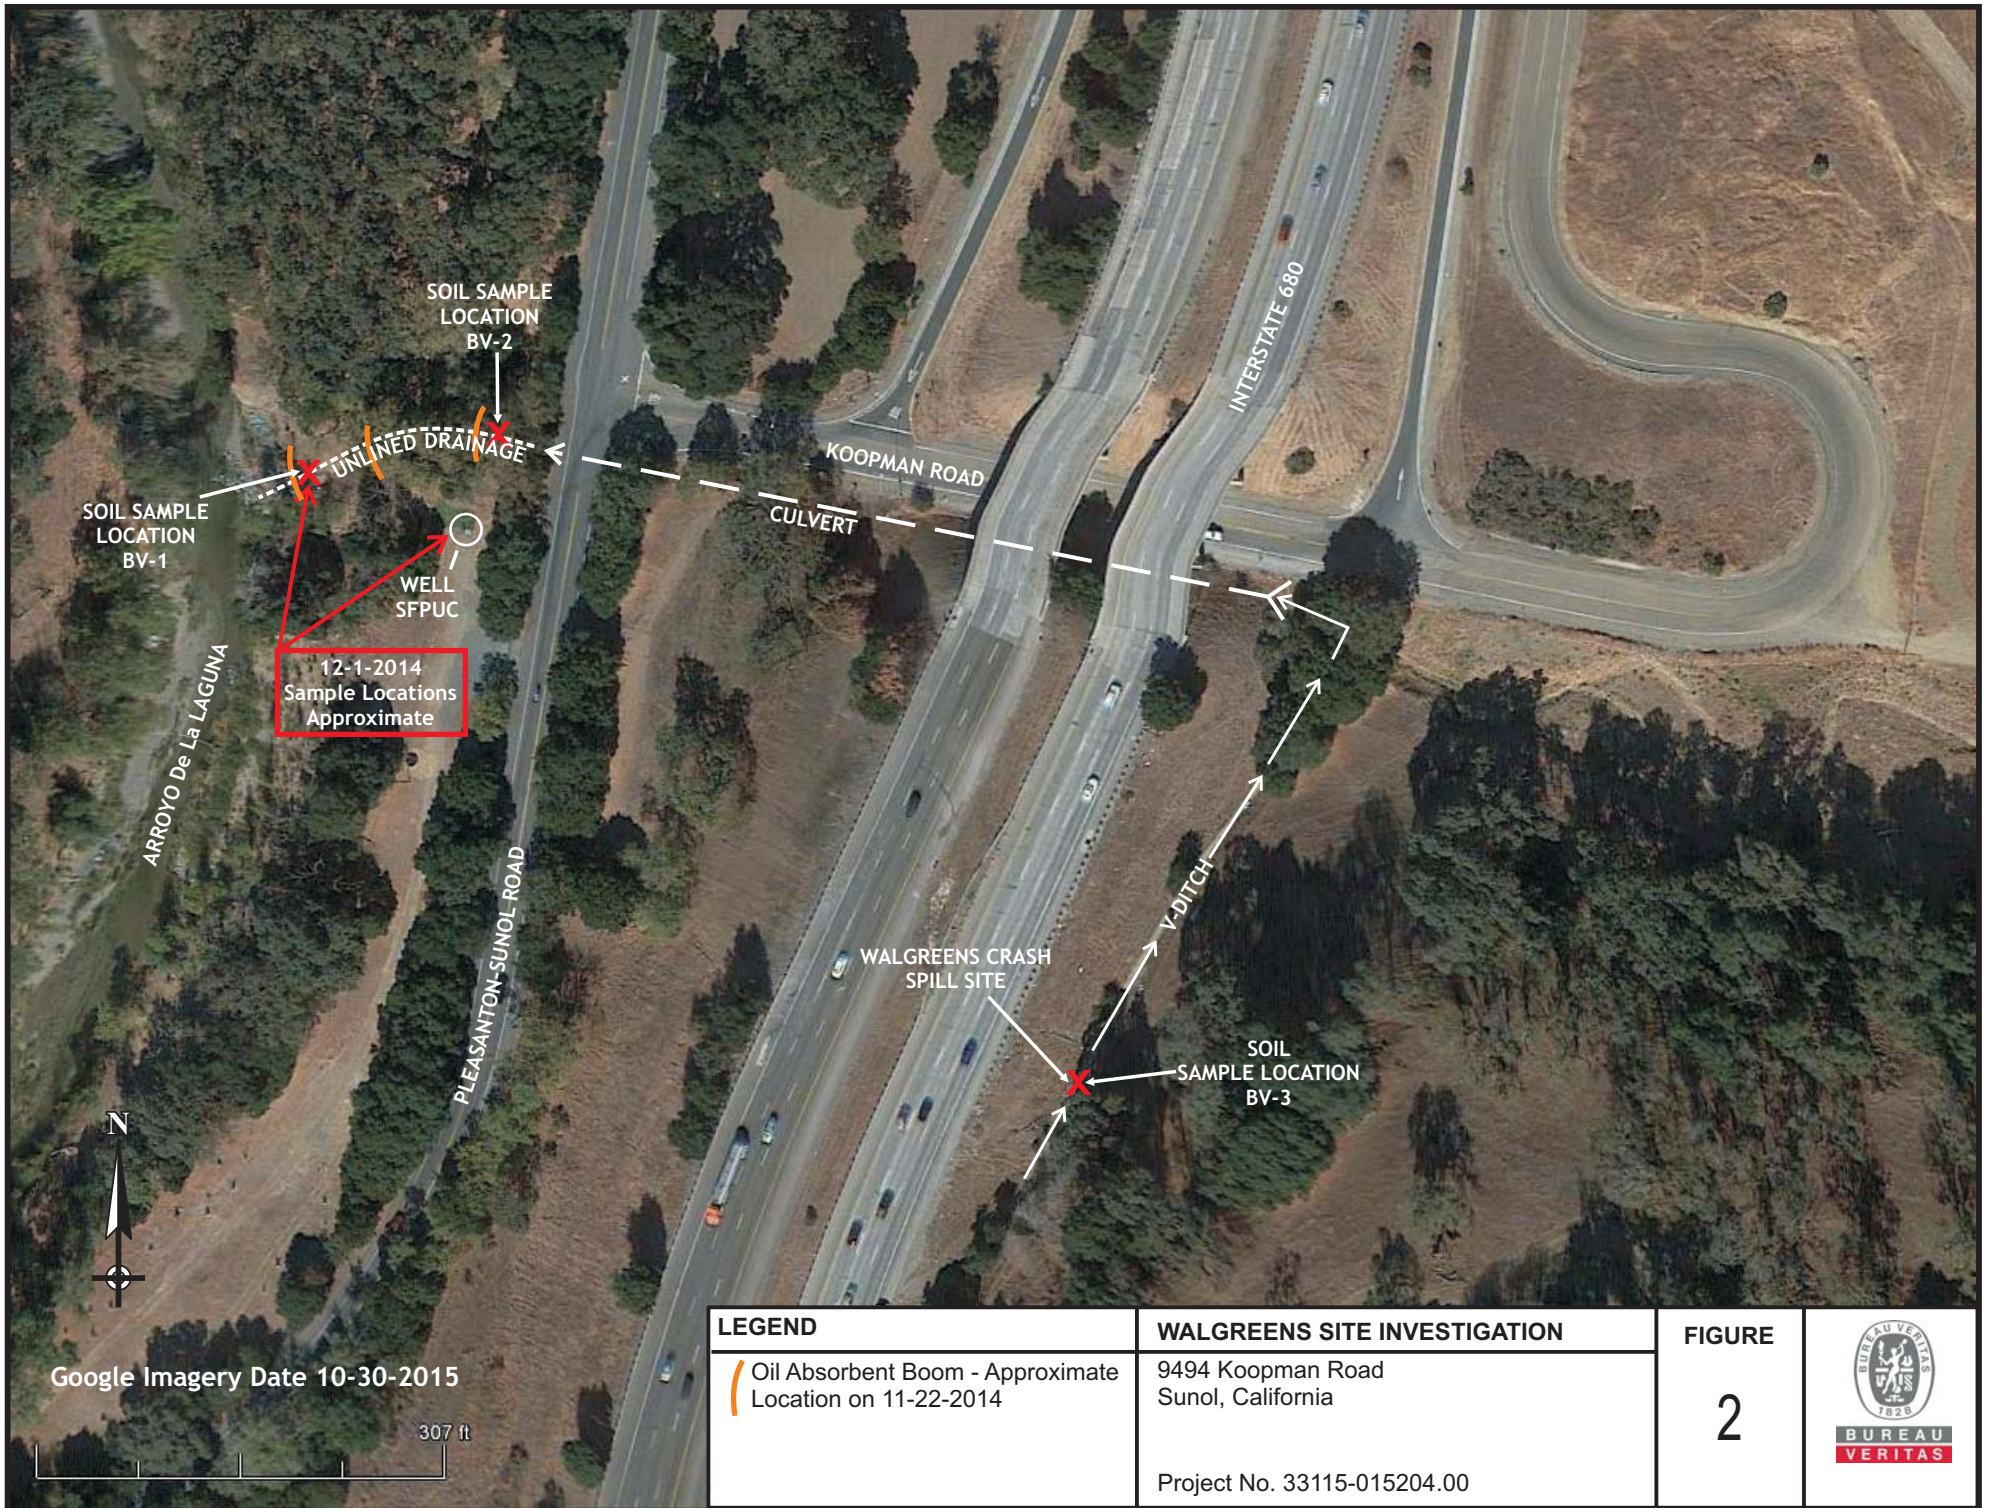
LEGEND	WALGREENS SITE INVESTIGATION	FIGURE	 
  Oil Absorbent Boom - Approximate Location on 11-22-2014	9494 Koopman Road Sunol, California Project No. 33115-015204.00	<p>2</p>

CHES collected two soil samples (Soil Sample #1 and #2, reportedly two discrete duplicate samples) from the distal portion of the unlined drainage (Figure 2 depicts the approximate sample location; BVNA replotted the sample location to align with the unlined drainage) as confirmation of the cleanup activities. Additionally, two well water duplicate samples (Water Sample #1 and #2) were collected from the nearby SFPUC well (Arroyo Well #1) spigot. The CHES report states that Mr. Fujita turned on the spigot for sampling; however Mr. Fujita stated that he was not on site that day and that someone else from SFPUC may have assisted CHES. The CHES Chain of Custody documents collection of the soil and well water samples on December 1, 2014 at 10:20 hours. Soil and water analysis was by U.S. EPA 8015B protocol for total petroleum hydrocarbons as diesel ranged organics (DRO). This analytical procedure used reports both polar and non-polar hydrocarbons within the diesel fuel range. Refined fuels consist of non-polar hydrocarbons; therefore, unless sample preparation is conducted using the silica-gel cleanup procedure removing polar compounds, the total DRO concentration as fuel is typically skewed to be high for soil samples that include biologic compounds.

On November 22, 2016, BVNA met Mr. Fujita on the SFPUC property to collect soil samples from the unlined drainage west of Sunol-Pleasanton Road. Mr. Fujita escorted BVNA while on SFPUC property. On the day of the site visit, BVNA observed an absorbent boom located in the drainage immediately west of the concrete lined outfall. It is unknown if the boom is from a more recent event or left over from the site cleanup activities from 2014 (see Appendix A site photographs). No indications of petroleum staining or odors were noted during the site visit in the unlined drainage or on the remaining absorbent boom. BVNA collected soil samples at two locations from the base of the unlined drainage. BV-1 was located near the bank of the Arroyo, just east of what appeared to be Arroyo bank reinforcement material or rip-rap (boulder sized angular crystalline rocks) that extended up the bank into the drainage. Two soil samples were collected from the center of the narrow drainage ditch. The first sample was collected by first hand augering a hole to a depth of about 0.5 feet. A core sample barrel lined with a stainless steel sleeve (2 inches in diameter by 6 inches in length) was then hand driven to a total depth of 1.0 feet below the ground surface (bgs). The core barrel was extracted and the liner containing a relatively undisturbed soil sample was removed and sealed. The liner ends were covered with Teflon sheets and plastic end caps, labeled with sample identification, and placed into a chilled cooler. The boring was then deepened using a hand auger to a depth of about 1.5 feet where auger refusal was encountered due to cobbles. The core sampler was then inserted into the hole with a new liner and a second sample was collected in the same manner from the depth of approximately 1.5 to 2.0 feet bgs. BVNA collected two additional samples from boring BV-2 at the end of the concrete lined channel near the drainage outfall at Sunol-Pleasanton Road (see Figure 2). The samples were collected in the same manner.

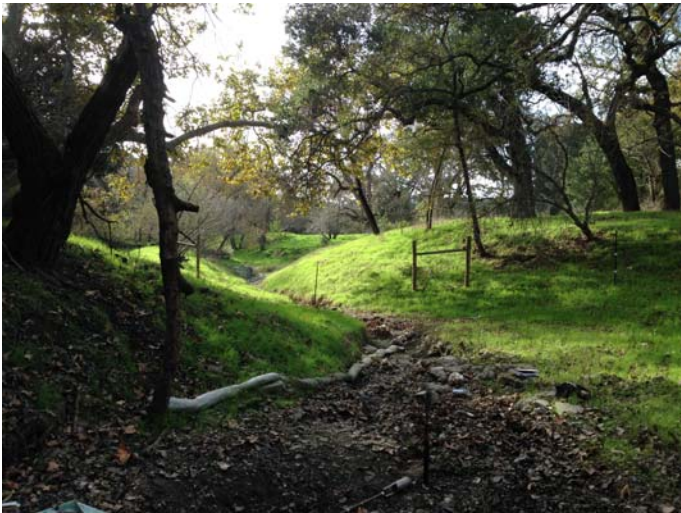
**PHOTO NO. 1
DESCRIPTION:**

Unlined drainage looking southwest, west side of Sunol-Pleasanton Road. Note old oil boom in ditch. Arroyo del la Laguna is at end of ditch before rise in background.

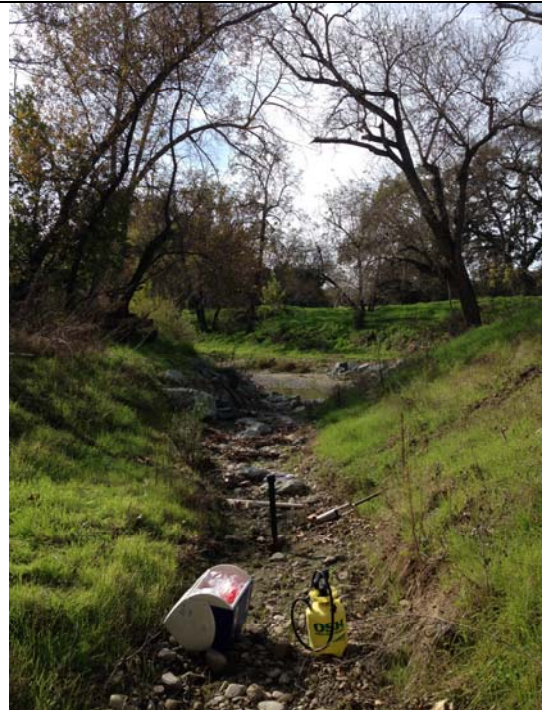
**PHOTO NO. 2
DESCRIPTION:**

West end of unlined drainage with bank of Arroyo de la Laguna just beyond large rocks in ditch. Verticle handle of core sampler is location of soil samples at BV-1 location

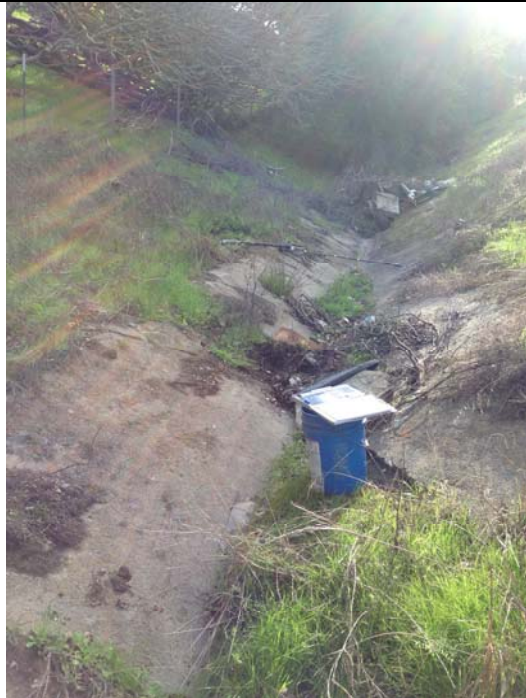
**PHOTO NO. 3
DESCRIPTION:**

V-ditch at Walgreen crash site, west side of I680. View to south. Hand sampling equipment at soil sample location BV-3.

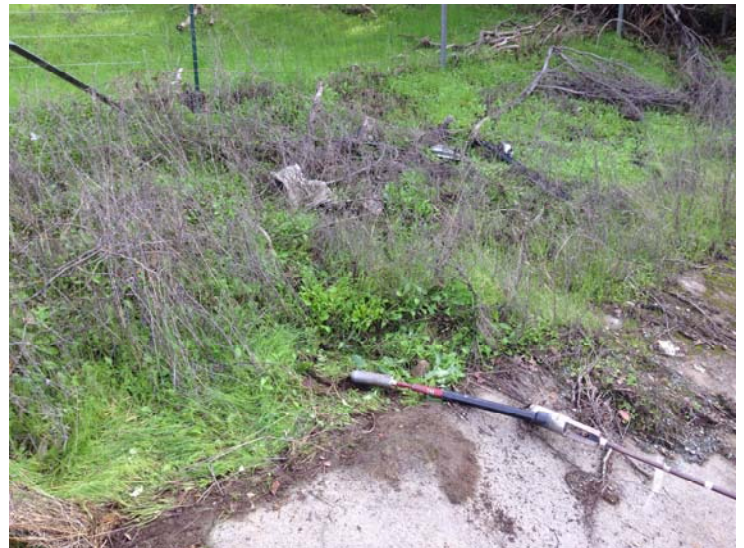
**PHOTO NO. 4
DESCRIPTION:**

Detail view of soil sample location BV-3. Weeds obscure view of depression that resulted from interim remediation that occurred on 11-22-2014 for diesel impacted soil removal.
