Subject: Work Plan for Walgreens Fuel Spill Site Investigation
Interstate 680 at Koopman Road
Sunol, Alameda County, California
Site Cleanup Case No. RO0003158

Work Plan for Walgreens Diesel Spill Site Investigation

Truck Crash Site
Koopman Road and Interstate 680
Sunol, California

January 22, 2016
33115-015204.00

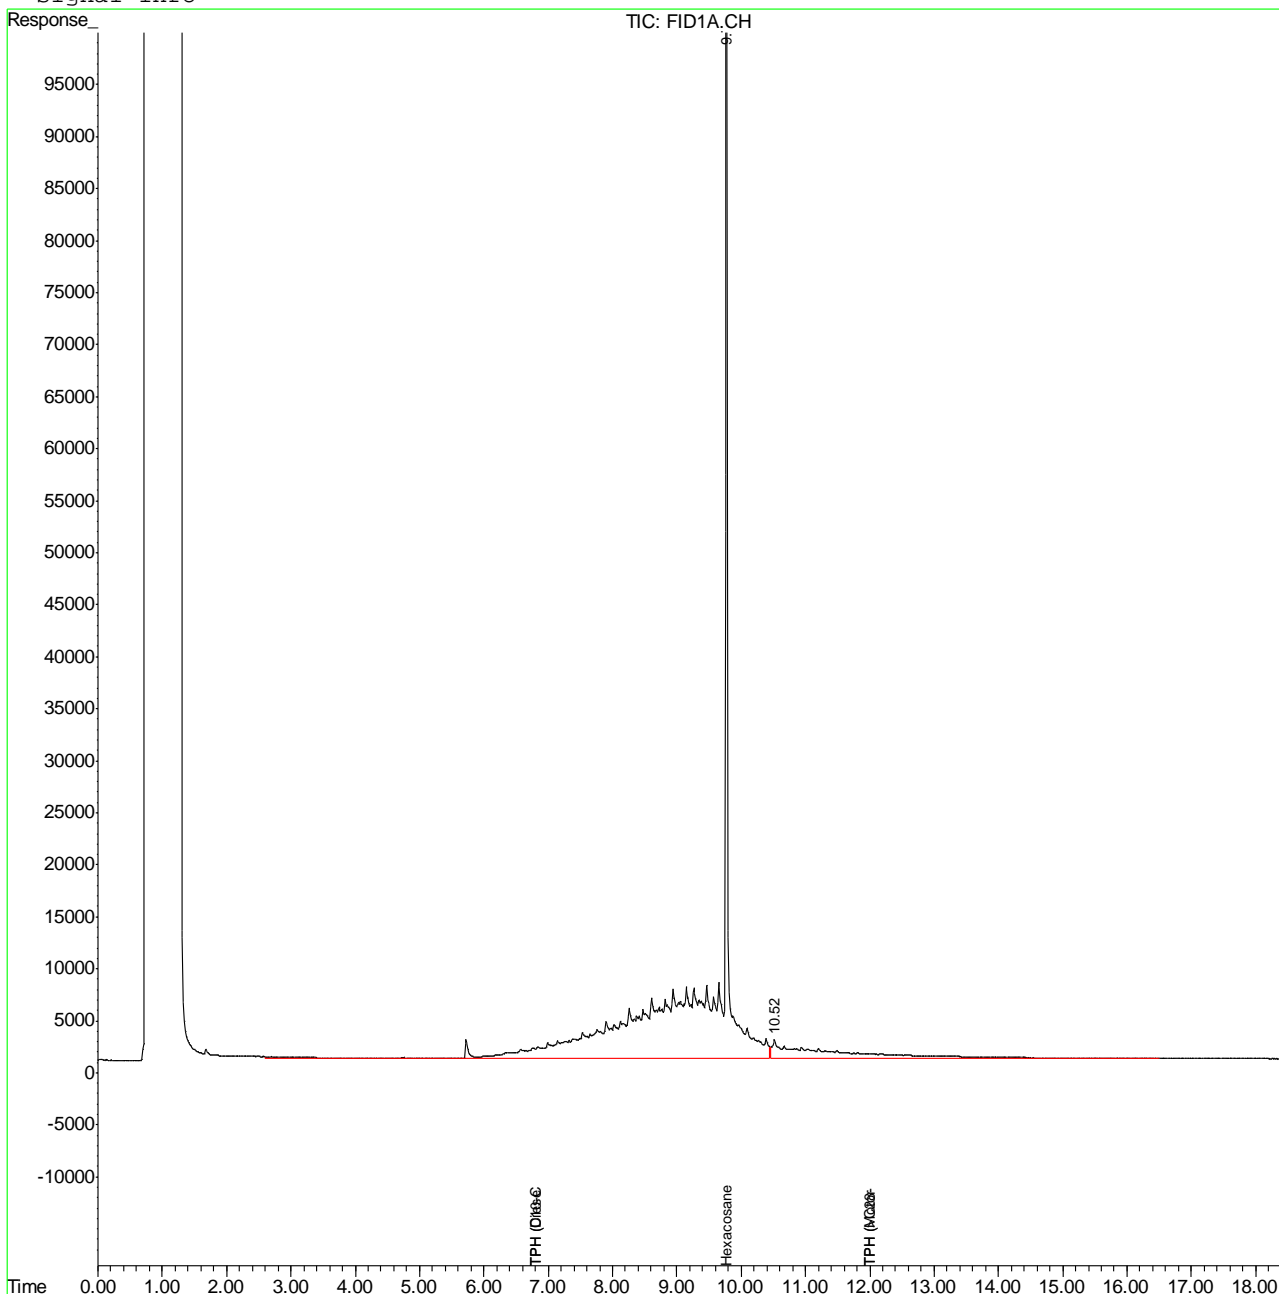
Quantitation Report (QT Reviewed)

BVNA reviewed the laboratory data records for the four samples collected by CHES and found that sample results were reported as a total concentration of DRO for each sample. BVNA obtained and reviewed the laboratory chromatograms for each of the samples along with a standard diesel chromatogram provided by the laboratory. Review of the chromatograms indicates that diesel standard chromatogram has a characteristic bell curve, and the two soil samples have a somewhat distinct petroleum hydrocarbon curve representative of DRO concentrations, but also a second and more pronounced curve of motor oil ranged organics (ORO); see Appendix A: C37385 page 20 and C37385R page 22). Chromatograms for the two water samples (Appendix A: C37385 page 22 and C37385R page 20) show a suppressed curve significantly skewed toward the longer chained carbon compounds within the DRO limits, characteristic of aged and weathered DRO with little to no ORO concentrations. Therefore, the skewed signature of DRO compounds in the well water samples indicate that that the petroleum hydrocarbons in the well water samples are likely from other sources and not due to the Walgreens release of diesel fuel to the drainage.

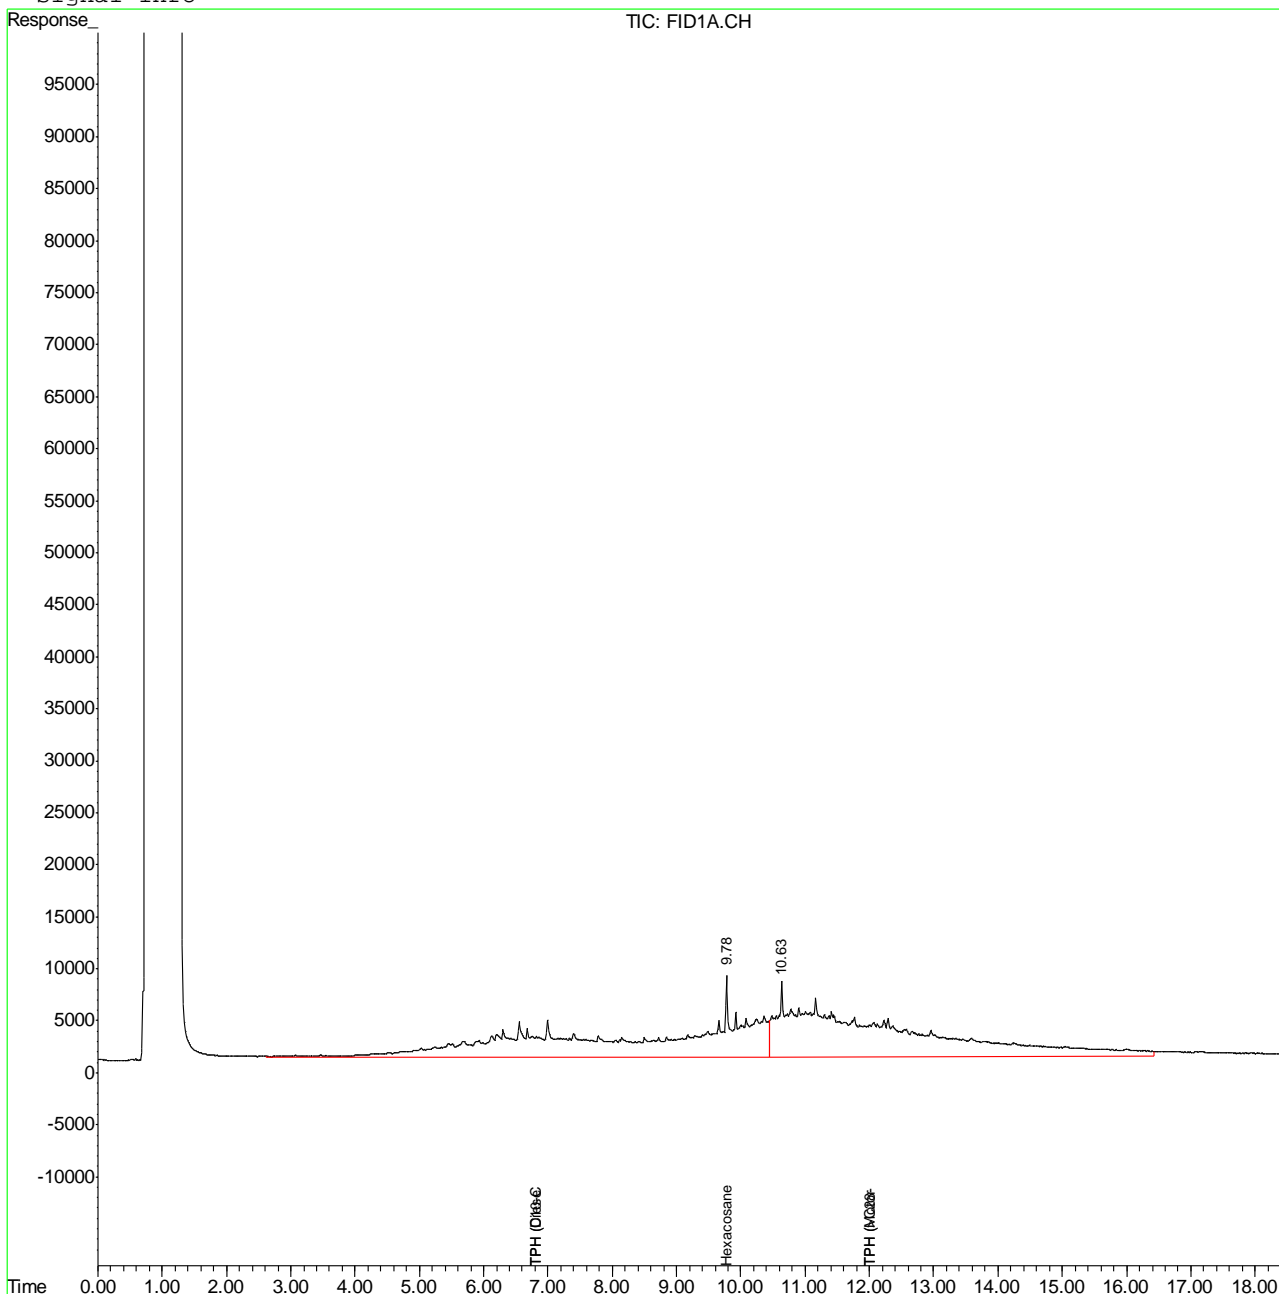
Quantitation Report (QT Reviewed)

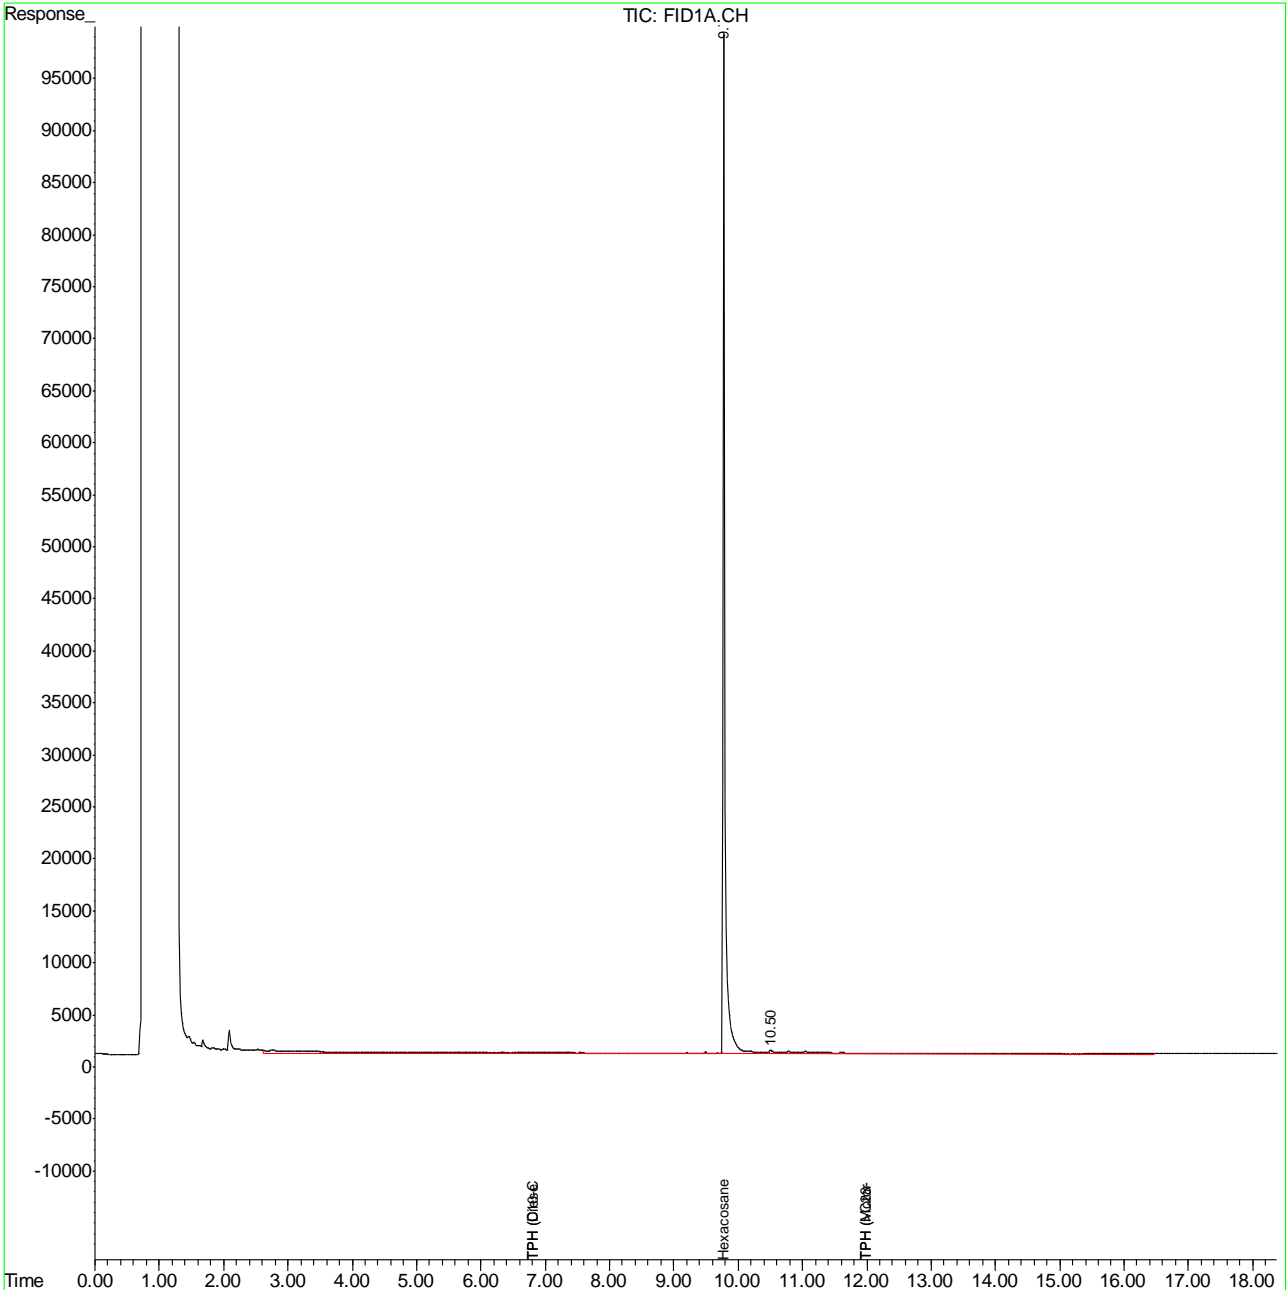
Quantitation Report (QT Reviewed)

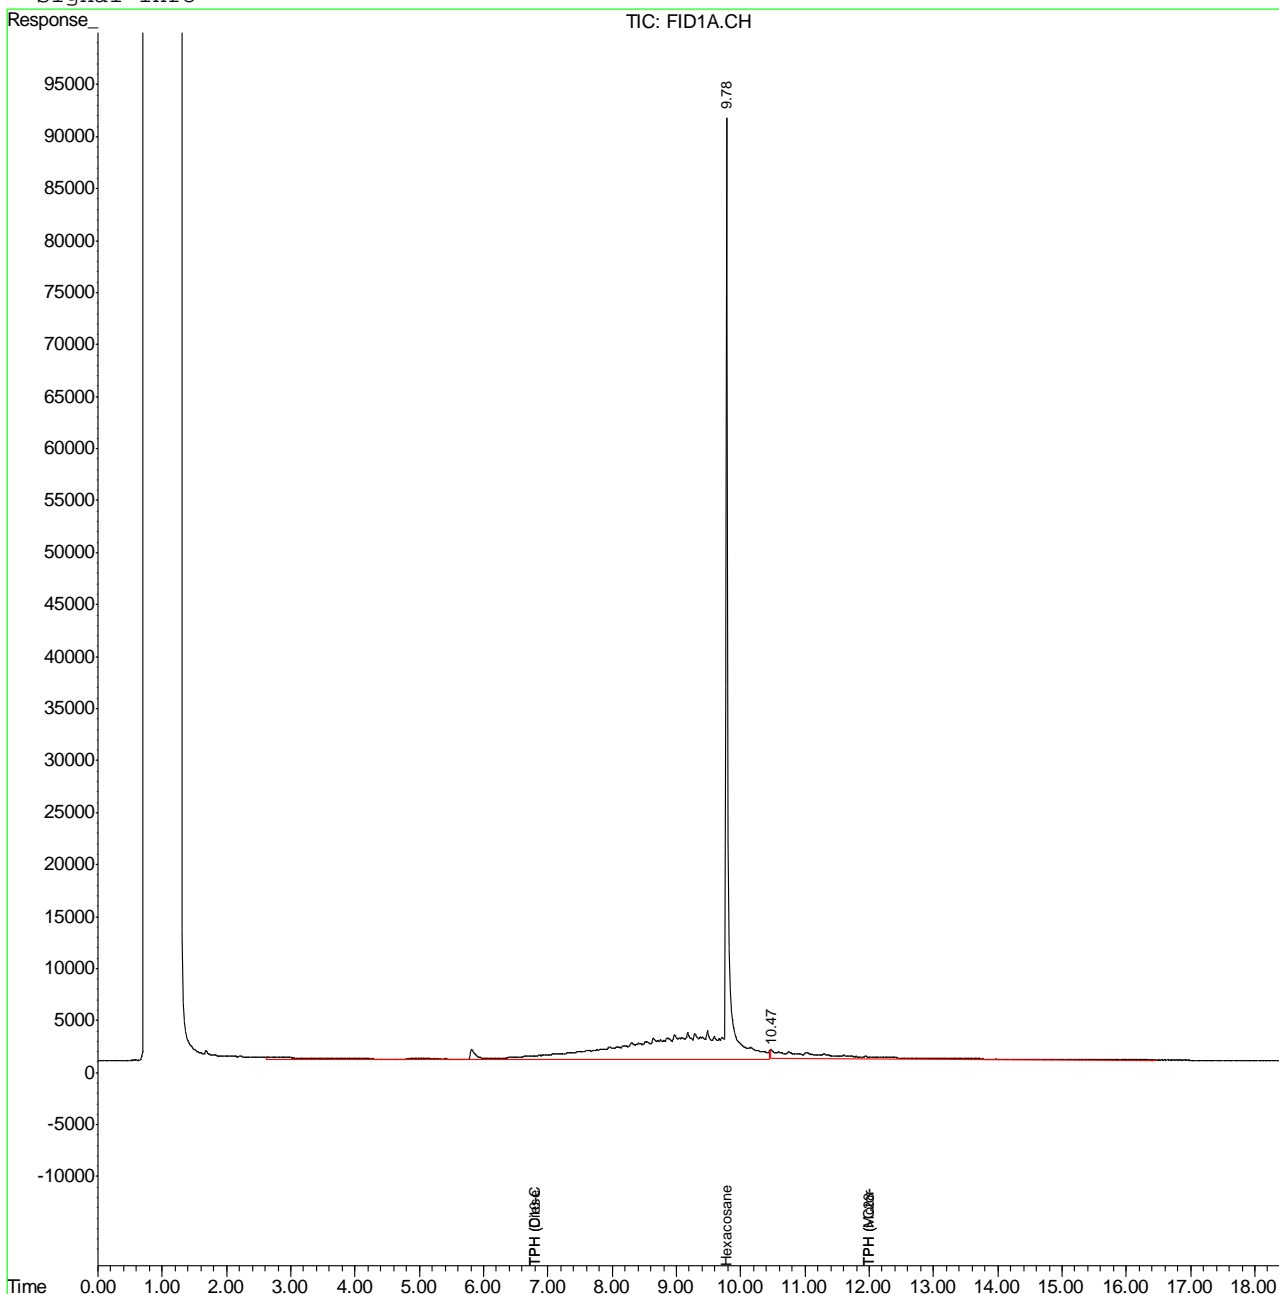
Quantitation Report (QT Reviewed)

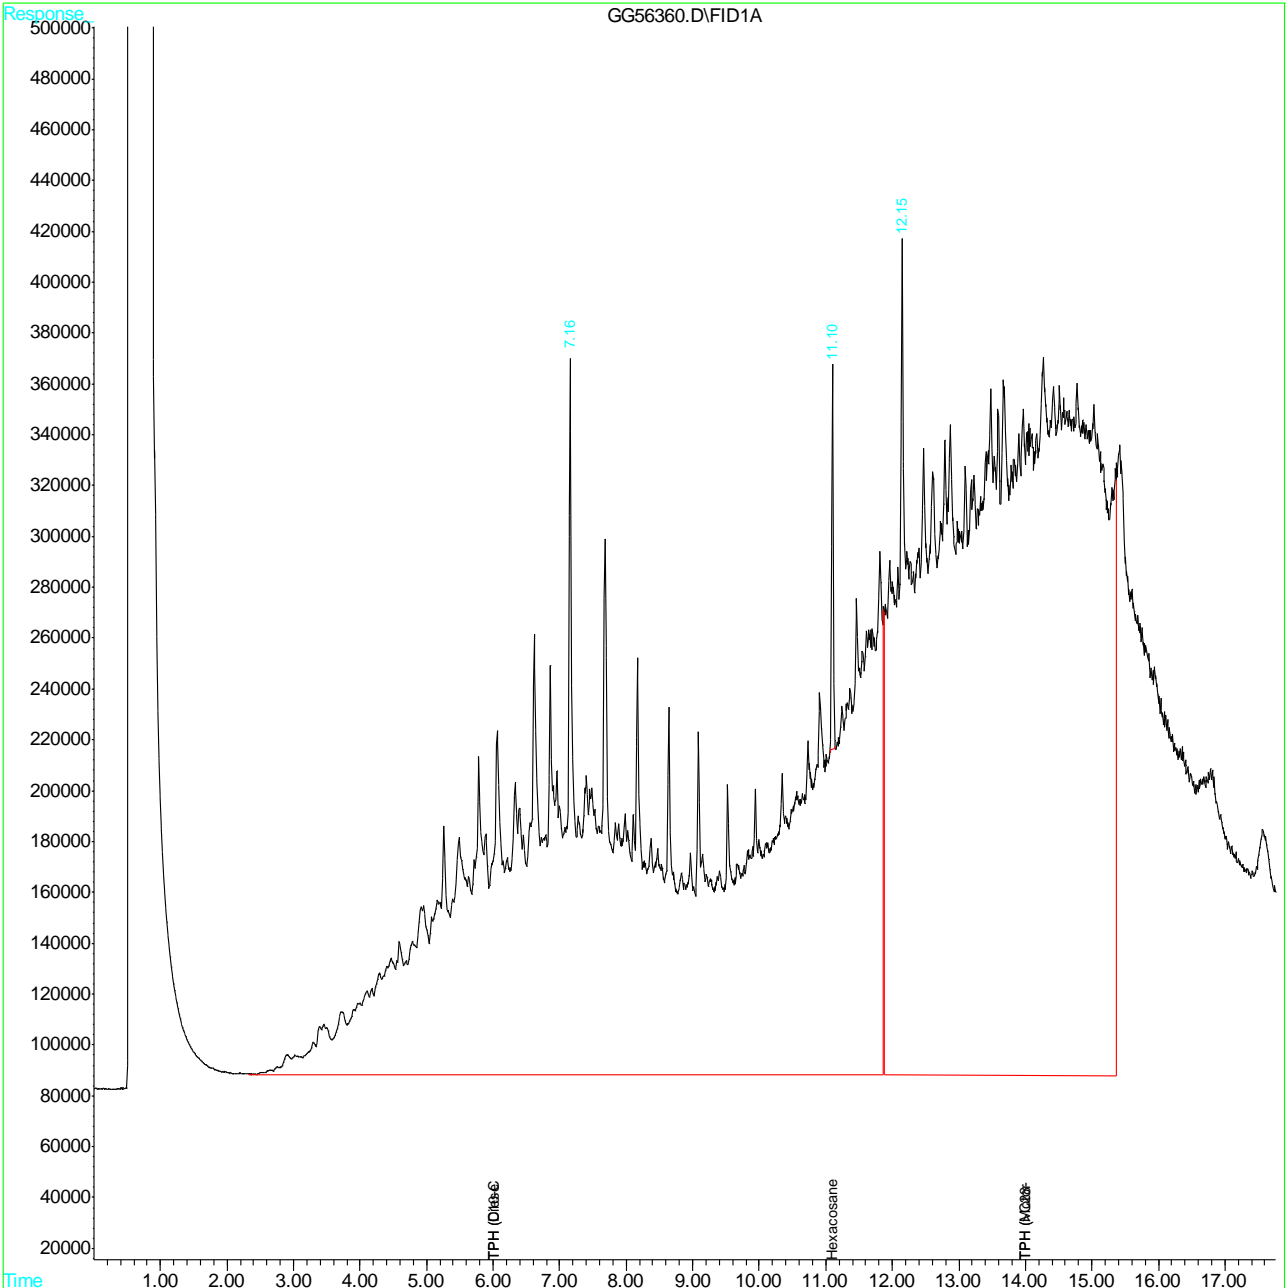
Quantitation Report (QT Reviewed)

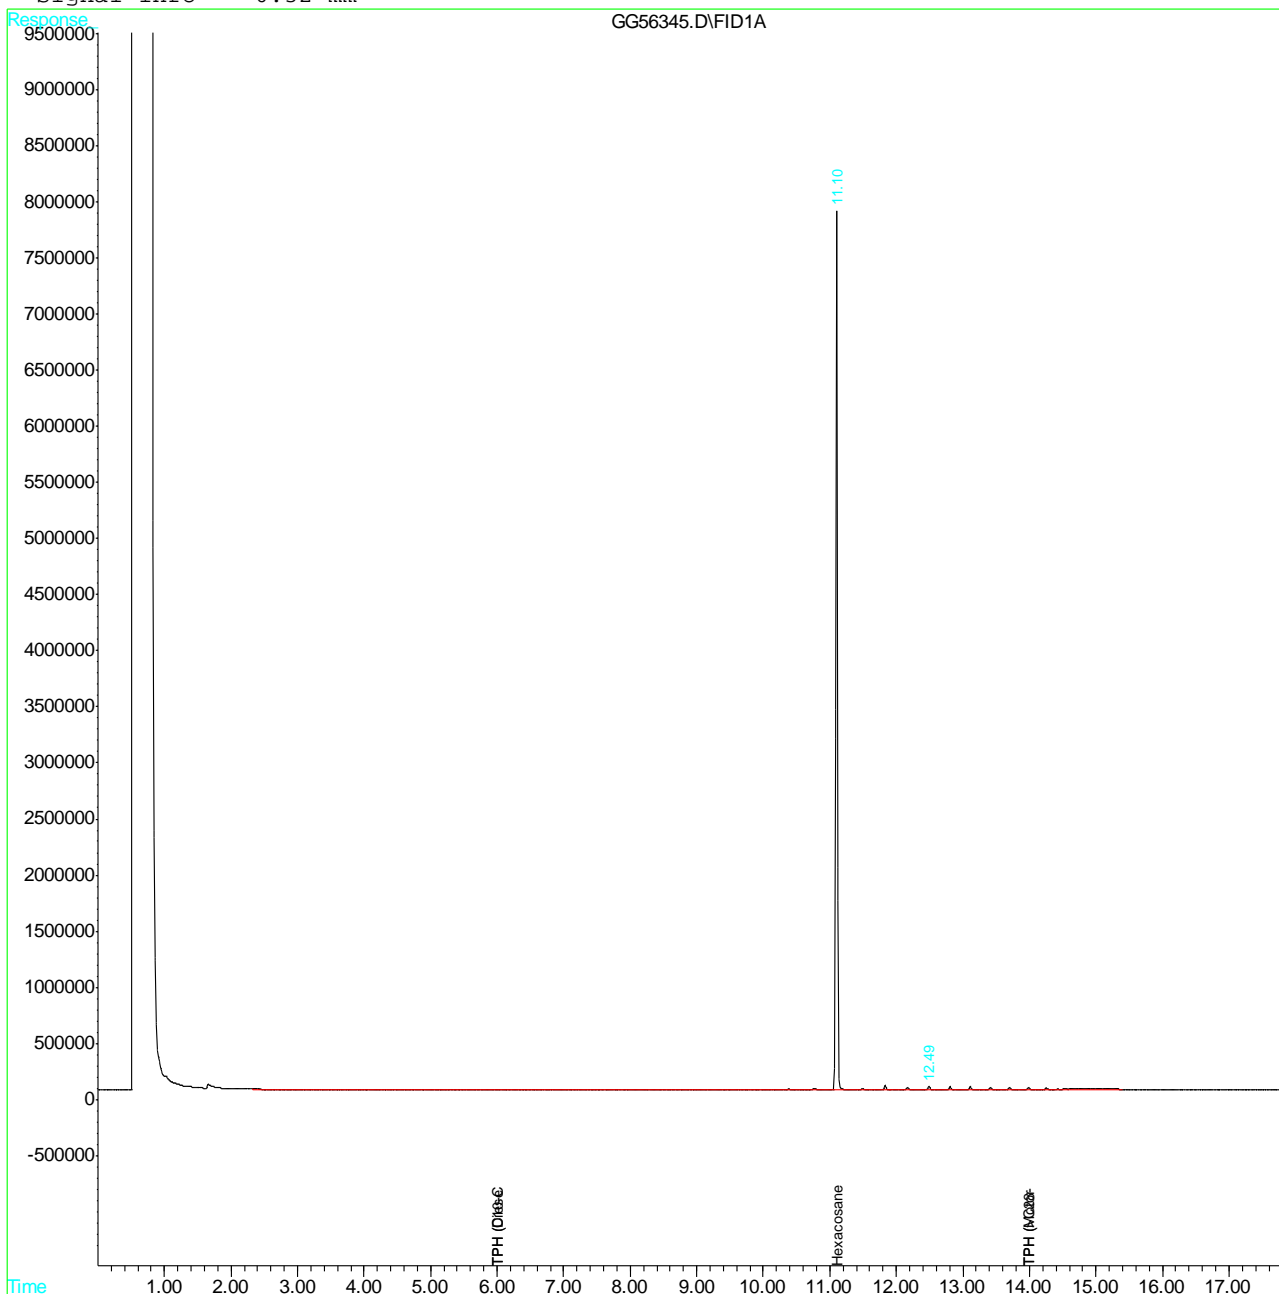
Quantitation Report (QT Reviewed)
