Re: **Data Gap Investigation Report**
Elegant Cleaners
1208 Lincoln Avenue
Alameda, California
ACDEH Case No. RO0003163

DATA GAP INVESTIGATION REPORT

**Elegant Cleaners
1208 Lincoln Avenue
Alameda, California**

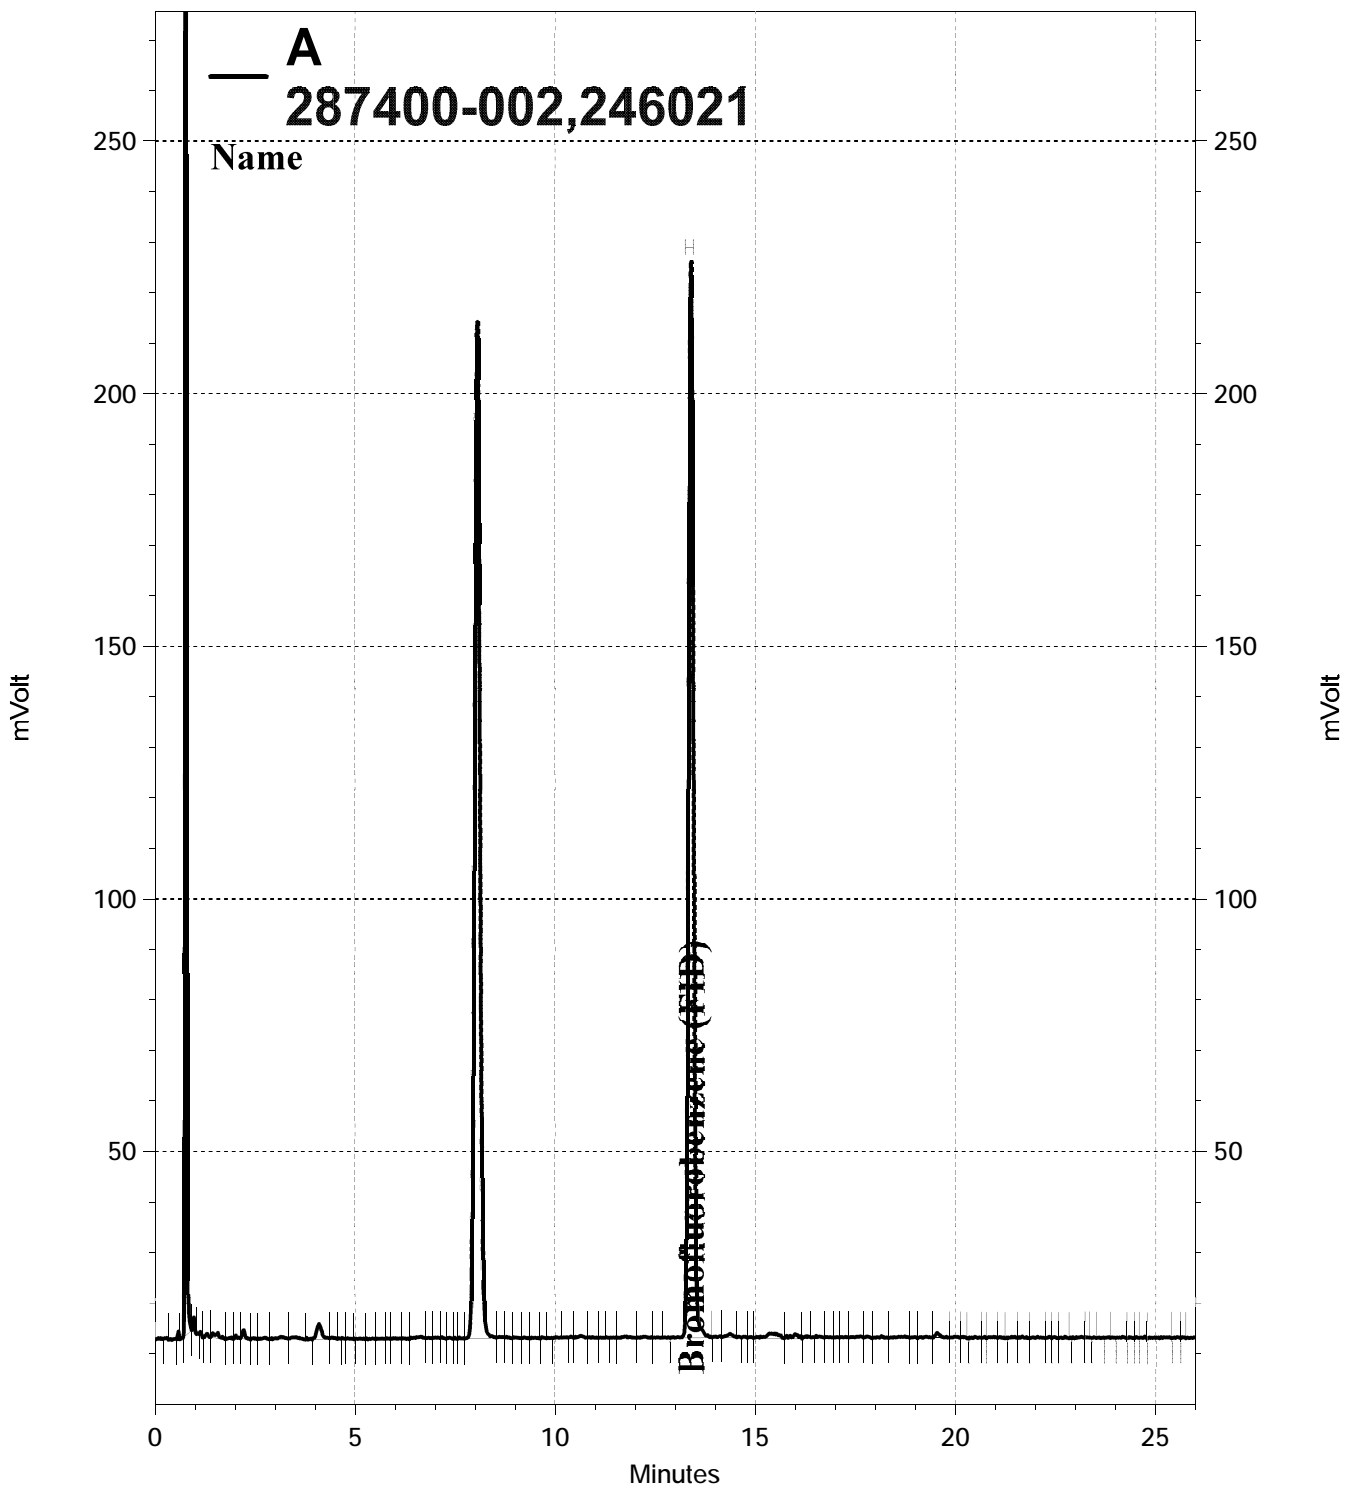
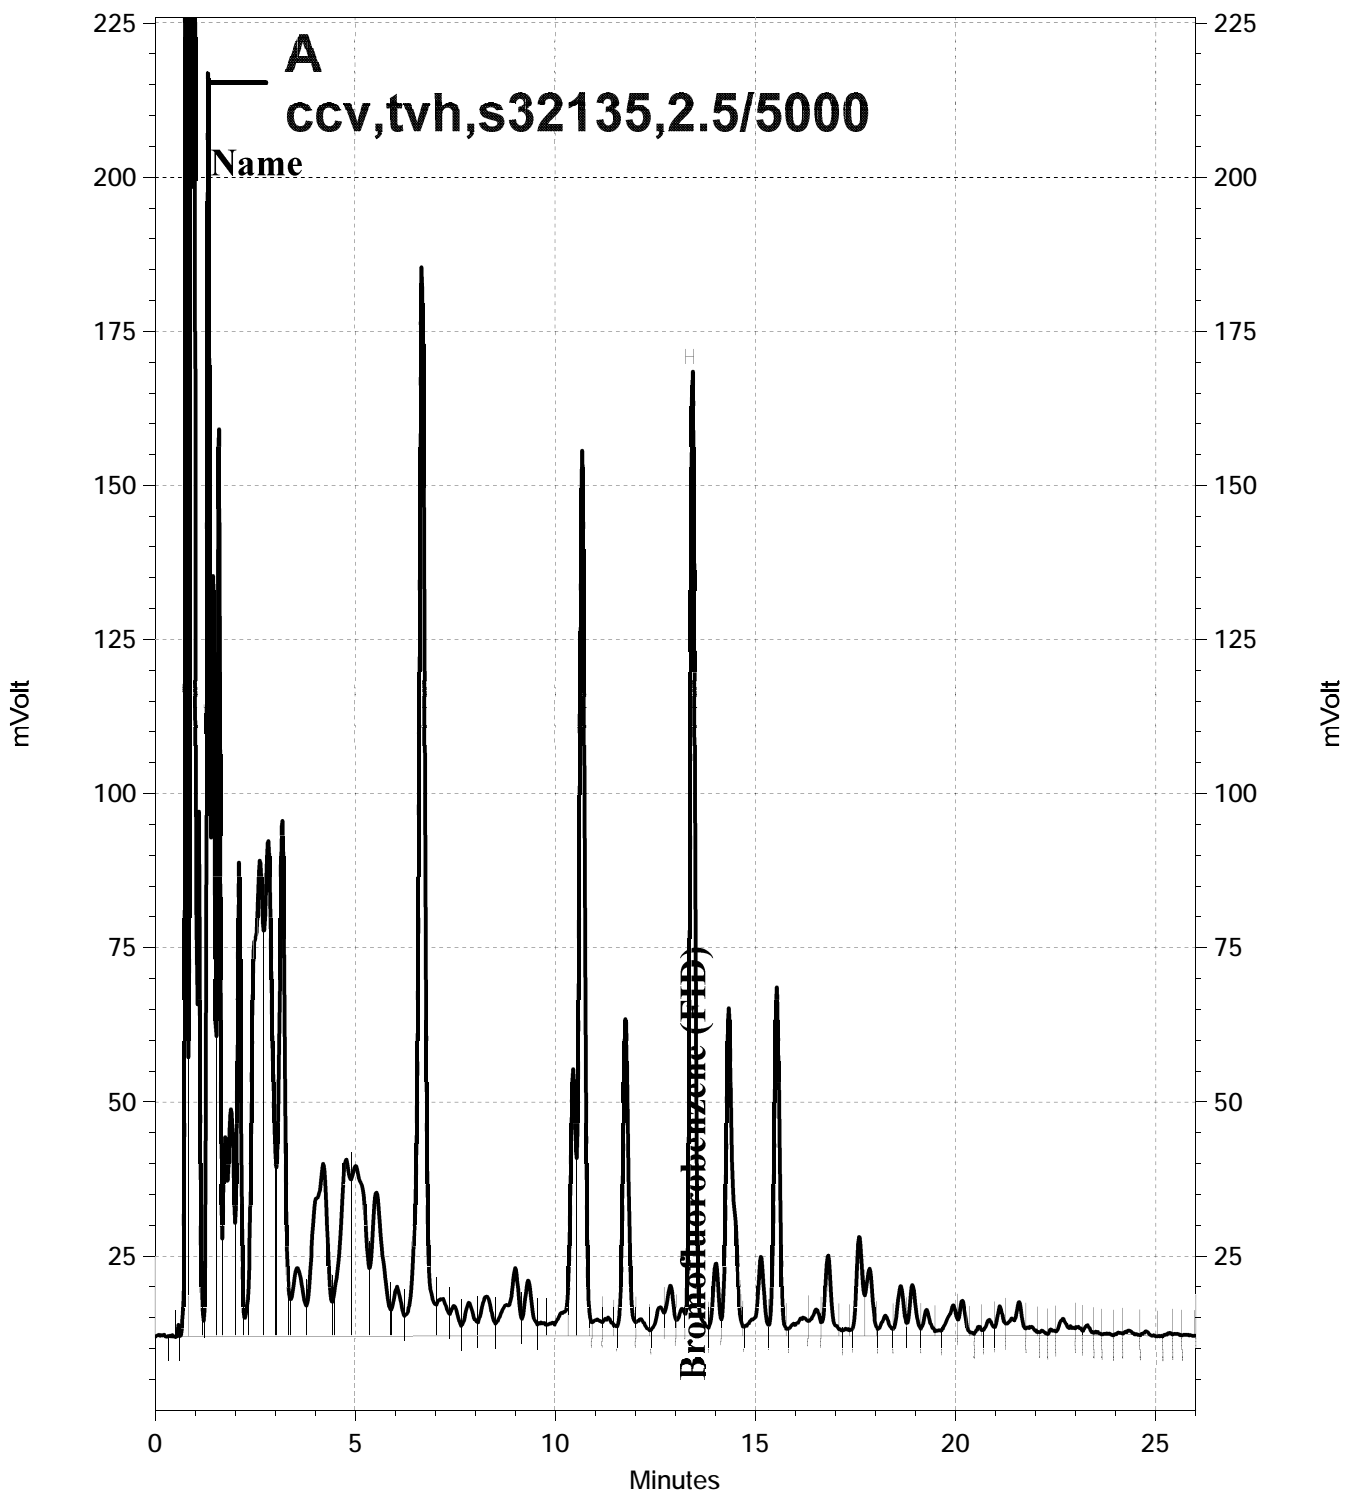
TPH: While TPHg was quantified and reported in boring B-5 at a concentration of 170 µg/L, the analytical laboratory noted that the “sample exhibits unknown single peak or peaks.” Comparing the chromatogram for the TPHg laboratory standard to the analyzed sample chromatogram suggests that this detection is not representative of petroleum hydrocarbons. Chromatograms are included in the analytical report in Appendix G. No TPHd was detected in boring B-5 above the laboratory reporting limit. The above information suggests no DF2000 hydrocarbon impact in groundwater in boring B-5, and that the single peak quantified as TPHg could be PCE.
