***PHASE I ENVIRONMENTAL
SITE ASSESSMENT REPORT***

3101 35TH AVENUE
OAKLAND, CALIFORNIA

PIERS PROJECT NO. 14185

**RE: PHASE I ENVIRONMENTAL SITE ASSESSMENT
3101 35TH AVENUE, OAKLAND, CA**

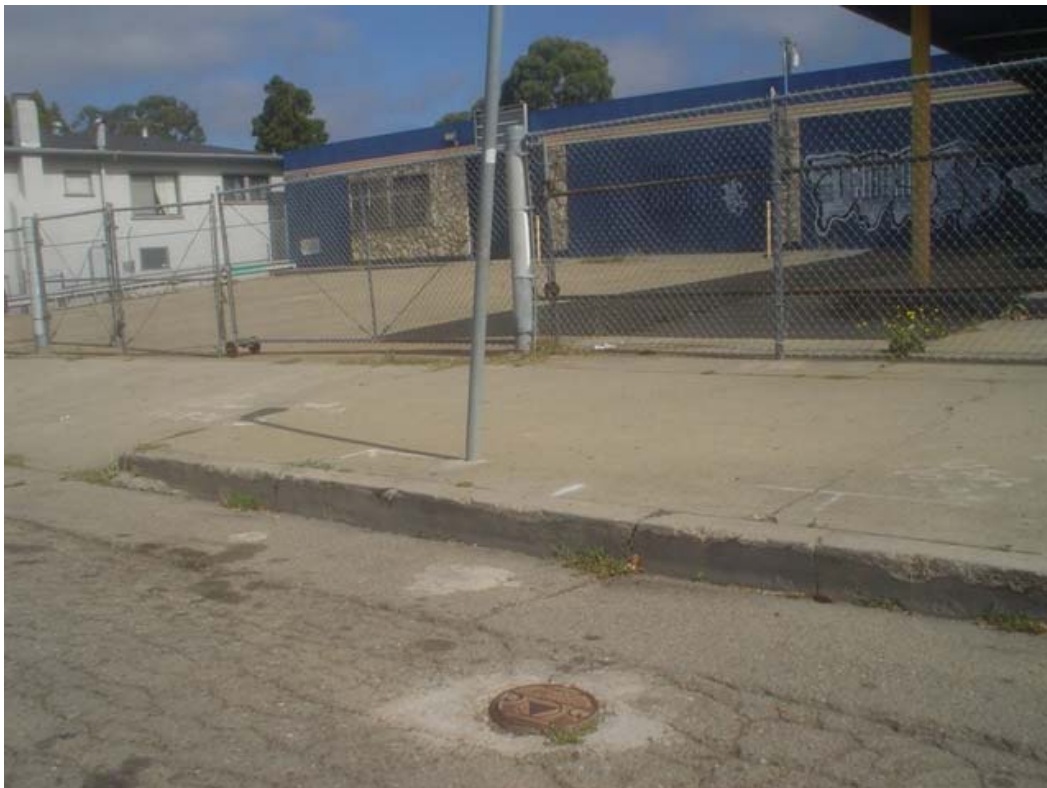
PHOTO #2. VIEW OF MONITORING WELL IN FRONT OF PROPERTY (MW-6).

No evidence of water supply, irrigation, oil, injection, or dry wells was observed on the Property. A groundwater monitoring well, MW-6, is located in front of the Property within School Street. There are numerous groundwater monitoring wells at 3055 35th Avenue, and one monitoring well is located on 35th Avenue down-gradient of the operating Quikstop (3130 35th Avenue).

A groundwater monitoring well, MW-6, from an adjacent down-gradient LUST case at 3055 35th Avenue has detected 1,800 parts per billion (ppb) of Total Petroleum Hydrocarbons (TPH) as gasoline and 230 ppb of benzene, significantly above the Water Quality Objective of 1,000 ppb and one ppb, respectively. PIERS contacted Mr. Keith Nowell of the ACEH regarding the 3055 35th Avenue LUST case and the consultant’s claim that, based on well MW-6 in front of the Property, contamination from the Property was migrating to the 3055 35th site. **Therefore, PIERS recommends conducting a limited soil and groundwater site investigation to determine if the gasoline and benzene concentrations detected in well MW-6 are due to an on-site source of contamination from the Property.**

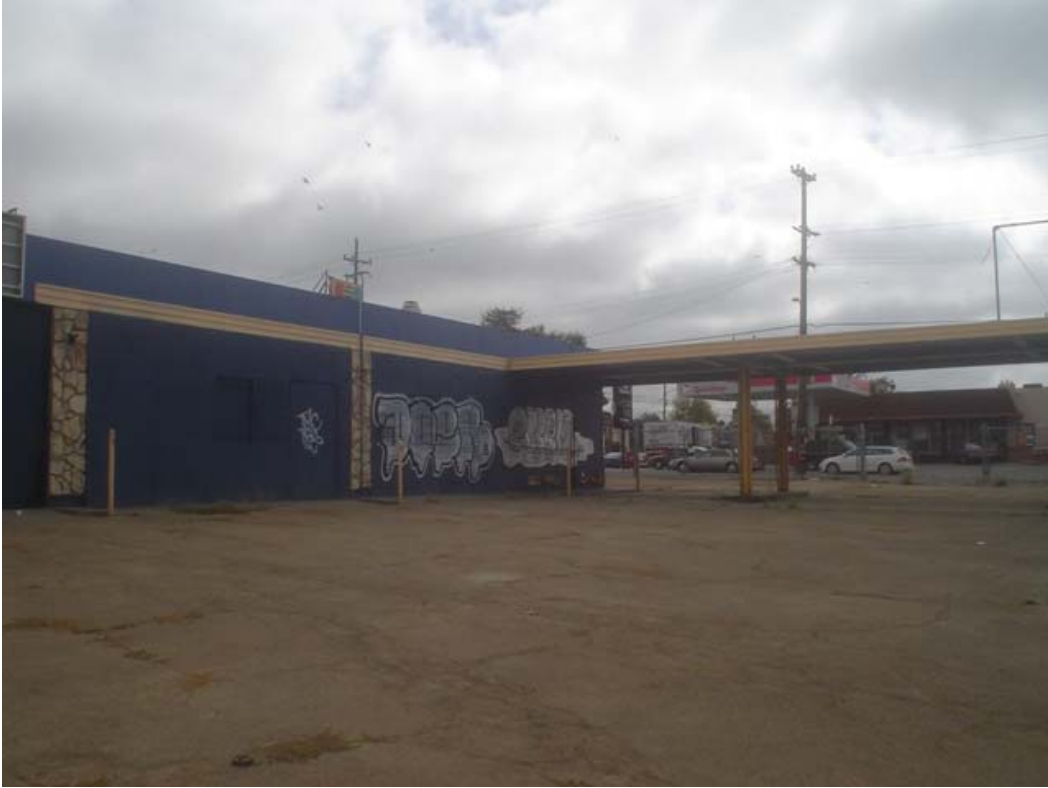
PHOTO #3. VIEW EAST SHOWING FORMER FUELING AREA.

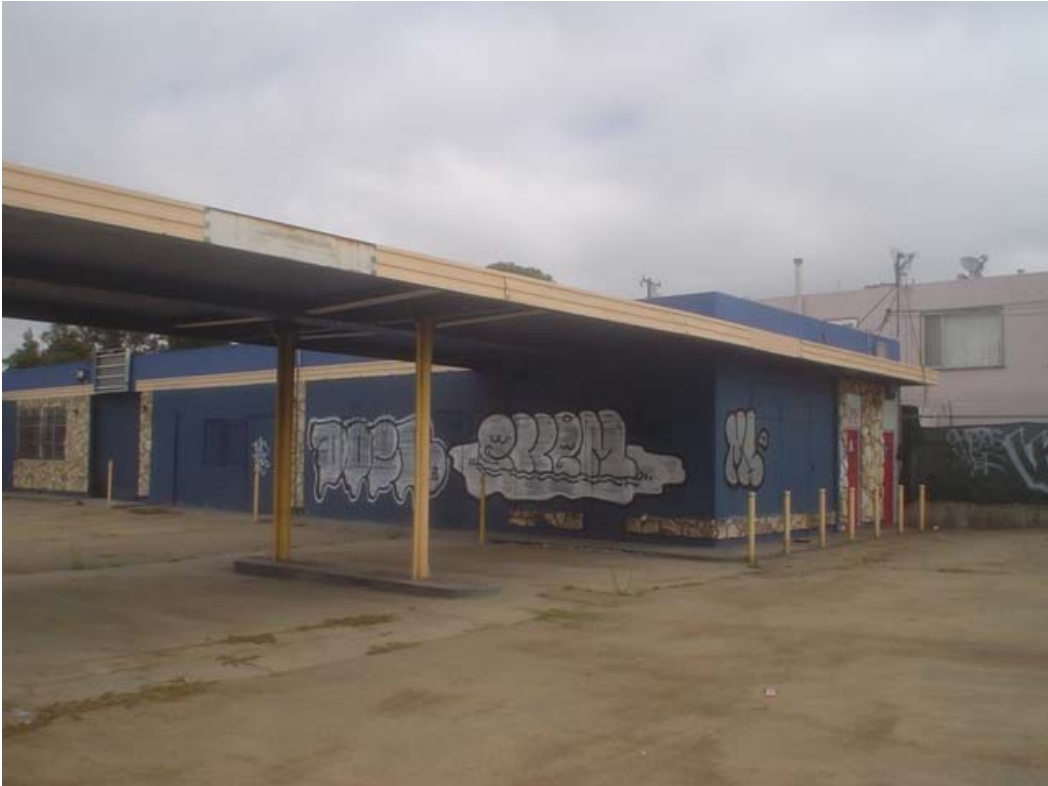
PHOTO #4. ADDITIONAL VIEW OF FORMER FUELING AREA.

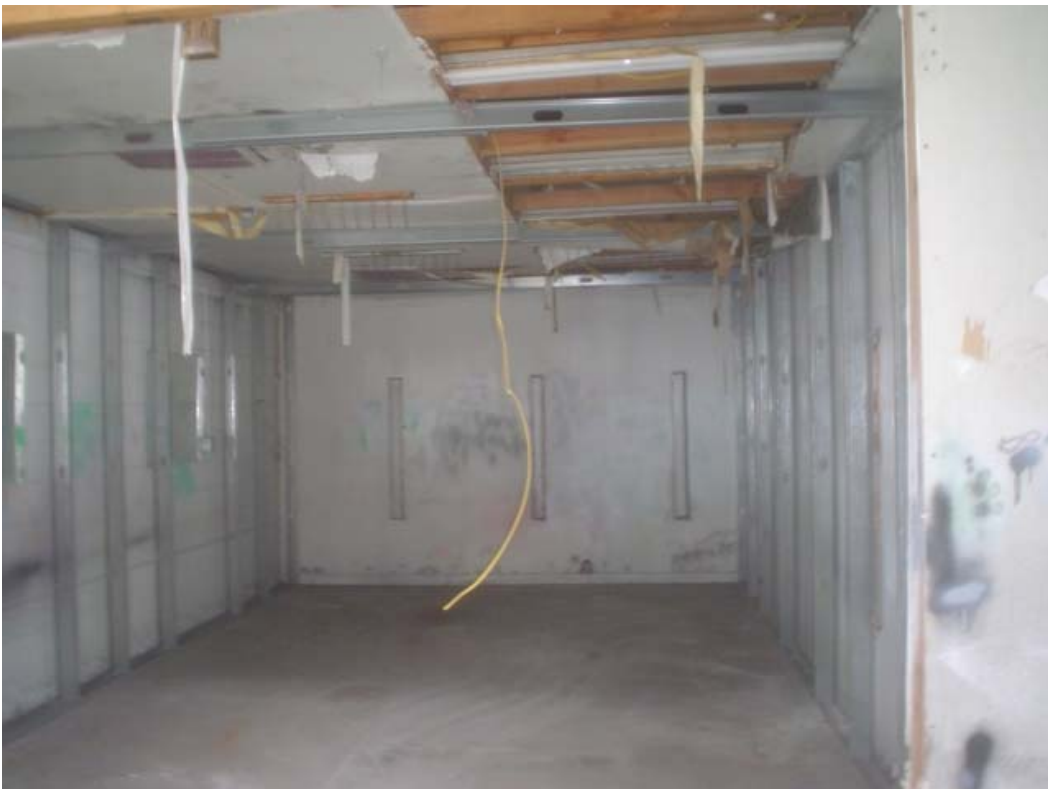
The interior of the Property building is vacant. There appears to be an old spray paint booth in the rear of the building. The building consists largely of two open work areas, one of which is accessible through a rollup door. There are restrooms in an eastern portion of the building.

PHOTO #6. VIEW OF FORMER SPRAY BOOTH.

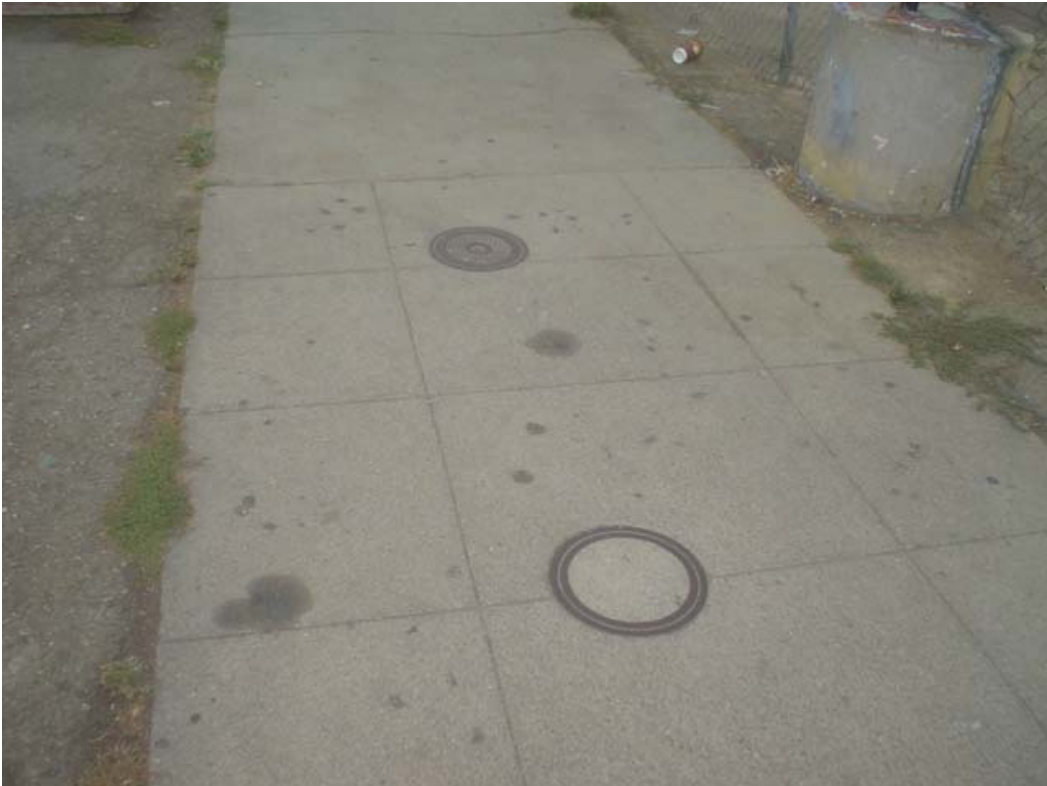
No storage tanks were observed at the Property. There is a concrete-sealed Christy box in the sidewalk along School Street, and another Christy box that could not be opened. These may be the fill ports to underground storage tanks (USTs) that were or are located beneath the sidewalk.

The sealed lid of a Christy box and a second Christy box that could not be opened are located within the sidewalk in front of the Property on School Street, and may represent fill ports to underground storage tanks, based on building department plans from about 1960.

PHOTO #8. VIEW OF CHRISTY BOX AND SEALED BOX IN SIDEWALK.

The gasoline service station closed before environmental regulations existed that required the tanks to be removed and inspected by the regulatory agencies. PIERS was unable to obtain any information concerning tank removals. **Therefore, PIERS recommends performing a geophysical survey in the known tank locations to determine if the tanks have been removed.**

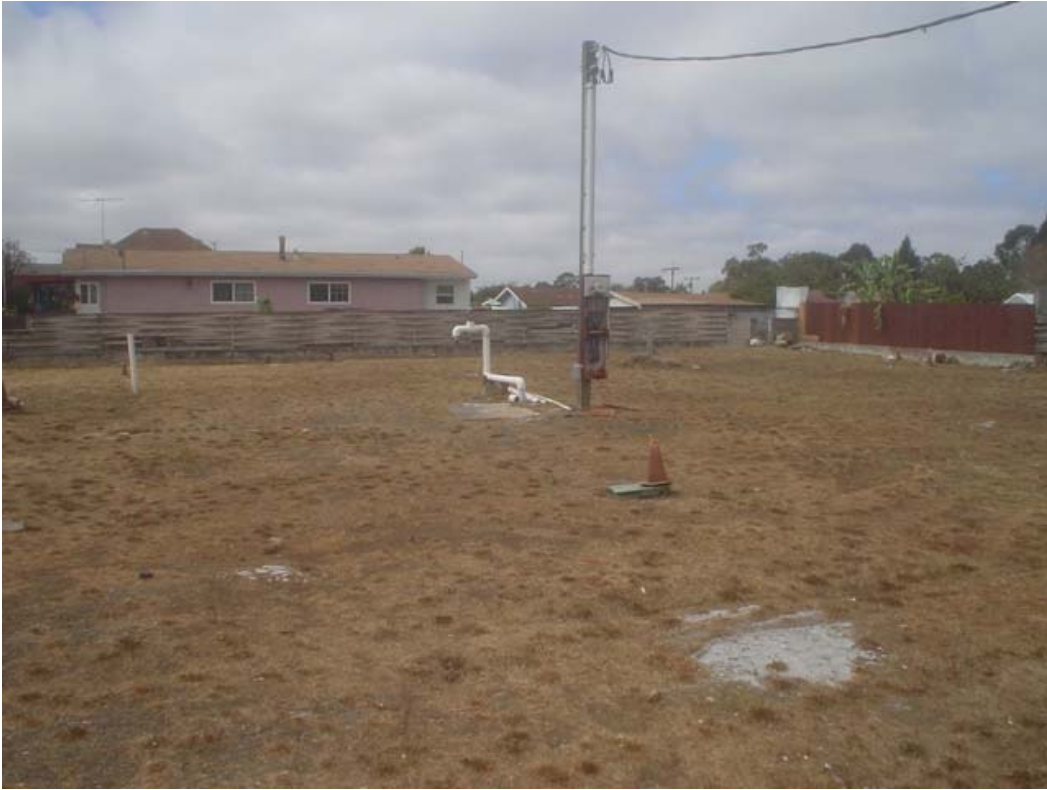
PHOTO #9. VIEW OF PORTION OF FORMER GAS STATION AT 3055 35TH AVENUE.
