Subject: Results of 20 July 2017 Soil Vapor Sampling and Recommendation for
Closure
Former Horton Street Underground Storage Tank
In Public Right-of-Way on Horton Street Adjacent to 5679 Horton Street,
Emeryville, California
Case No. RO0003185

Attachment: Results of 20 July 2017 Soil Vapor Sampling and Recommendation for
Closure

Subject: Results of 20 July 2017 Soil Vapor Sampling and Recommendation for
Closure
Former Horton Street Underground Storage Tank
In Public Right-of-Way on Horton Street Adjacent to 5679 Horton Street,
Emeryville, California
(EKI B20006.00 T7)

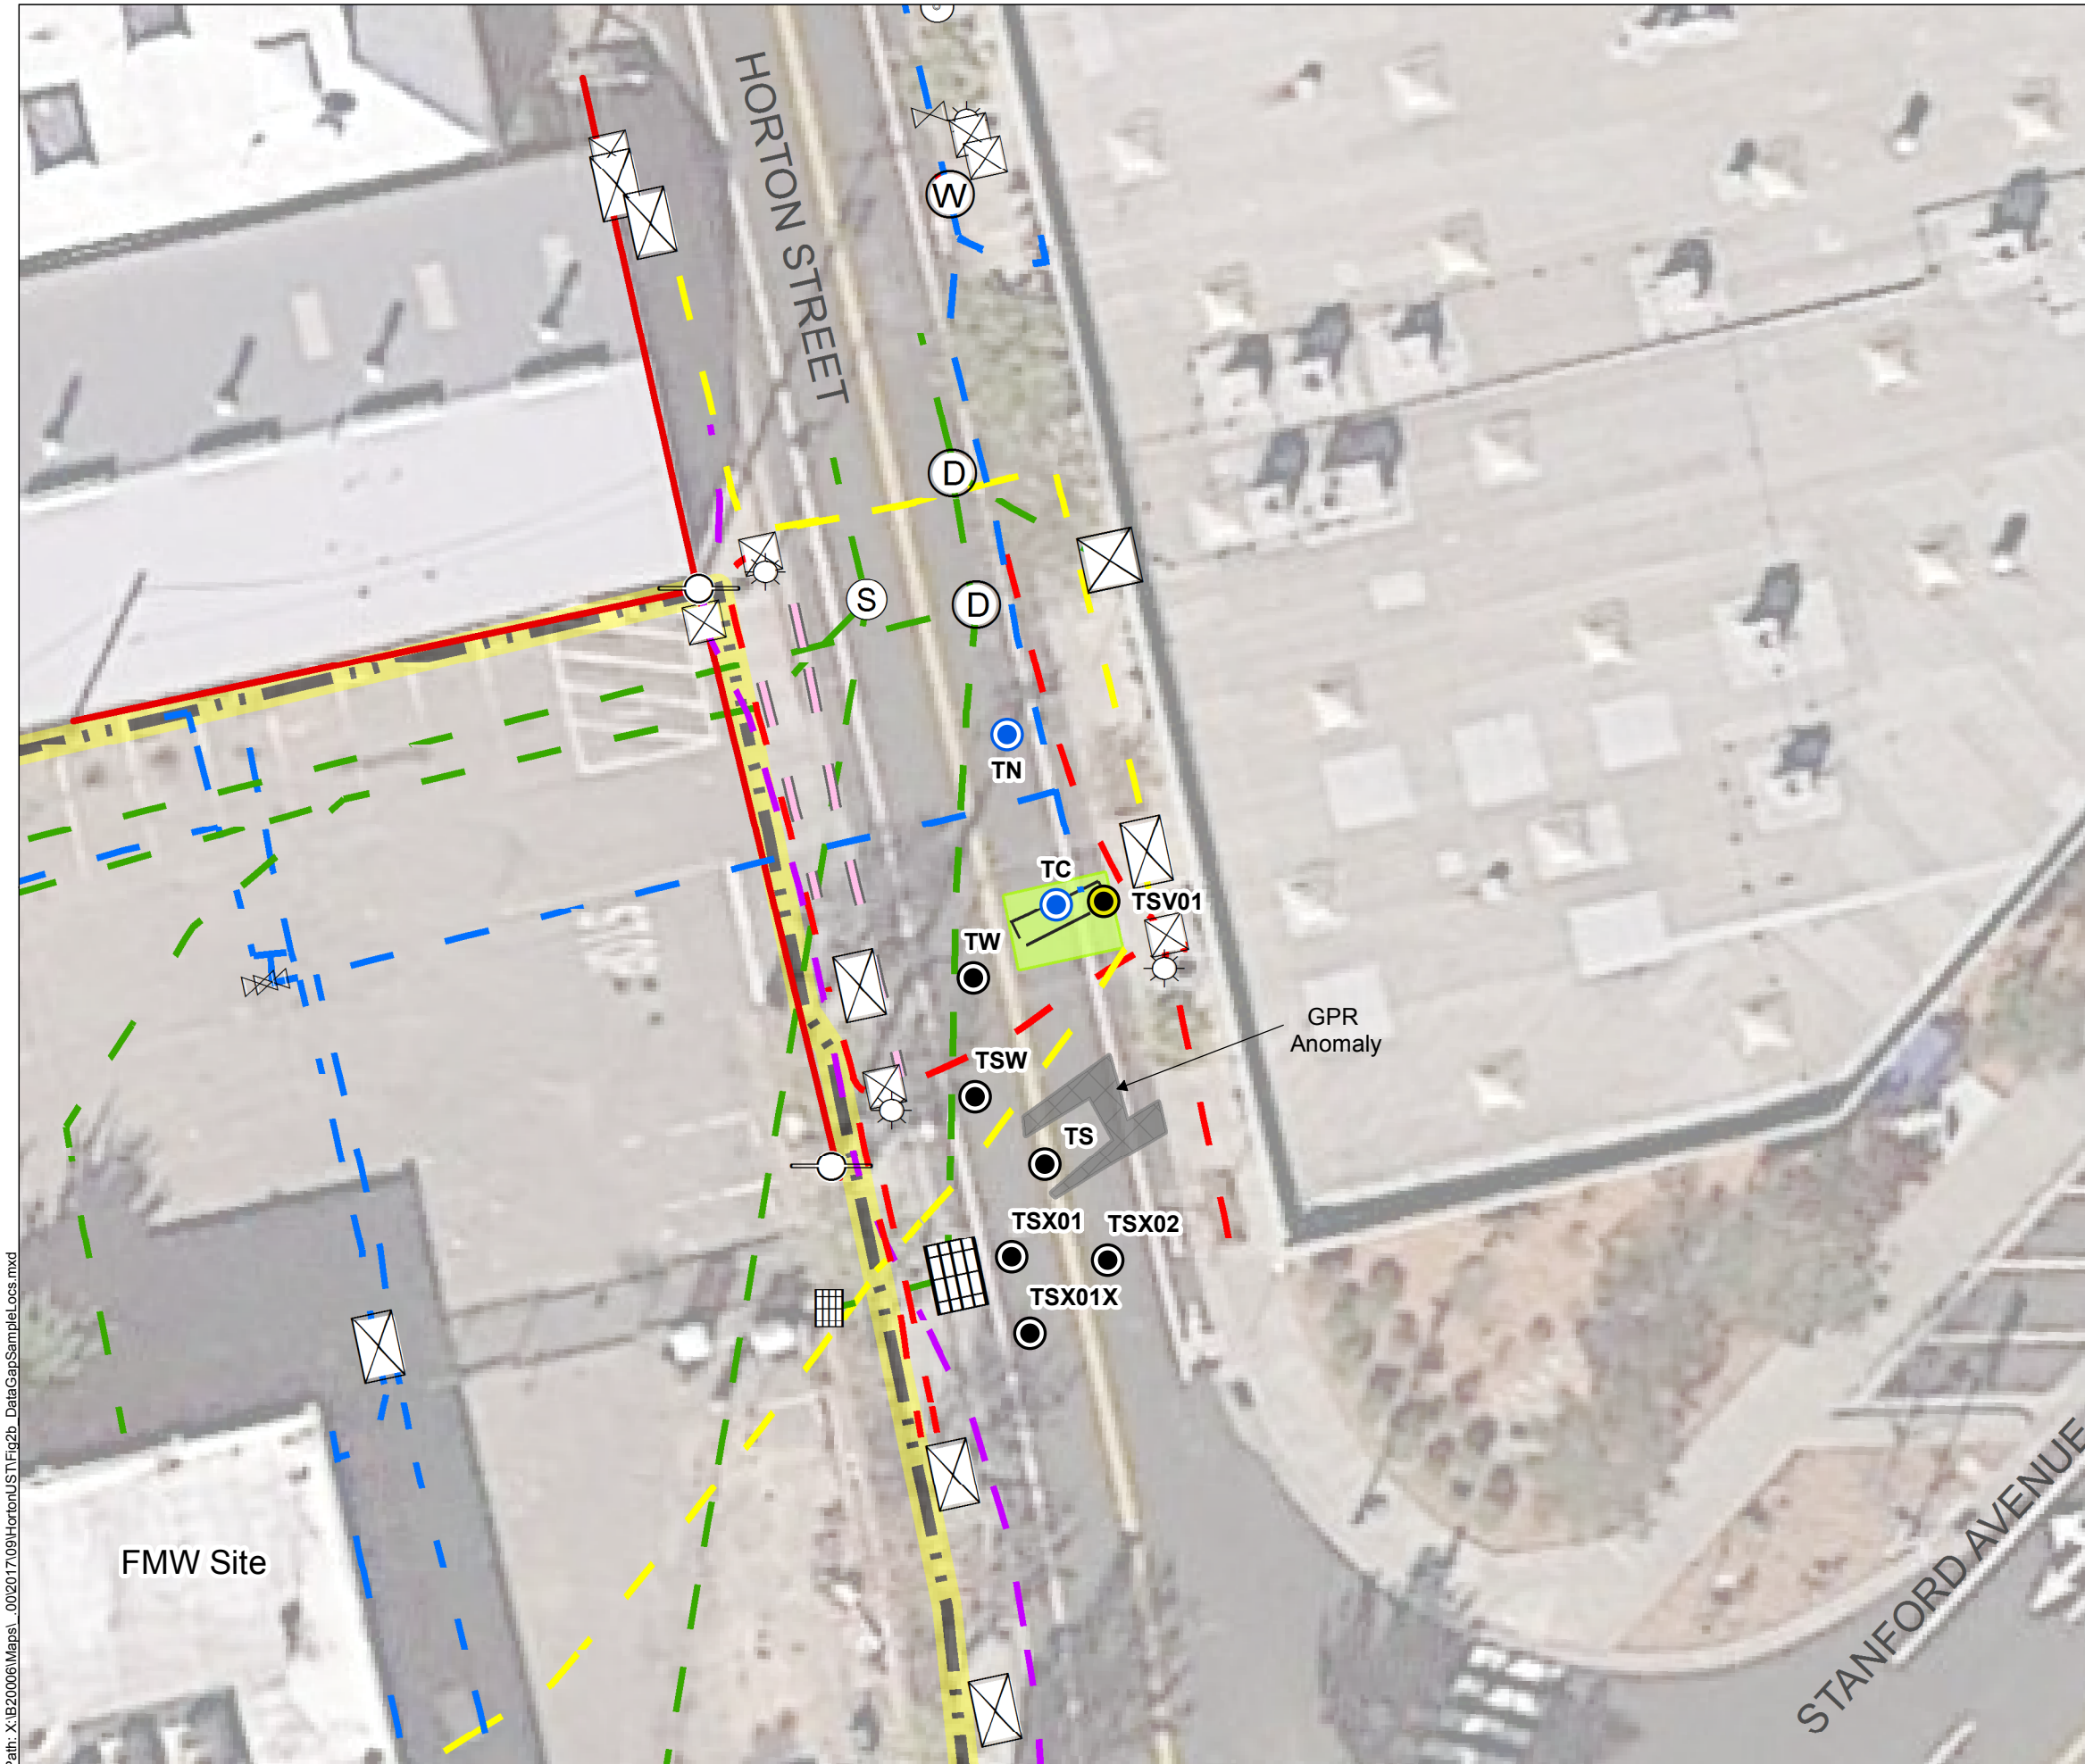
Former Horton Street UST
 Emeryville, CA
 September 2017
 EKI B20006.00 T7
Figure 2b

| Figure 2b | Data Gap Sampling Locations |

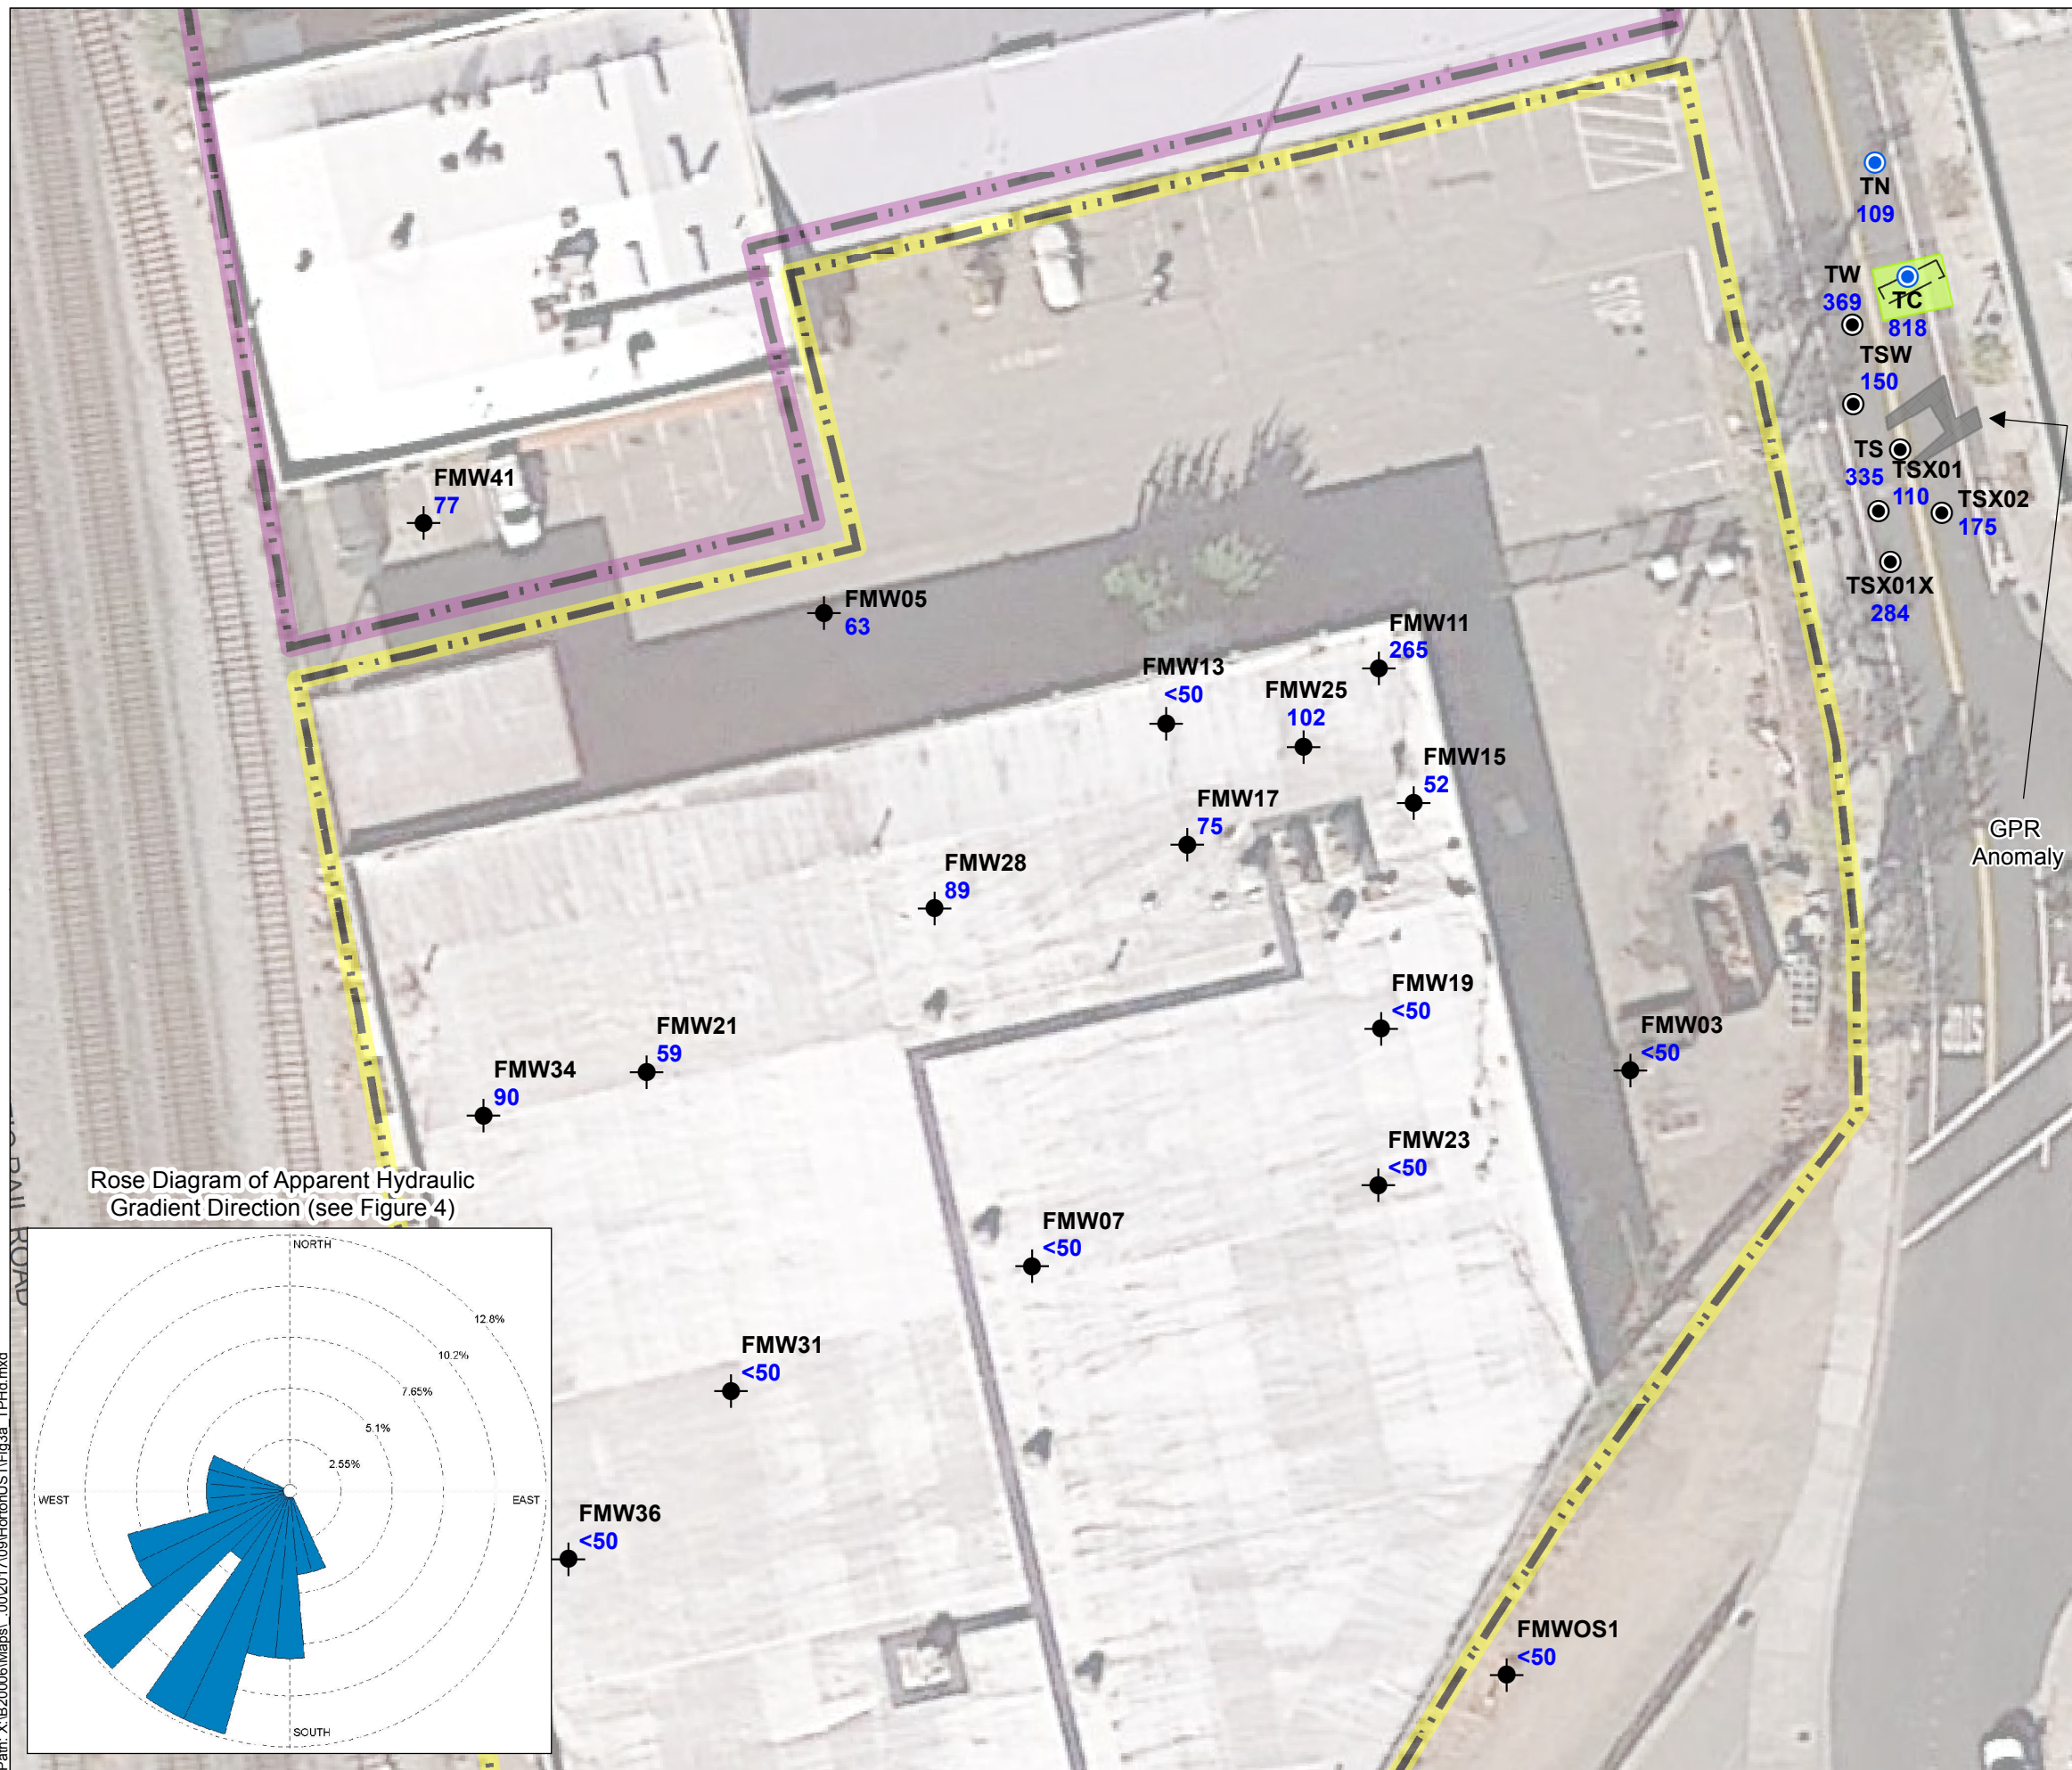
Former Horton Street UST
 Emeryville, CA
 September 2017
 EKI B20006.00 T7
Figure 3a

| Figure 3a | TPH-d in Groundwater |

TPH-d in Groundwater

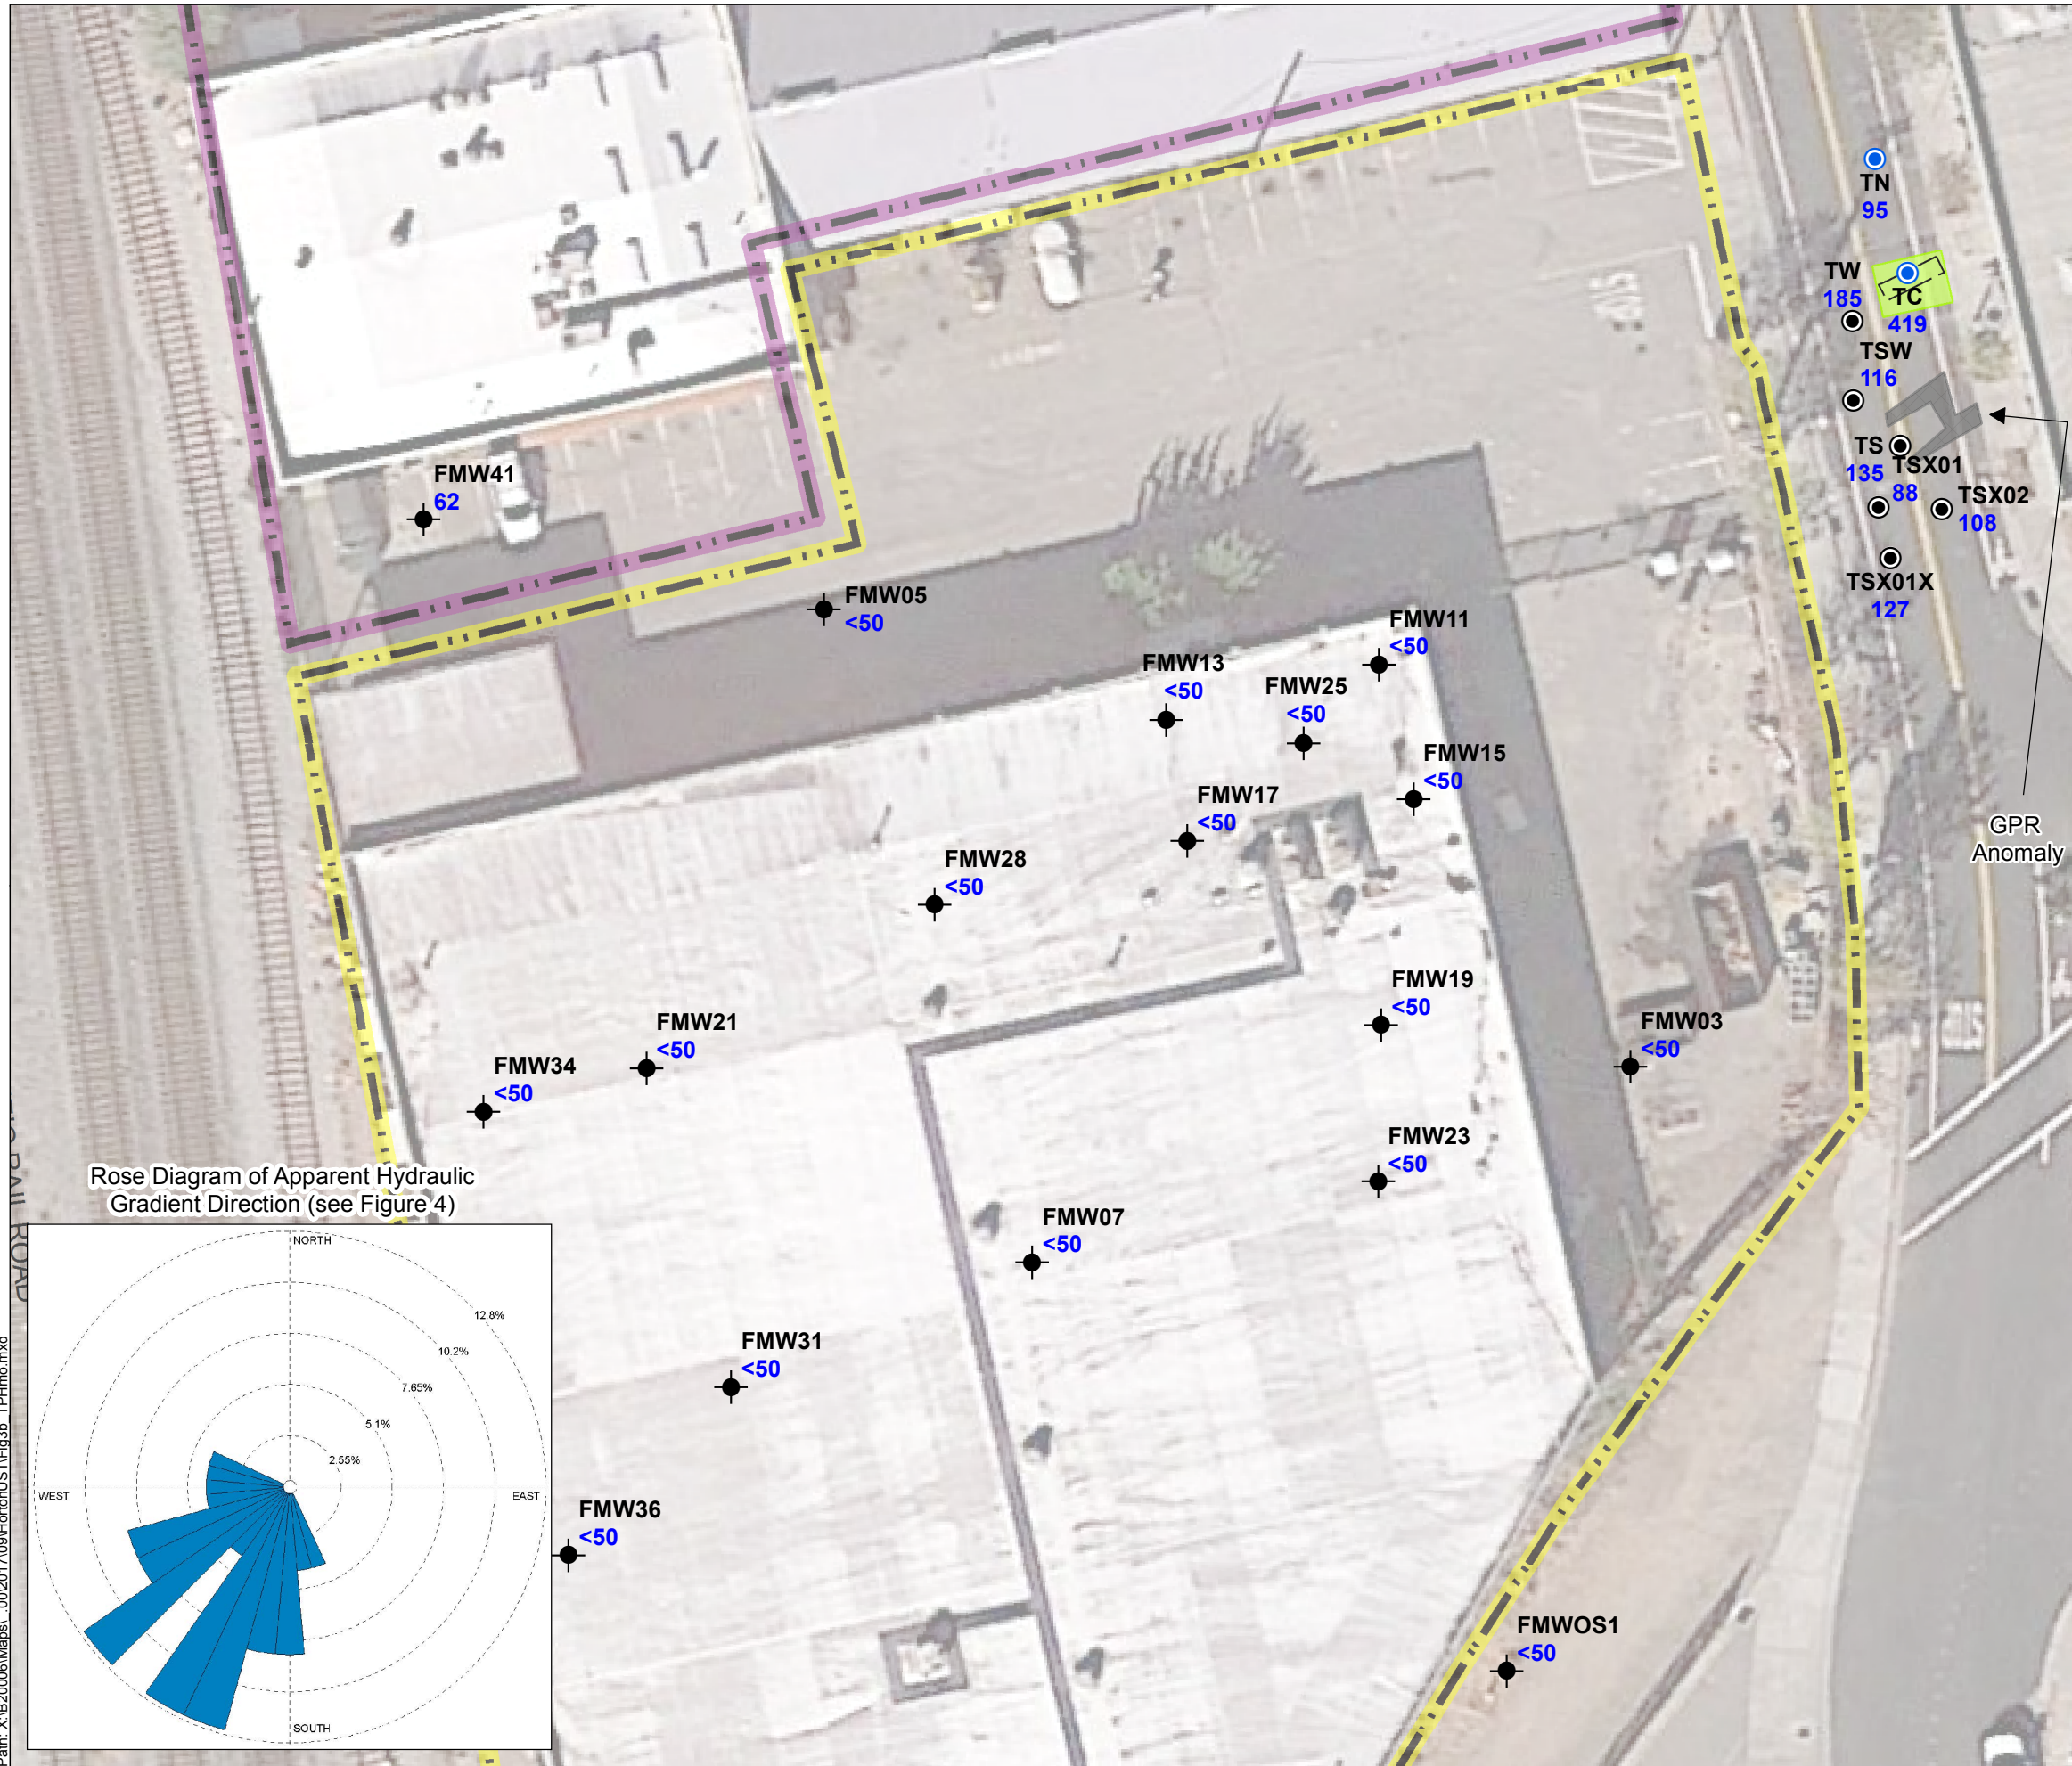
| Figure 3b | TPH-mo in Groundwater |

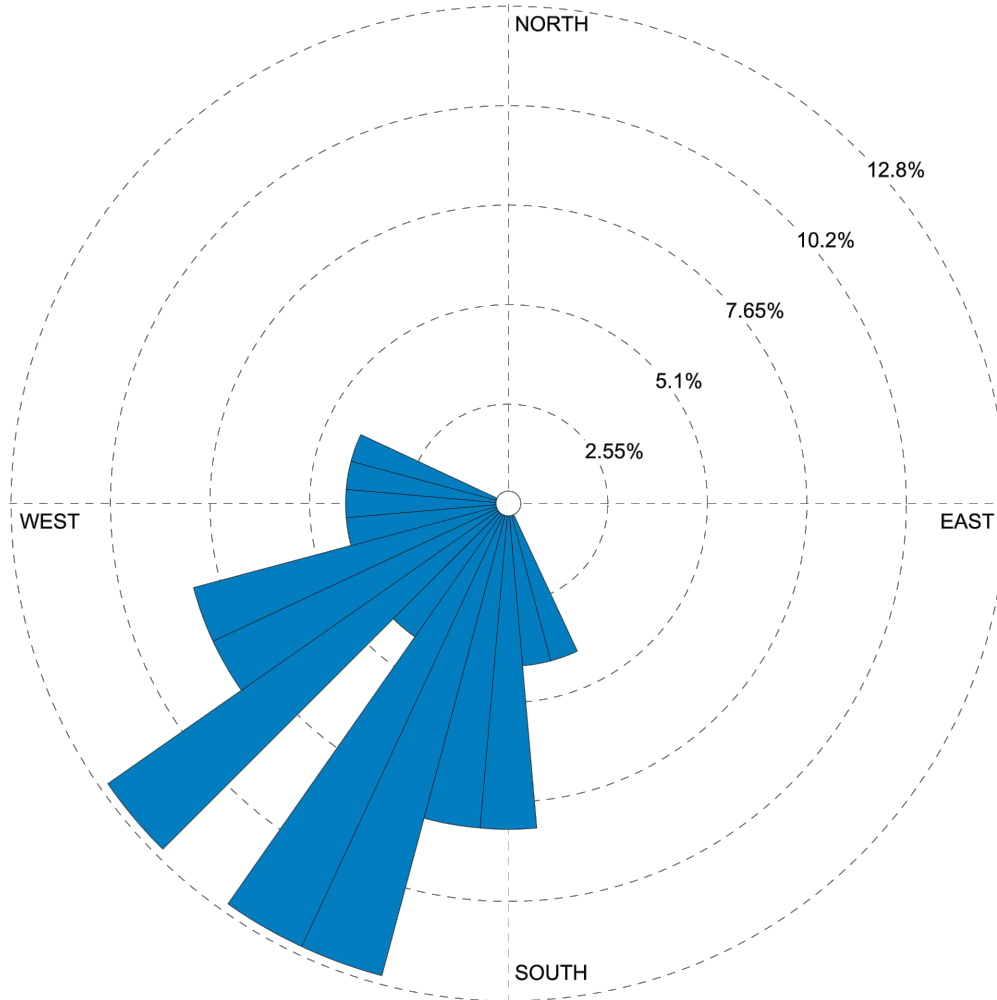
| Figure 4 | Rose Diagram of Apparent Hydraulic Gradient Direction at Site Vicinity |

1. This figure presents a graphical summary of the apparent hydraulic gradient direction of compiled from water level data from wells located in the northeast portion the adjacent Former Marchant/Whitney site, located to the west and southwest of the Former Horton Street UST. Water level data for this figure was collected July 2015, September 2015, November 2016, and January 2017.
2. This figure was compiled using WRPLOT View, Version 8.0.0 by Lakes Environmental.

| SCM Element | SCM Sub-Element | Description | Data Gap (a) | How to Address (a) |
|---|---|---|---|---|
| | b. Site & Vicinity | The apparent hydraulic gradient direction is generally to the southwest in the S10, 1032, 3243 and 4360 Units based on data from the adjacent FMW Site to the west of the Site. A rose diagram of apparent hydraulic gradient direction in the S10 Unit in the northeast portion of the FMW Site immediately downgradient of the Site is shown on Figure 4, and the predominant hydraulic gradient direction is to the southwest/south-southwest. A slight upward hydraulic gradient was also observed between co-located wells in the S10/1032 Units, 1032/3243 Units, and the 3243/4360 Units on the FMW Site. (Reference: EKI, 2016b) | None | NA |
