**RE: Former Sisters of Providence Hospital  
27<sup>th</sup> Street and Broadway Avenue  
Oakland, CA (the "Site")  
Site Cleanup Program No. RO0003191  
dilan.roe@acgov.org**

On behalf of CRP/THC Oakland Broadway Uptown Venture LLC (the "Developer"), I would like to thank you for taking time to meet on November 17, 2017 to discuss the foundational feature that Developer encountered during redevelopment of the Site. As we discussed during our meeting, Developer committed to providing the Alameda County Department of Environmental Health (the "County") the additional information we discussed in that meeting which supported a conclusion that the foundational feature was not an underground storage tank and, therefore, should not be regulated as an underground storage tank. The purpose of this letter is to provide the County with this additional information.

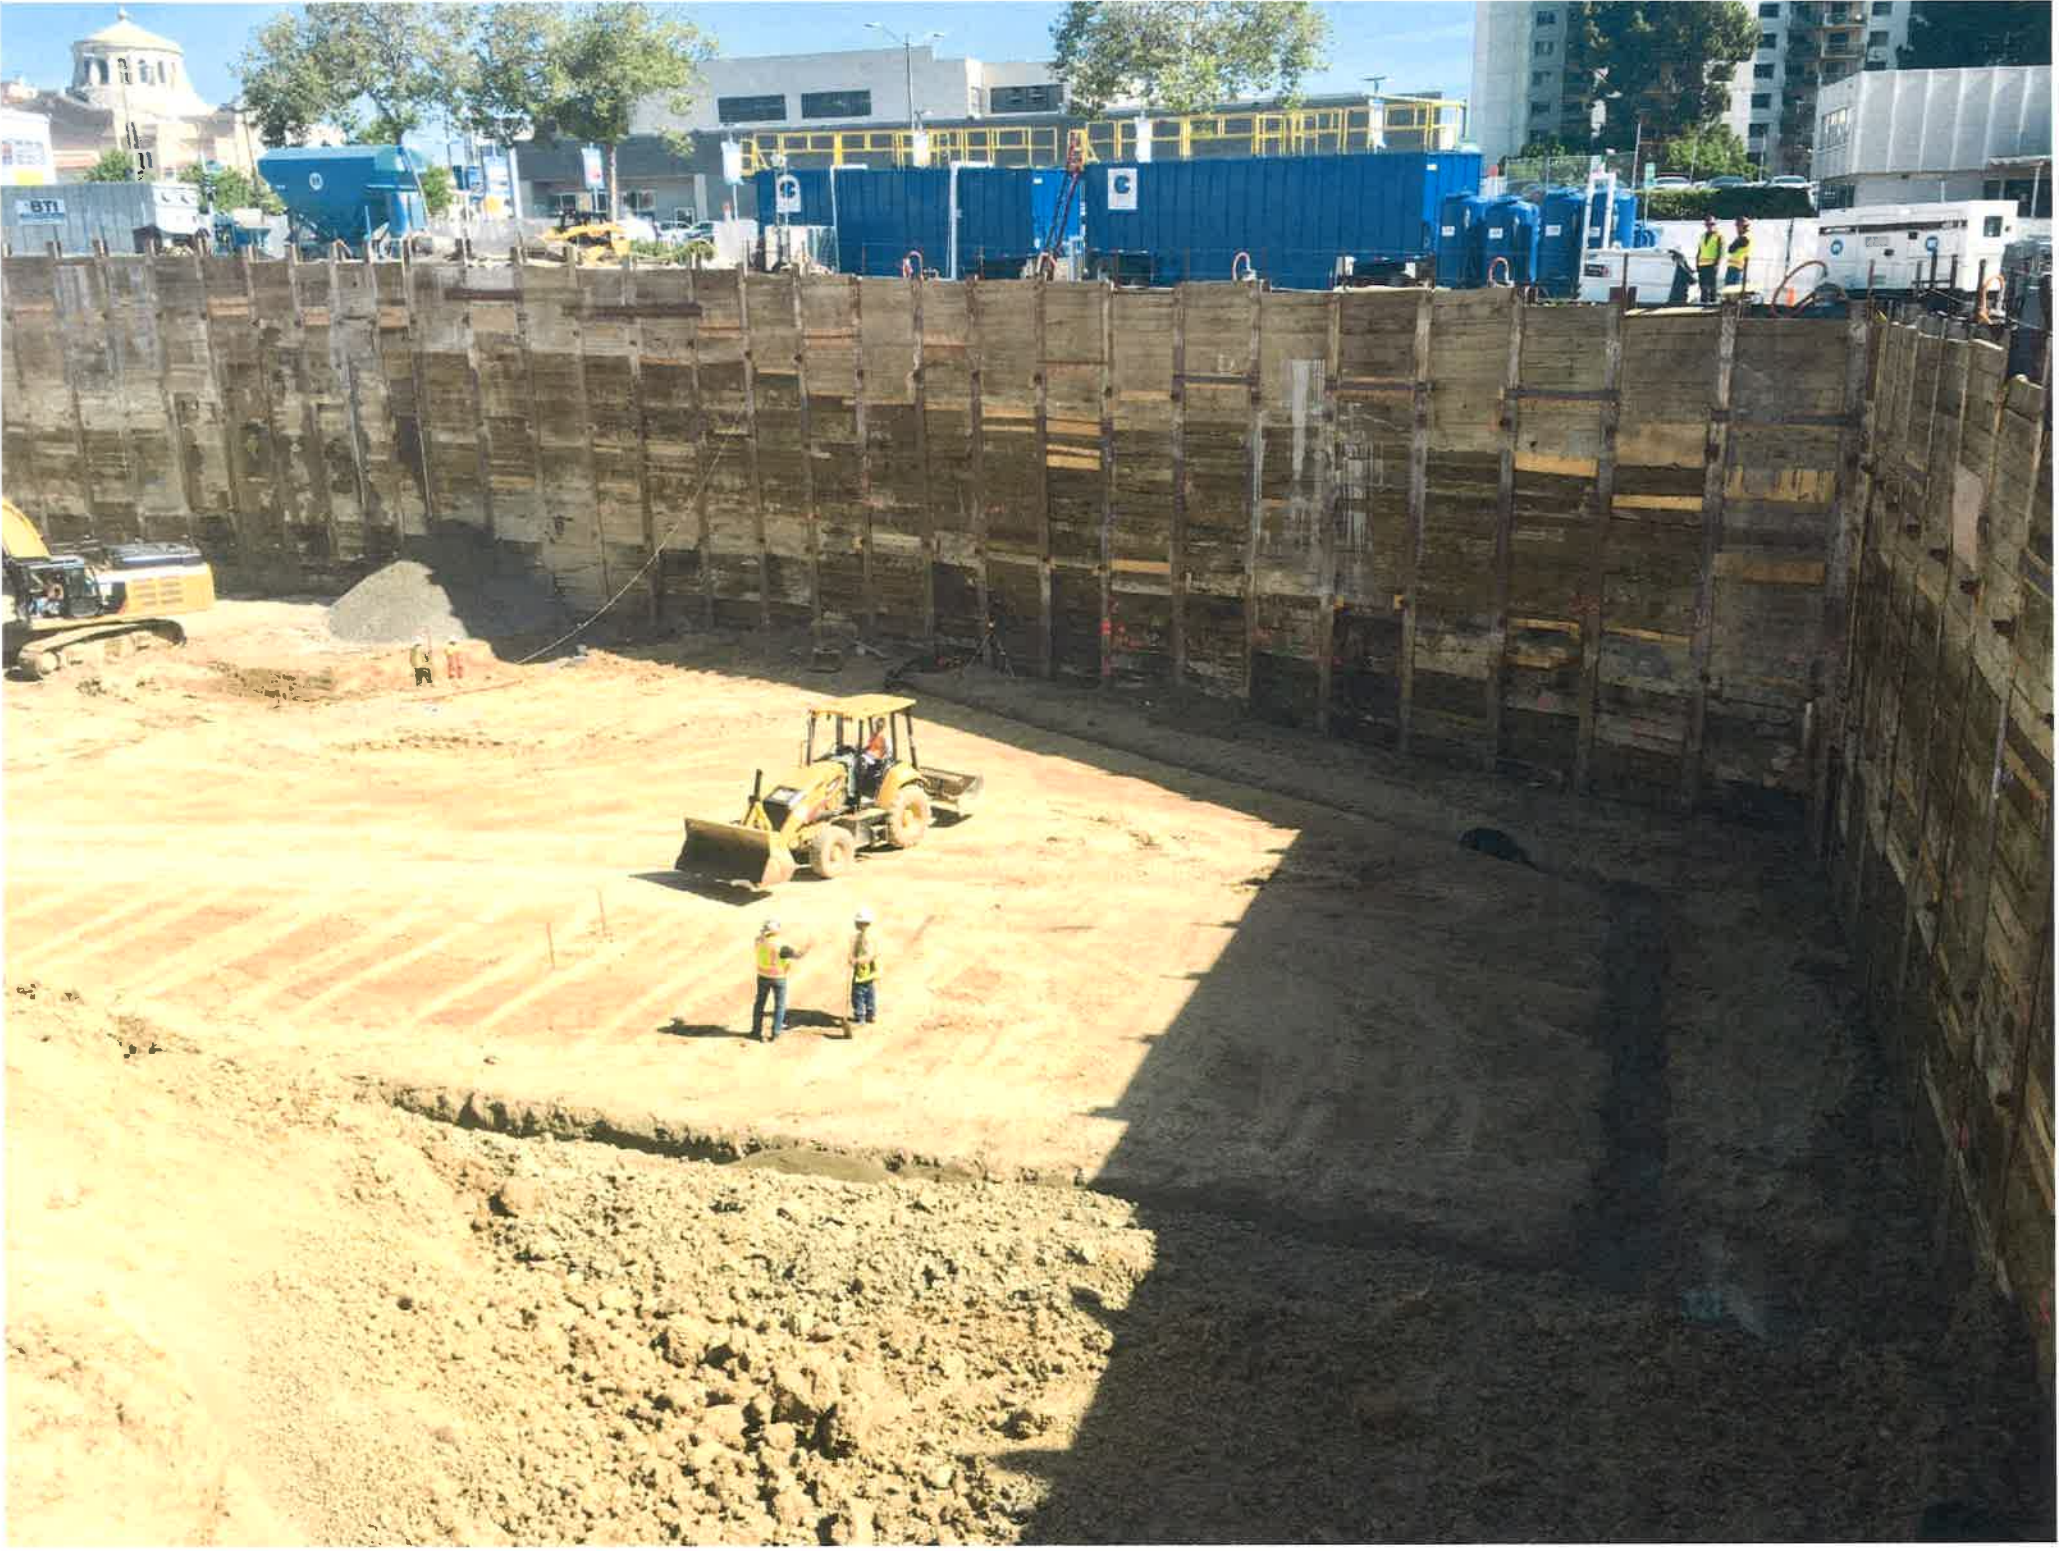
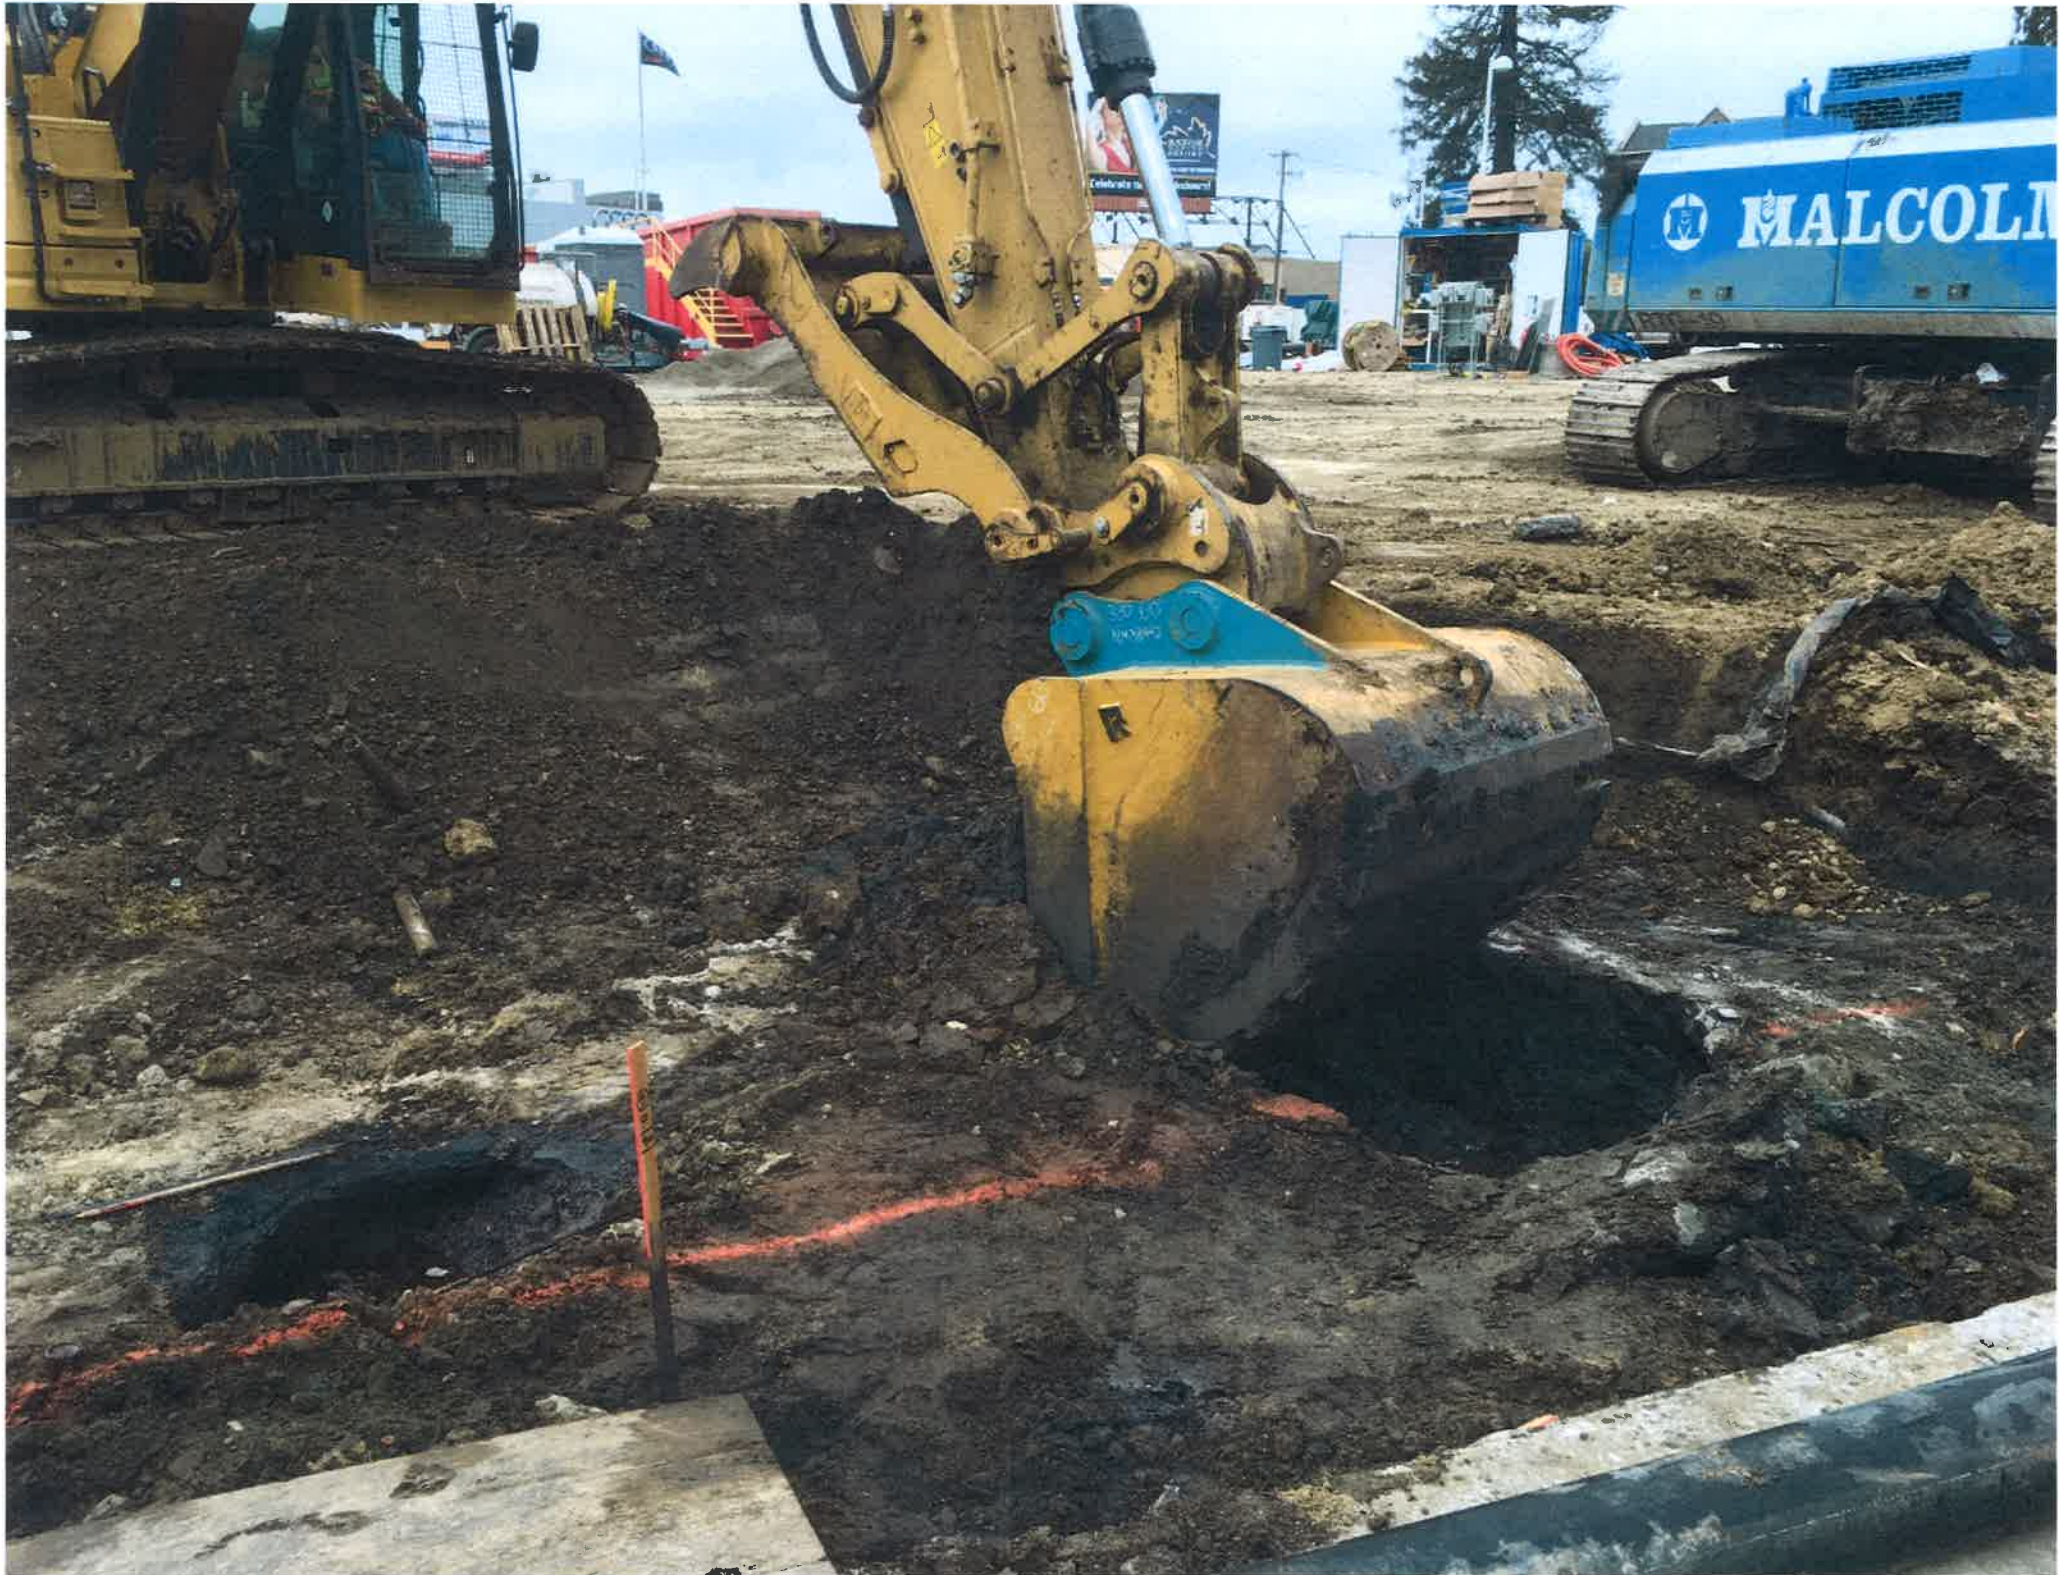
2. **Design of the Foundational Feature.** As depicted in the attached photographs, the top of the foundational feature was completely open when Developer encountered it. There was also no indication in the field that a top ever existed on the foundational feature. The fact that the foundational feature was not an enclosed structure and had an open top indicates that it was not “designed to contain an accumulation of hazardous substances.” Further evidence that the foundational feature was not used as an underground storage tank is that a layer of thick concrete was located below and attached to the bottom of the foundational feature. This suggests that foundational feature was designed to serve as a component to a larger foundation system rather than an underground storage tank.

3. **Shape and Size of the Foundational Feature.** The foundational feature’s shape and its size are inconsistent with the shape and size of a typical underground storage tank. The foundational feature was an irregularly shaped structure and measured approximately 10 feet by 20 feet. It did not have any piping or other connections leading from the foundational feature, which are often observed when encountering an underground storage tank. As such, the foundational feature did not bear any resemblance to an underground storage tank.

4. **Contents of the Foundational Feature.** The contents of the foundational feature included dirt, fill material, bottles, trash and a liquid. Testing of the liquid within the feature indicated that it was primarily water with a small concentration of petroleum. Due to heavy rains in the months immediately prior to Developer encountering the foundational feature and the fact that the foundational feature was not sealed on the top, it is likely that liquid discovered within the foundational features resulted from the heavy rain events. As explained in Developer’s prior letters to the County, Developer properly

removed and disposed of the liquid in accordance with the Site Management Plan. Because the foundational feature included a variety of materials and not just the liquid, it is likely that such materials and liquid were moved to the foundational feature as part of the demolition of the former hospital in the 1940s rather than stored in the foundational feature as part of the former hospital operations.

All of the factors discussed above led Developer to conclude in the field that the foundational feature encountered during development was not an underground storage tank. As noted during our meeting, Developer has completed the excavation of the entire Site to a depth of approximately 40 feet. All of the excavated soil was handled and disposed of properly in accordance with the Site Management Plan and applicable California regulations.
